# **Bicycle Lane**

## **State of Good Repair 2010**

**Presentation to the Toronto Cycling Advisory Committee  
18 January 2010**

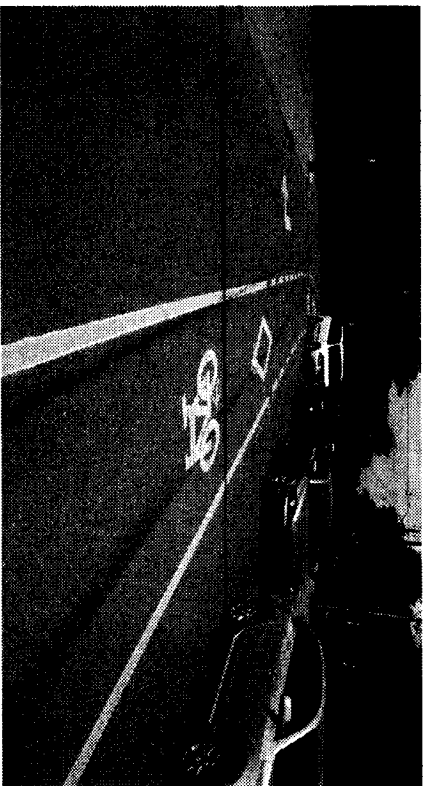
Millwood Rd. south of the bridge.

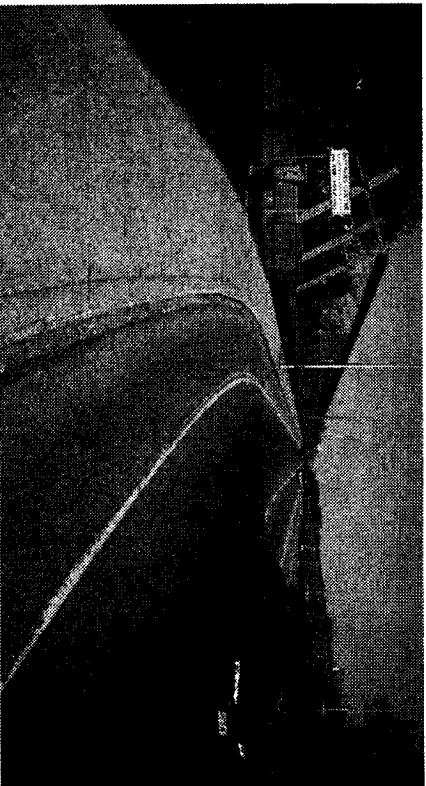
Bloor St. E. west of the viaduct

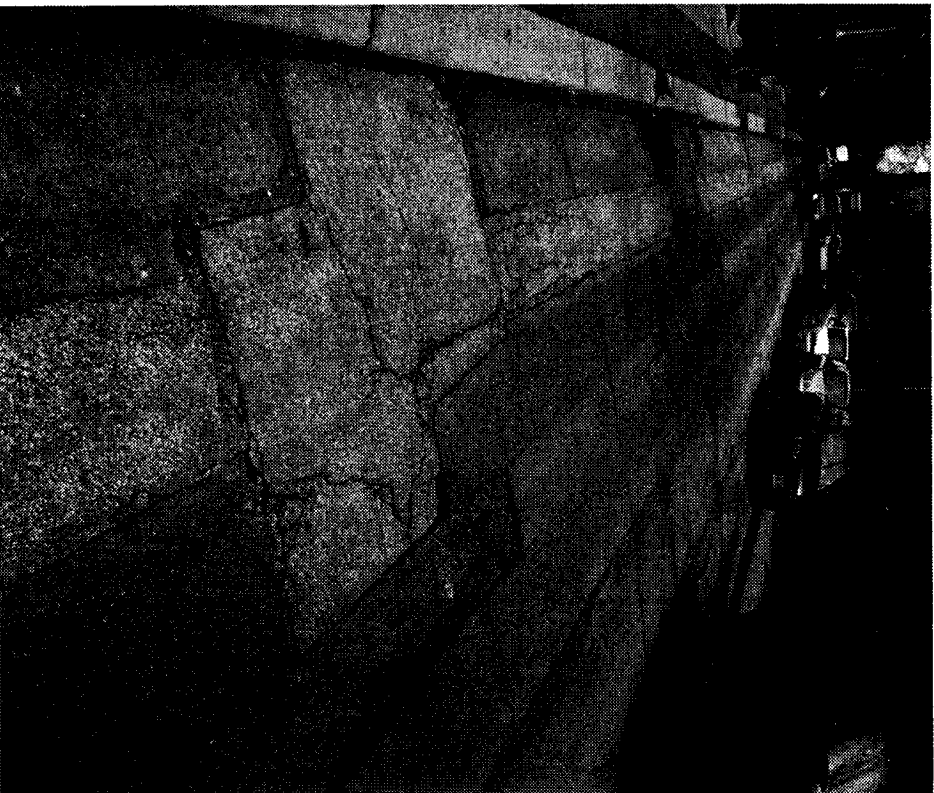
Shuter St. east of Jarvis St. — Priority One

- **Cycling Infrastructure, Surface Maintenance and Road Operations will review compiled list**
- **Work to be coordinated with Capital Program**
- **Intent to remedy the deficiencies in 2010**

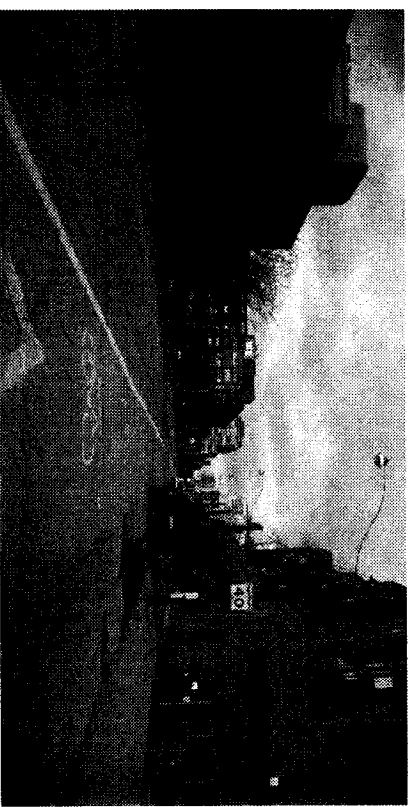
Runnymede Rd. south of Bloor St. W. — Priority Two

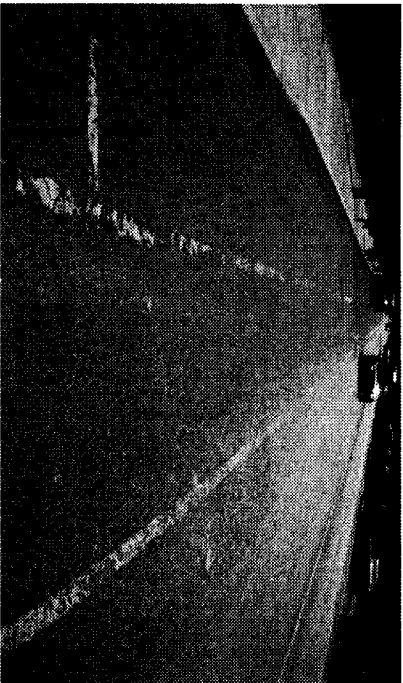
Runnymede Rd. south of Bloor St. W.

**Pavement marking deficiencies included faded or non-existent lines and symbols. Intersection gaps were also noted.**

- To be addressed in our 2010 program
- Some issues will require Council Approval (missing sections)

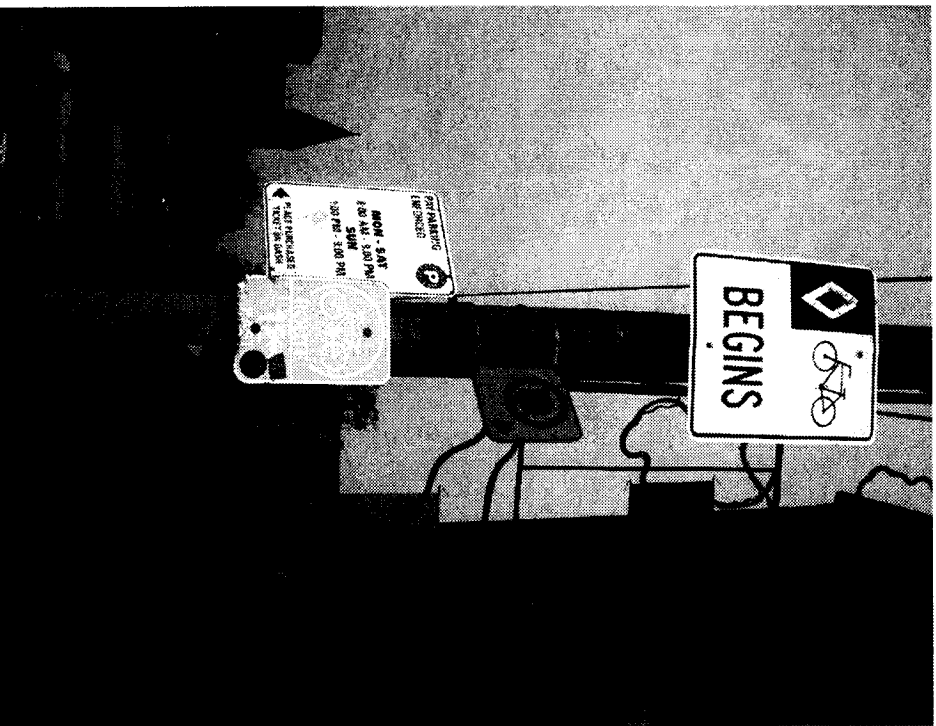
College St. west of Spadina Ave.

# Missing Signage included Bike Lane Begins/Ends signage and Bikeway Route signage.

- To be addressed in our 2010 program
