## STAFF REPORT ACTION REQUIRED

### Fence Exemption Request - 68 Frost Street

<b>Date:</b>	February 26, 2007
<b>To:</b>	Etobicoke York Community Council
<b>From:</b>	Curtis Sealock, Manager, Municipal Licensing and Standards
<b>Ward:</b>	Ward 2 - Etobicoke North
<b>Reference Number:</b>	ML&S Folder No. 06-173531FEN

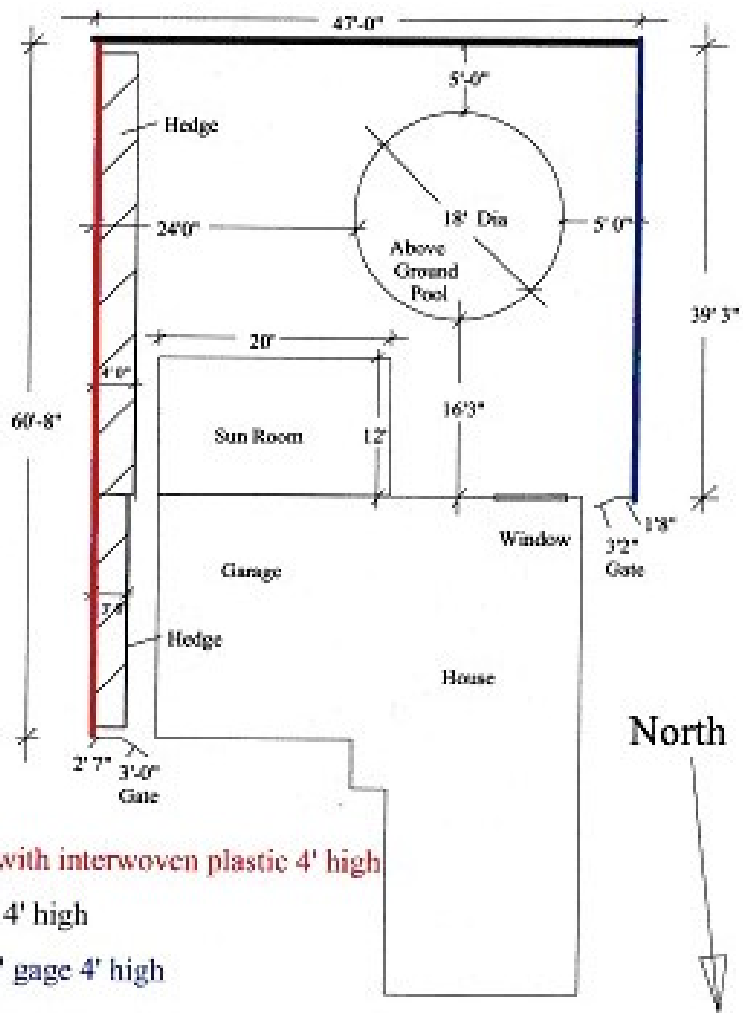
**Attachment 1: Drawing of the Fence Enclosure**

It should be noted that remaining fencing which forms part of the pool enclosure does comply with the By-law (Attachment 1).

East Fence - 2" gage with interwoven plastic 4' high  
 Other enclosure type 4' high  
 West chain link 1 1/4" gage 4' high

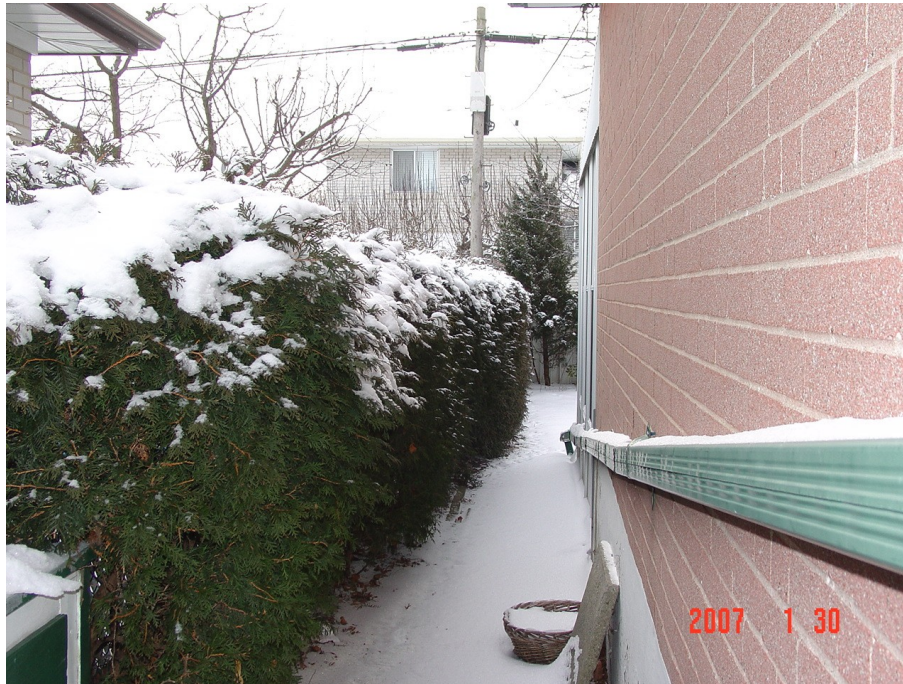
**Attachment 2: Photographs showing the fence on the east side**

The fencing on the east side is within the required height under the said By-law. The By-law requires a chain-link meshing forming part of swimming pool enclosures to be of 38 millimetres (1½ inches) maximum in size, pursuant to Section 447-3E(2)(a) of Toronto Municipal Code Chapter 447. The cedar hedge on the inner side of the fence may be deterrent to climbers, but it does not preclude the possibility of someone climbing over it. The window at the south elevation of the house forming part of the swimming pool enclosure does not have a limiting device to prevent it from opening more than 100 millimetres, this being contrary to Section 447-3C(3) of Toronto Municipal Code Chapter 447.

Fence on the east elevation partly covered by a cedar hedge

The Etobicoke York Community Council deny the request for the exemption based on non-compliance with the requirements set out in Chapter 447 of the Toronto Municipal Code.

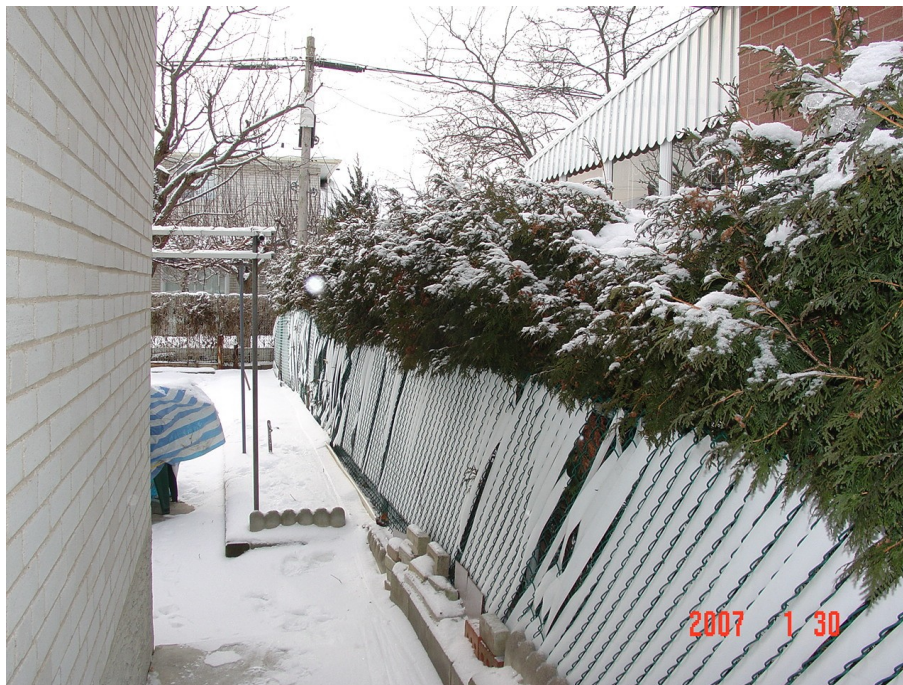
It is understood that the property owners/applicant(s) erected an above-ground swimming pool in May of 2000. The fence on the east side is of a chain-link type, with a 50-millimetre (2 inches) metal mesh interwoven with vinyl slats and also has a cedar hedge on the inner side of the fence (Attachment 2). A window facing the rear yard which also forms part of the swimming pool enclosure does not have any protection to prevent it from opening more than 100 millimetres (4 inches). Both issues/infractions are the subject of this exemption request.

Photograph showing the subject fence on the east elevation  
Taken from the neighbouring property at 66 Frost Street  
(Note: The fence appears to be out of plumb because of the way that the vinyl slats are woven)

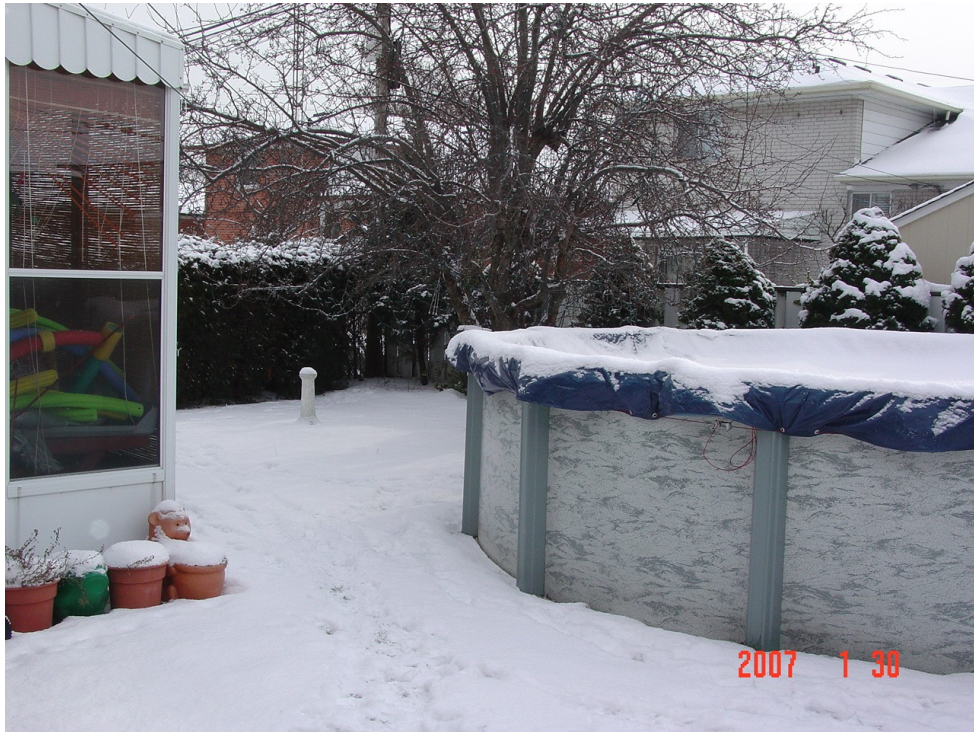
**Attachment 3: Photographs showing the Pool**

On September 6, 2006, a Municipal Standards Officer attended at the subject property in response to a complaint and found an above-ground swimming pool at the rear yard

which did not have a proper pool enclosure (Attachment 3). A search of our records indicated no permit being issued for this pool enclosure.

Photograph showing the pool relative to the house (looking south east)

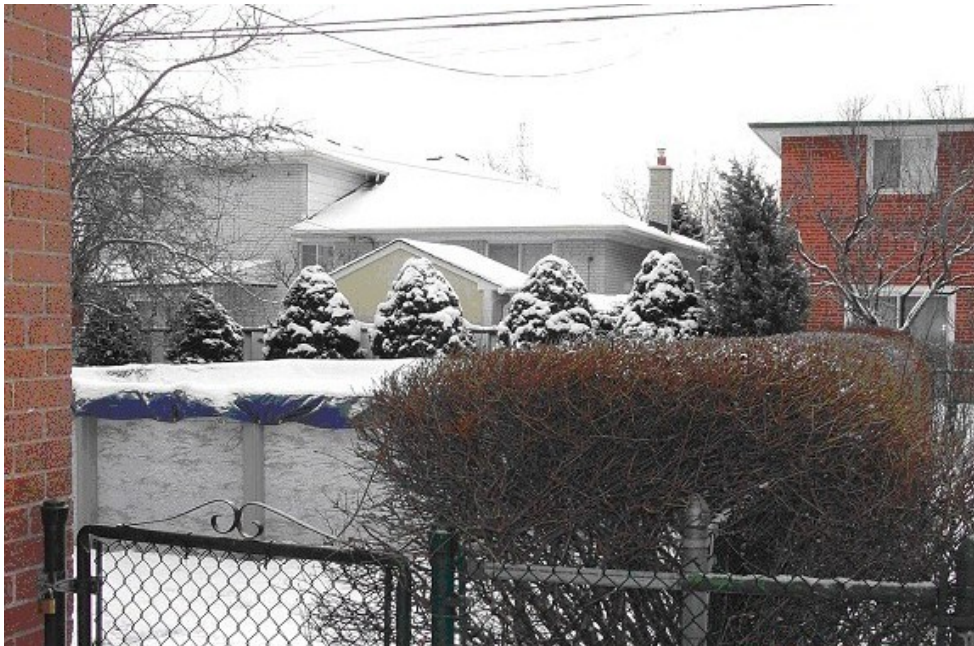
Photograph showing the entrance gate and the fence on the west side (the mesh here which is 32 millimetres (1¼ inches) in size is in compliance)
