**MOULD ASSESSMENT REPORT  
134 Coxwell Avenue  
Toronto, Ontario**

**SEL Project Number 210107**

**Re: Results of Mould Assessment  
134 Coxwell Avenue, Toronto, Ontario**

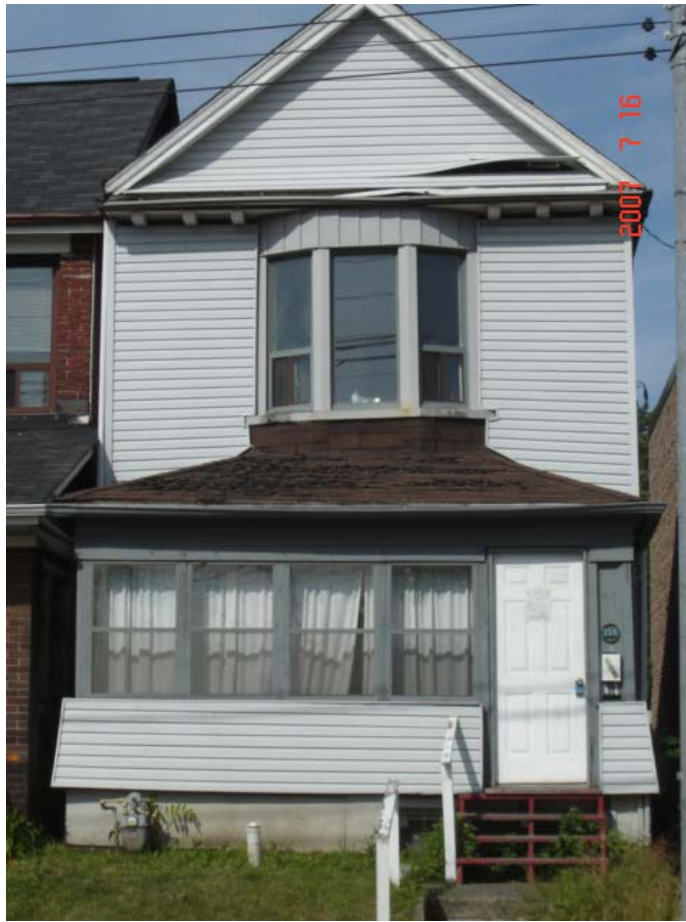
P1

<b>1. Exterior</b>	<b>Area Classification: 1+</b>	<b>Level of Remediation: 0</b>
<p><b>Observations:</b> The front (east side) of the residence exhibited some damage to the vinyl siding on the second floor level and the shingles associated with the front porch were noted to be deteriorating (P1). The north side of the porch itself was noted to be deteriorating, with suspect mould growth noted to sheathing materials located behind the siding (P2). Paving stones along the north side of the residence were noted to be sloping towards the foundation at the back side of the house, with visible greenish algae-like discolouration noted in this area. Several areas of the cement parging were also cracked. The basement window was missing on the north side, near the front of the residence.</p> <p>Exterior siding and bricks at the back (west side) of the residence appear to be in satisfactory condition although some re-pointing may be required in the centre, near the chimney. Building materials around the back entrance are deteriorating and portions of siding area missing.</p> <p>There was limited access to the south side of the residence, which was sheathed in vinyl siding over the original brick exterior finish. The lower sections of siding were noted to be bowed out significantly, with minor brick and other debris noted along the bottom of the wall. It appears from our visual observation as well as conditions noted within the residence (see below) that the south exterior brick wall is deteriorating significantly.</p>

Front of Residence: Vinyl siding damaged above 2<sup>nd</sup> storey window. Shingles associated with front porch are damaged.

<p><b>Remedial Action:</b> Further investigate the south brick wall and the front porch to determine structural integrity and feasibility for repair. Other areas of damaged siding, roofing, windows and concrete as noted above also require repair. The full extent of damage present to exterior walls is likely hidden by the presence of the vinyl siding.</p>		
<b>2. Attic</b>	<b>Area Classification: 0+</b>	<b>Level of Remediation: 0</b>
<p><b>Observations:</b> Access into attic space was restricted to small access hatch in washroom. Wood plank sheathing and wood framing in the attic exhibited visible evidence of dark staining, discolouration and weathering, but no visible evidence of obvious mould growth.</p>		
<p><b>Remedial Action:</b> No further action necessary.</p>		
<b>3. 2<sup>nd</sup> Floor</b>	<b>Area Classification: 2+</b>	<b>Level of Remediation: 3</b>
<p><b>Observations:</b> 2<sup>nd</sup> floor consists of three bedrooms and a washroom. Building surfaces present within the bedrooms included wood or vinyl flooring, and plaster walls and ceiling. Surfaces exhibited varying degrees of debris accumulation, with minor dirt and suspect mould noted to window sill and trim (quarter round) around the window in the centre bedroom. There was no visible evidence of obvious mould growth to other areas within the bedrooms although there were signs of suspect water damage, with peeling and cracking to plaster wall and ceiling surfaces within each room. Large cracks were present to the south wall within the back bedroom area. Relative readings taken from representative plaster wall and ceiling surfaces within these rooms indicated dry conditions (&lt;100 REL). Moisture content readings taken from wood floors also indicated dry conditions (&lt;7.8%).</p> <p>Sections of the washroom wall around the tub were missing, with sections of wallboard present within the tub from the removed section of wall exhibiting visible evidence of suspect mould growth. Remaining portions around the tub were deteriorated, with visible mould growth present within the grout surrounding the ceramic wall tiles (P3). Floor and ceiling surfaces did not exhibit any visible evidence of obvious mould growth although paint on the plaster ceiling was noted to be peeling heavily.</p>

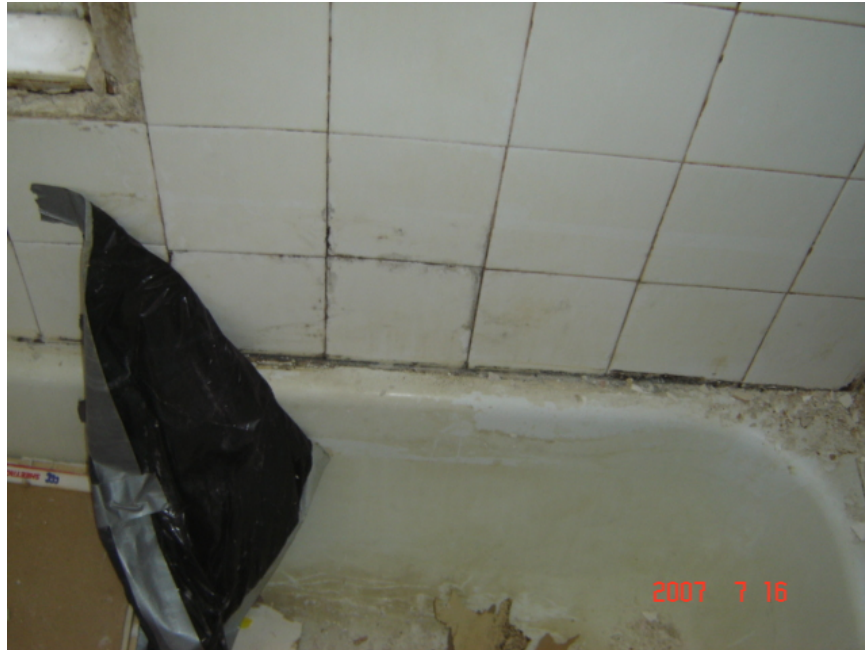
P3

**2<sup>nd</sup> Floor Washroom: Walls around tub are deteriorated, with visible mould growth present within grout lines around ceramic tiles.**

Additional remedial work would include removing the walls surrounding the 2<sup>nd</sup> floor tub and surface cleaning remaining wall, ceiling and floor surfaces within this area of any suspect mould growth (or removing if found to be heavily mould contaminated). Similarly, removal of water damaged and mould contaminated exterior wall sheathing, surface cleaning of windows and sills, and removal of wood wall/ceiling paneling is recommended to be performed within the front porch, with further investigation and remediation of materials behind, if required. Remediation of these areas is recommended to be performed following Level 3 mould remediation procedures in conjunction with remediation of the south wall on each floor.

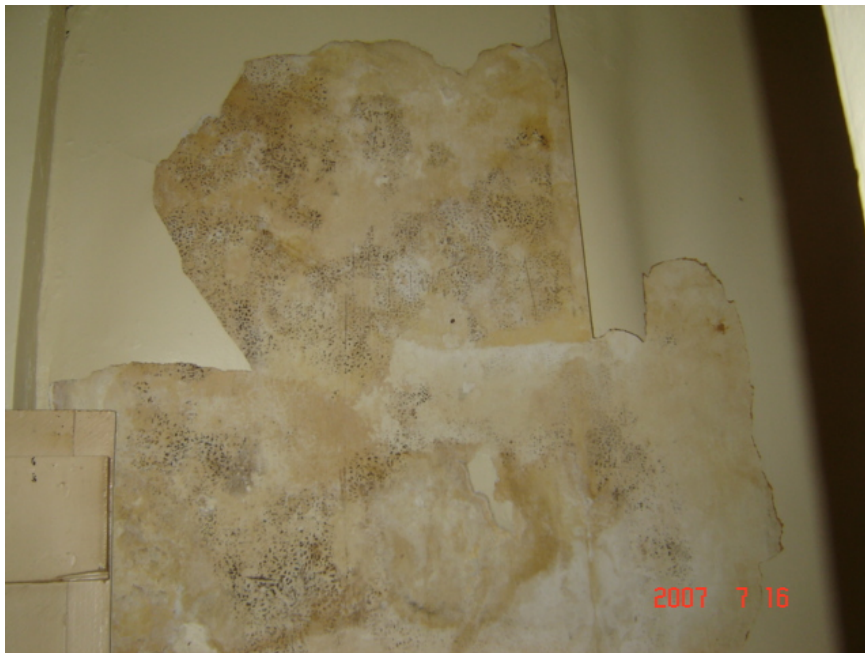
P4

Building surfaces within the bedroom corridor included wood floors and plaster walls and ceiling. Ceiling and floor surfaces were found to be free of significant water damage and obvious visible mould growth. The south wall of the corridor exhibited signs of heavy water damage, with heavy peeling of paint and staining to the plaster wall, with areas of visible mould growth (**P4**). Relative moisture readings taken from areas of the south wall exhibiting damage indicated elevated levels (REL 170 – 180) as compared to other location (REL <100).

**2<sup>nd</sup> Floor Corridor: Heavy water damage and obvious mould growth to surface of south plaster wall.**

**Remedial Action:** Remove south wall within the corridor area and surface clean interior wood framing or remove if found to be heavily contaminated. Structural integrity of this south wall should be further investigated prior to performing any type of removal. The full extent of remediation required along the south wall is unknown due to the potential for significant mould growth to be hidden behind the wall and therefore additional removal along this wall (and into the bedrooms) may be required. Walls surrounding the tub and the tub itself should also be removed, with remaining surfaces (interior framing, walls, ceiling and floor surfaces) surface cleaned of any remaining mould growth and debris accumulation. Surface clean and/or remove window sill/trim within centre bedroom. Remediation of these areas should be performed following Level 3 mould remediation activities.

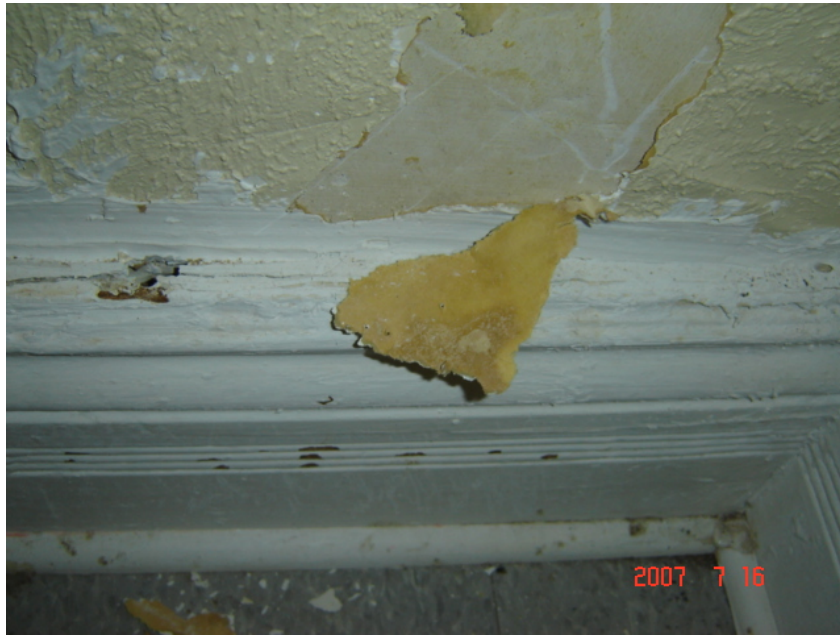
P5

**Family Room: Water damage and minor suspect mould growth behind peeled wallpaper.**

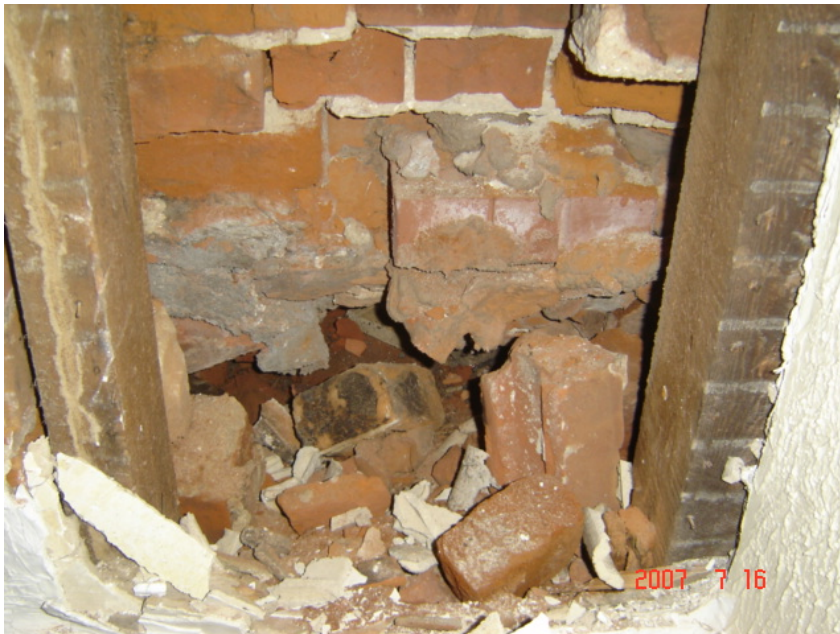
P6

Of greater concern than the presence of water damage and mould growth are the potential structural issues associated with the south wall and possibly the front porch, as our destructive testing indicated that the south brick exterior wall is significantly deteriorated in some areas. Wood floor joists visible within the basement also indicate the presence of rotting and deterioration along the south perimeter wall. As such, it is recommended that a structural engineer be retained to determine the underlying structural deficiencies associated with the residence prior to performing any remediation activities. Remediation of the property should not proceed until all structural concerns are addressed and corrected. In our opinion, the cost of performing structural repair followed by remediation may be cost prohibitive compared to demolition.

**Family Room: Heavily deteriorated exterior brick wall behind deteriorating plaster wall.**

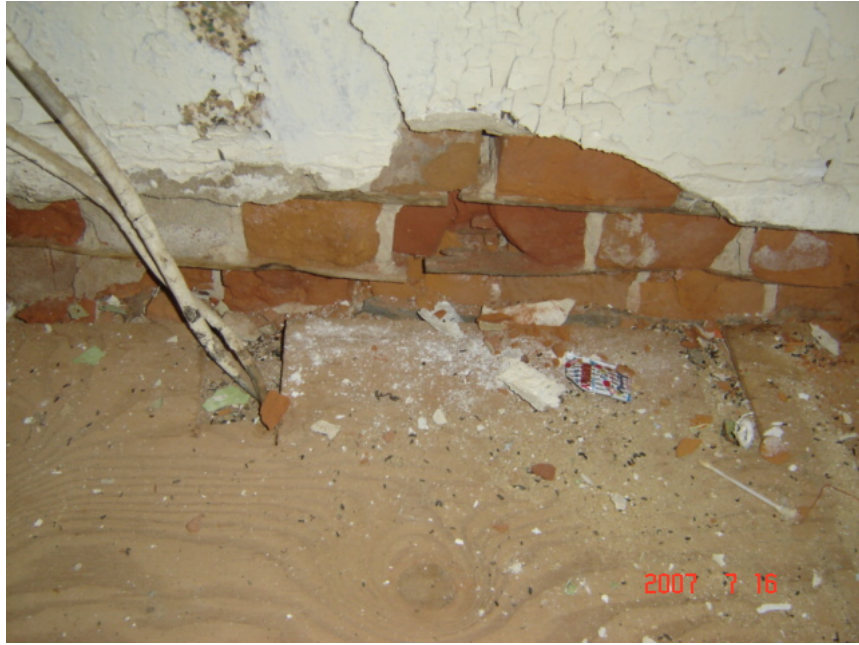
P7

Kitchen: Deteriorating brick wall at floor level.

Remove the entire south wall and water damaged/mould contaminated bulkhead within the kitchen. Remaining surfaces (interior wood framing) should be cleaned of any remaining mould growth and debris accumulation. Remediation of the main floor is recommended to be performed following Level 3 mould remediation protocols. The structural integrity of the south wall should be investigated further prior to performing any mould remediation activities.

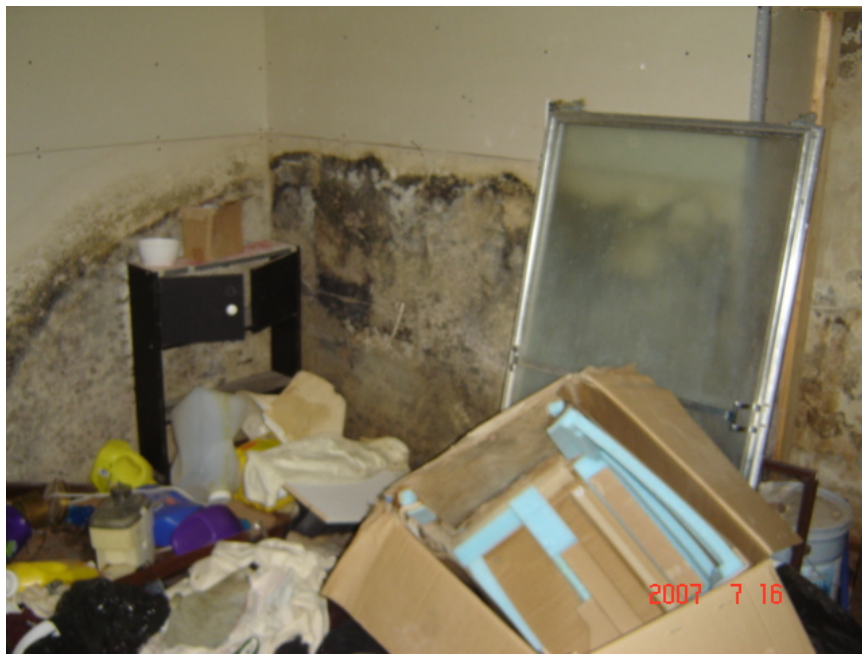
**Observations:** Access to basement areas was limited due to the presence of a significant quantity of stored materials. However, it was evident that significant water damage and mould growth was present throughout the basement. Heavy mould growth was present on drywall walls (**P9, P10**) and ceiling and water was noted to be accumulating on areas of the floor along the south wall (**P10**). Moisture content readings taken from drywall walls and ceiling (16% to >60%) and to wood framing (14%-26%) indicated elevated levels at conditions supportive of mould growth. Areas of the wood support beams along the south side of the basement were deteriorated and rotted (**P11**) and moisture content readings of the beams were elevated (15.6% to 20.7%). Suspect asbestos-containing pipe insulation associated with radiator heating lines was observed to be in poor condition (**P12**).

**P9** Basement – Heavy mould growth to drywall wall and to stored materials in basement.

**Remedial Action:** Remove all building materials back to base building throughout the basement areas. This would include removal of all drywall, wood framing, flooring, insulation, etc. Remaining building materials should then be surface cleaned of dirt and debris accumulation and any visible mould growth. Any heavily water damaged, mould-contaminated or rotted sections of beams should be removed and replaced while other wood surfaces should be surface cleaned of any visible mould growth. All stored materials within the basement are also recommended to be removed and disposed of as mould-contaminated waste. Remediation of the basement is recommended to be performed following Level 3 mould remediation protocols. The structural integrity of the wood joists and water penetration issues associated with the foundation wall/south wall should be investigated further prior to performing any mould remediation activities.

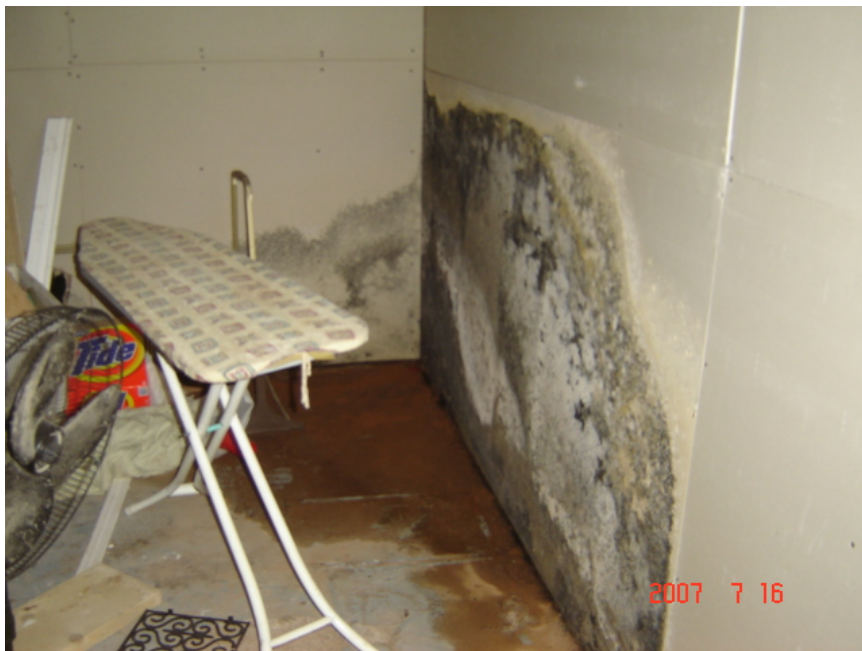
**P10** Basement – Heavy mould growth to drywall walls. Water accumulation on floor at south wall.

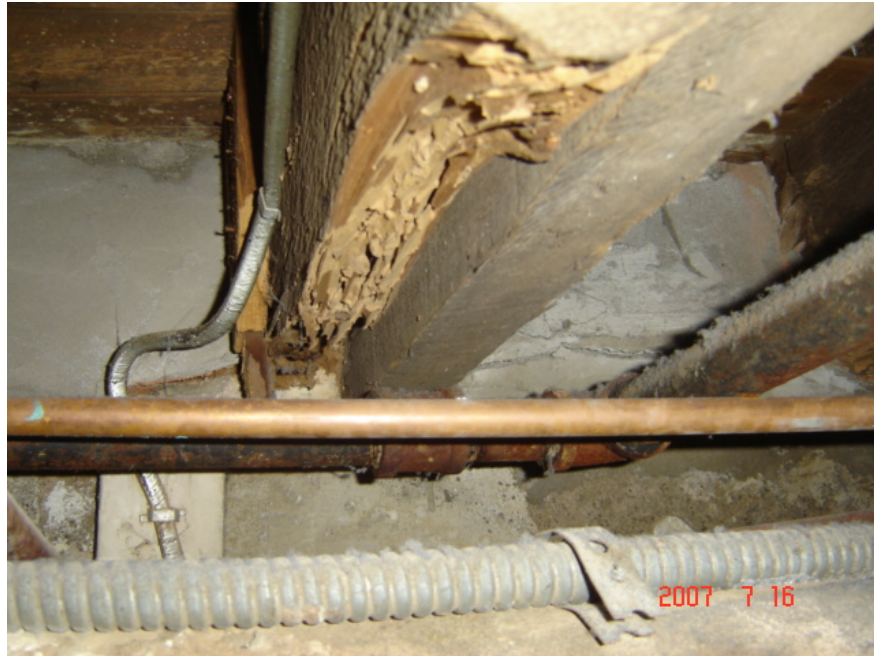
P11

Basement – Wood floor joists for main floor rotted in areas along south wall.

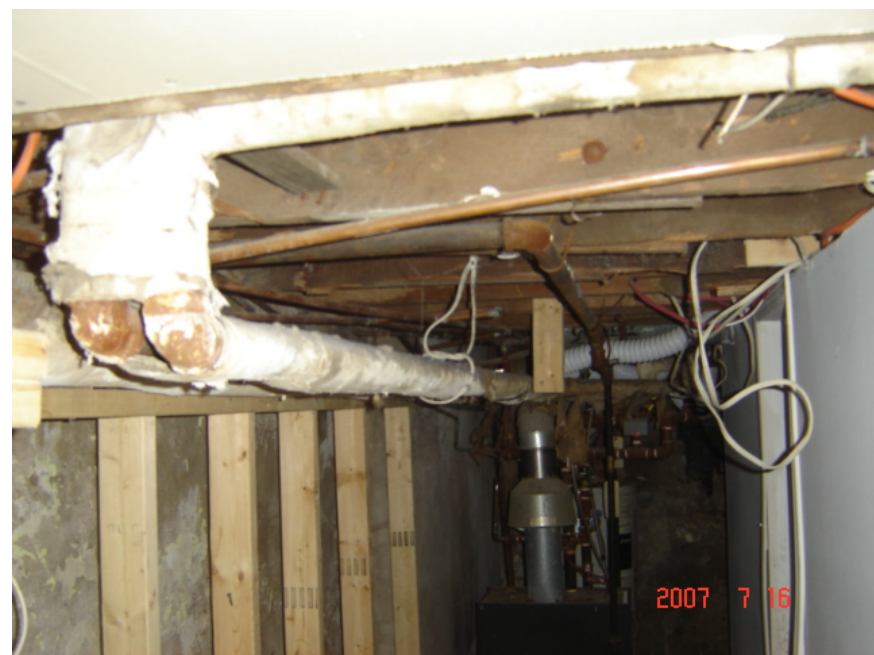
P12

Basement: Suspect asbestos-containing pipe insulation in poor condition.

In addition to the above recommendations associated with mould remediation activities we recommend that bulk sampling of potential asbestos-containing materials (such as pipe insulation, texture coat and plaster) that will be disturbed during mould remediation be performed to determine the asbestos content of these materials prior to mould remediation to ensure compliance with Ontario Regulation 278/05, Designated Substance - Asbestos on Construction Projects and in Buildings and Repair Operations - made under the Occupational Health and Safety Act. If demolition of the residence is contemplated a complete and thorough asbestos survey is recommended to be performed, as our current sampling protocol would only focus on mould-impacted areas.
