DATE: June 29th 2010

SITE VISIT REPORT STRUCTURAL EVALUATION

Reference: 79 Dawlish Ave

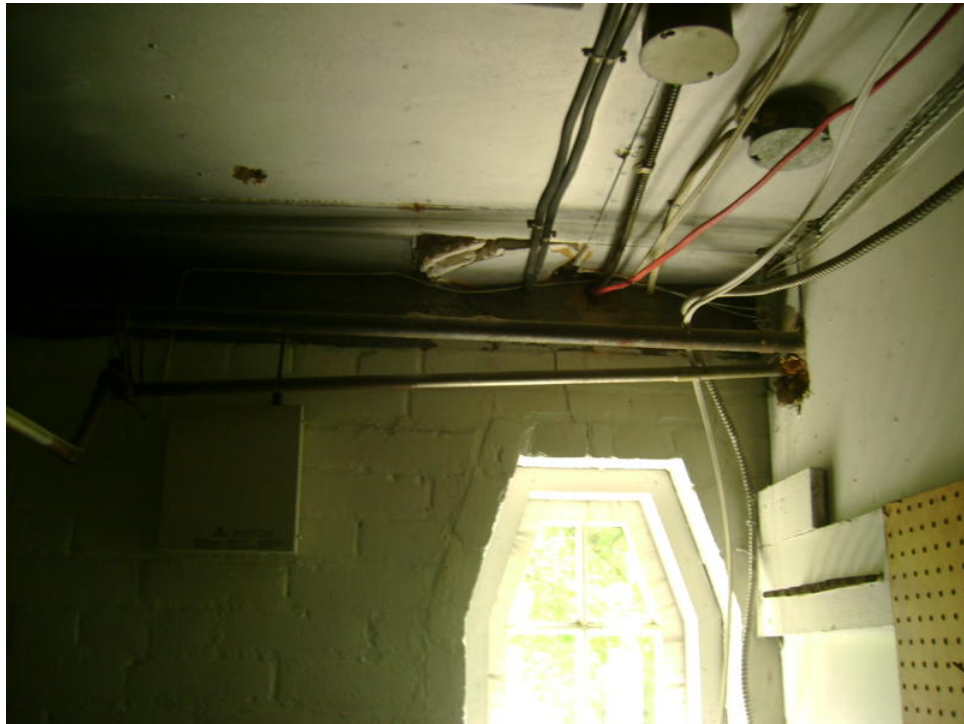
Picture 5:

- Building is a single family two storey dwelling house.
- Exterior walls are masonry (brick).
- House has a partial basement.
- Integral-at grade garage is located at west side of the house and one story living space is constructed above the garage.
- Westerly exterior wall is settled more than other parts of the building.
- Garage door's frame is sloped toward the west side (Pic. 1).
- Major cracks are visible on masonry walls around the garage (Pic. 2).
- Major Cracks are measured from 5 mm to 25 mm (Pic. 3).
- The storey above the garage is sunken due to west wall settlement and interior door frames are skewed and sloped toward the west side (Pic. 4).
- Masonry bricks around windows in the basement and second floor are cracked and lintels are damaged (Pics. 5 and 6).
