STAFF REPORT ACTION REQUIRED

Investigations into Lower Simcoe Street CN Underpass Flooding

Date:	April 24, 2014
To:	Public Works and Infrastructure Committee
From:	General Manager, Toronto Water
Wards:	Ward 20
Reference Number:	P:\2014\Cluster B\TW\pw14002

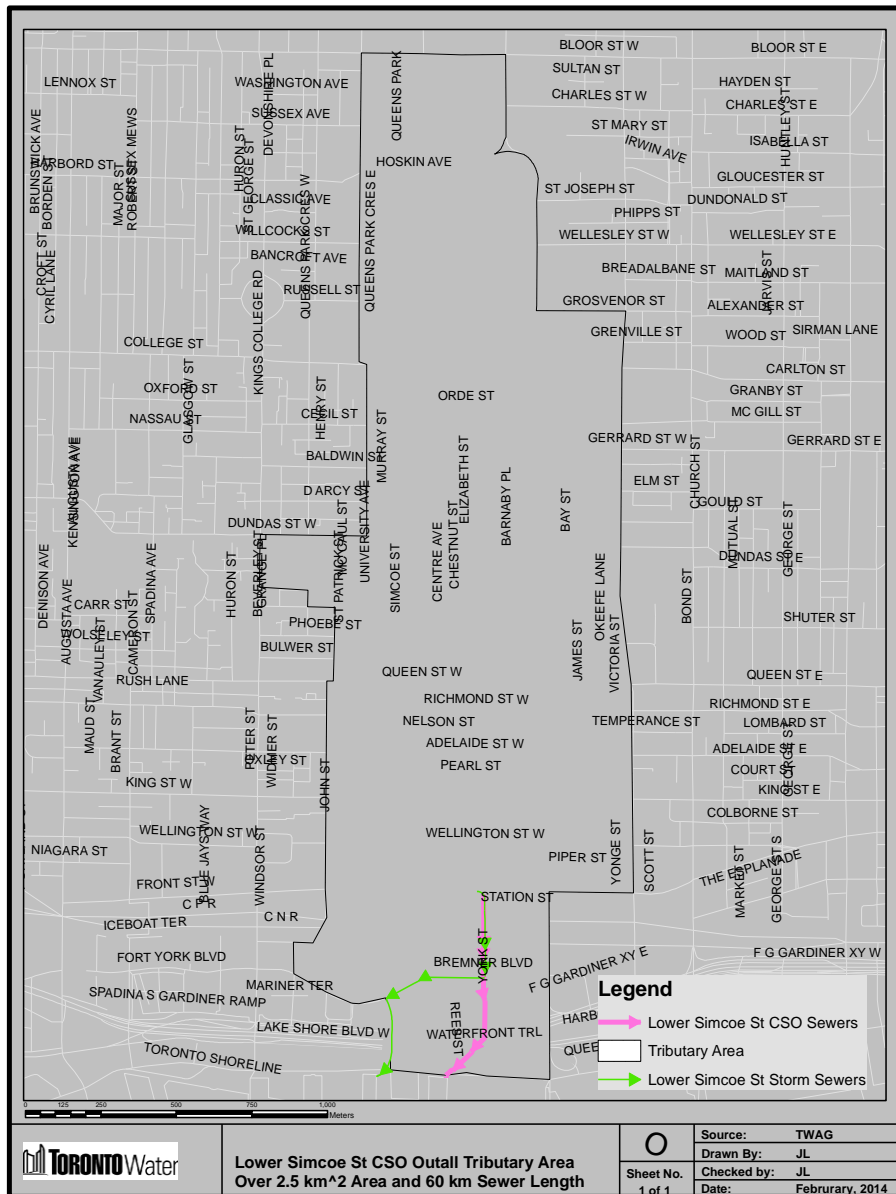
Figure 1 – Lower Simcoe Street Combined Sewer Service Area

- Wet weather flow (storm runoff and CSO) from the drainage area north of Front Street West (more than 2.5 km²; see Figure 1) is conveyed past the underpass in the closed CSO sewer with no drainage connections from the surface.
- The CSO sewer was lowered to accommodate the underpass, which means that it now operates under pressure as a siphon beneath the underpass. This section of the CSO sewer contains two new maintenance holes.
- There are no drainage connections to the CSO sewer south of Front Street West in the depressed section of the underpass.
- Stormwater runoff in the local area around the underpass drains to a new separate storm sewer, not the CSO sewer.
- A holding tank was installed as part of the separate storm sewer system to retain local stormwater runoff from large intensity storms and release it at a rate to match the constraints of the storm sewer system.
