Re: Item 20.25; 150 Hamilton Street – Application to Injure Private Tree

Re: Addendum to Pruning plan for tree #5 at 154/150 Hamilton Street, Toronto, Ontario. Original Report, June 2, 2014, Revised report, May 9, 2016

Re: Pruning plan for tree #5 at 154/150 Hamilton Street, Toronto, Ontario. Original Report, June 2, 2014, Revised report, May 9, 2016

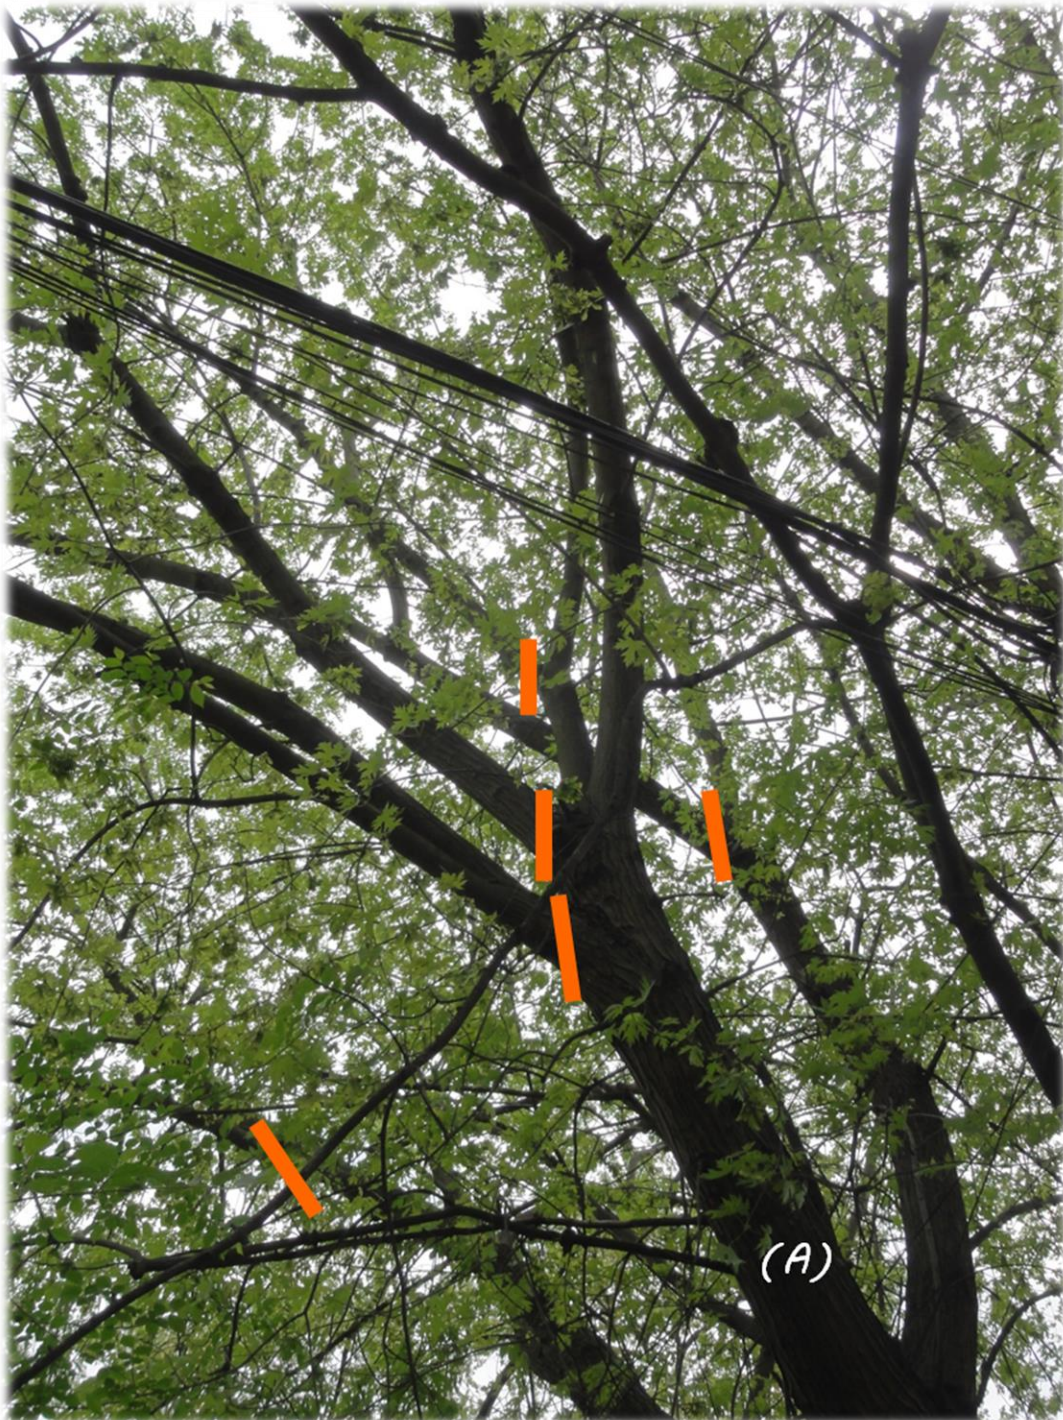
Figure 2: Orange lines show approximate location of proposed scaffold pruning cuts. Note that limb (A) is to be retained despite overhanging subject property in close proximity to proposed building face.

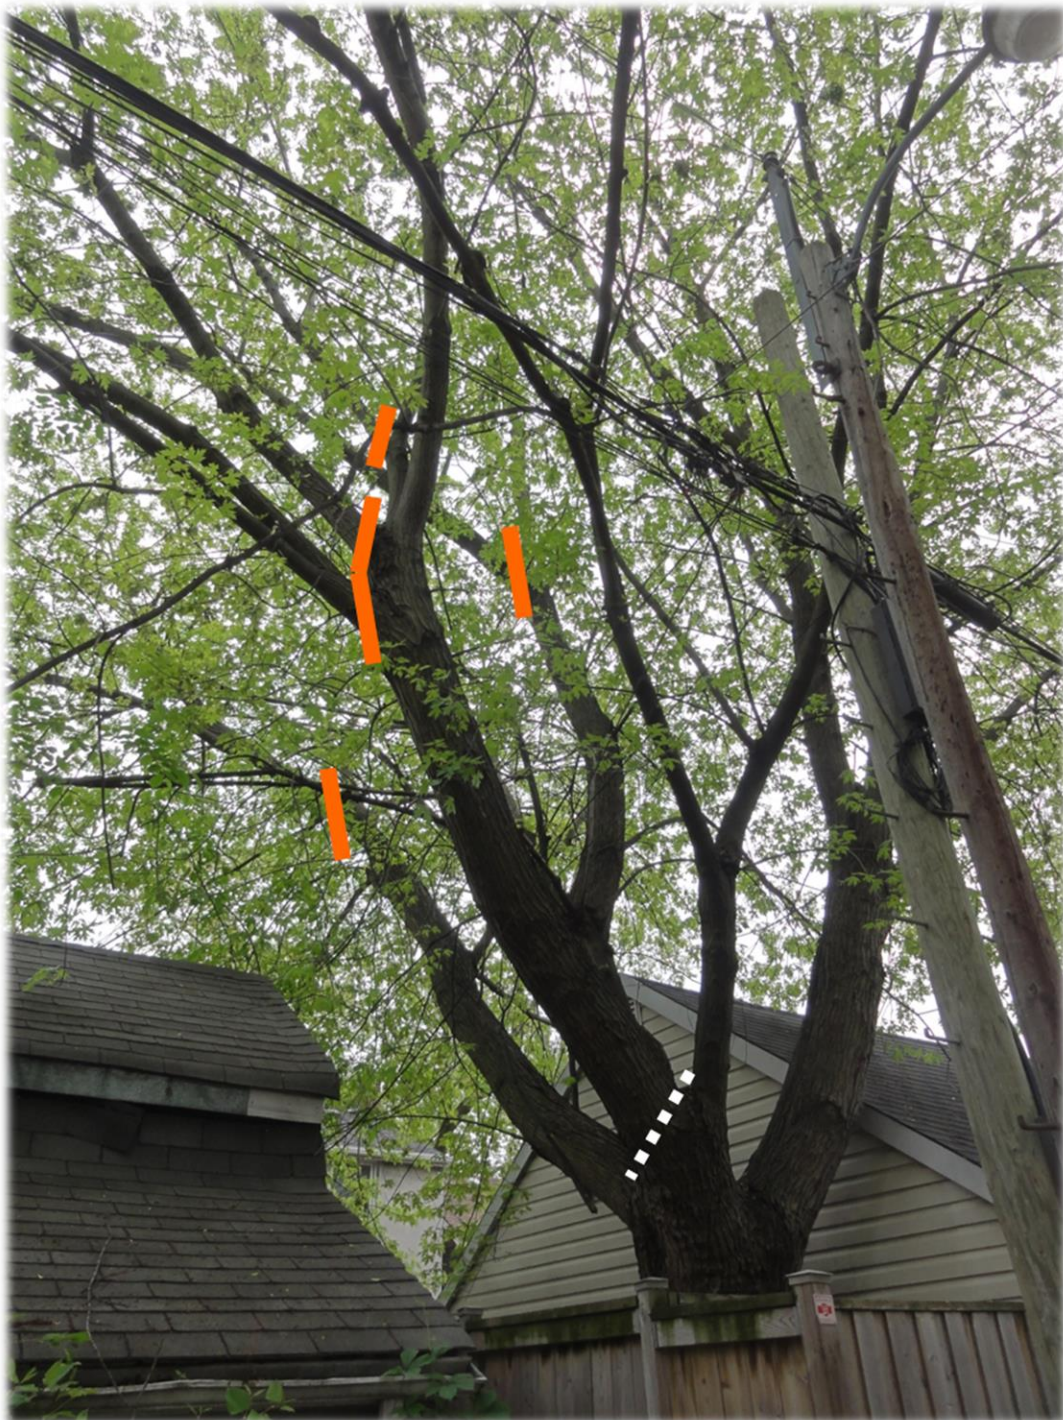
Figure 3: Overview of proposed pruning. White dashed line shows area of potential large pruning cut if limb (A) was to be removed. Limb (A) will be retained despite overhanging subject property.

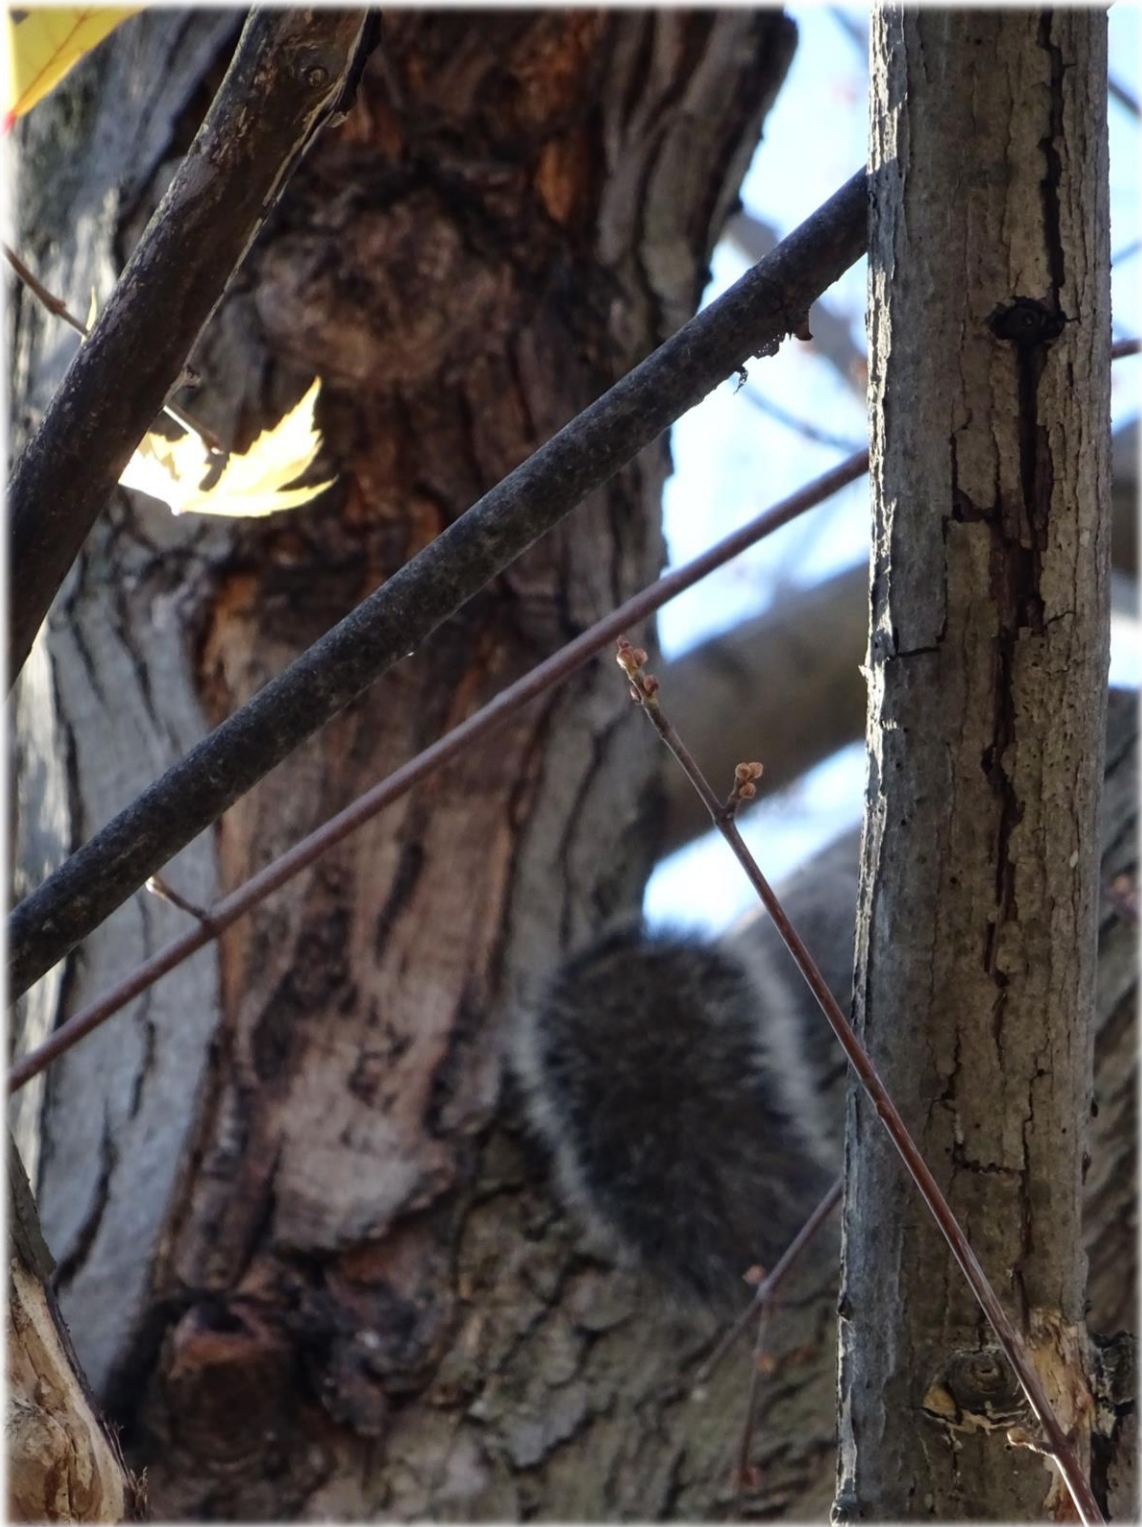
1. Branch 1 - This branch is part of a branch in the centre of the tree. At the time of the most recent inspection, a squirrel tail was observed at the base of this branch (Figure 6). This is an indication that there may be a decay cavity at the base of the branch that the rest of the squirrel was hidden in. In order to maintain as much foliage as possible, this branch can be pruned to the last small side branches to avoid a large cut at the base (Figure 7). If the arborist who undertakes the pruning discovers a cavity at the base, the branch may need to be removed to its base as previously prescribed.

Figure 6. Squirrel burrowing at the base of Branch 1.

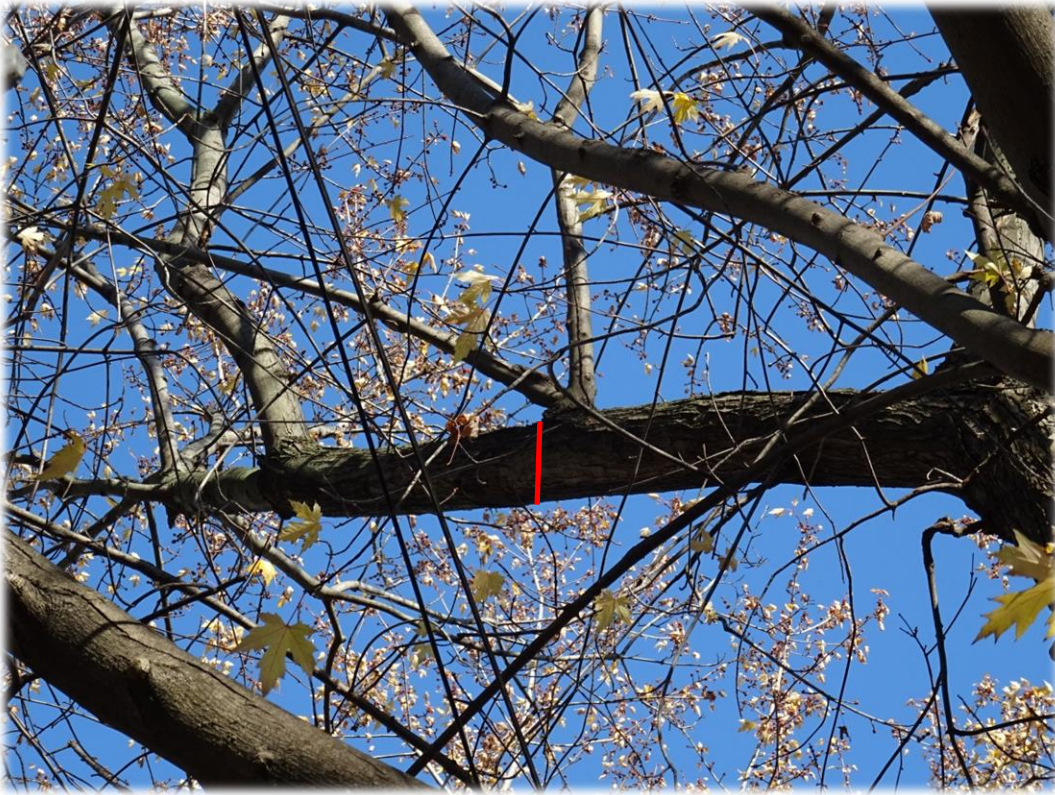
Figure 7: Alternate pruning point for Branch 1.

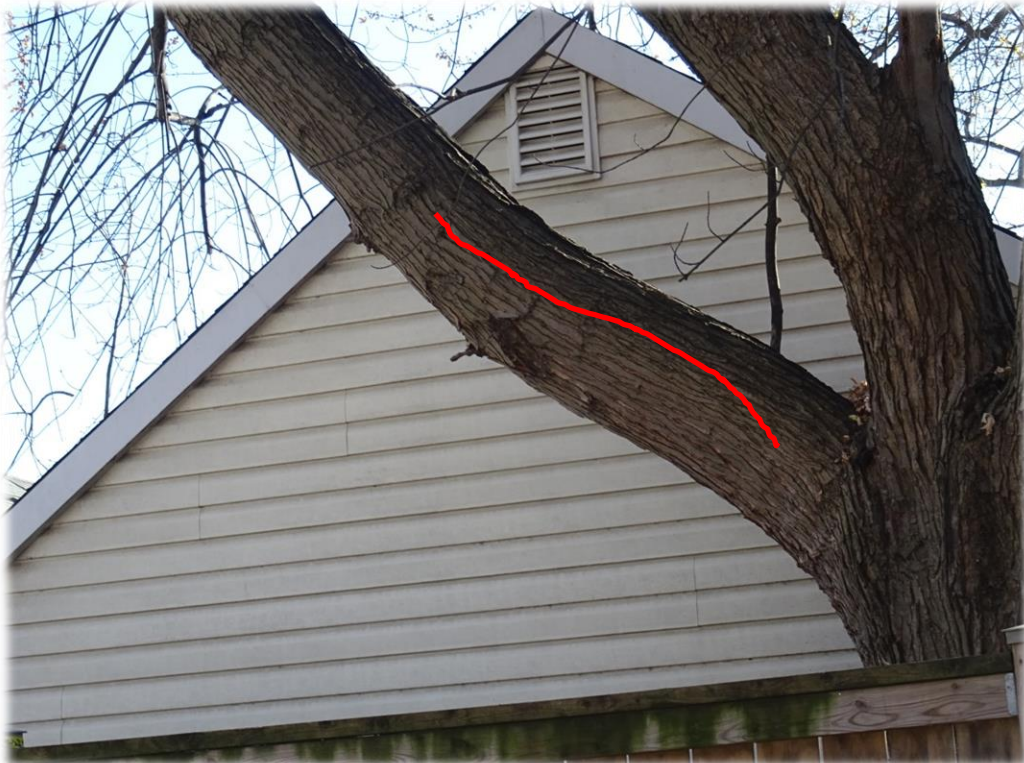
2. Branch 2 - This is a very large and extended lower stem that extends over both rear yards at 150 and 154 Hamilton. This type of extended stem is prone to what is described as a “hazard beam” failure. The base of the stem has the classic crooked appearance indicative of this type of failure (Figure 8). Regardless of any construction, significant weight should be reduced on this stem to avoid whole-stem failure. The proposed pruning on this stem will facilitate the proposed construction but also accomplish weight reductions that will greatly reduce the likelihood of failure. Since there are no logical side branches to reduce the branch that extends over 154 Hamilton, good arboricultural practice requires that this branch be completely removed back to its connection with the main stem.

Figure 8: Base of Branch 2 showing crooked shape typical of “hazard beam” failures.

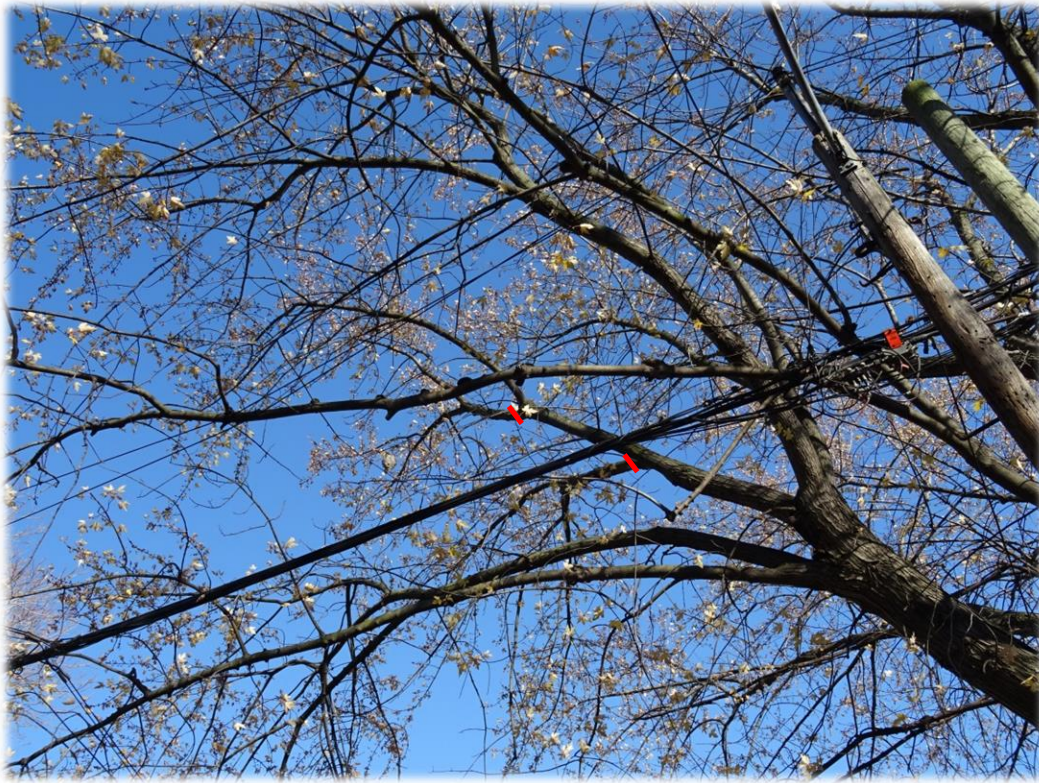
Figure 9: Possible pruning alternative for Branch 4.

4. Branch 4 - This branch is also growing directly over 154 Hamilton. Removal of the whole branch may be avoidable by removing one side where the branch has its first major fork (Figure 9). This would be determined once the rear outside wall was built on the proposed structure. We recommend removing one side initially and the second branch only if required.
5. Branch 5 - This branch is also growing directly over 154 Hamilton. Removal of the whole branch may be avoidable by removing one side where the branch has its first major fork (Figure 10). This would be determined once the rear outside wall was built on the proposed structure. We recommend removing one side initially and the second branch only if required.

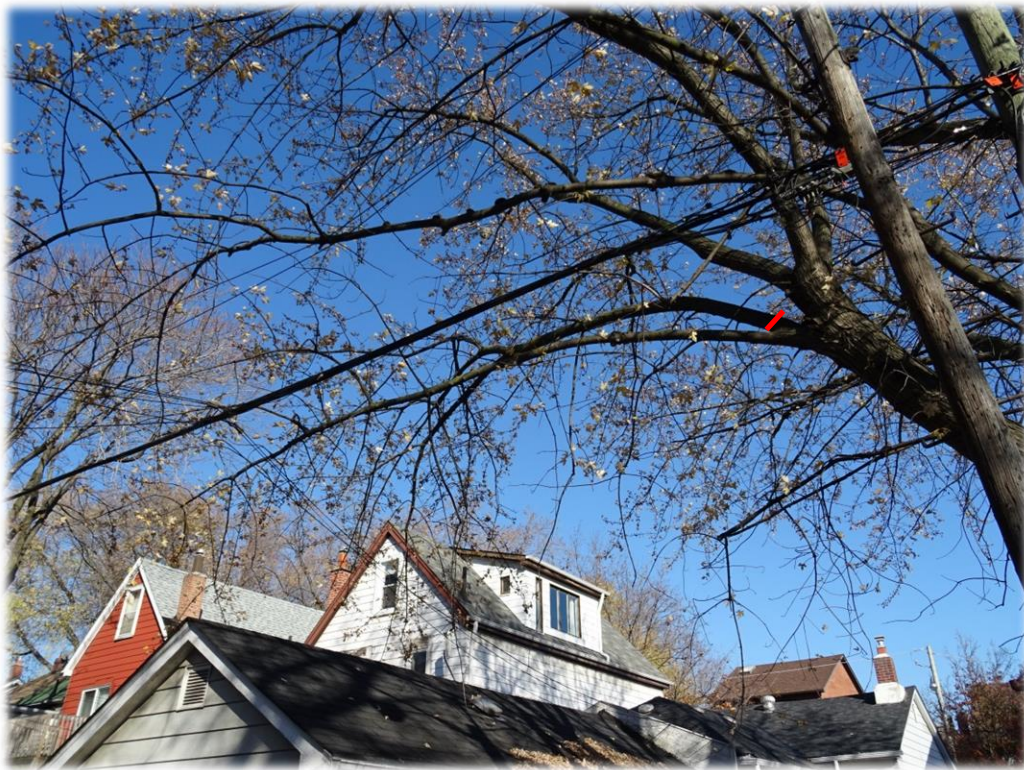
Figure 10: Possible pruning alternative for Branch 5.

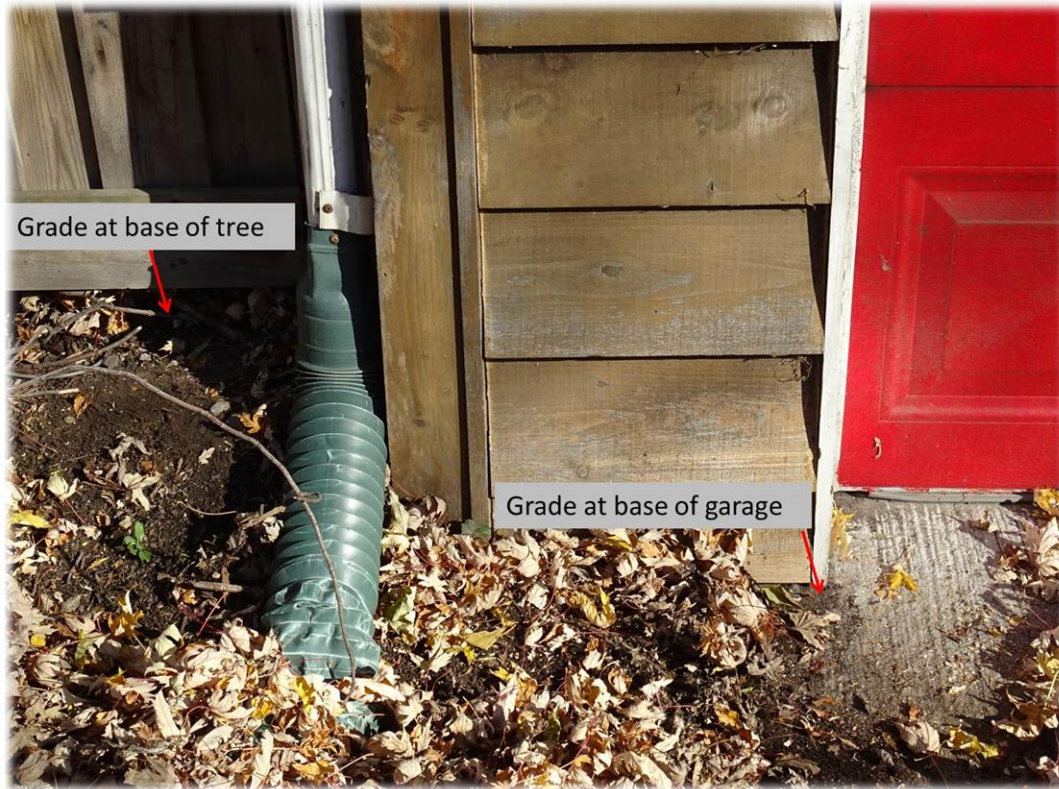
There were two structures over the subject tree's root system at its base. These structures are at 150 Hamilton, the property from which the tree grows, and 154 Hamilton, Mr. Borovsky's property. Significant structures above root systems at the base of a tree are widely regarded by arborists as being harmful to a tree's survival, this is one of the reason the city demands tree-protection zones.

Figure 11: Showing significant change of grade immediately adjacent to the base of the tree. Garage is on 150 Hamilton Street.

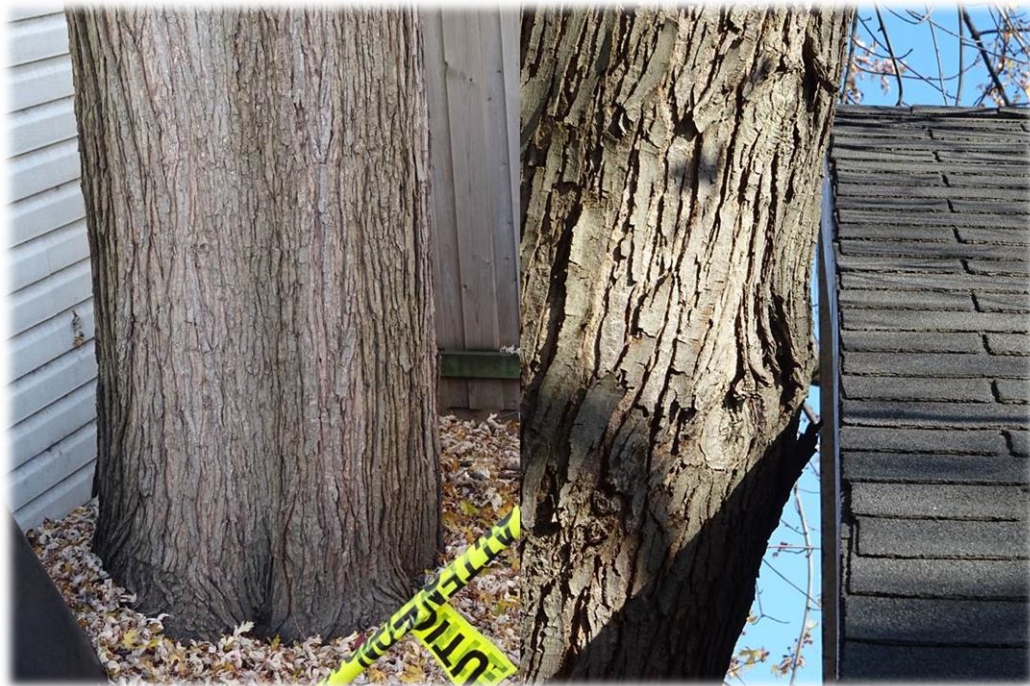
Figure 12: Photos show proximity of base of the tree to the garage foundation (left) and the proximity of a large stem to the roof of the garage (right). Garage is on 150 Hamilton Street.

Mr. Borovsky has removed the structure on his property, which, with other tending measures, will represent a vast improvement to the health of the subject tree's root system. The same cannot be said of the two-car garage built atop the root structure at 150 Hamilton Street, the property of the tree's owner.

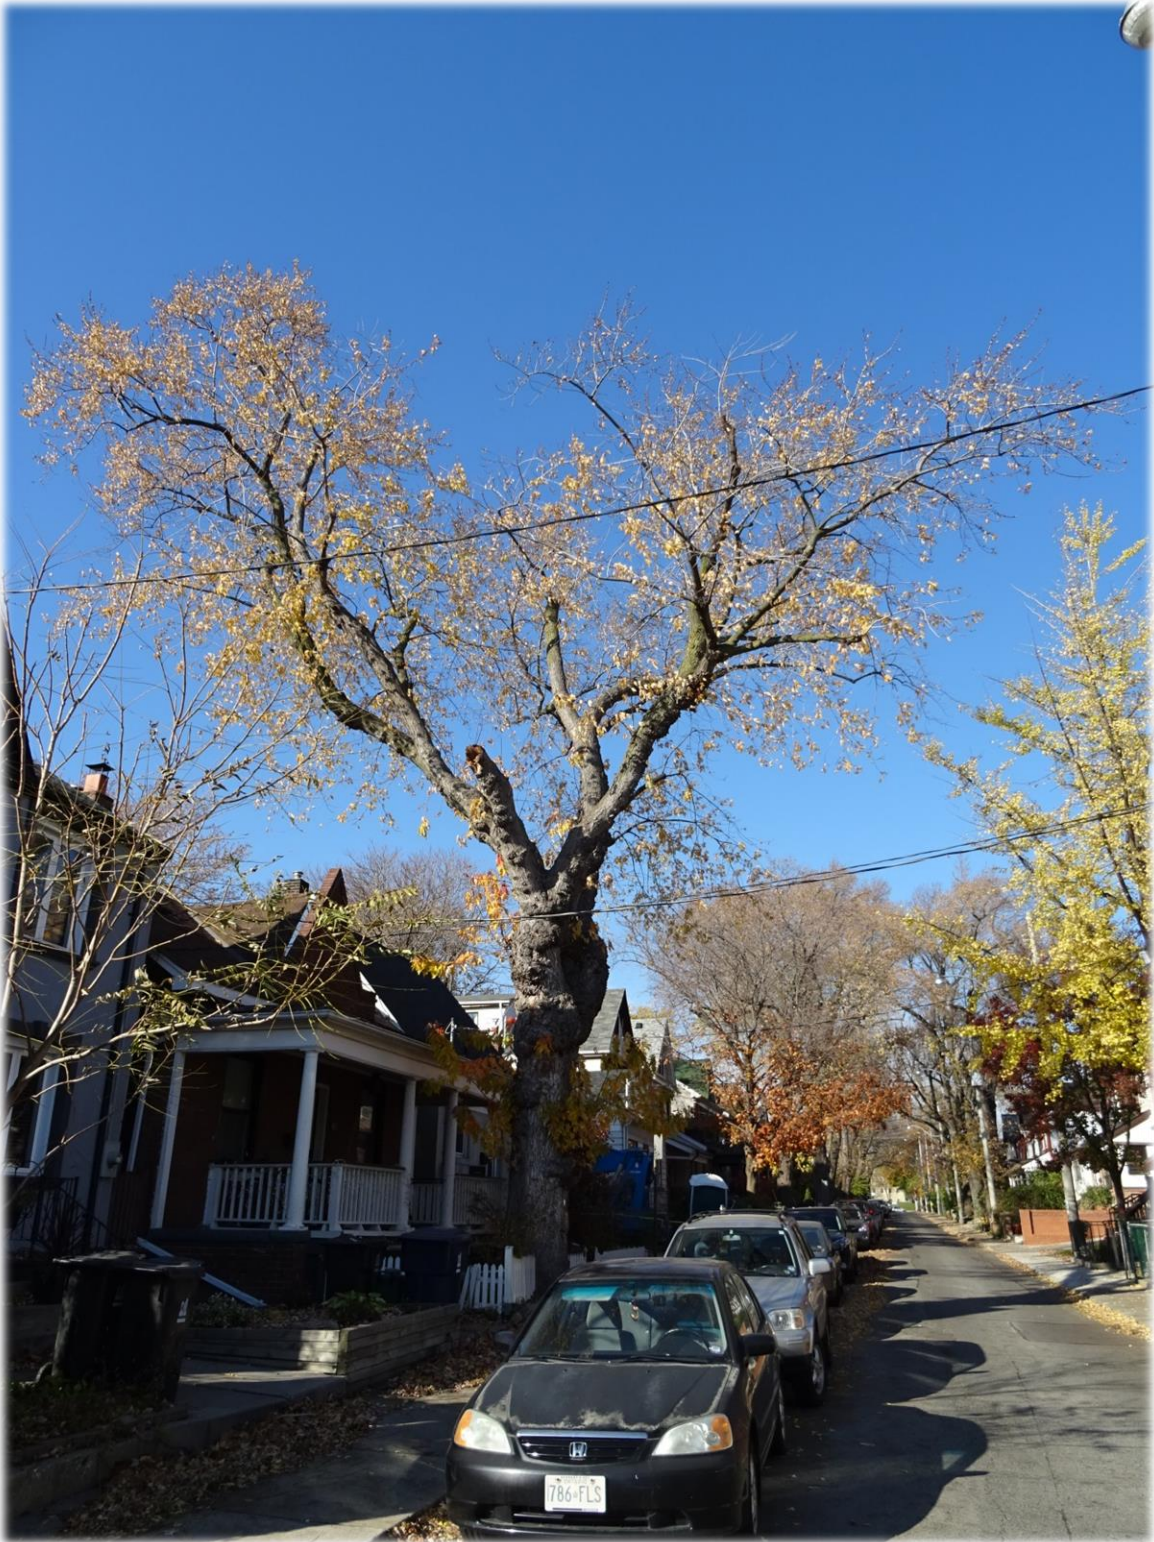
question. In Figures 13 – 18 we have provided photographs of Silver maple street trees (managed by the City of Toronto Urban Forestry) on Hamilton Street directly adjacent to the subject property. All of these trees have had anywhere from 30 – 60 % of their canopies removed for various reasons such as street, wire or building clearance. Despite having significant portions of their canopies removed in the past, these trees are still being maintained by the City for the benefits that they provide. All of the trees grow in very constrained rooting sites between the sidewalk and house frontages. Figure 17 shows the tree at the front of 192 Hamilton Street. The entire lower canopy has been removed at some point in the past and a relatively small percentage of foliage remains in the canopy. The large, recent fresh wounds on the tree indicate that the City is managing the tree by removing unwanted portions of the canopy. The sizes of branches that have been recently removed (see pruning wounds) are significantly larger than any branches contemplated for removal in our pruning plan for the tree at 154 Hamilton Street.

Figure 13: Silver maple at 184 Hamilton Street. Note large portions of crown removed.

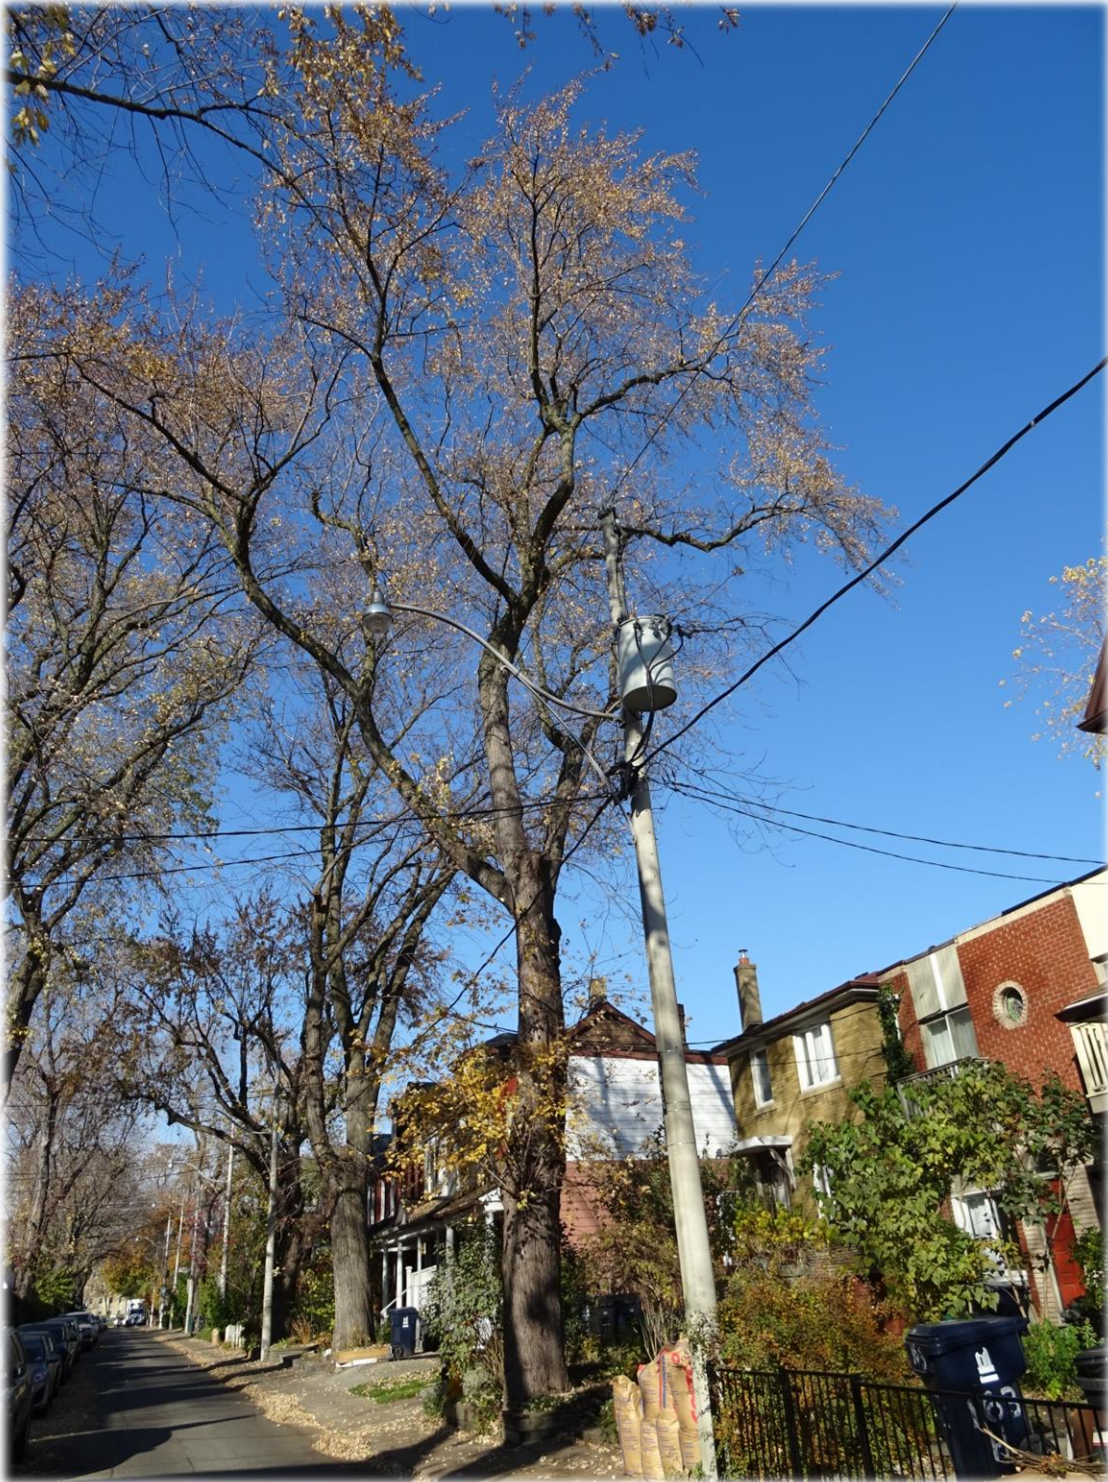
Figure 14: Silver maple at 167 Hamilton Street. Note large portions of crown removed.

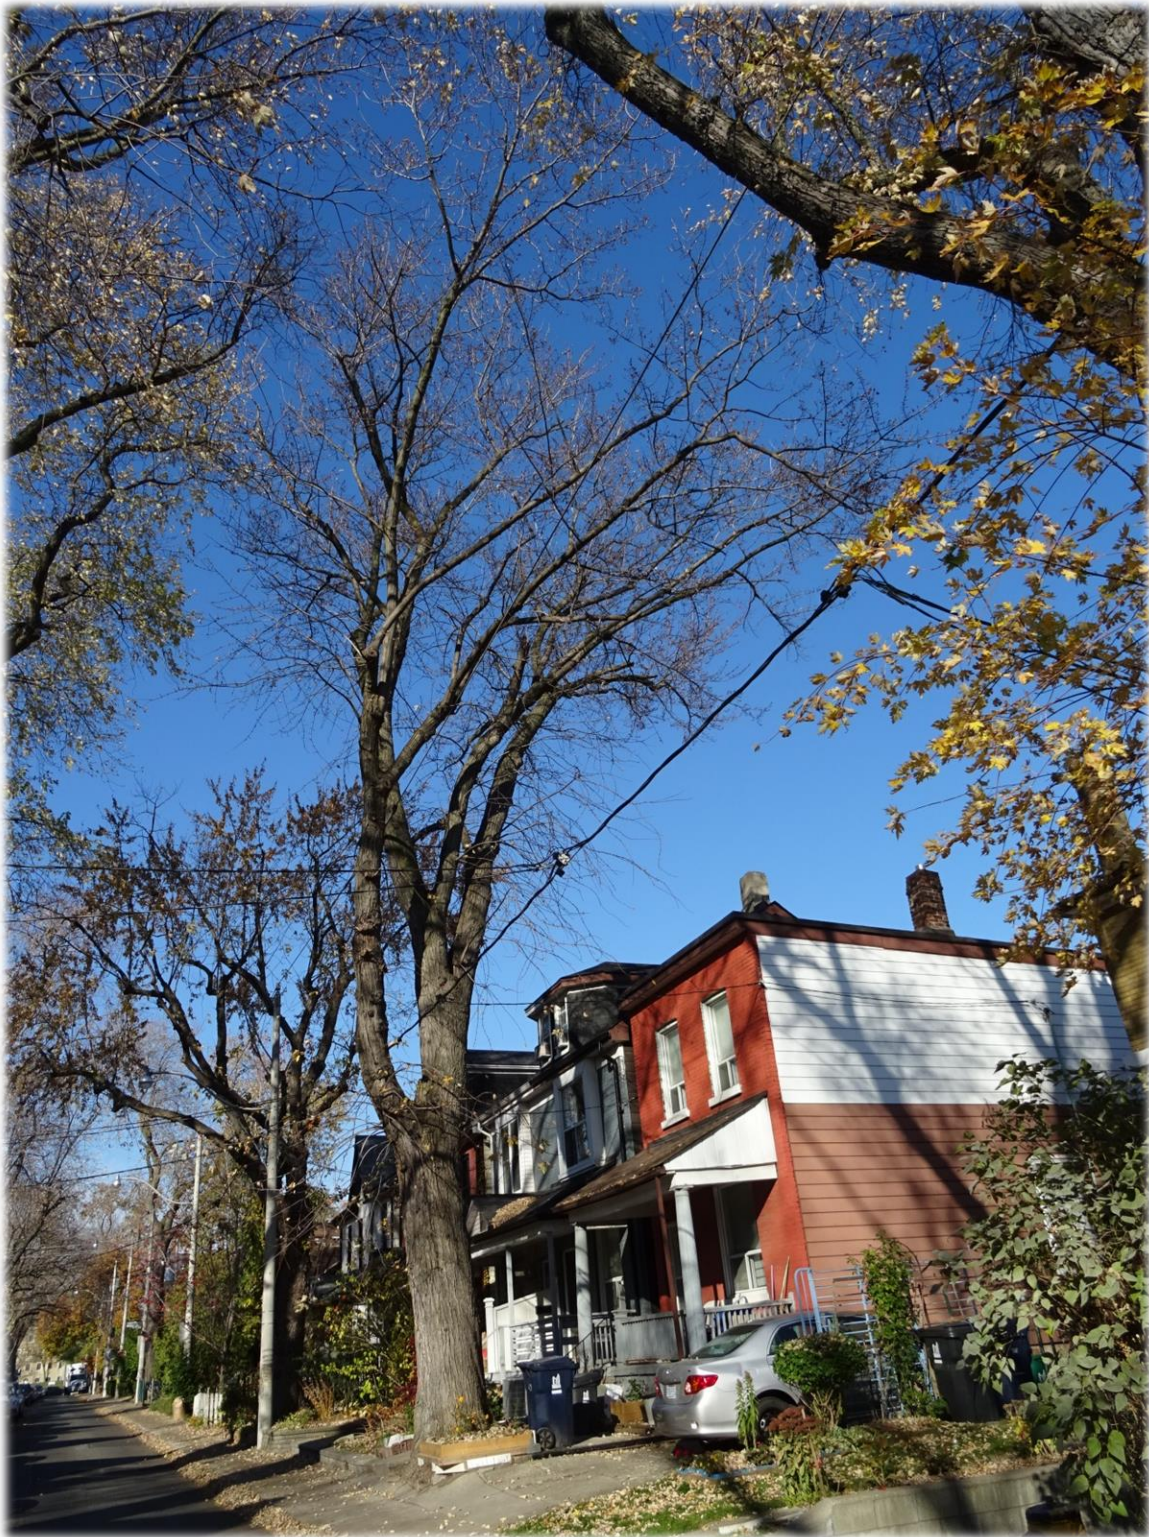
Figure 15: Silver maple at 173 Hamilton Street. Note large portions of crown removed.

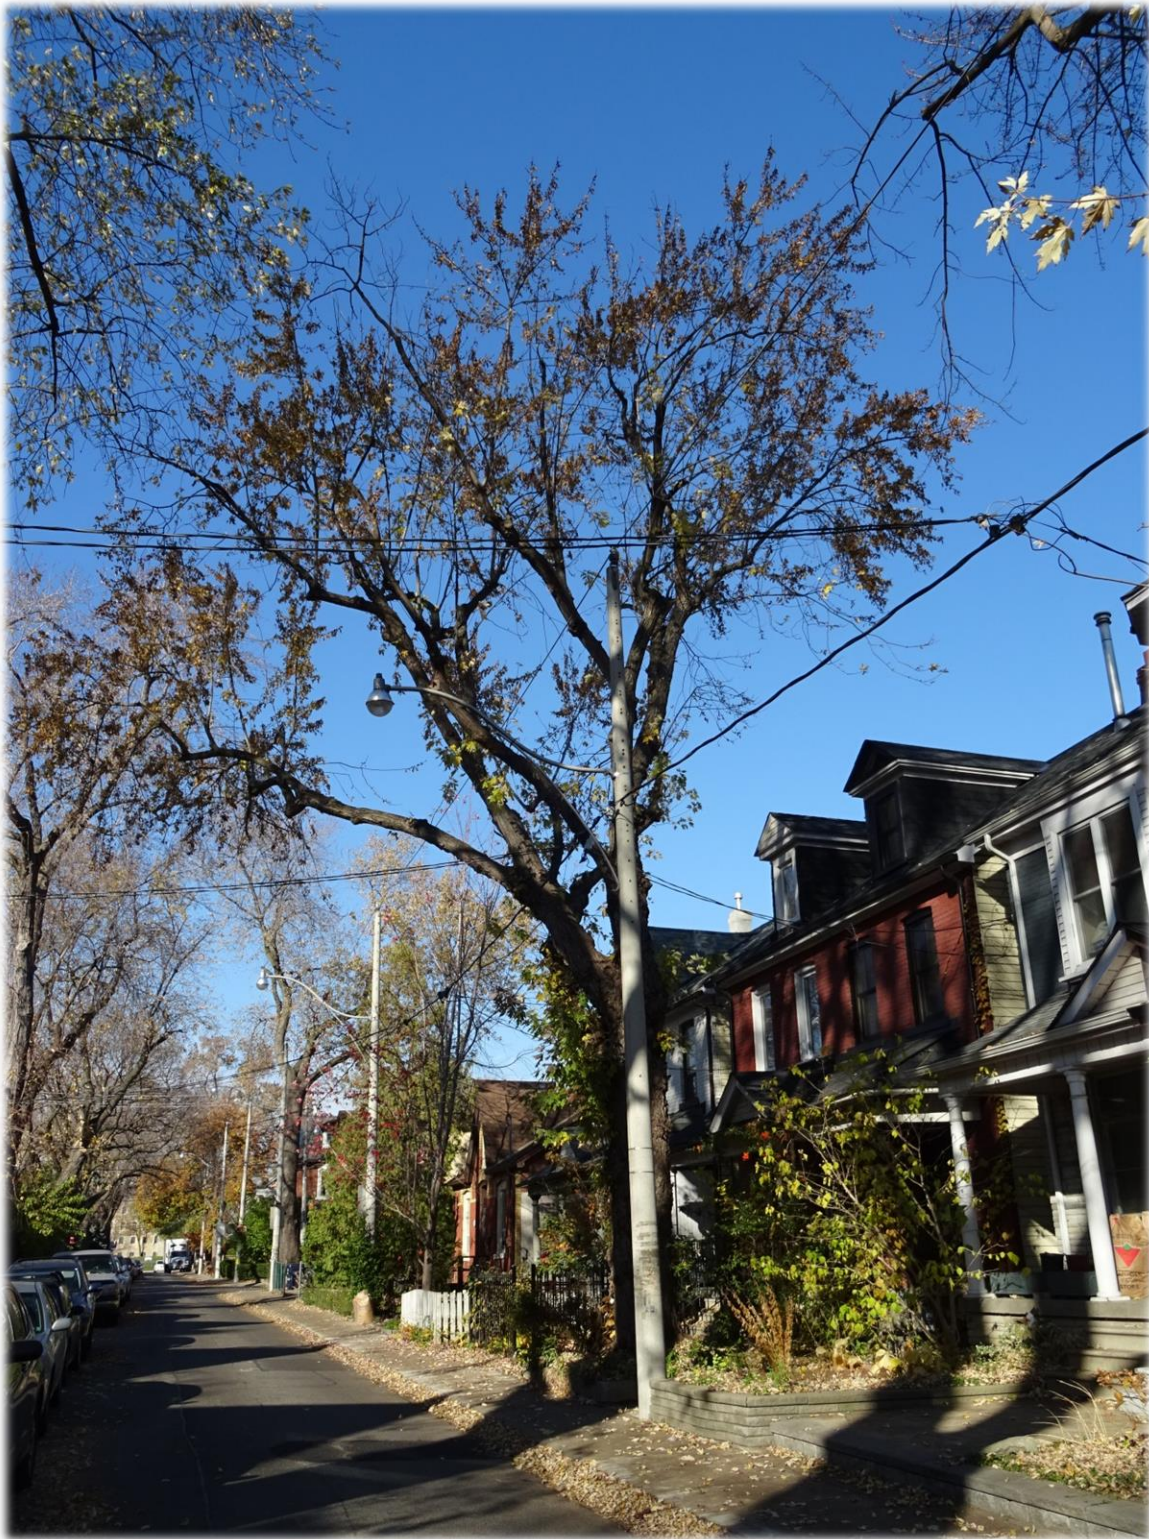
Figure 16: Silver maple at 184 Hamilton Street. Note large portions of crown removed.

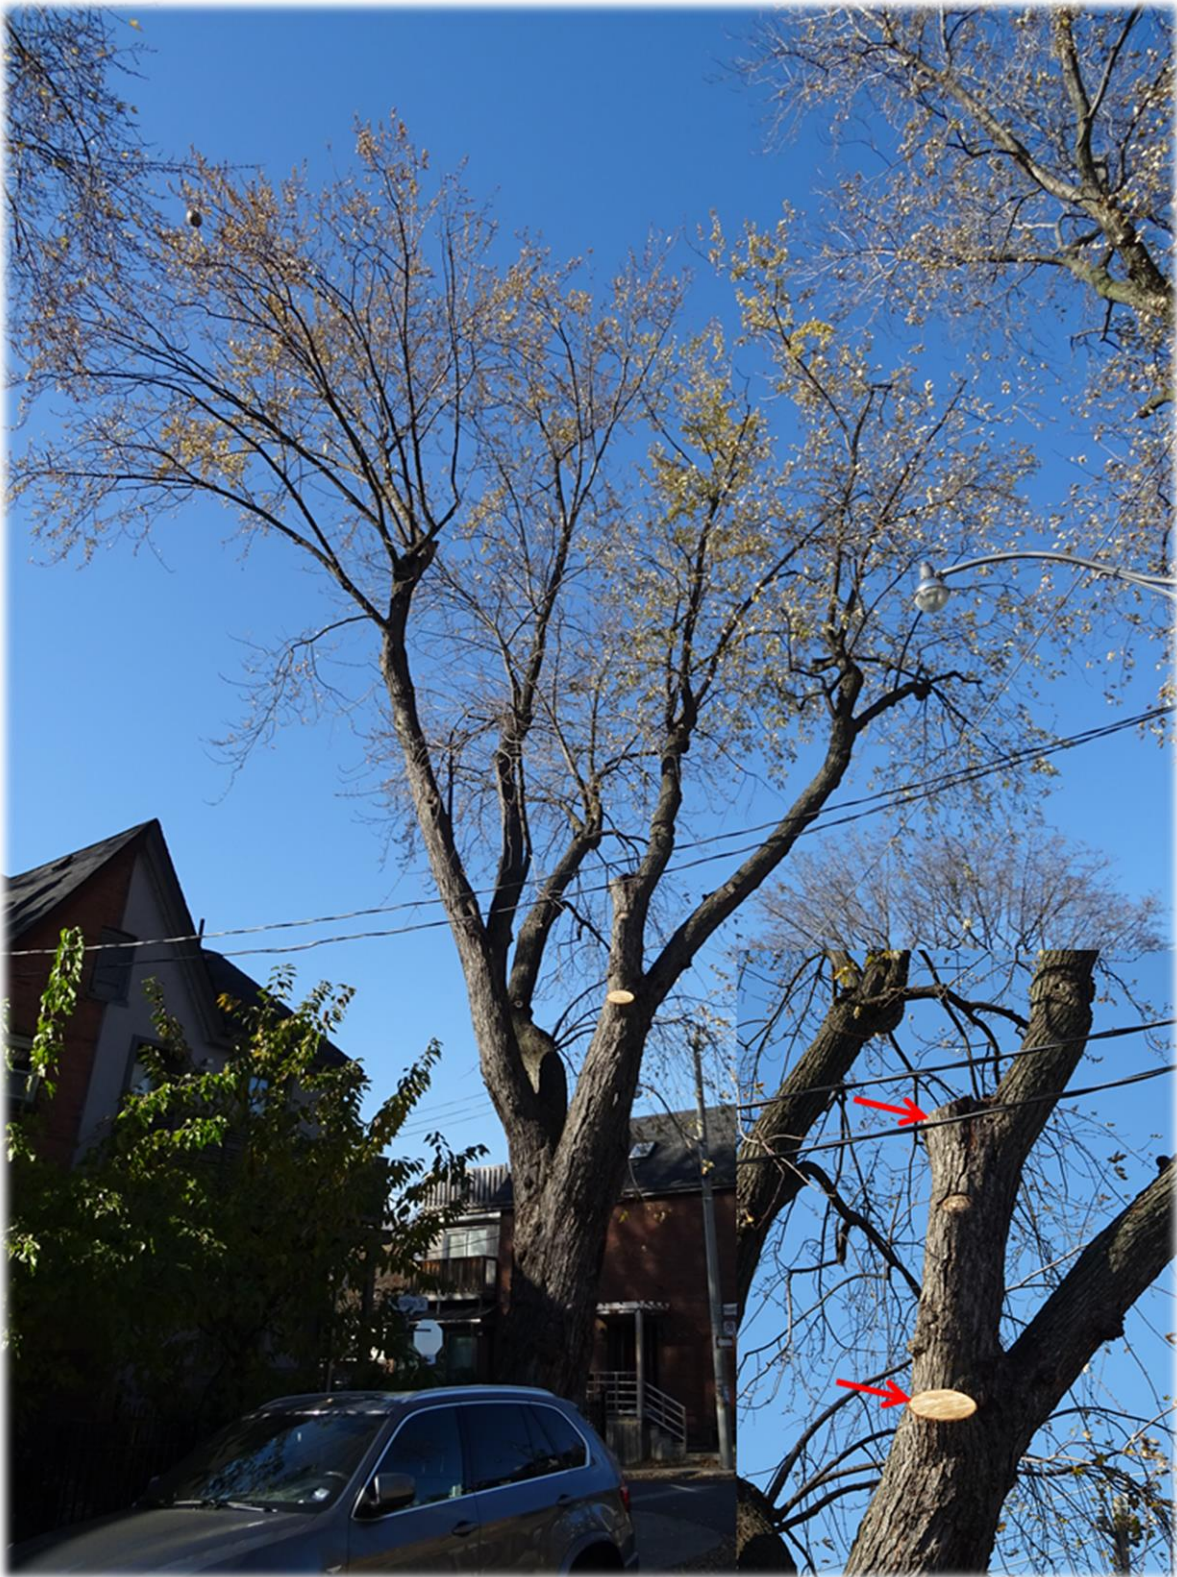
Figure 17: Silver maple at 192 Hamilton Street. Note large portions of crown removed and very recent large pruning wounds (inset, red arrows).

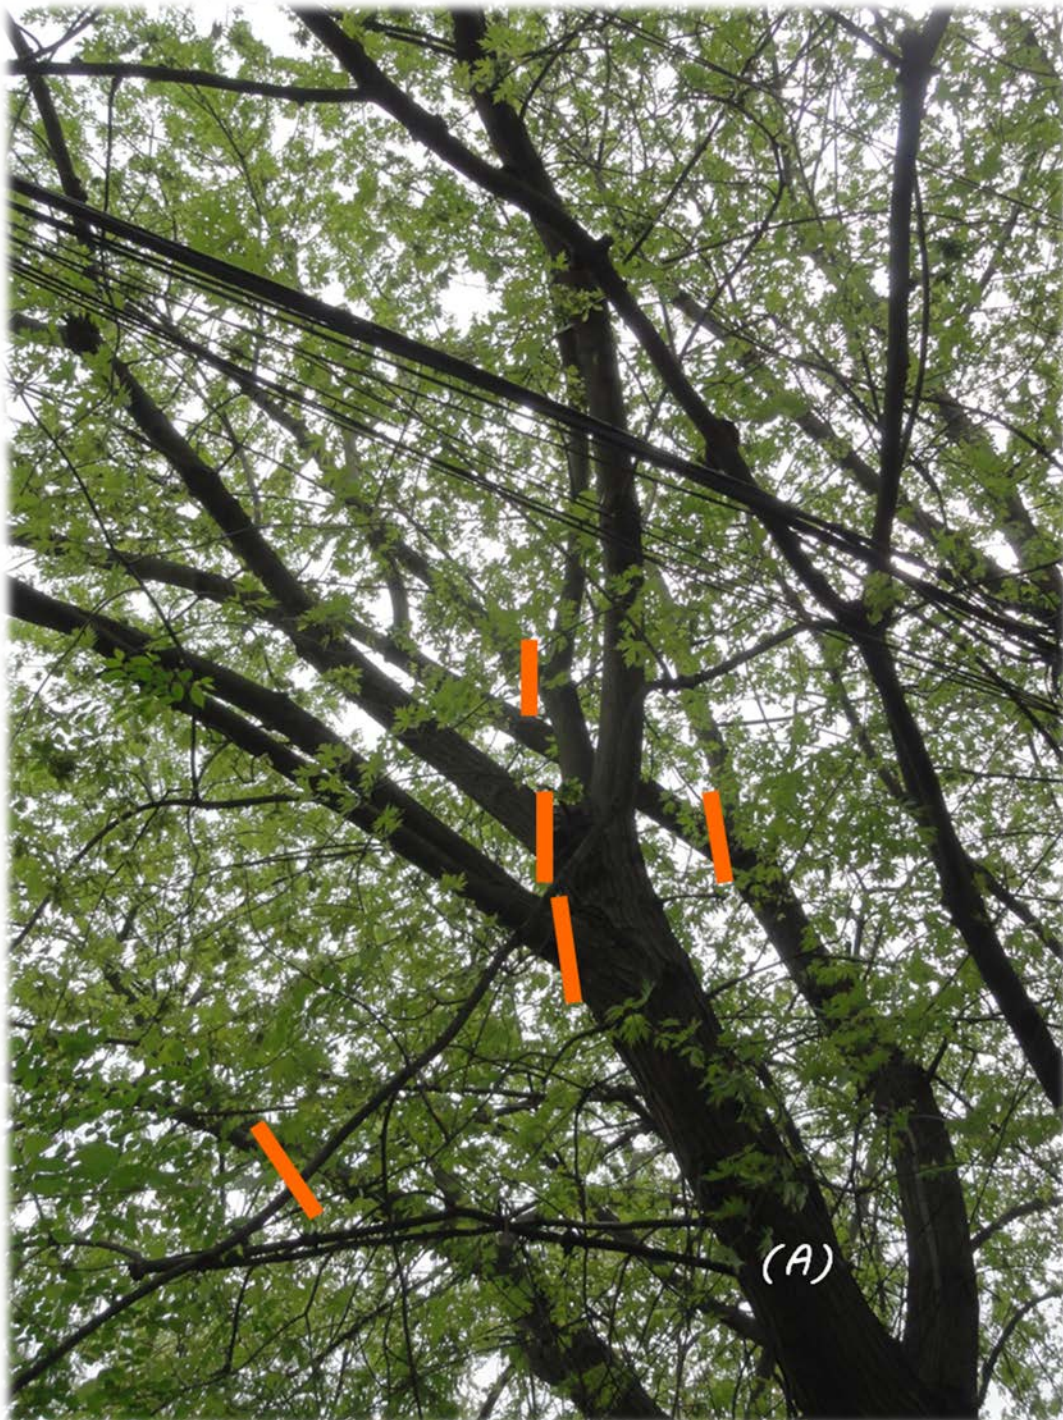
It should be noted that, despite the potential complications associated with its retention in terms of site and construction access and building clearance, a significant scaffold limb (limb 'A' in Figs. 2-4) extending over the subject property is proposed to be retained in order to minimize potential adverse effects upon the tree. Removal of this limb is not recommended due to the large size of the resultant pruning wound, which would be unlikely to be effectively compartmentalized by the tree.

Figure 2: Orange lines show approximate location of proposed scaffold pruning cuts. Note that limb (A) is to be retained despite overhanging subject property in close proximity to proposed building face.
