Re: Item 20.25; 150 Hamilton Street – Application to Injure Private Tree

Re: Addendum to Pruning plan for tree #5 at 154/150 Hamilton Street, Toronto, Ontario. Original Report, June 2, 2014, Revised report, May 9, 2016

Re: Pruning plan for tree #5 at 154/150 Hamilton Street, Toronto, Ontario. Original Report, June 2, 2014, Revised report, May 9, 2016

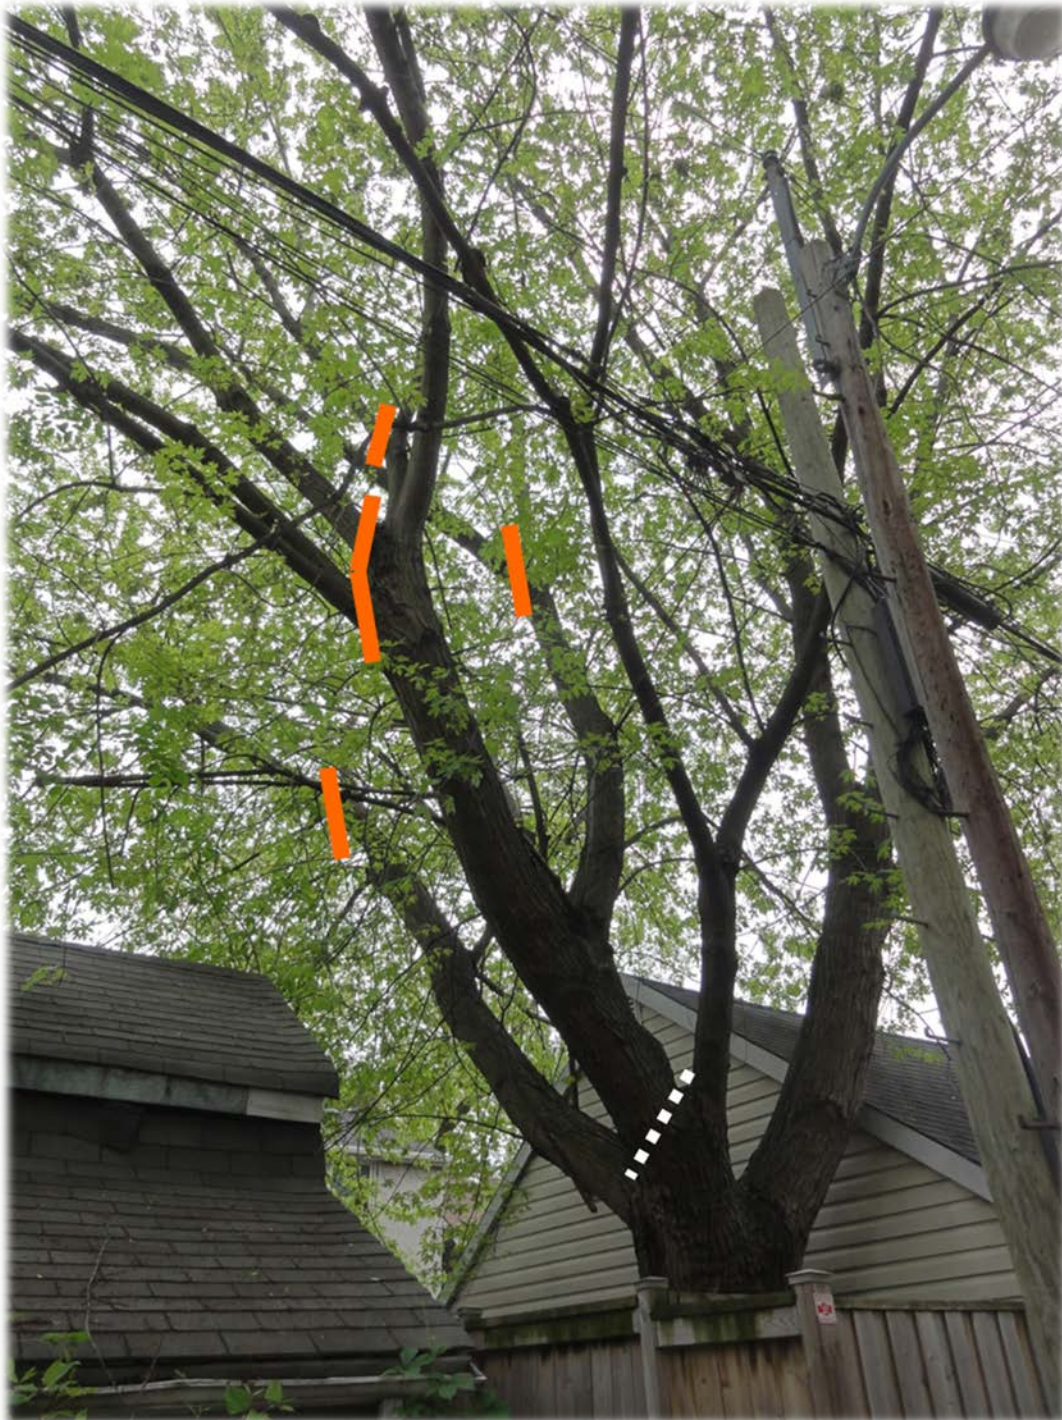
It should be noted that, despite the potential complications associated with its retention in terms of site and construction access and building clearance, a significant scaffold limb (limb 'A' in Figs. 2-4) extending over the subject property is proposed to be retained in order to minimize potential adverse effects upon the tree. Removal of this limb is not recommended due to the large size of the resultant pruning wound, which would be unlikely to be effectively compartmentalized by the tree.

Figure 3: Overview of proposed pruning. White dashed line shows area of potential large pruning cut if limb (A) was to be removed. Limb (A) will be retained despite overhanging subject property.
