PUBLIC MEETING AND OPEN HOUSE

Royal York Road Safety Audit From Ashley Road to Mimico Creek

Tuesday, January 11th, 2005

The City of Toronto

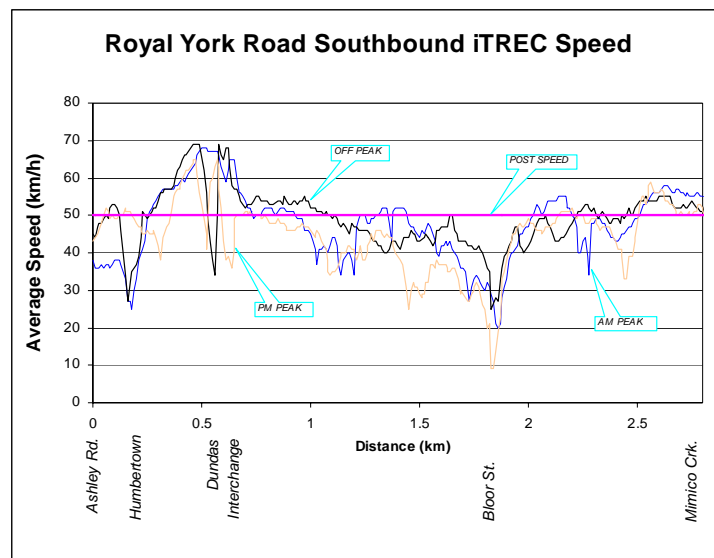
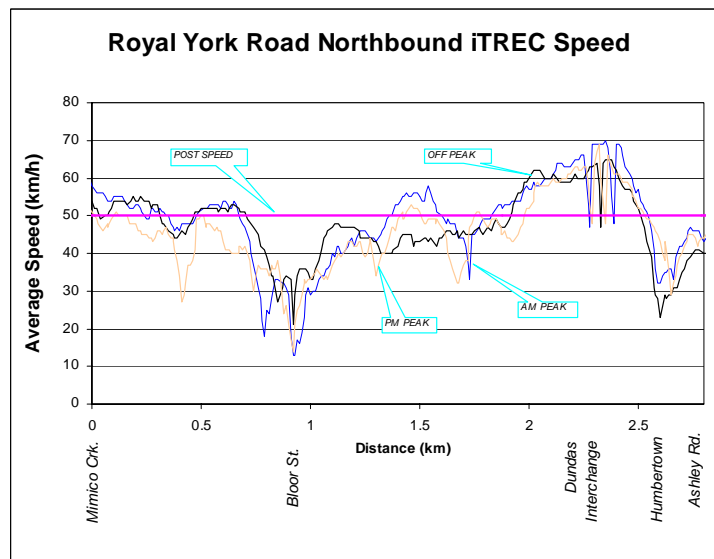
Travel Speeds

- Average travel speeds are greater than the 50 km/h posted speed limit within the Dundas Street Interchange, and at the Mimico Creek Bridge
