Royal York Road Reconstruction - Interim Arborist Report

Philip van Wassenauer, B.Sc., MFC

Urban Forest Innovations Inc.

Feb.16/05

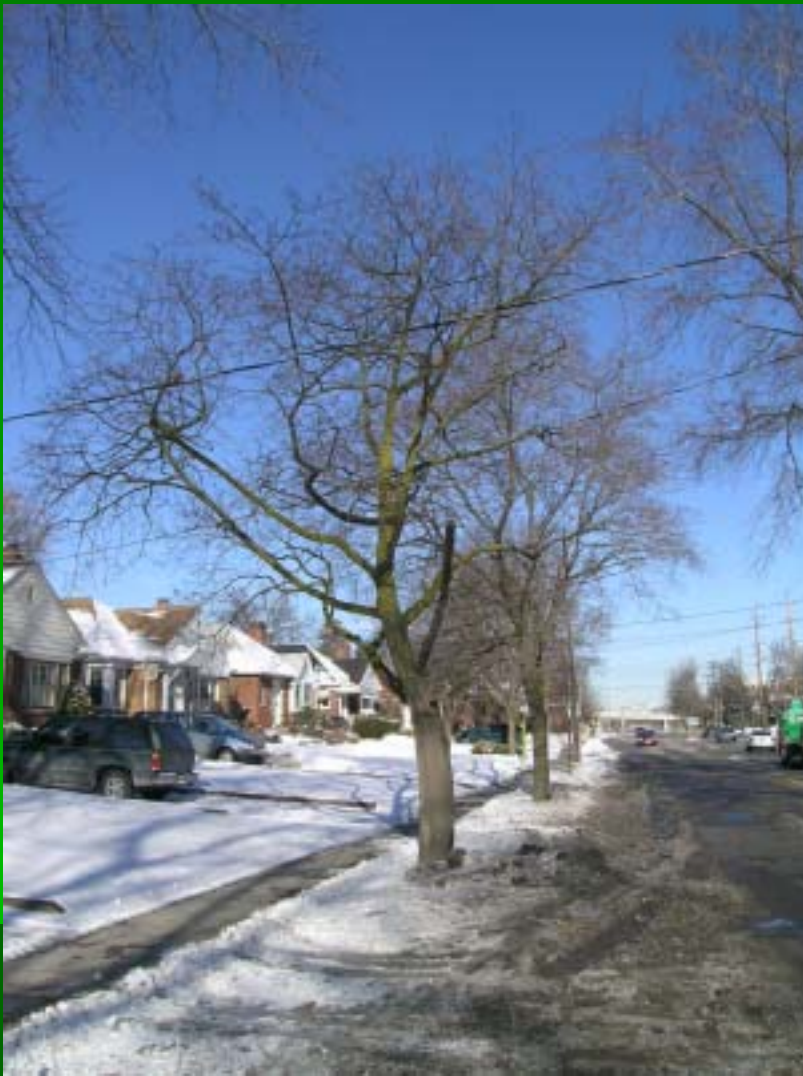
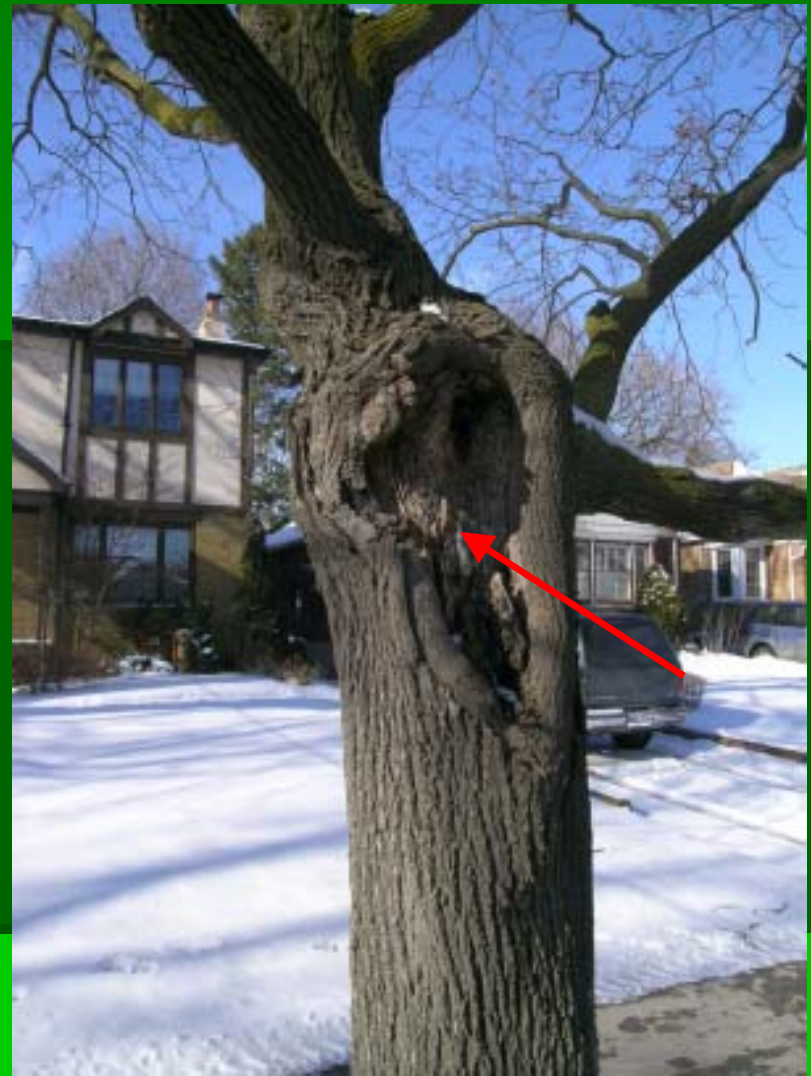
Tree Number 190 at 1070 Royal York Road. This tree has a serious stem canker and is at risk of failure.

Tree #	Species	Address	DBH	TI	CS	CV	Comments
66	Silver Maple	868	47	F	G	G	Two wounds at base. Slated for removal by City
105	Norway Maple	963	70	P	P	F	Remove - large canker in stem.
109	Norway Maple	971	51	P	P	P	Suggested removal
116	Silver Maple	981	53	F	P	F	Decay in stem
252	Norway Maple	982	30	F	F	G	Poor trunk and crown
121	Norway Maple	987	56	G	VP	F	Unbalanced, over road Low branches hit by trucks.
194	Norway Maple	1056	50	F	P	P	Tree is dying, hazard
167	Norway Maple	1057	47	P	P	P	Remove
190	Norway Maple	1070	40	P	P	F	Large stem canker - remove.

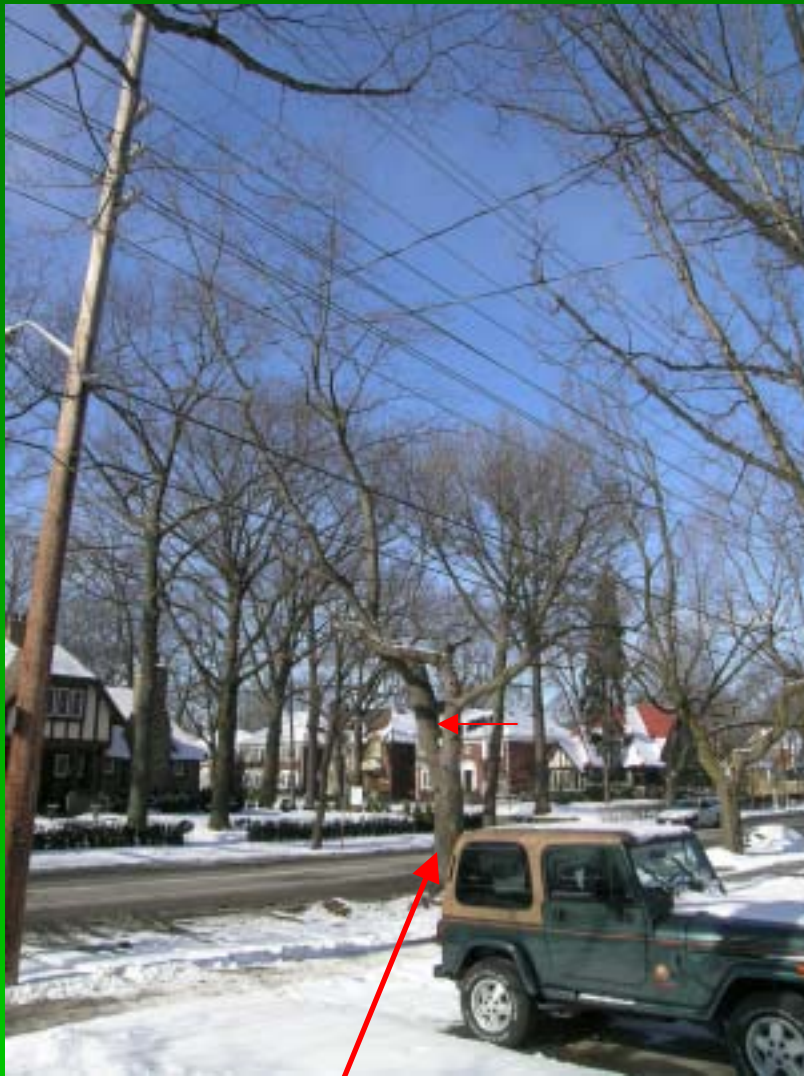
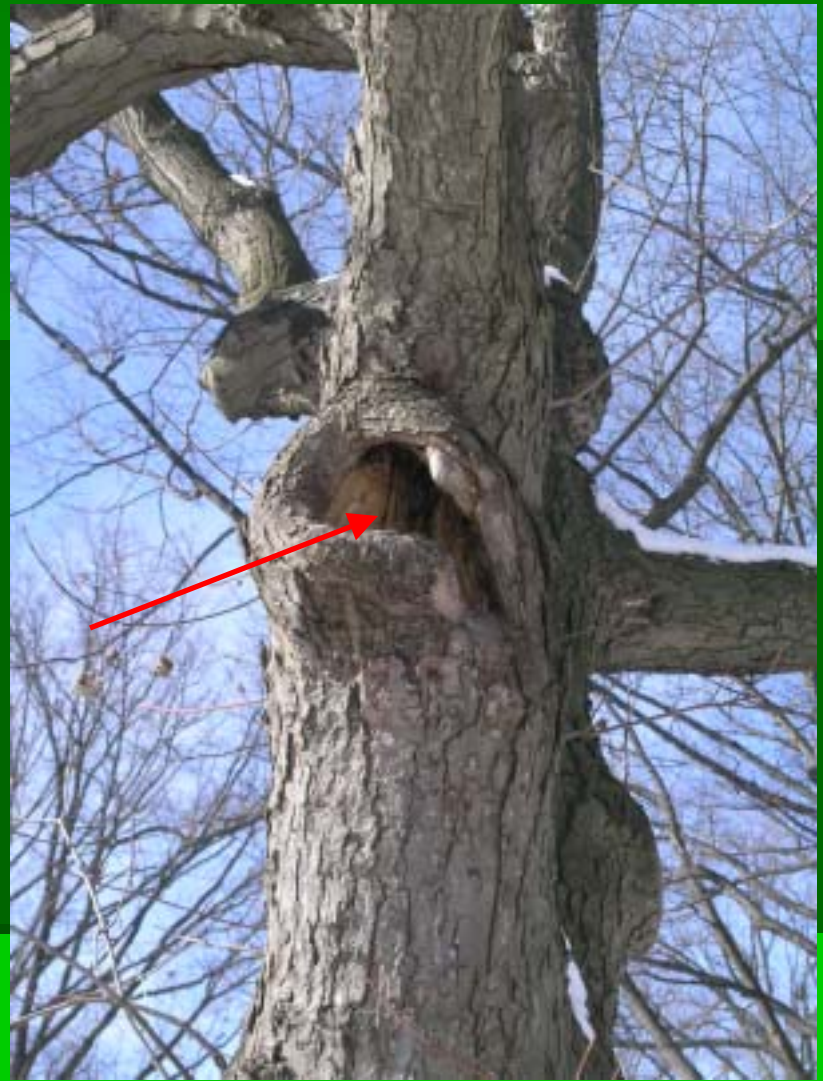
Tree number 116 at 981 Royal York Road. This tree has a serious cavity from an old pruning wound and leans over the road.
