South of Bloor Street

North of Bloor Street

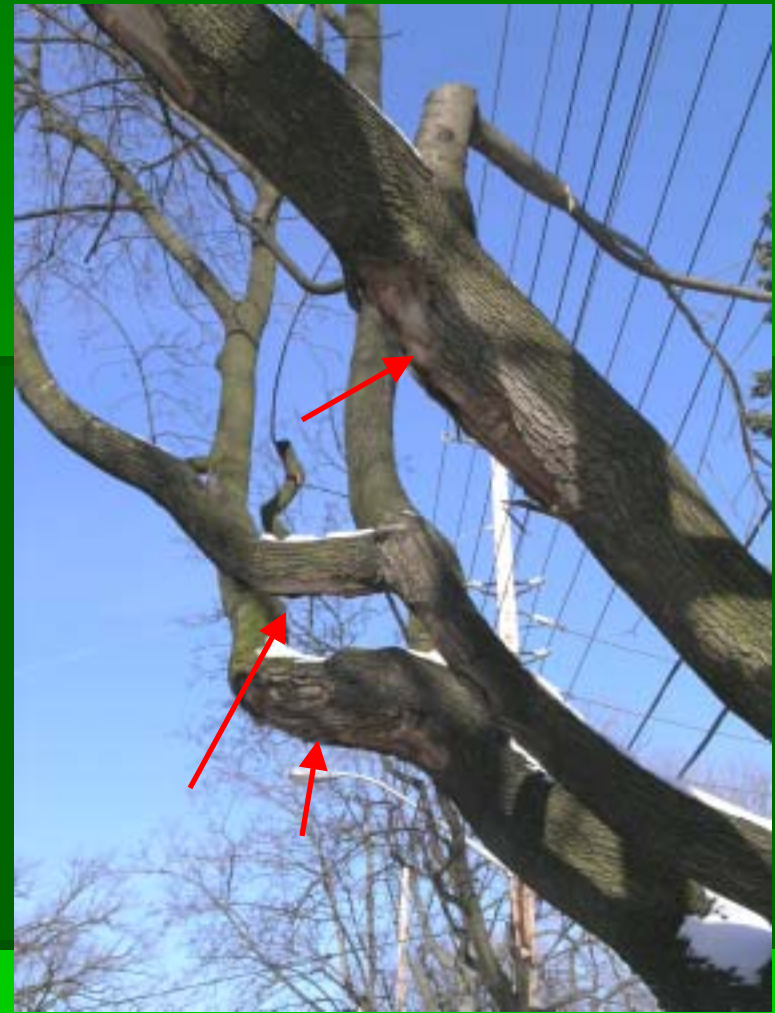
Tree Number 121 at 987 Royal York Road. This tree has been unbalanced by “hydro pruning” and all of its stems over the road have been damaged by vehicles.

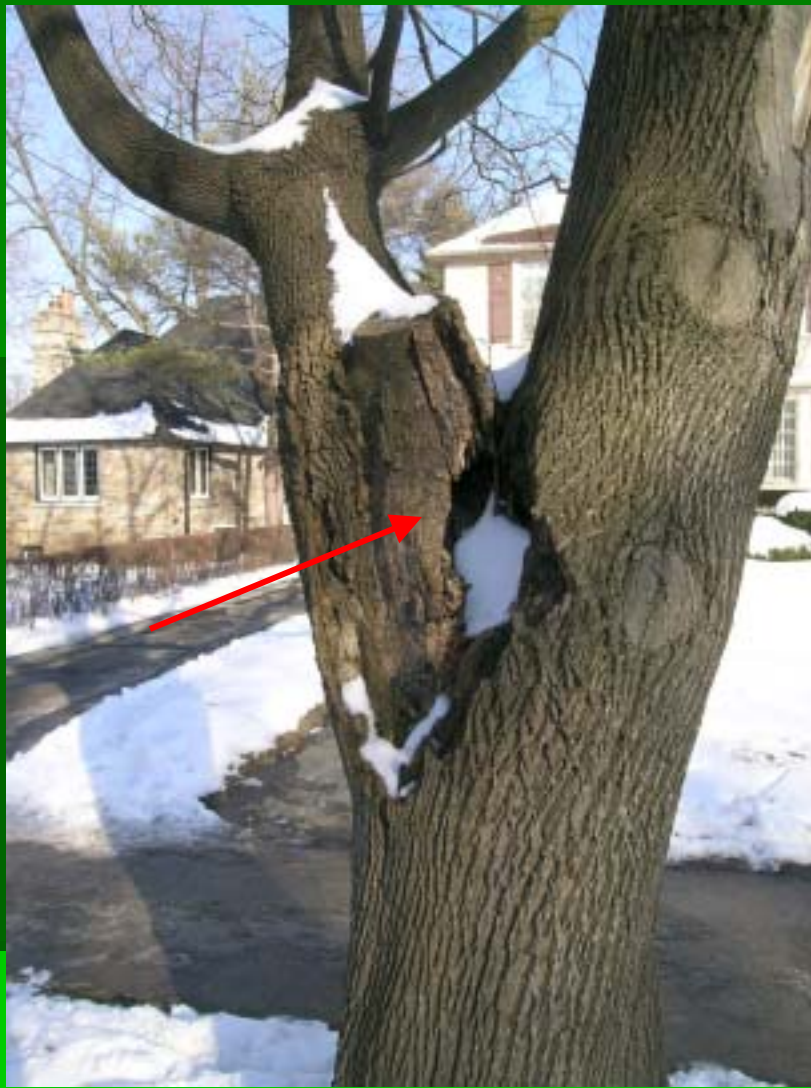
Serious decay in the stem and main branch union of tree number 105 at 963 Royal York Road. Tree is a potential hazard.

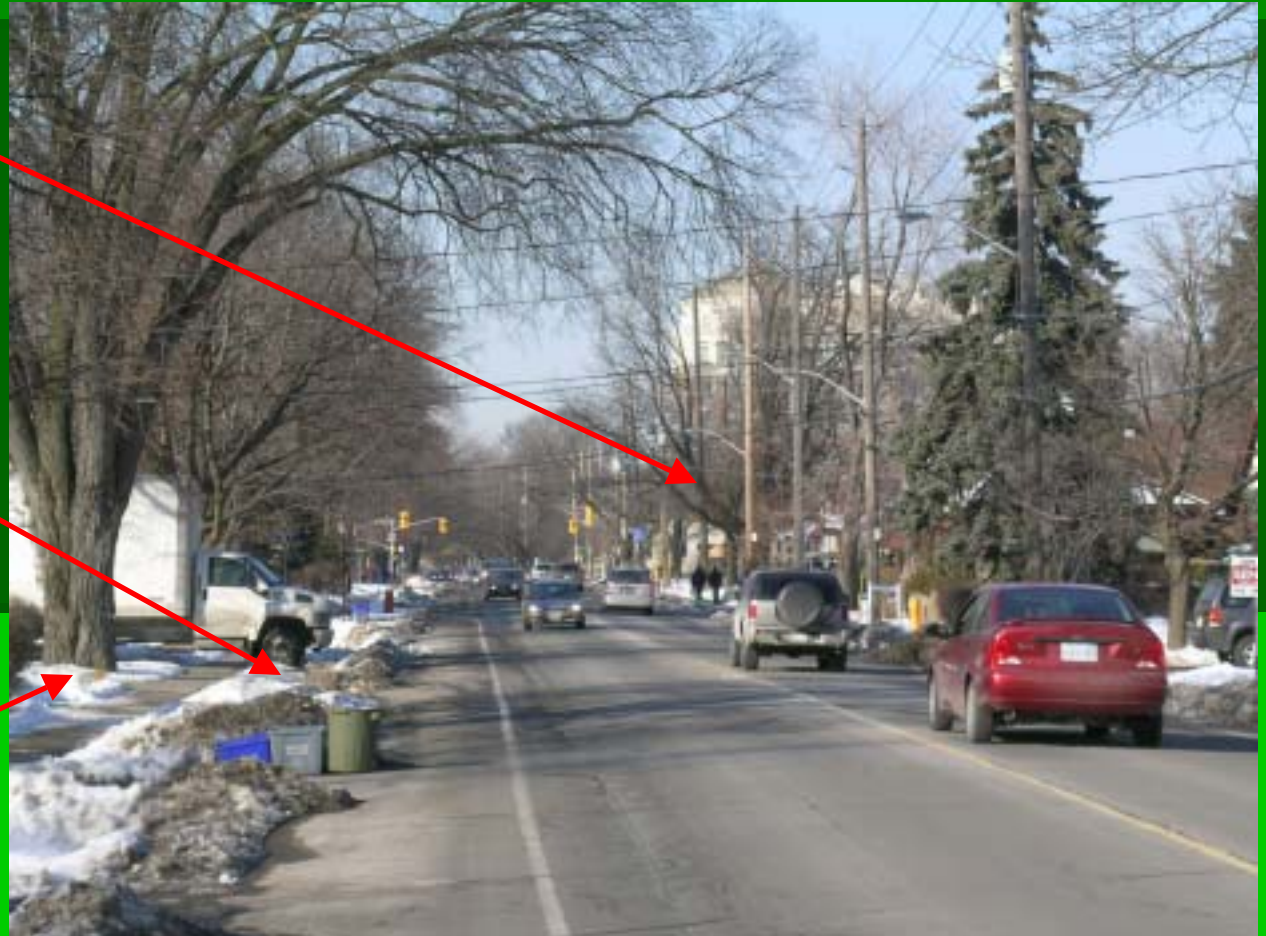
South of Bloor

- Roadway appears wider because there are no trees between sidewalk and road
- In general, the area between the road and the sidewalk is already paved
- Ditches on west side may have tree roots
- Trees adjacent to sidewalk may have roots underneath
- Root explorations as conditions permit

Less trees affected
by wires

Ditches on
west side

Trees outside
sidewalk

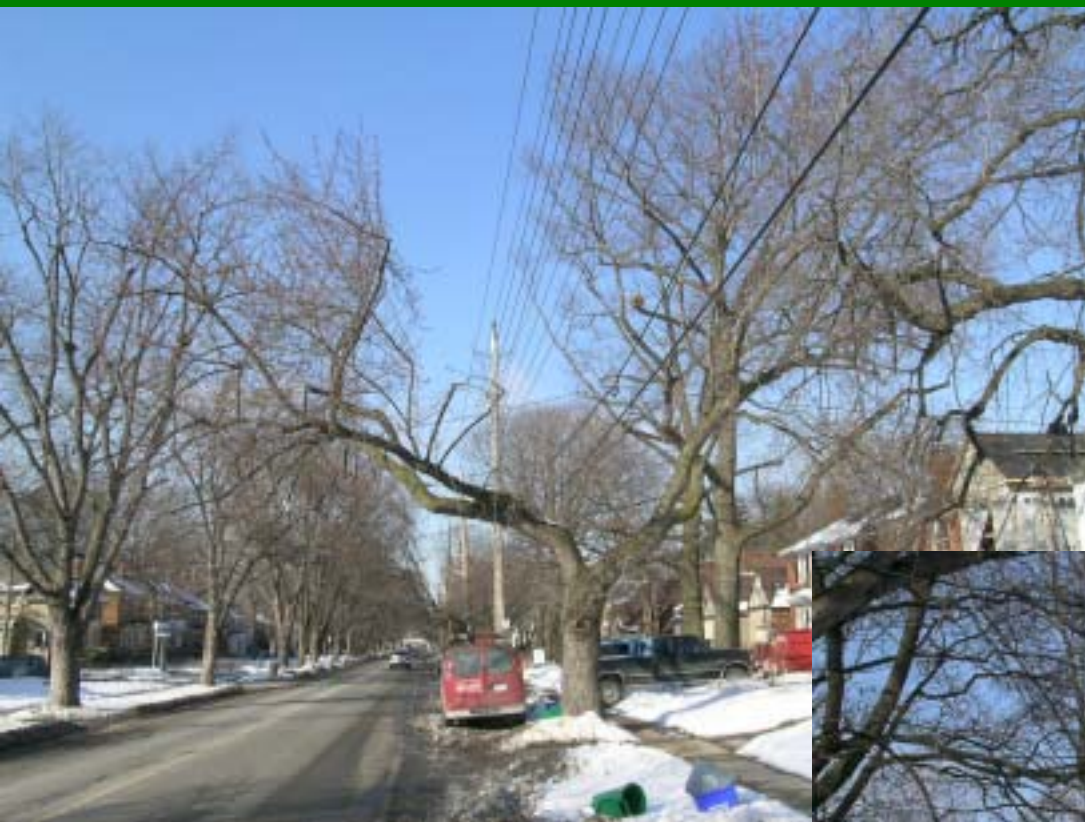
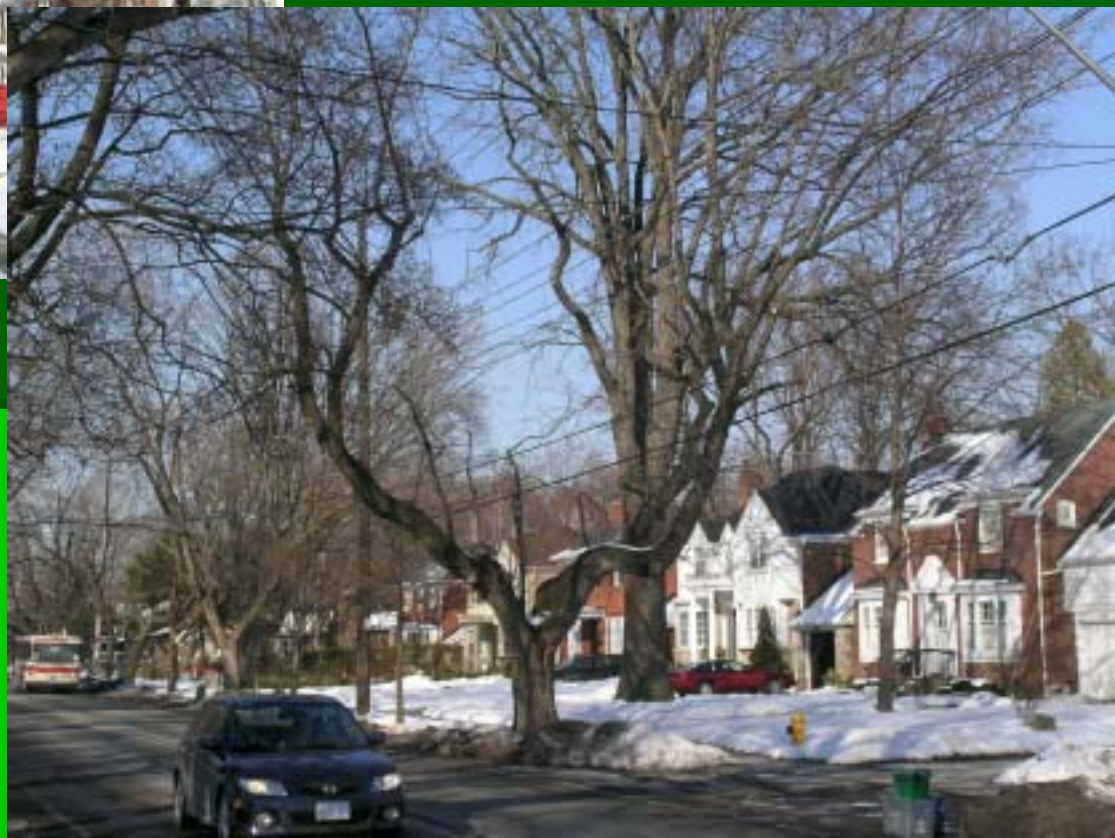
Trees under hydro wires

- These trees have a history of pruning to accommodate the wires
- When the “new”, higher wires were installed the tops and sides of many trees had to be removed
- Many trees have poor structure and unbalanced crowns

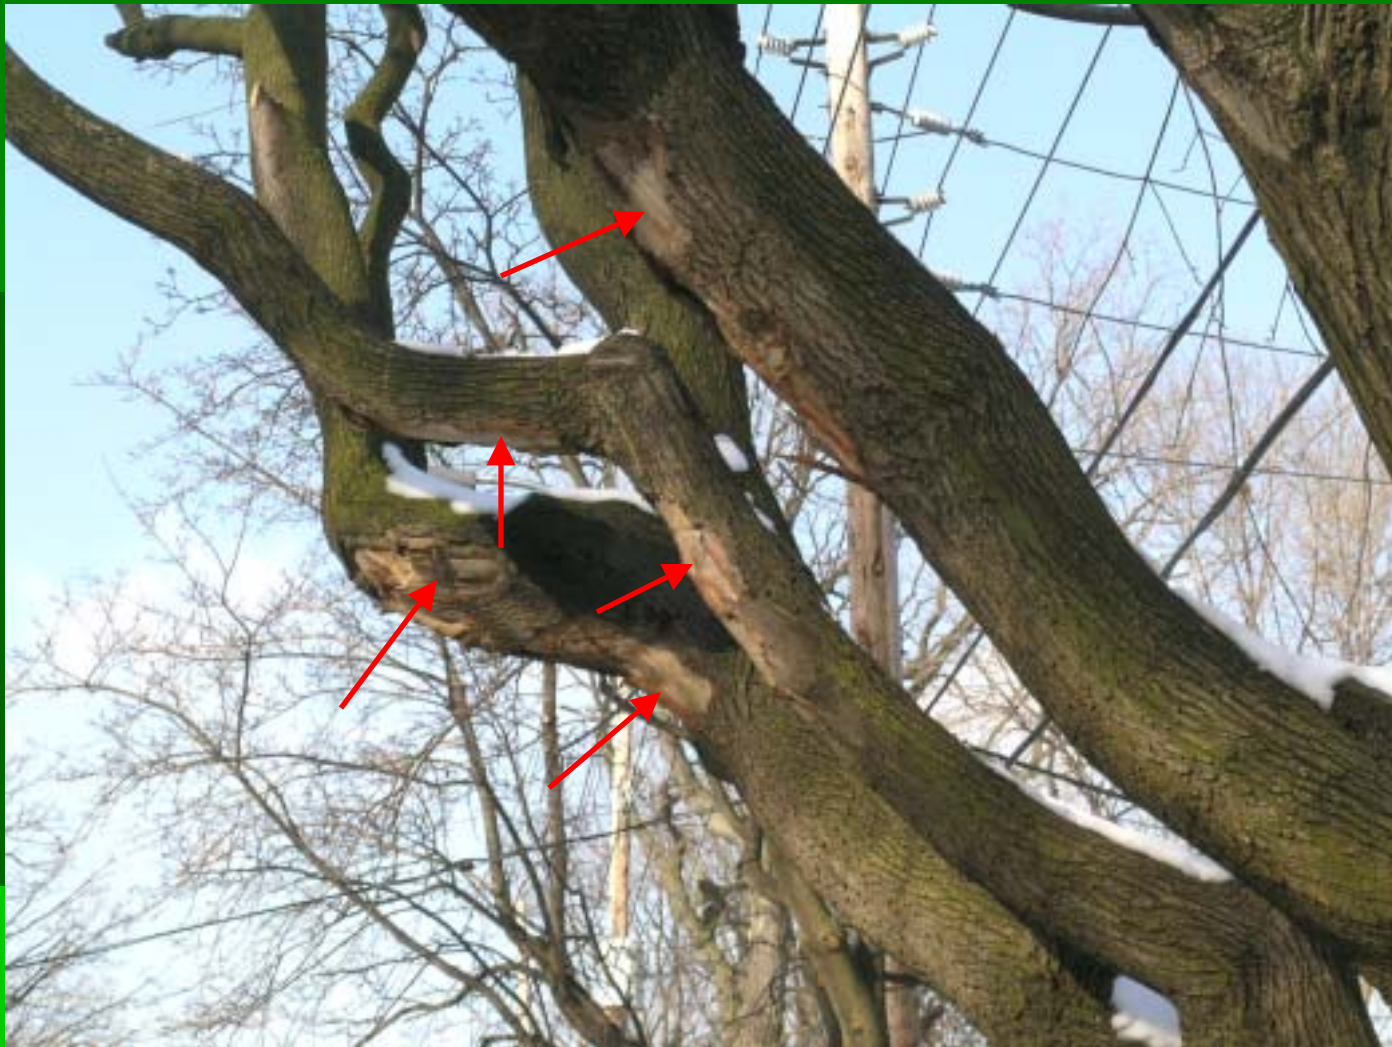
- Large pruning cuts often lead to internal decay
- Risk of failure of large horizontal branches bearing large loads
- Some branches are so low that they have been struck by vehicles

Damage from vehicles

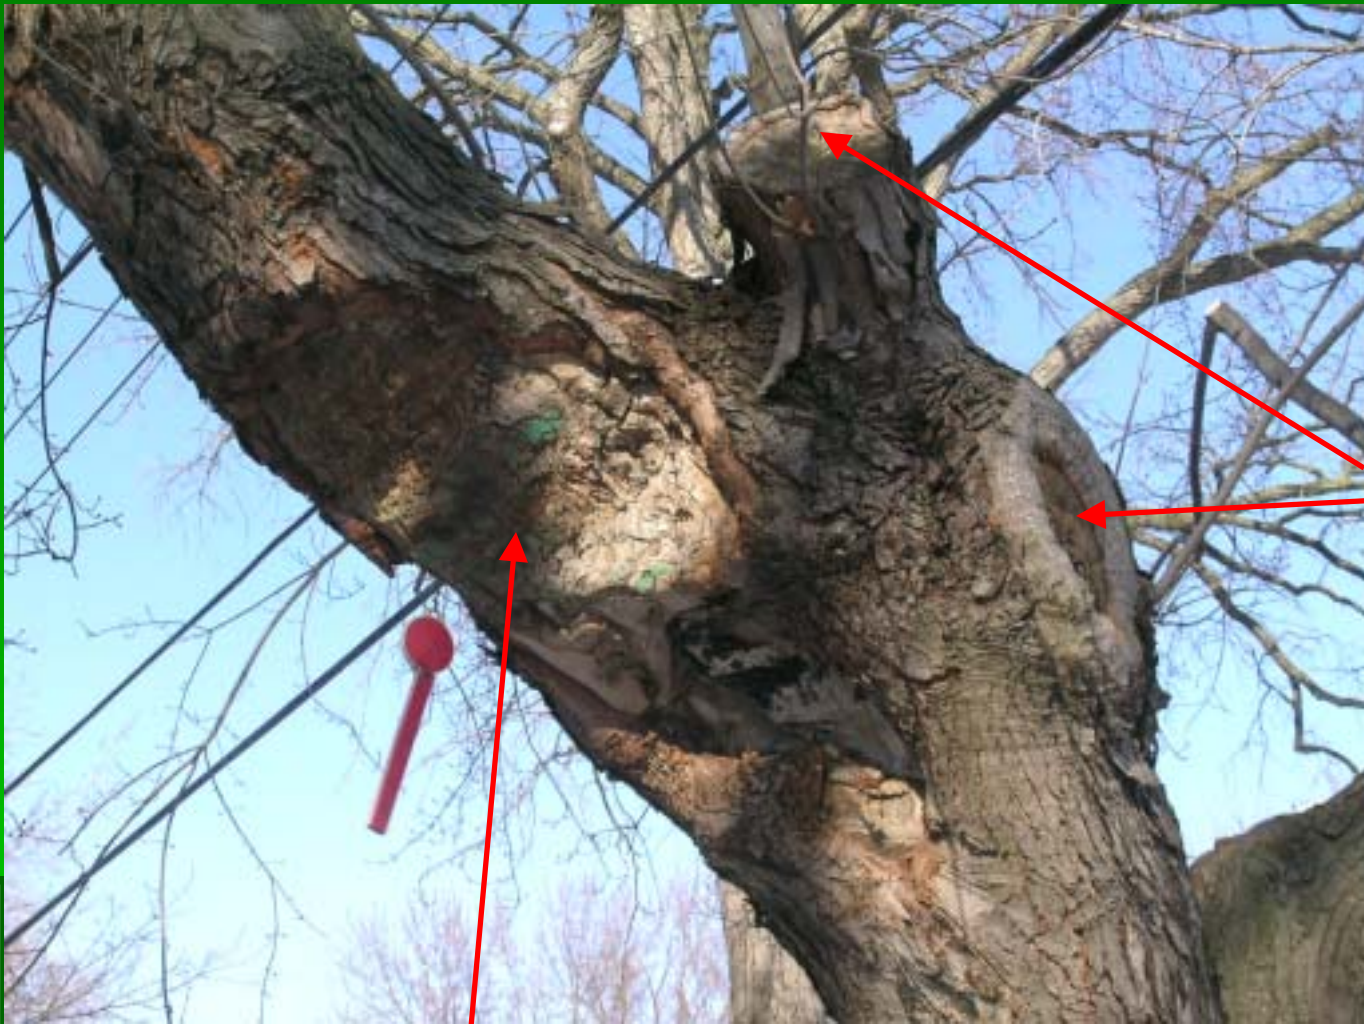
Damage from vehicles

Internal decay
from old
pruning cuts
