APPENDIX H
Photographs – Deck Condition from Bent #295 to #297

Attention: Mr. Vic Zubacs, P. Eng.
 Senior Project Manager
**RE: F.G.Gardiner Expressway
 Existing Deck Condition Observations
 on October 23, 2011**
 Our File: W.O. 3211118

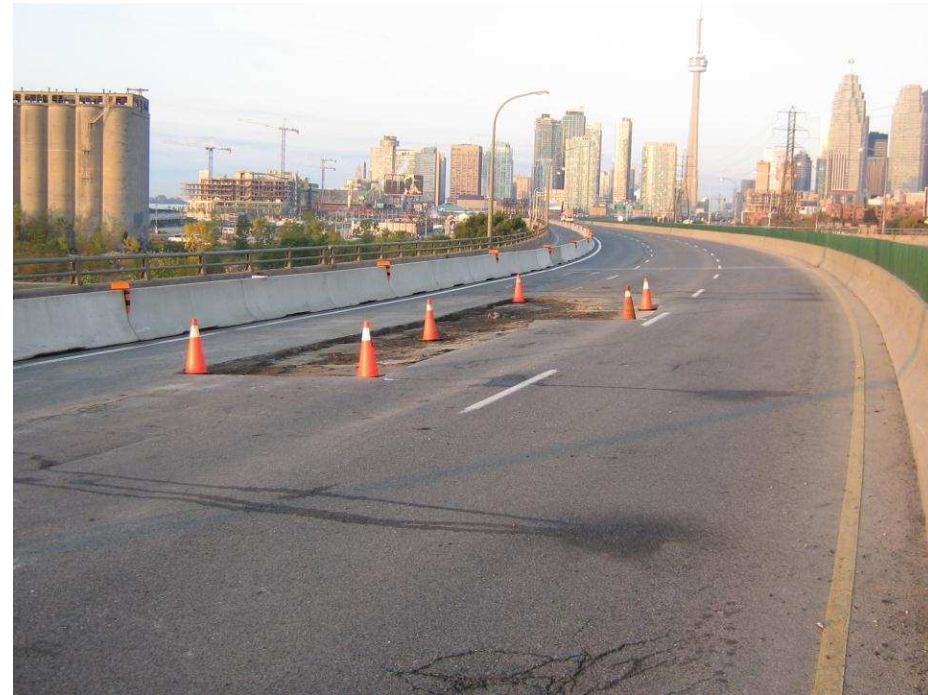
Upon arriving at the location the asphalt had been removed from two (2) areas. One area was approximately 2.2m wide and 14m long. The second area was 2m long by 1.5m wide (See Photograph 1 and Photograph 2 respectively). These areas occupied the number 2 and number 3 lane (Photograph 2).

Photograph 1. - Showing removed Asphalt.

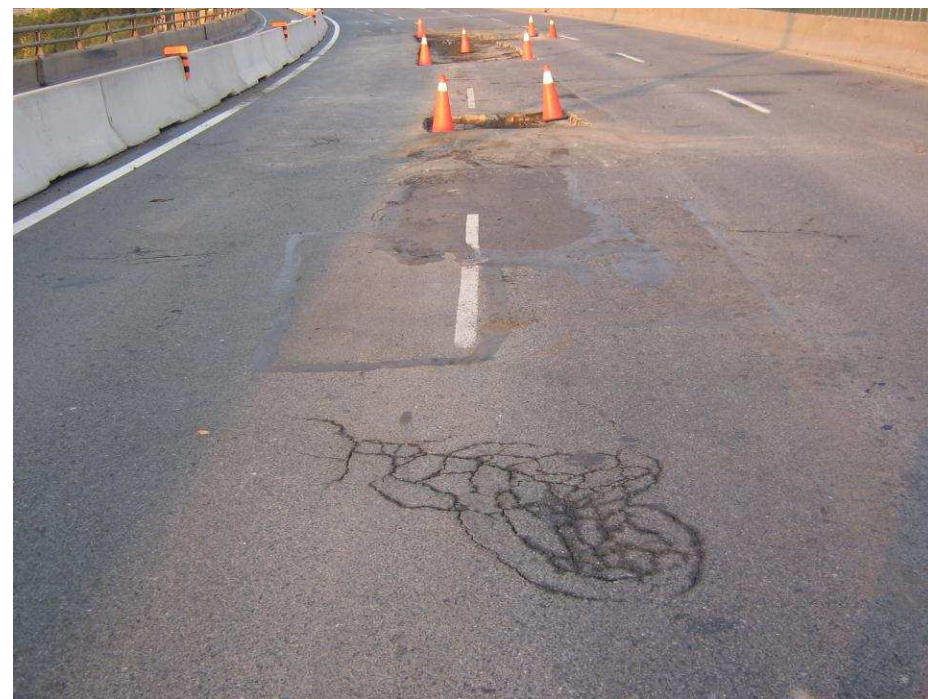
Photograph 2. - Showing removed Asphalt lanes 2 and 3.

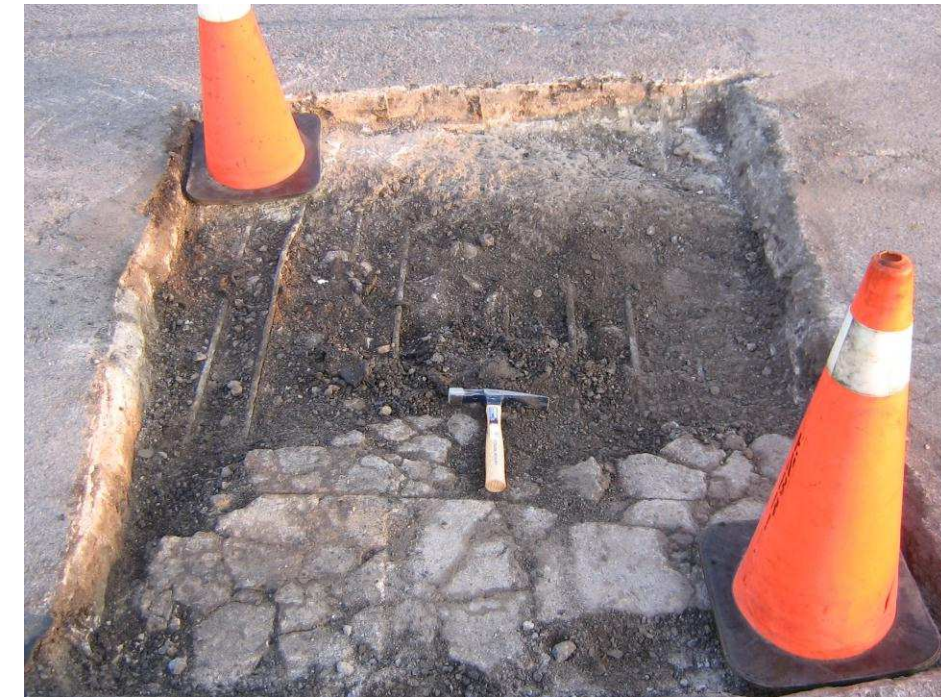
The exposed reinforced concrete in the deck (which supports traffic) was in very poor condition. The concrete had deteriorated to the point where it could easily be removed by hand or with small hand tools (Photograph 3). The top mat of reinforcing steel in the deck was exposed (Photograph 4) over much of the area. Water was standing in the deteriorated deck concrete. From below (viewed later) it was evident as damp areas on the deck soffit.

Our assessment of this section of the Expressway deck is that there is a high risk of a localized punch-through of the deck. Freezing temperatures during this winter may also cause concrete on the deck soffit to be spalled off due to the freezing action on the saturated deck concrete. Either of these occurrences would result in concrete falling to the area beneath the elevated Expressway and short term closure of the roadway to repair the decks.

Photograph 3. - Exposed reinforced concrete in very poor condition.

We would recommend that the same system of heavy timber falsework be installed in this general area as soon as practical. This system will help prevent both a punch-through of the deck and debris from falling from the deck soffit.

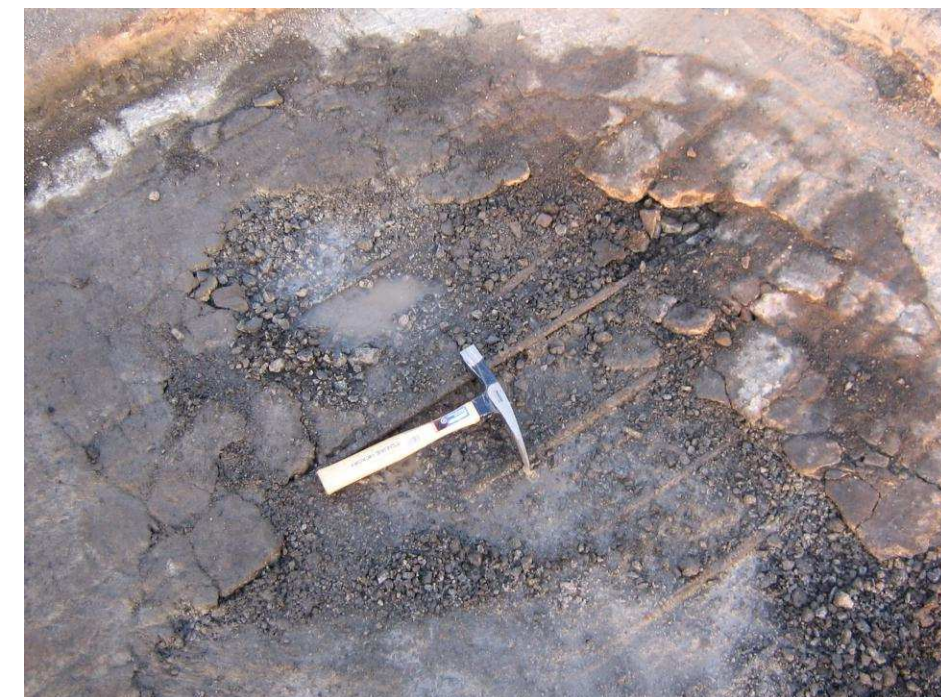
Photograph 4. - Exposed top mat of reinforcing steel.

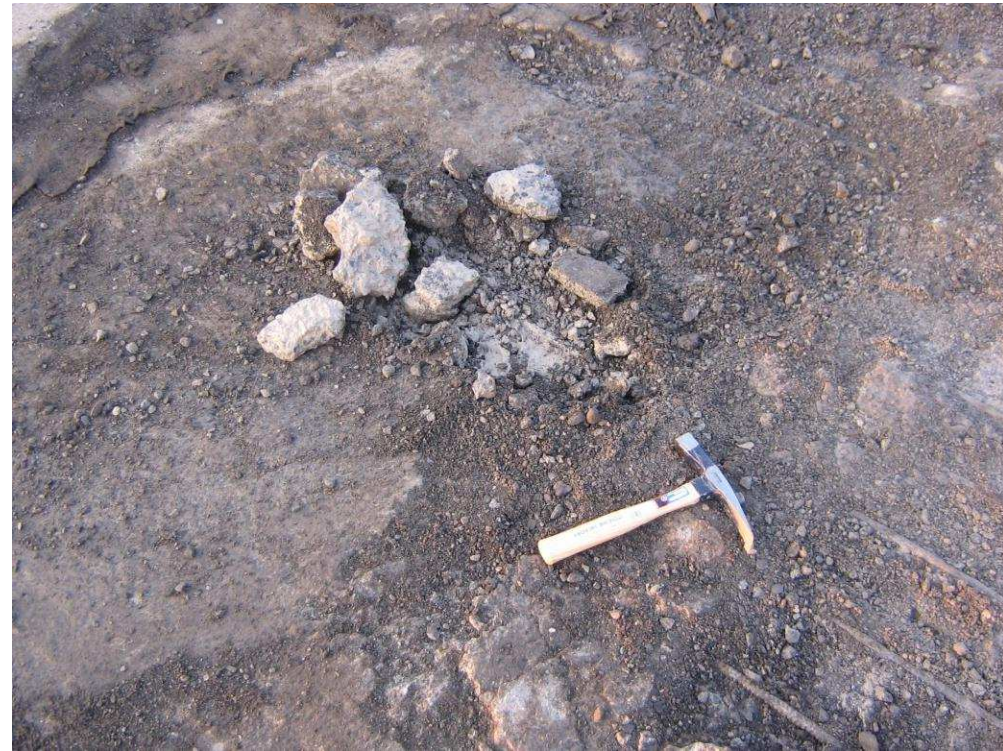
Where the reinforcing steel was not exposed, the concrete cover was fractured into fragments that could be easily removed (Photograph 5) with little effort.

Photograph 5. - Fractured fragments of concrete cover.
