URBANGREEN TREE LTD.

Location: 102 Wimbledon Rd. The 4 Trees are located in the back yard. Tree 1 is near the south fence line, Tree 2 is the center of the yard, Trees 3 and 4 are by the back walkway.

Nature Of Work: Request permission to remove the 4 trees.

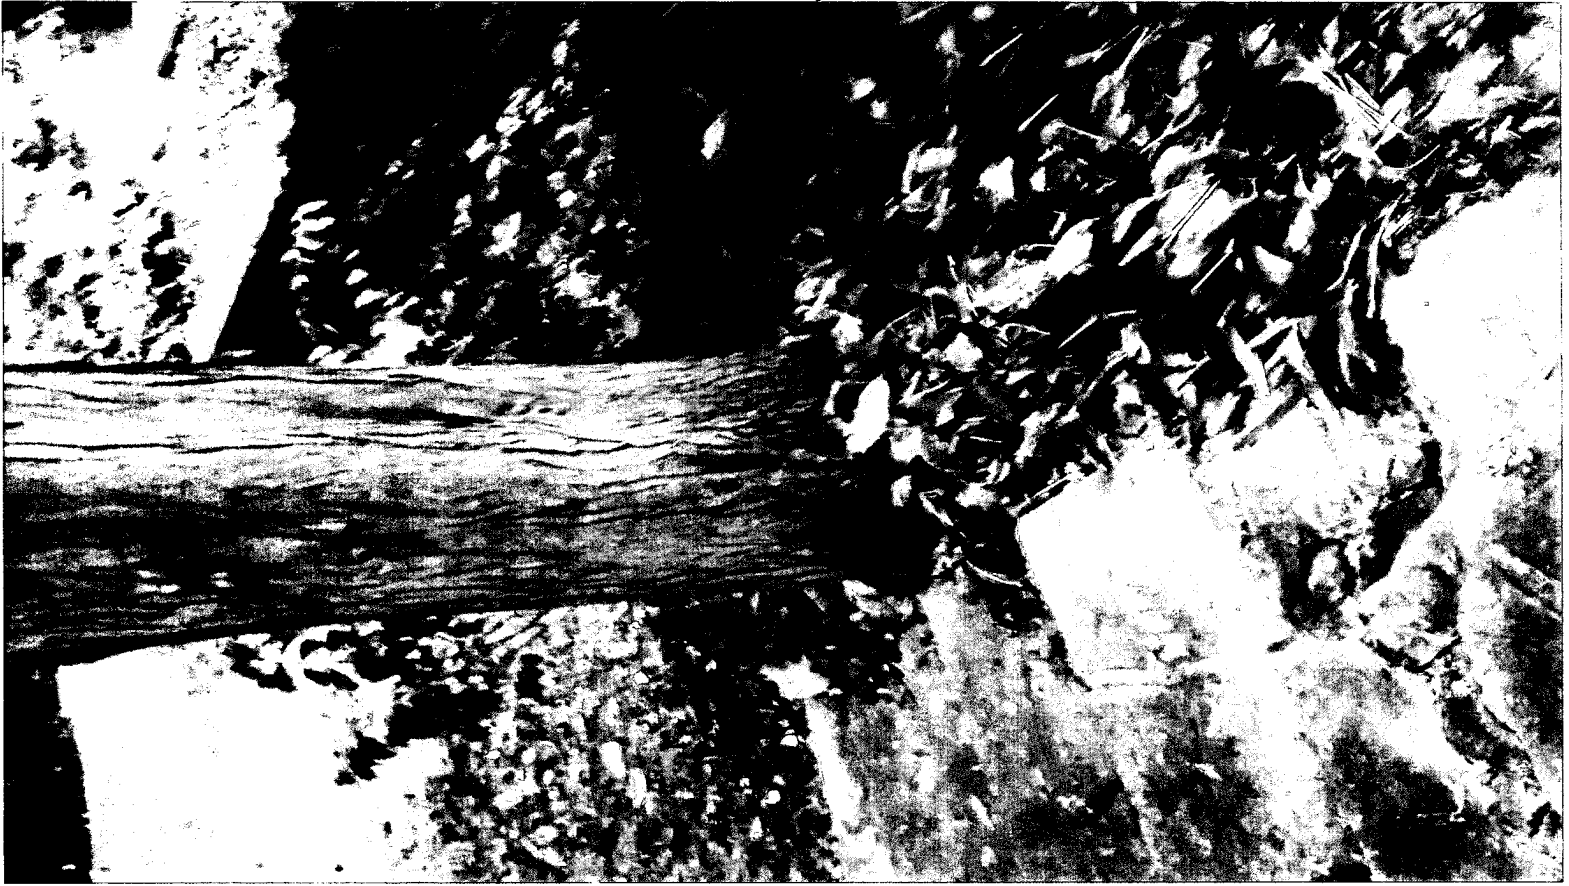
TREE 3

Tree 3 – Cedar: Co-dominant stems with weak union, branch dieback throughout crown with majority of branches on north side stem and very few on south stem causing an imbalance to the tree. Is growing on grade causing potential loss of root foothold due to erosion.

Tree 3 – Cedar: The client is worried about the risk to neighbouring property and would like to remove the tree to prevent future property damage or personal injury.

Arborist Recommendation: These trees have poor structure and with the risk to property damage or personal injury due to the locations, are therefore no longer viable to maintain. I recommend removal and replacement.
