VISUAL TREE ASSESSMENT REPORT

Project Address:
45 and 43 Leuty Avenue
Toronto, ON
M4E 2R2

Report created: 30 September 2015

**VISUAL TREE ASSESSMENT REPORT
45 and 43 LEUTY AVENUE
(WARD 32: BEACHES EAST YORK)
TORONTO, ON M4E 2R2**

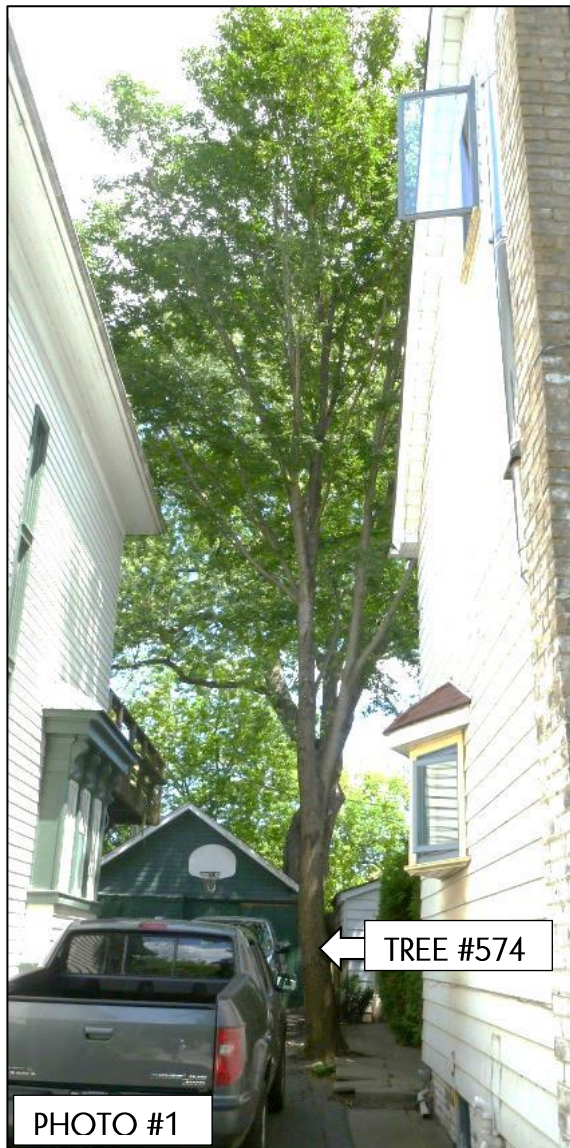
The orientation of the houses at 45 and 43 Leuty Avenue create a wind tunnel in the immediate area where the tree is located (see Photo #1). The western facing gap creates stronger winds than usual, increasing the wind load on tree #574, adding to the probability of failure.

The trunk of Tree # 574 has several key structural defects. The base of the tree only shows root flare on the South side of the trunk. The entire North side of the trunk shows no visible root flare (see Photo #4). The tree is growing on a slight lean North towards the house located at 45 Leuty Avenue (see Photo #1). There is also a minor cavity at the base of the tree. Furthermore, the tree is co-dominant at 4m in height resulting in included bark at the branch union (see Photo #8).

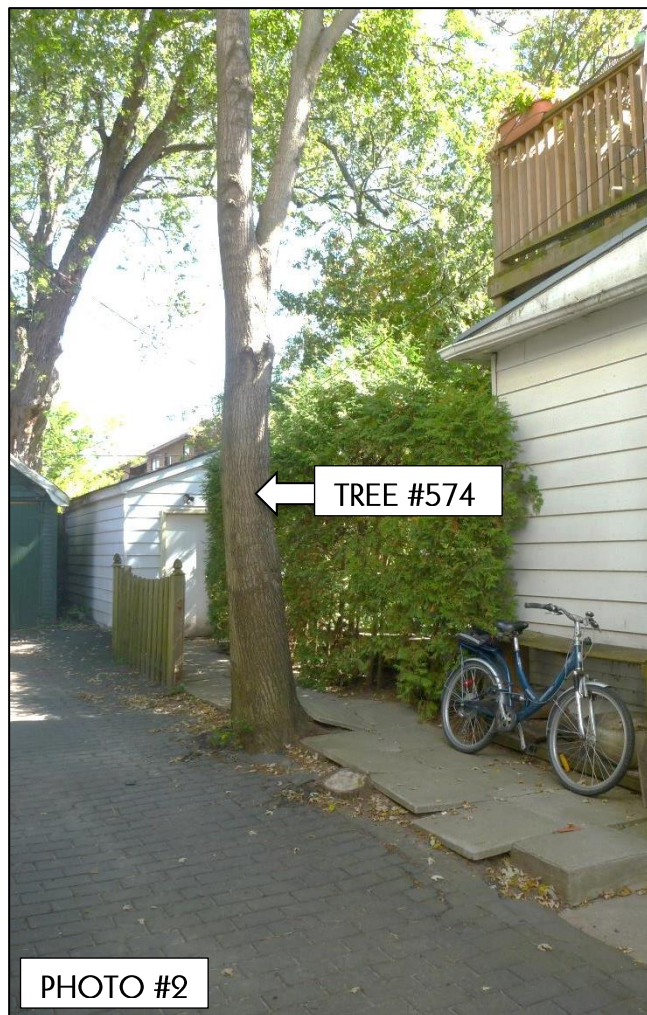
Tree #574, a 42 cm dia. Slippery Elm (*Ulmus rubra*), is a privately-owned deciduous tree growing on the South property line between 45 and 43 Leuty Avenue. The tree is situated approximately 2.8m from the South-east corner of the dwelling at 45 Leuty Avenue and approximately 2.8m from the North-East corner of the dwelling at 43 Leuty Avenue. A significant portion of the Critical Root Zone (CRZ) of this tree is either paved driveway or pre-cast paver walkway (see Photo #1 and #2 and sheet T1).

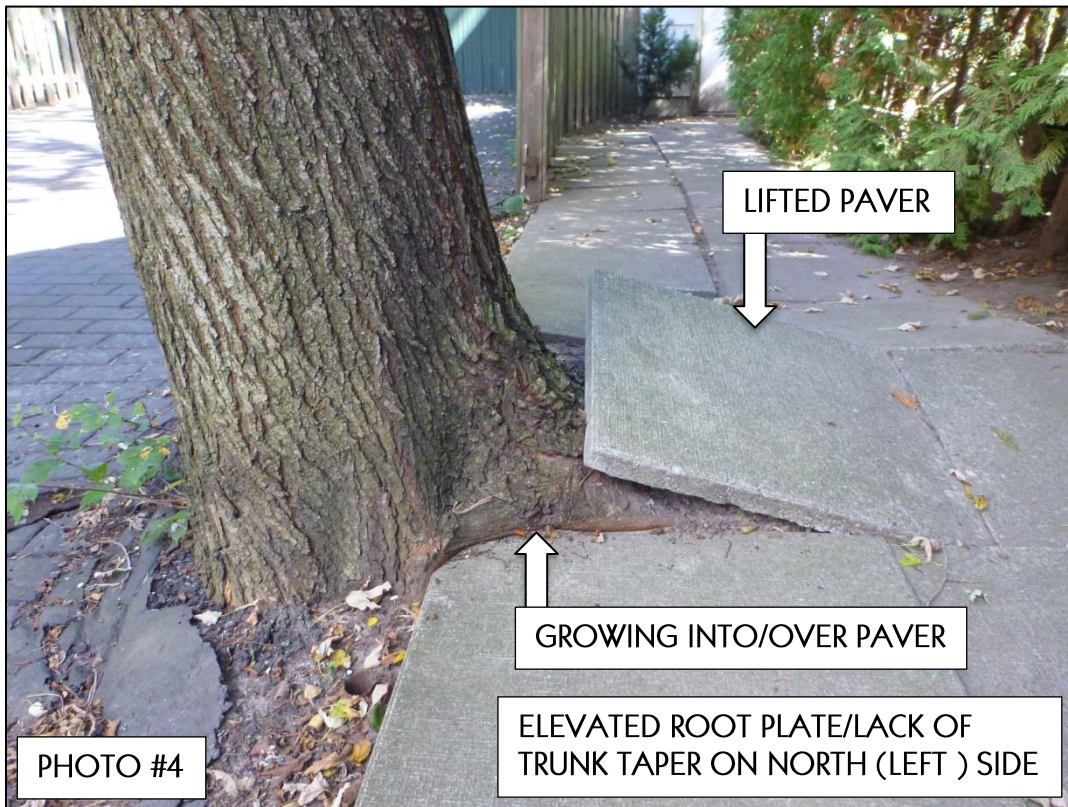
environment, Tree #574 has an elevated root plate causing the buttress roots on the South side of the tree to lift the surrounding pavers (see Photo #4).

The second largest buttress root is growing South-West directly into and over one of the pavers at the base of the tree (see Photo #4). Removing the paver would injure the tree and potentially contribute to its structural instability. Since this is a shallow rooted tree, and the majority of the roots are located under the walkway, we can conclude that the tree has been compensating, using the weight load of the pavers over its roots for structural stability. Therefore, the pavers provide for structural support for the root plate of the tree and play an integral part of the current structural profile of Tree #574. If the pavers are removed to accommodate for future growth, this could result in the structural instability of the tree and potential failure at its base. It is the professional opinion of Tree and Ravine Inc. that any major excavation necessary for relocating the walkway or repairing of the driveway next to the tree may cause the tree to fail during the construction process.

It is recommended that no pavers be removed from the base of the tree, and that no excavation take place at the base of the tree until the tree is removed. Any significant changes to the root environment of Tree #574 could potentially contribute to its structural instability since this is a shallow rooted tree. Any major excavation necessary for relocating the walkway or repairing of the driveway next to the tree may cause the tree to fail during the construction process. It is the professional opinion of Tree and Ravine Inc. that due to the combination of all the factors mentioned in this report that Tree #574 be recommended for removal due to maintenance reasons.

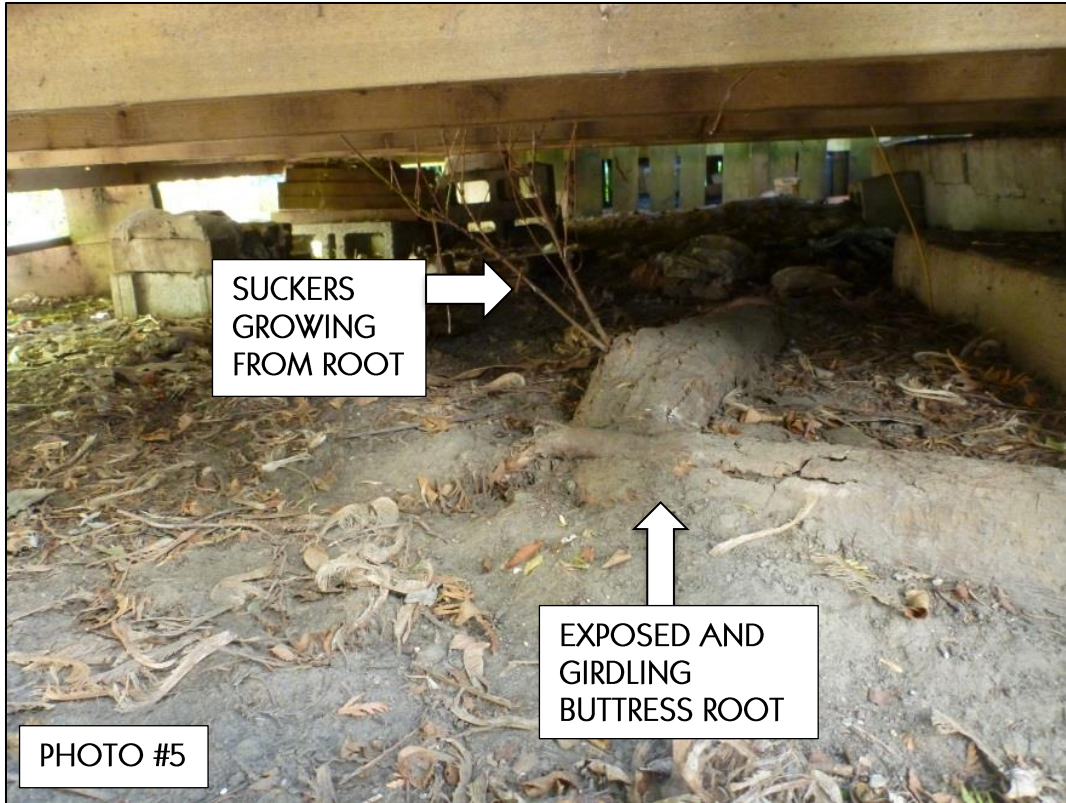
The largest buttress root of the tree is growing South under the walkway pavers, lifting the paver that is closest to the tree (see Photo #4 and #7). This root then grows South in a downward direction, and re-surfaces on the South side of the cedar hedge, under the wood deck, where it is exposed, girdling and growing on a 90 degree bend before straightening out again (see Photo #5 and sheet T1). The sudden change in direction of growth is due to the concrete slab and foundation under the wood deck blocking the root and forcing it to change course. This exposed root is also an indication that the soil is most likely too compacted for proper root depth growth. Furthermore, this root also had suckers growing from it that had died off due to lack of sunlight under the wood deck (see Photo #5).

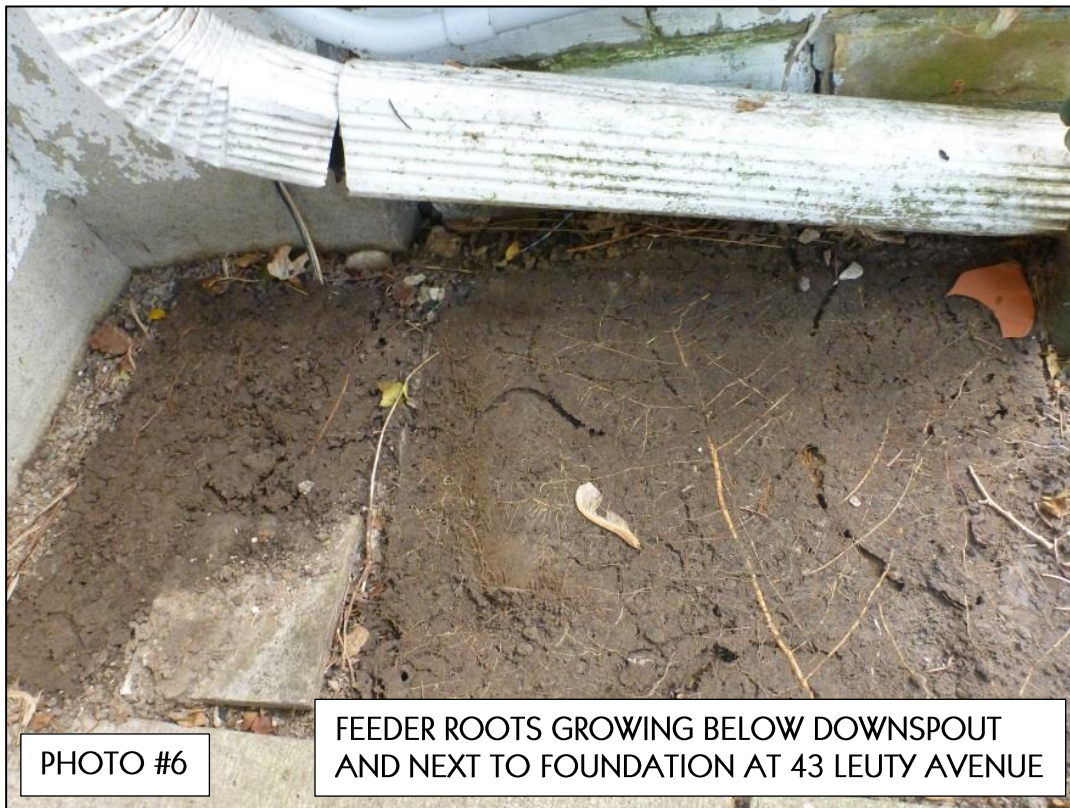
It appears that a significant source of water for Tree #574 is what infiltrates through the wood deck, lifted pavers of the walkway, and what drains out of the downspout and overflows from the eaves troughs at 43 Leuty Avenue (see Photo #6). This is evident by the path of lifted pavers that the roots have created leading to the foundation of the house at 43 Leuty Avenue where water flows from the downspout and overflows from the eaves troughs (see Photo #3). A paver located next to the corner of the house at 43 Leuty Avenue was lifted during the site visit on the 22nd of September 2015 to examine damages, and there were several feeder roots present growing at the foundation of the house (see Photo #6).

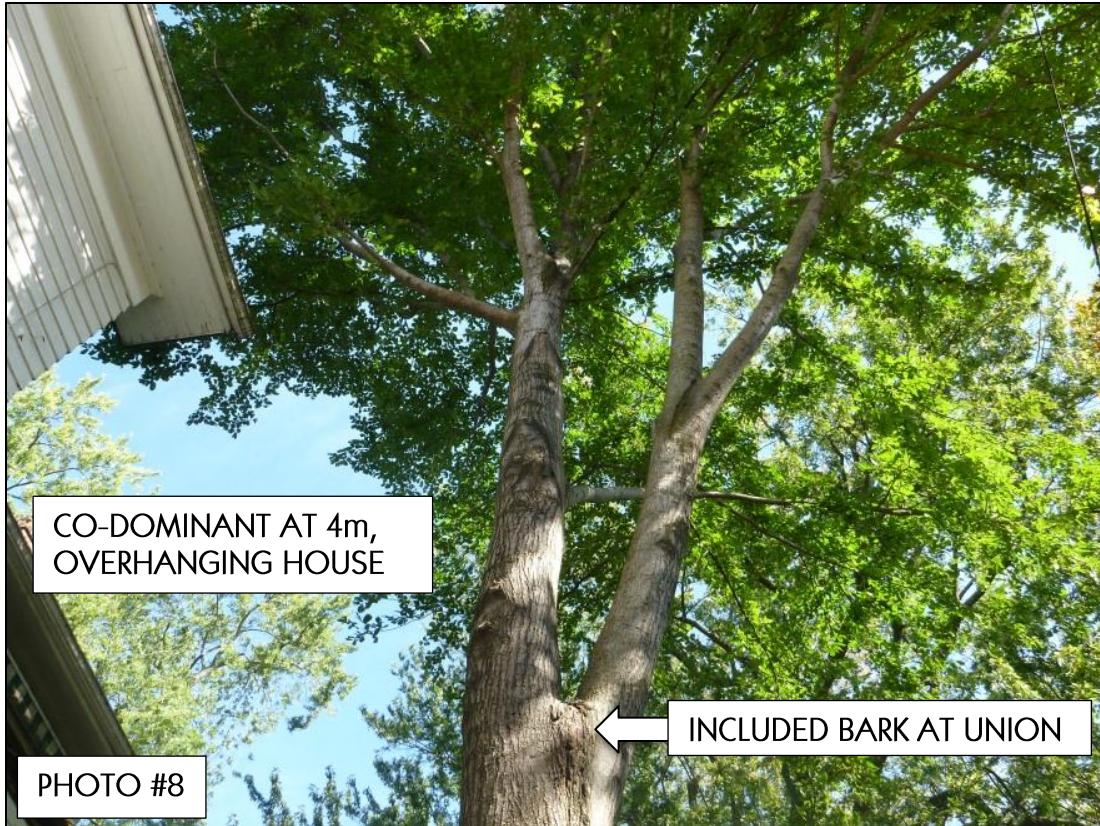
Tree #574 has a full canopy with good structural form. The branches of the tree overhang the houses at 45 and 43 Leuty Ave., as well as the adjacent driveway and the walkway (see Photo #8). The leaves on the lower portion of the canopy exhibit minor signs of insect damage as the foliage has leaf spots as well as minor dieback (see Photo #9).
