## STAFF REPORT ACTION REQUIRED

### Application to Remove a Private Tree - 49 Brookridge Drive

<b>Date:</b>	August 16, 2016
<b>To:</b>	Scarborough Community Council
<b>From:</b>	Jason Doyle, Director, Urban Forestry, Parks, Forestry and Recreation
<b>Ward:</b>	Ward 37 – Scarborough Centre
<b>Reference Number:</b>	P:\2016\Cluster A\PFR\SC16-090716-AFS#23389

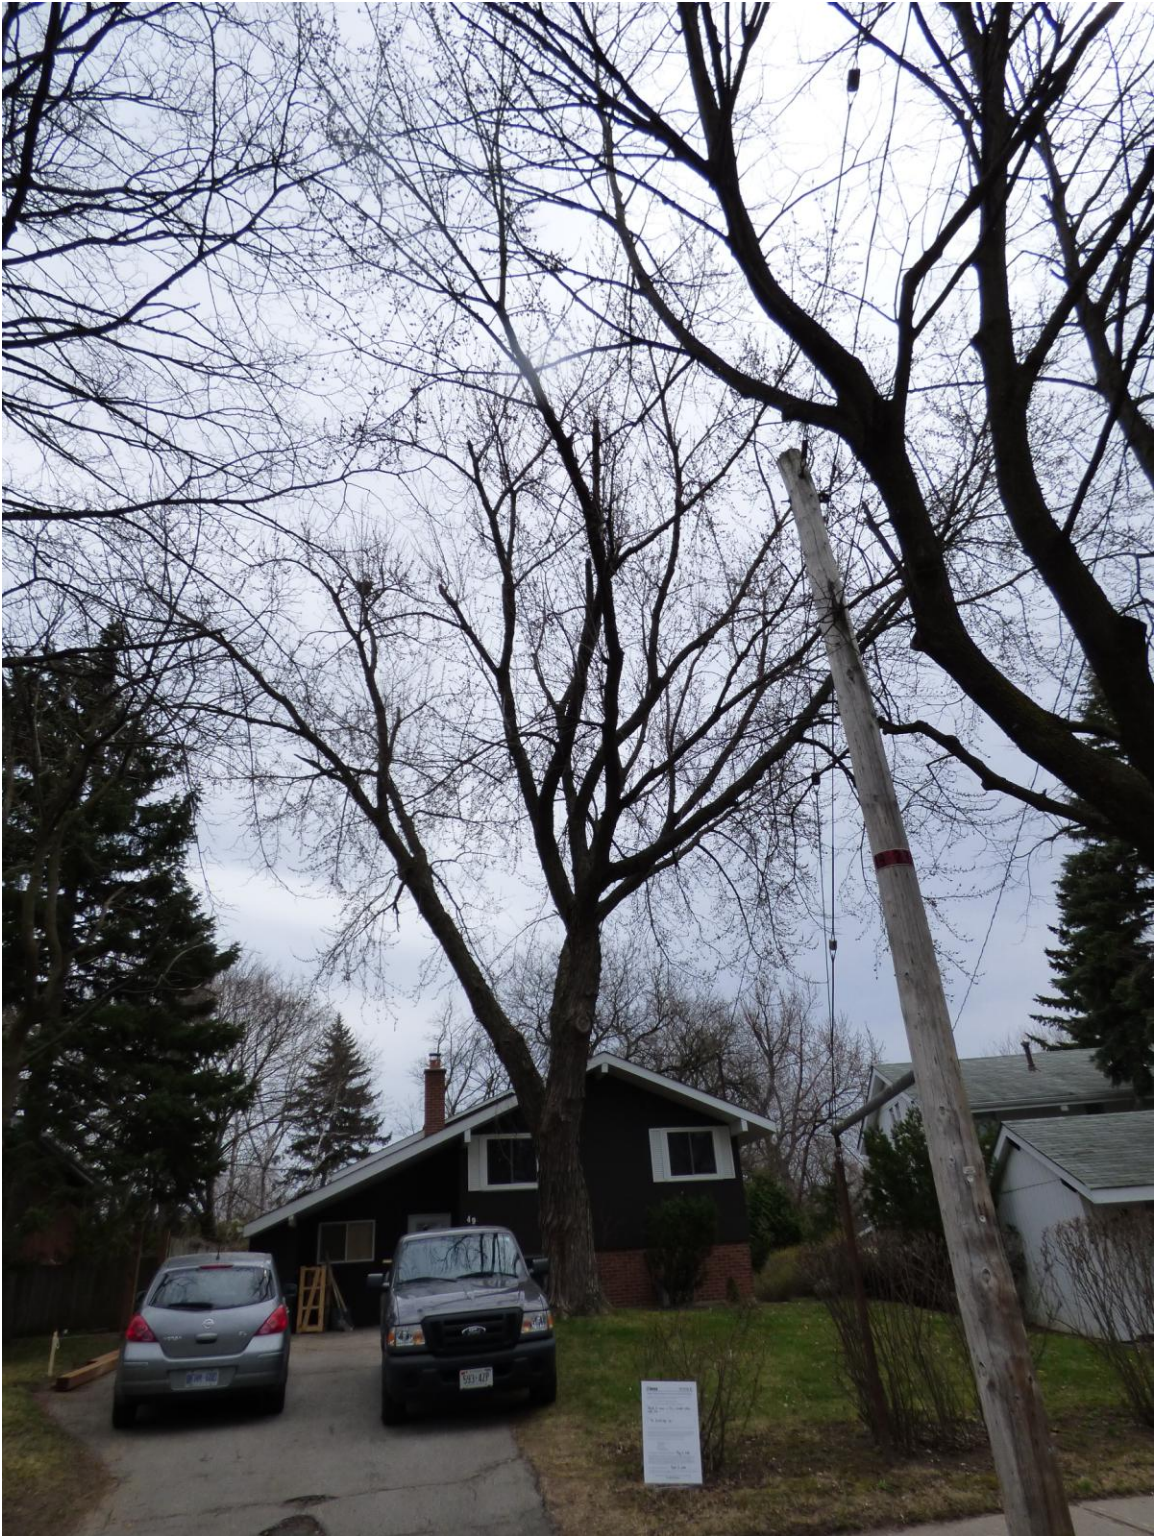
Urban Forestry staff inspected the tree and determined that it is healthy and structurally sound. The main stem of the tree was noted as having a lean between 5 to 10 degrees but was structurally sound. Cracks on the driveway were observed, but the causes of these cracks could not be ascertained. Minor deadwood and stubs, typical for a tree of this species and size, were present within the crown.

Attachment 1 – Photograph of the silver maple tree, measuring 93 cm in diameter  
Attachment 2 – Photograph showing cracks in the driveway

Any above-ground structural concerns could be addressed through routine inspection and maintenance in accordance with good arboricultural practices. The driveway and walkway could be repaired by removing the asphalt or paving stones, re-grading the base layer, and then laying new interlock pavers on top, as proposed in writing by the homeowner. As long as the roots are sufficiently protected while completing the repairs, the installation of interlock pavers in the future would result in less damage to the tree compared to the existing asphalt, as pavers can be easily removed without damaging tree roots.

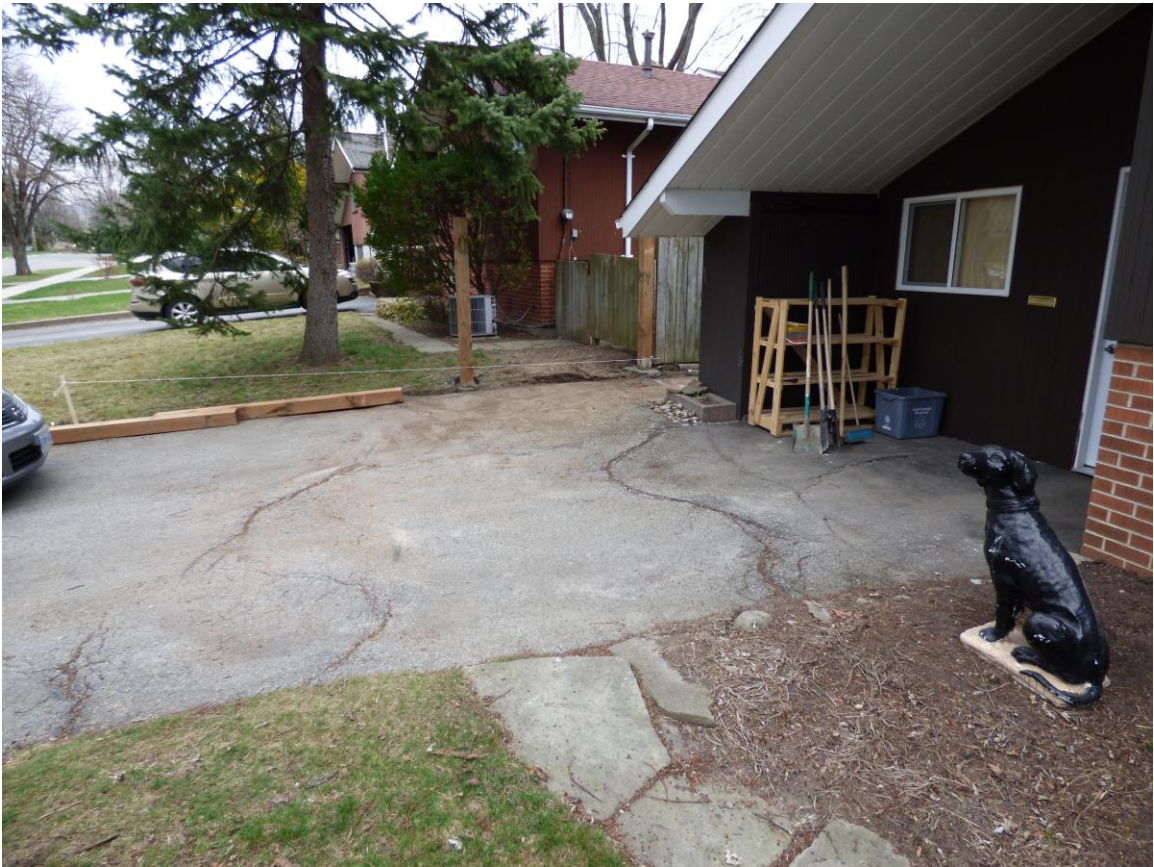
Tree roots are not physically capable of exerting the force required to lift or crack concrete or asphalt, nor are they able to go where there is no water. Tree roots are capable of growing into any available space that offers water and air such as damaged drain pipes. Any roots found below the concrete basement slab would have made their way there via damaged sewer pipes leaching water and nutrients into the surrounding area. Urban Forestry staff has been advised that tree roots found previously in the foundation and pipes in the basement have been removed and the necessary repair completed.
