From: Tamara HermannSent: Monday, November 14, 2016 9:22 AMTo: Yvonne DaviesSubject: SC18.13 Arborist's report for 29 MacDuff Cres

# **Arborist Report**

## Prepared for Michele and Mark Gonsalves 29 Macduff Crescent, Toronto M1M 1X6

Date: May 1st, 2016

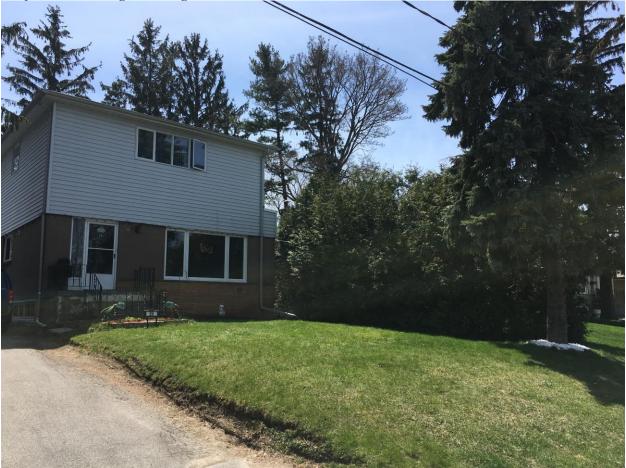
The subject row of hedge is in fair condition with no visible flaw or signs of stress. The row consists of 14 multistemmed trees, diameter less than 12 inches. Its current dimension is 30' x 7.5' x 13' (LxWxH). Though it was not recently maintained by the owners, it provides benefits of a hedge such as privacy, noise absorbing and increased property value. In the field of Arboriculture, it is a common knowledge that we should not remove more than 25-30% of its canopy (leaves) in one year when pruning. It is considered a bad practice because removing significant amount of foliage overnight can add streess to the tree and shorten its lifespan, and possibly result in tree mortality.

<u>Photos</u> Subject Cedar hedge row (right side of house)

The subject hedge is one of the common fence hedge that we see around the city. I believe that it stands its value to the property and should be retained with required attention from qualified Arborist followed by scheduled maintenance. The hedge is currently overgrown. However, to perform a good Arboricultural practice, we should only reduce the crown of the hedge down to 8'.

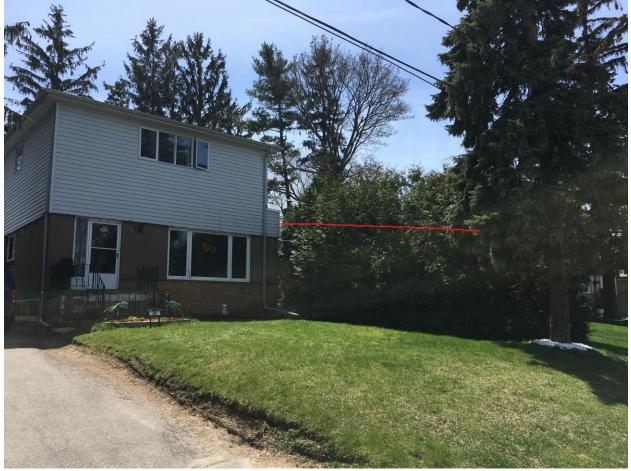
### Reduction (approximate)
