TD3.2 - Attachment 3

Attachment 3: MRAB Case Studies, 2015

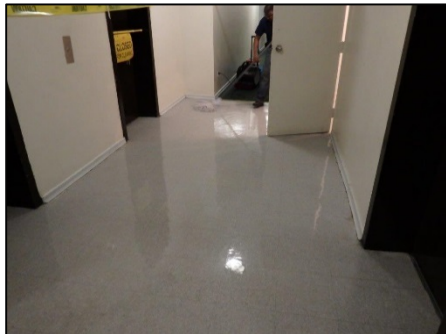
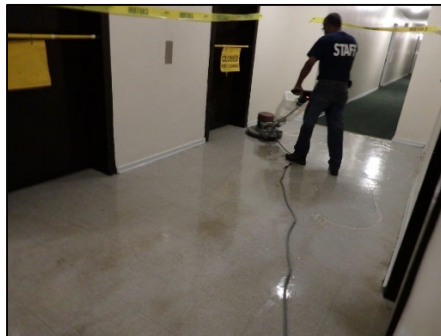
Interior cleaning undertaken by contractors as a result of MRAB action

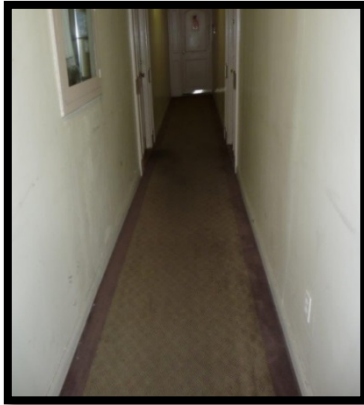
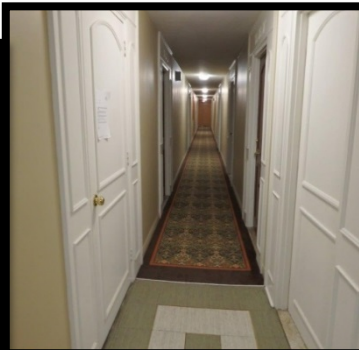
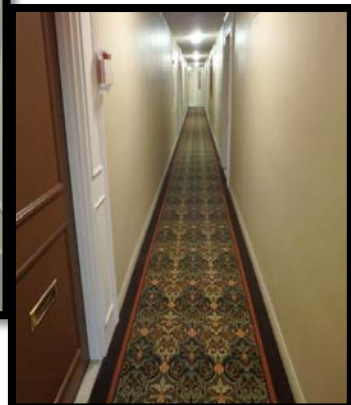
Common area hallways including ceilings, apartment doors and trim have been repaired and painted, and carpets are being replaced.

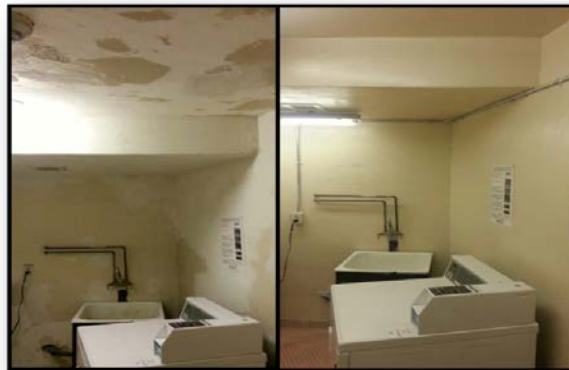
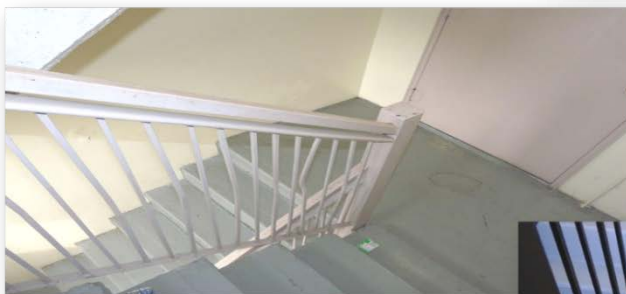
Laundry facilities and garbage chute rooms are repaired and painted.

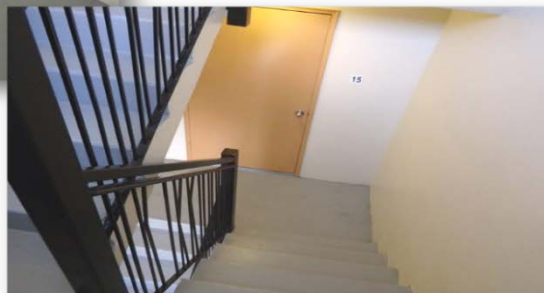
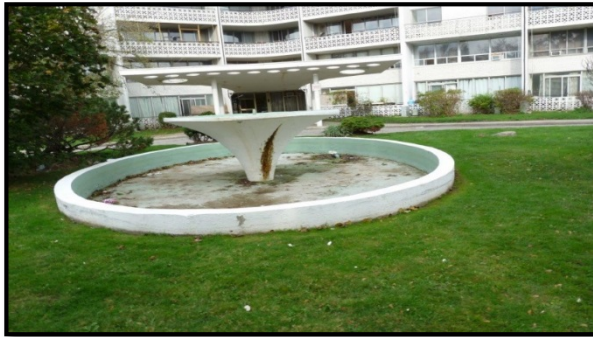
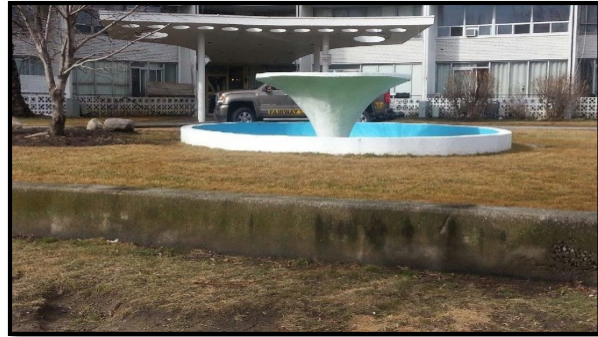
Stairwell walls, railings and ceilings repaired and painted, including doors.

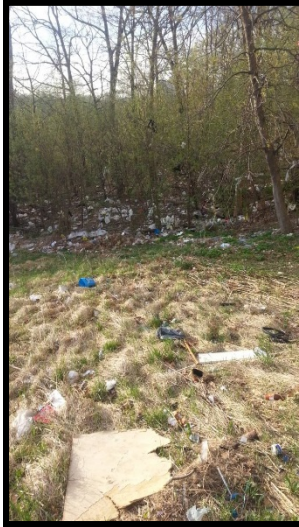
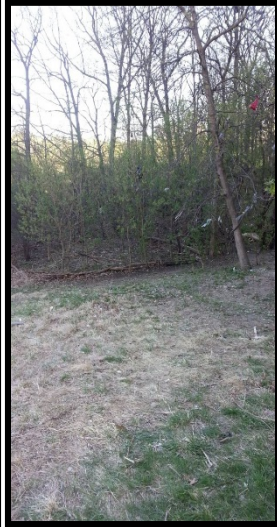
On May 1, 2015 officers issued a notice of violation pertaining to an excessive accumulation of garbage and waste strewn throughout the exterior of the property. Officers subsequently initiated city action and hired a contractor to clean and remove the garbage and waste.

This exercise took four days and resulted in a total cost of \$53,727.71, which was applied to the building owner's property taxes.

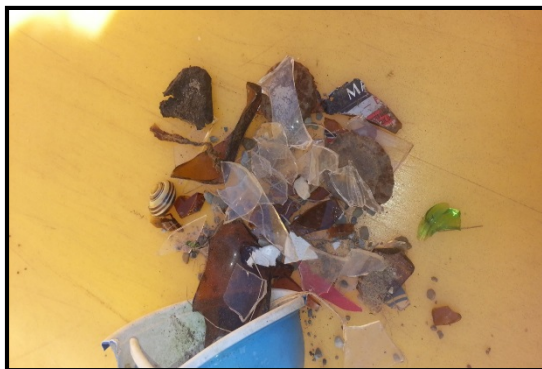
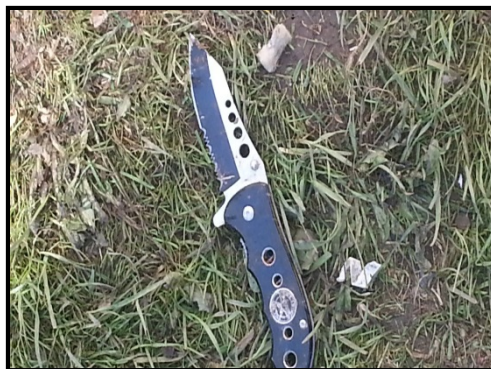
Below are some of the items removed from the playground.
