Attachment # 1 to Agreement with Toronto Event Centre  
EB Cox's sculpture of Hercules: Condition and Repair, Post Removal From Base Into Storage  
Exhibition Place, Toronto

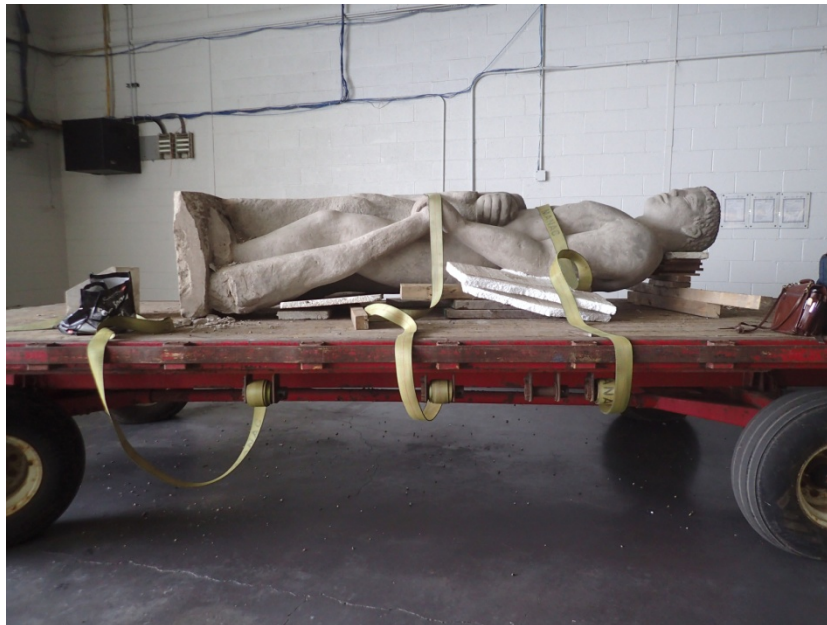
Fig.1

Action was taken during the autumn of 2018 to remove Hercules entirely from its location within the property. We did not participate in that move, but our services were called on soon after to visit the statue, now laid upon a flat bed wagon inside an Exhibition Place grounds building (figs. 1).

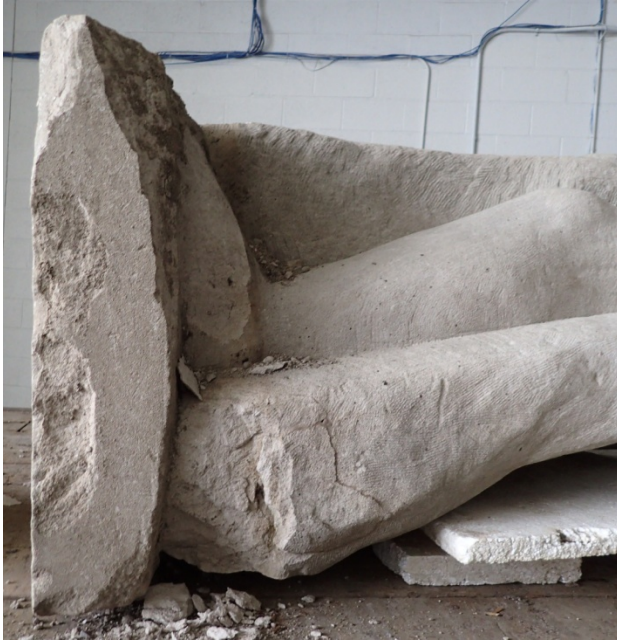
Fig.2

It was a shock to see just how extensive the deterioration and associated loss of sculpted surface had taken place at the lower foot/base zone while situated below grade. Broad thick exfoliation has led to a significant amount of detachment and loss (fig.2, 3), especially at the left side.

Some effort is required to attempt reattaching portions of surface sculpted fragments retained in the shopper bag. A low proportion is anticipated to have the required integrity and completeness to make this possible. However, reattachment of a small portion, combined with sensitively prepared mortar fills that are shaped to fill gaps and round off voided gaps will go some way, if small, in returning visual harmony to the artistic quality of the artist's work. But it must be clear to all concerned that only a small percent of original contour and volume of the sculpture form will be returned. It would be ethically wrong, mostly impossible and visually incongruous to attempt inserting new carved or moulded portions of lost surface.

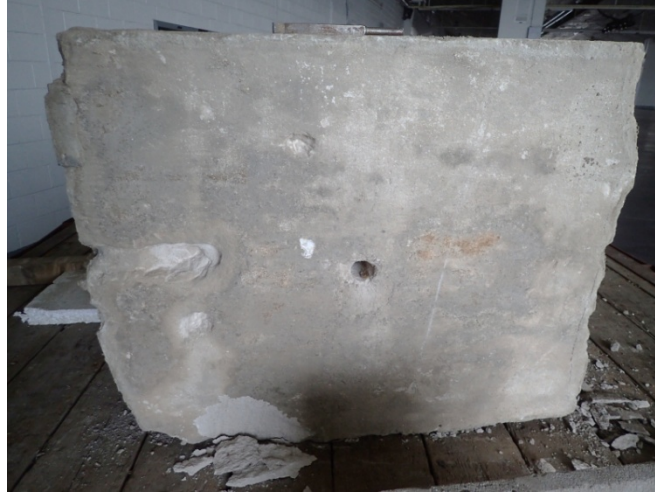
Fig.4

The sculpture is not perfectly protected in the present arrangement of wood and padding support. For example, there is a great of weight load stress upon the vulnerable base/foot and leg region. The fact that the base is directly borne upon the wagon floor is unfortunate, since major fissures and one substantial crack are present within the base (figs.4, 5, 6).

Numerous fissures and cracks present in the base and within the feet zone will be secured by mechanical consolidation methods, namely in the form of stitching and securing with fine stainless steel rods.
