Attachment #2 – Agreement with Toronto Event Centre
EB Cox's sculpture of Hercules: Conservation Repair to Lower Foot Zone of the Sculpture
Exhibition Place, Toronto

3.0 REPAIR PHOTO DOCUMENTATION FOR EACH OF THE MAJOR ZONES

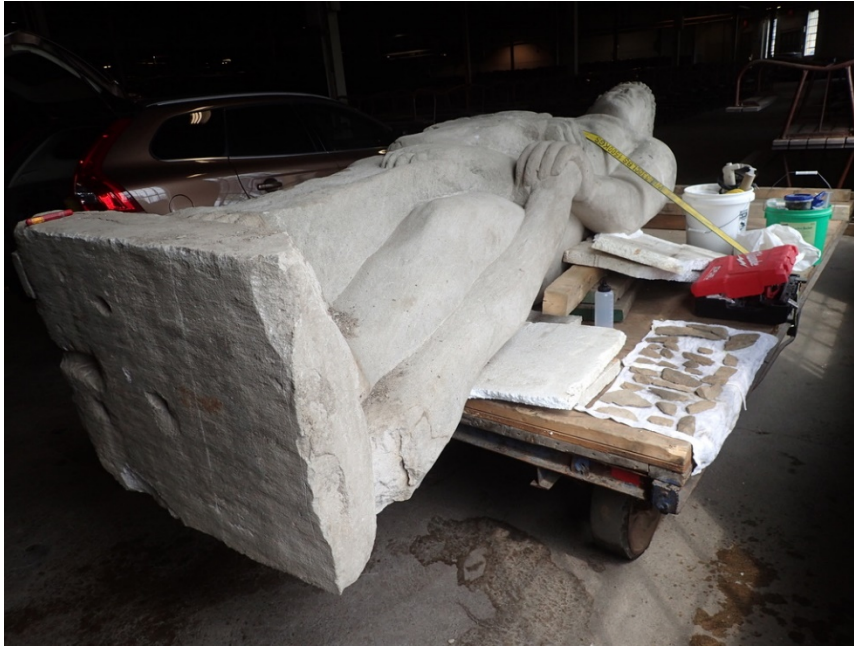
Fig. 1

Following on from our condition and conservation recommendations report of the Hercules sculpture from February 2019, the actual conservation work to repair and preserve the damaged lower leg and feet zone was carried out over three sessions during the month of June this year. The statue was positioned horizontally upon a wagon which was parked inside the North Extension of the Enercare Centre at Exhibition Place (fig.1).

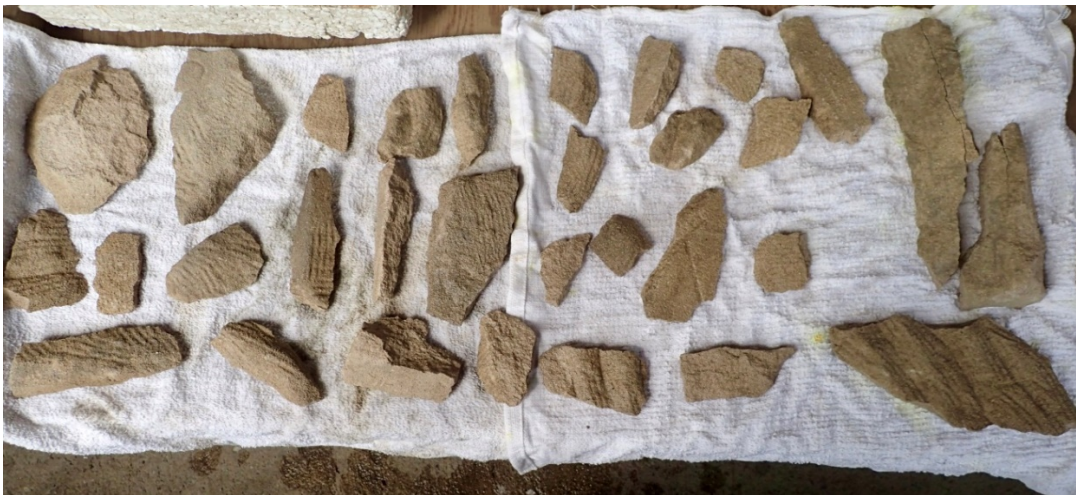
Fig.2

As described in the February condition report, the spalled pieces of limestone that were collected during the lifting process were fragmented and amounted to so many pieces of a difficult puzzle. These pieces sorted according to completeness, were cleaned and set out near the repair area (fig.2).

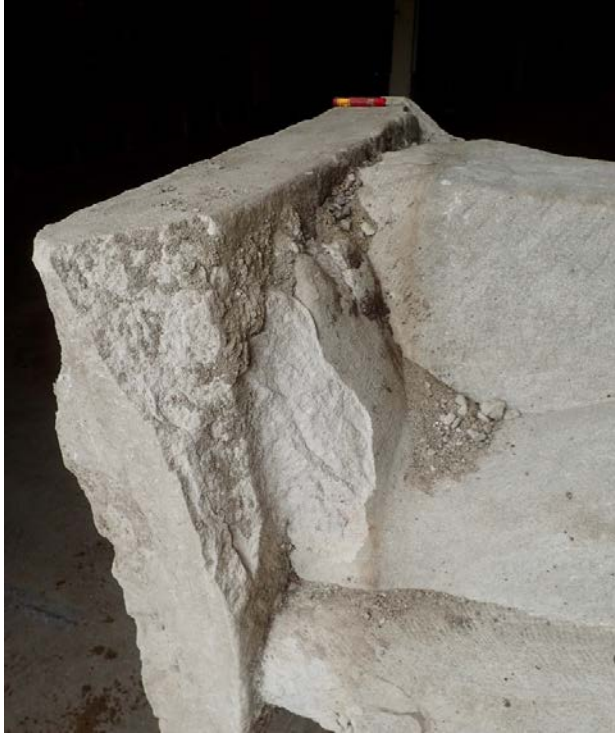
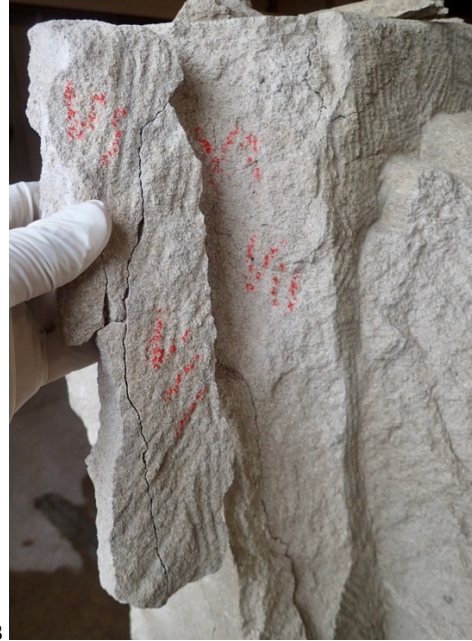
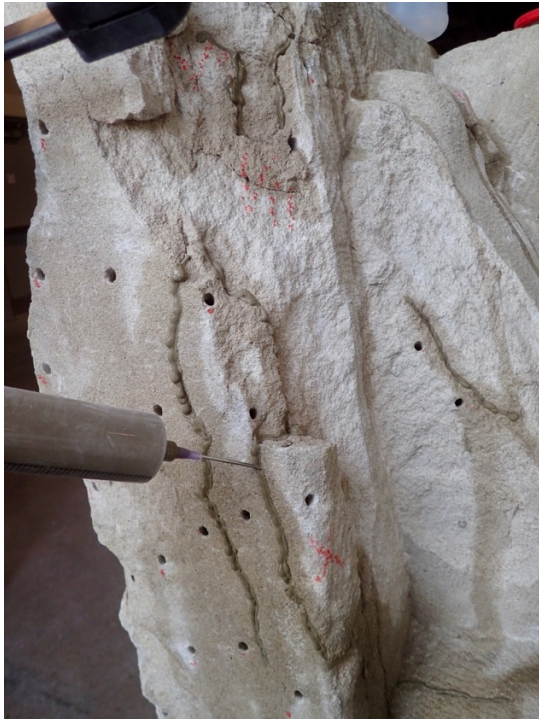
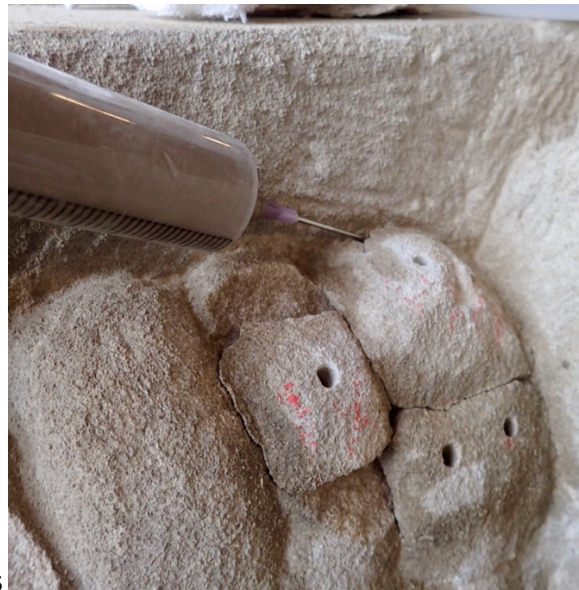
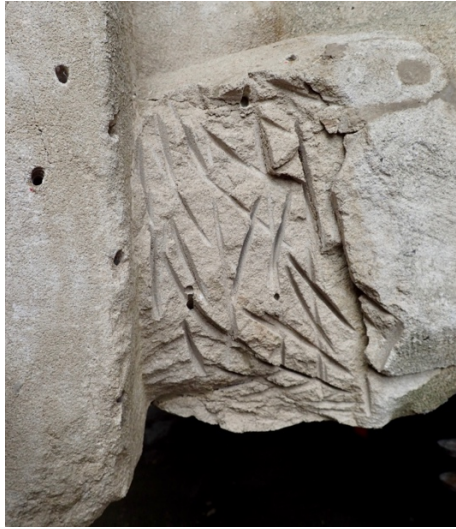
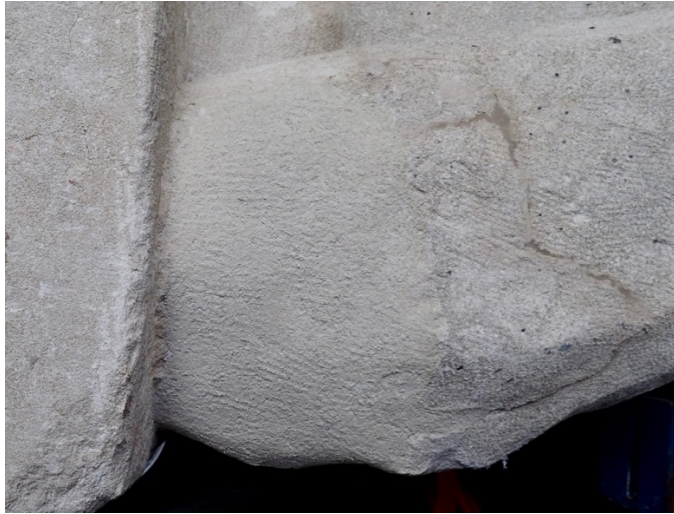
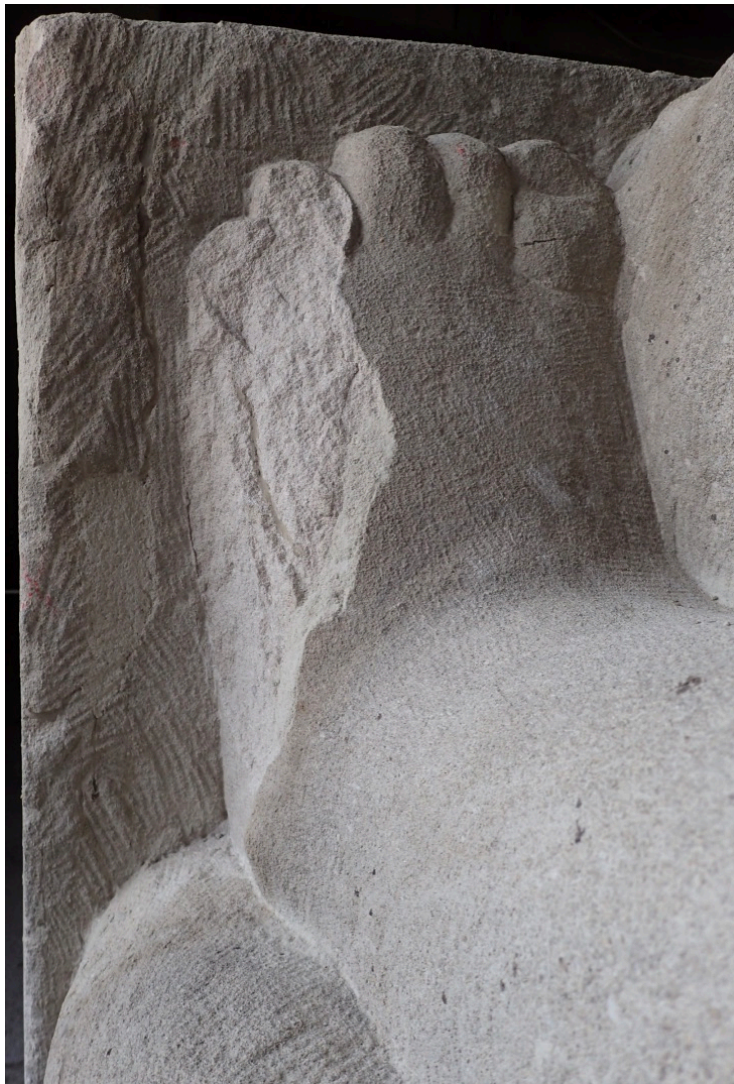
Area zone 1: The left foot and general left side adjacent

There were 6 main areas of severe damage loss and cracks/fissures: 1) the left foot and general left side adjacent; 2) the front base side; 3) the right foot and adjacent lion paw; 4) the top surface behind the right foot where the EB Cox had inscribed his name; 5) the rear right foot ankle area and adjacent area between the two feet; and 6) crack repair at base bottom. This latter no. 5 area was very difficult to access due to the low, upward working and difficult to view position with which the statue was set on the wagon-table.

From the salvaged pieces provided by the client, the majority were reattached to their original surface location wherever possible. This often meant finding and reconnecting several pieces of the same surface detail. The pieces were attached using small dots of epoxy resin and slurried mortar or injection mortar applied on the remaining interface surfaces.
