# SV1.5.3

submission from  
RTEK2RA, MSO.

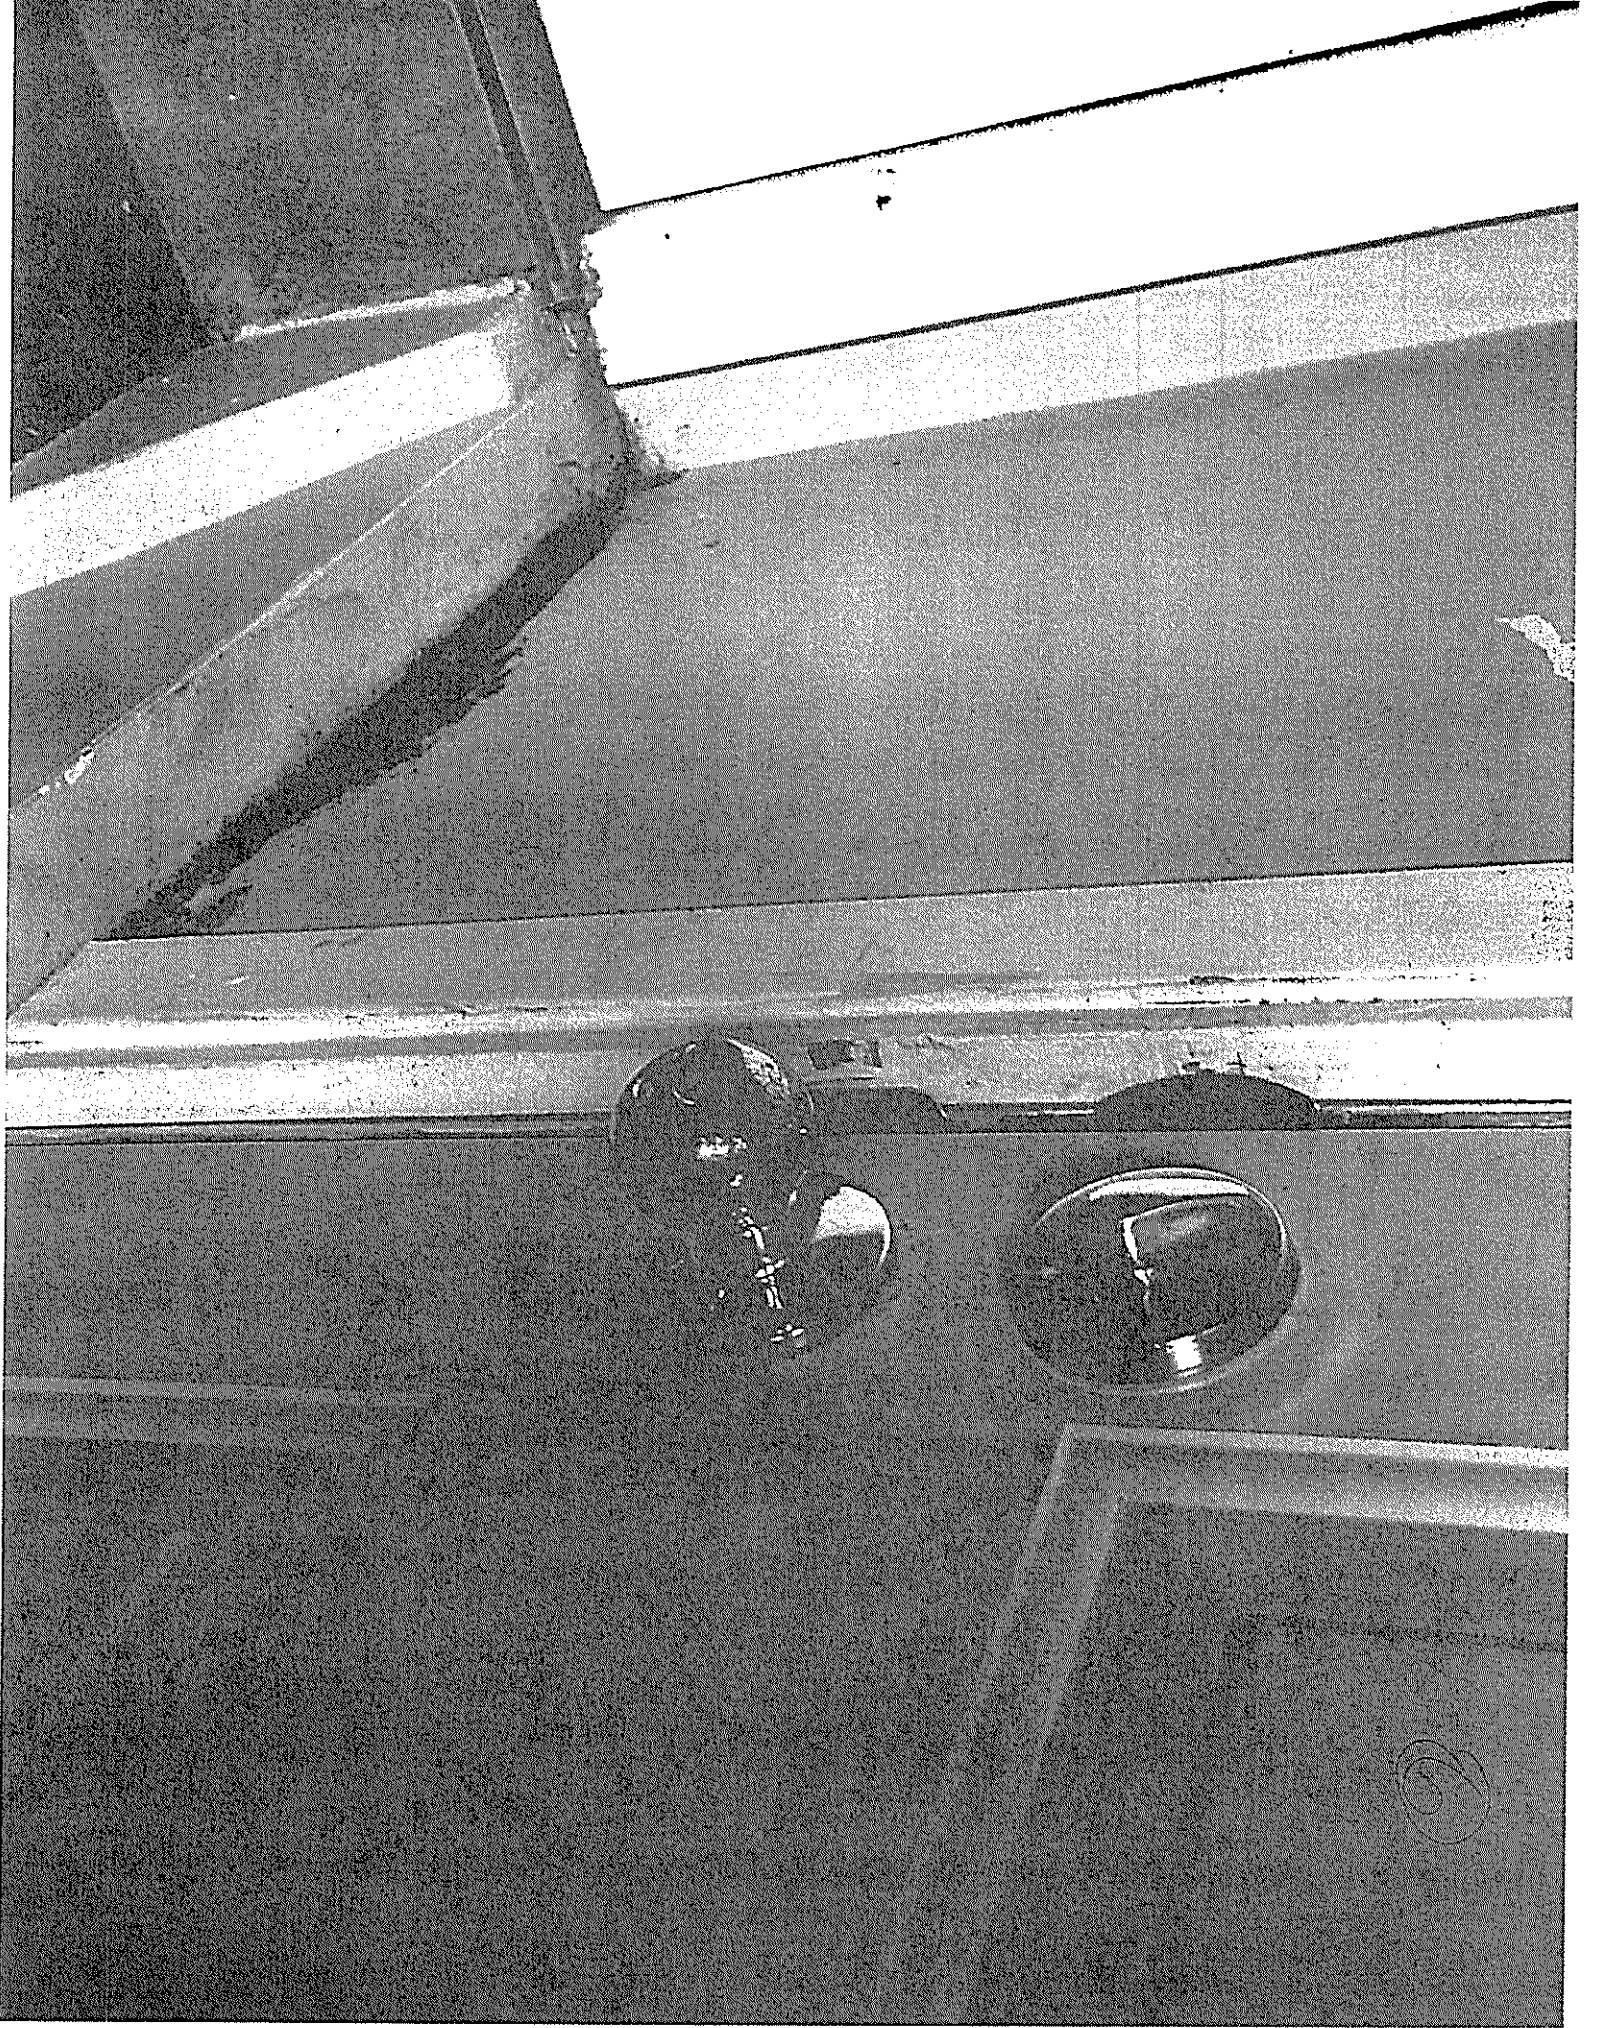
| y Documentation | Process<br>Deficiency | | 4 | 3. Bathroom Basement - Vanity is not maintained in a satisfactory condition. Namely, vanity is loose from wall and wobbles | N/A | |
| y Documentation | Process<br>Deficiency | | 4 | 4. Bathroom Basement - Vanity is not maintained in a satisfactory condition. Namely, vanity has deteriorated materials on the side and underside of counter | N/A | |

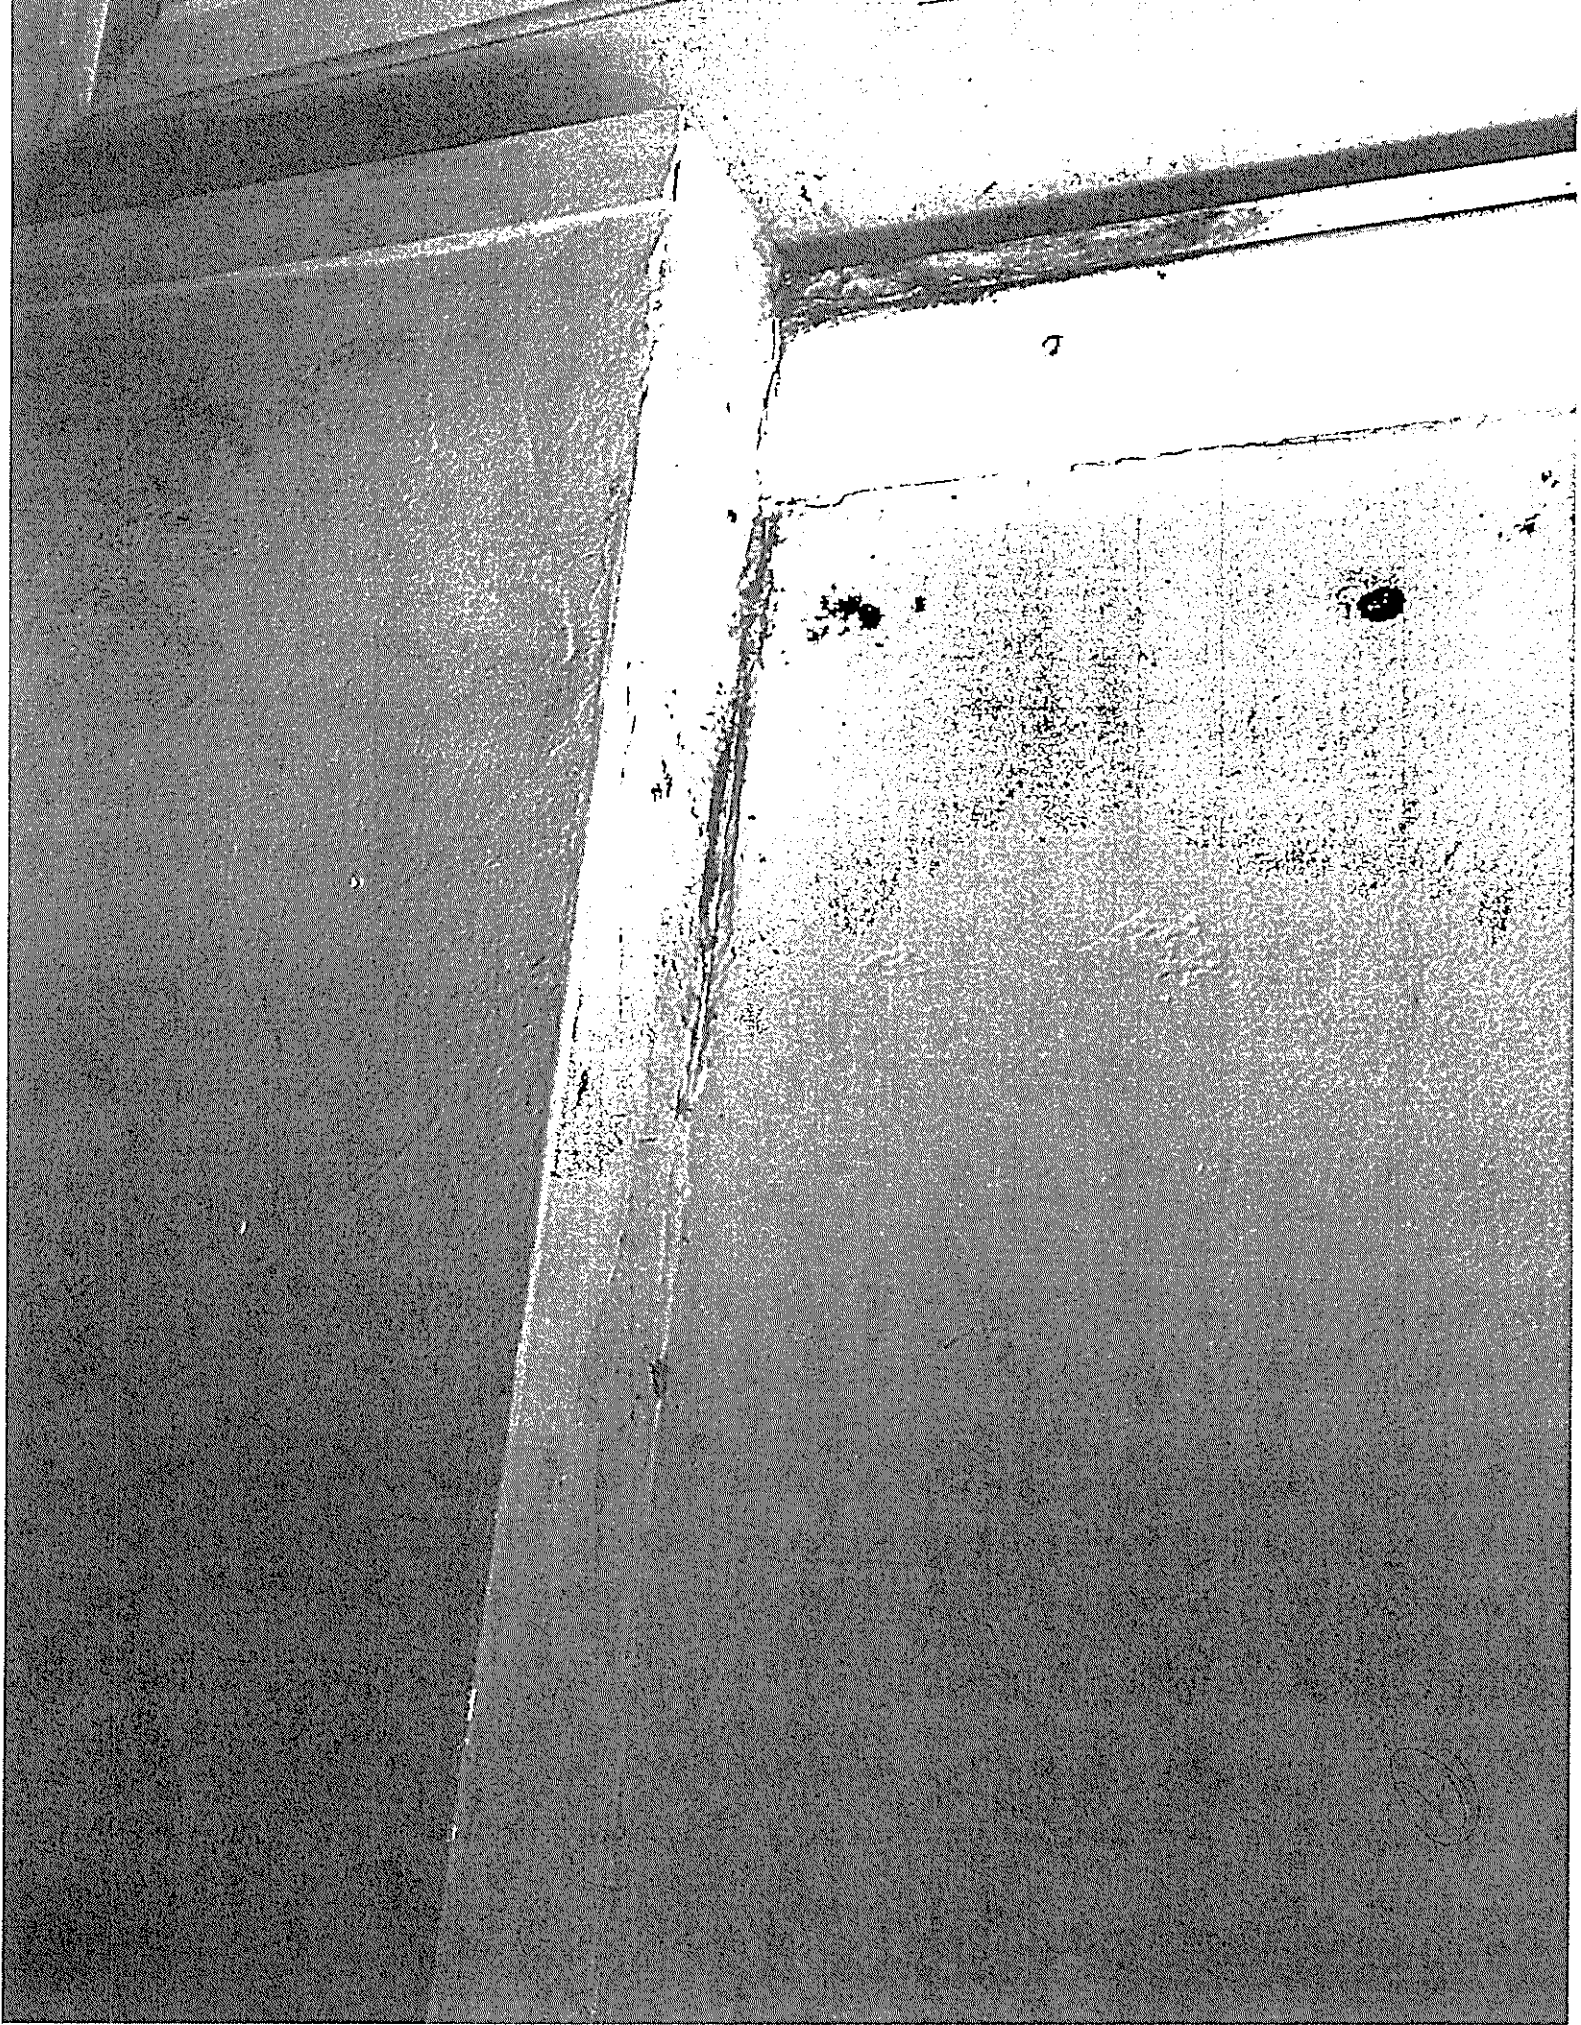
5

| y Documentation | Process<br>Deficiency | | ⑤ | 5. Bedroom - Wall(s) not maintained free of holes, cracks, damaged and deteriorated materials. Namely, large gap under window frame of main bedroom | N/A | |
