## **Request to demolish the Residential Building - 162 Bathurst St.**

**Date:** January 14, 2019  
**To:** Toronto and East York Community Council  
**From:** Director and Deputy Chief Building Official, Toronto Building  
**Wards:** Ward 10 Spadina-Fort York

**Re: Fire Damage Assessment**

Location: 160-162 Bathurst Street, Toronto, ON  
Insured: Corrado Accaputo  
Your File: AM007933/ Can-Sure file number 43929  
Our File: 190274TGP  
Incident Date: March 4, 2019

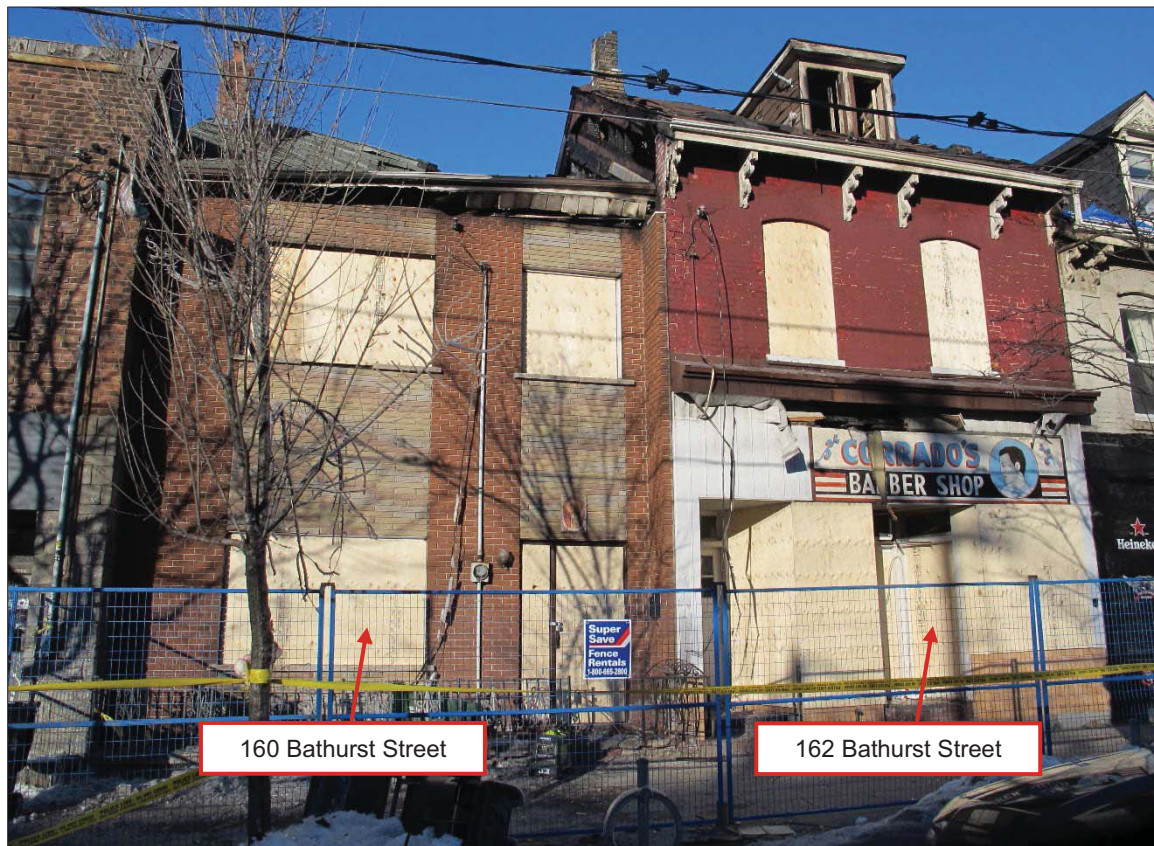
Figure 1: View of east elevation of subject building

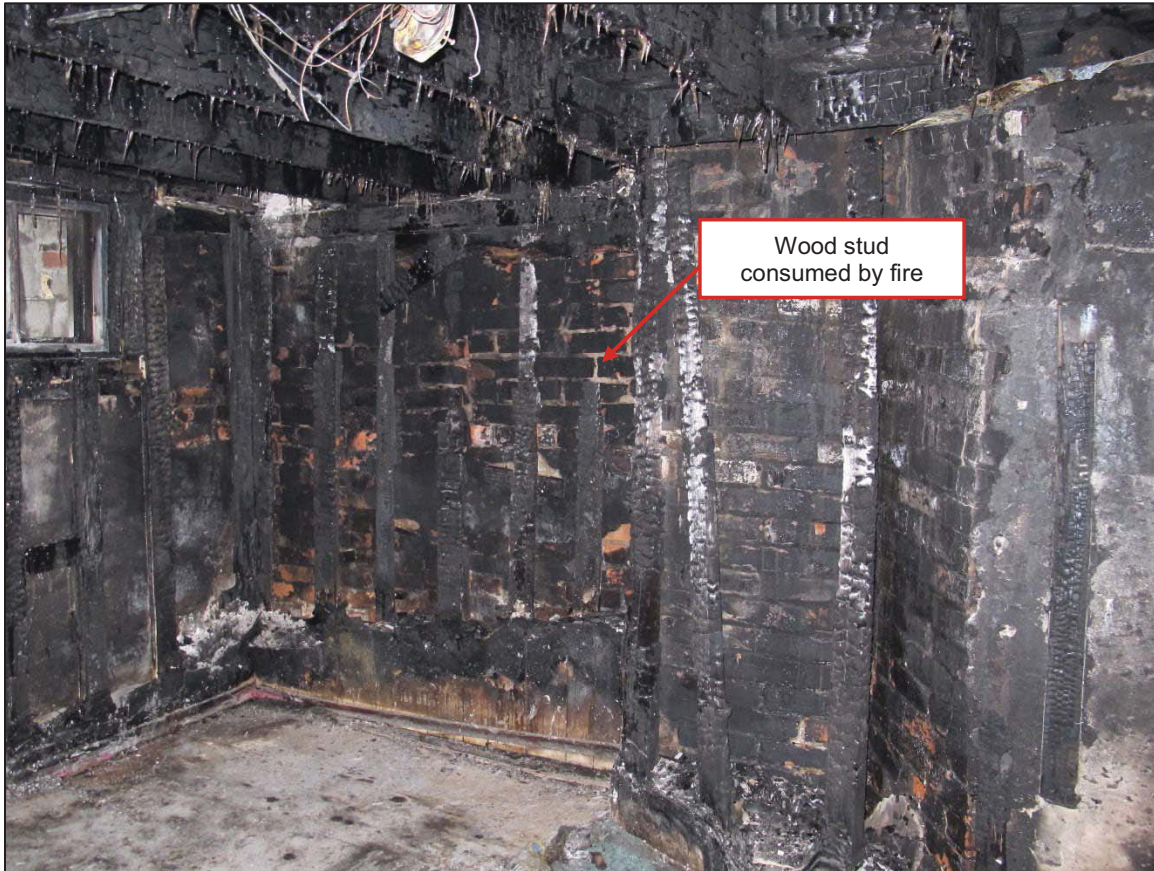
Along the east end of the south wall of the basement, the wall framing was heavily charred, and portions of the wood studs had been completely consumed by the fire (Figure 7).

**Figure 7: View of east end of south wall in basement showing charred wood studs and wall framing**

The north portion of the structure has become structurally unsound since much of the structural framing was damaged by the fire, and the roof structure has collapsed. Due to the extent of fire damage, we recommend that the complete structure be demolished.

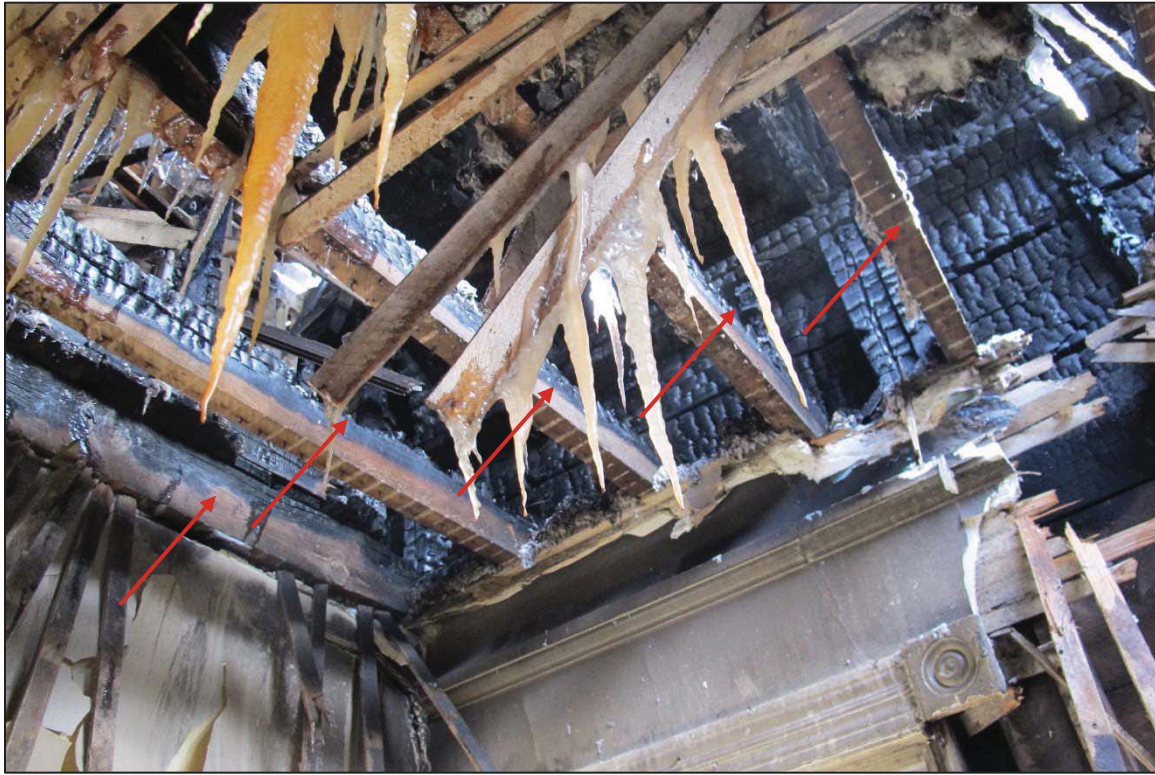
The third floor level joists above the second level kitchen were extensively charred (Figure 14).

**Figure 14: View of charred floor joists above second level kitchen**

Based on our observations at the time of our site visit, it is possible for this structure to be salvaged. However, extensive temporary shoring will need to be installed at multiple locations throughout the structure to reinstate it and to remediate the unsafe conditions. Demolition of select areas will be required including the third level walls and roof structure, as well as the portion of collapsed second floor framing. Once the structure is shored and is deemed to be structurally sound, all fire damaged components will need to be removed and replaced, and all remaining smoke and soot contaminated components will need to be cleaned and treated. However, this would be a labour-intensive and likely a cost prohibitive option.

Alternatively, based on the extent of fire, smoke, soot, and water damage, and the original construction methods (i.e., balloon framing with full height wall studs),<sup>3</sup> the most cost-effective method to remediate the unsafe conditions would be to demolish and rebuild the structure.

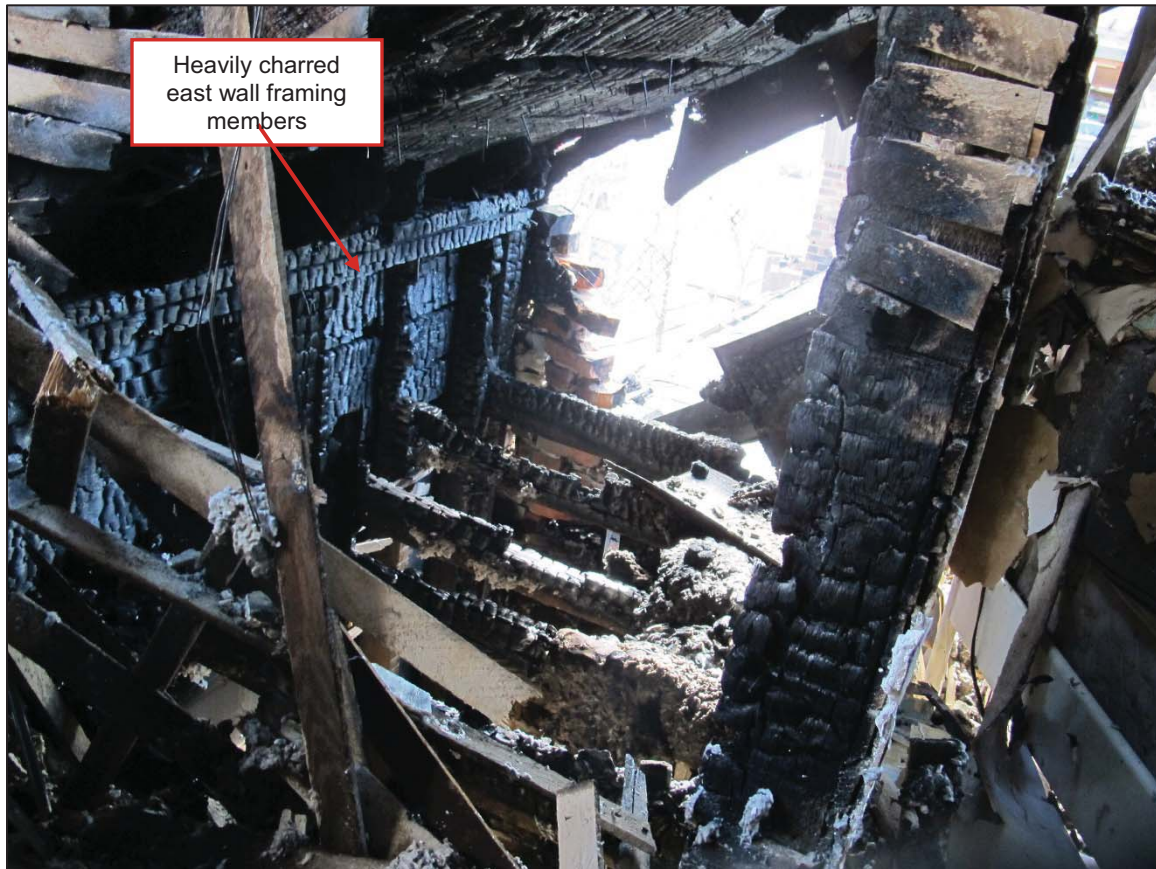
The south wall structure of the third level had been entirely consumed by the fire, and the framing members along the east wall were heavily charred (Figure 17).

**Figure 17: View of southeast corner of third level showing fire damaged framing members**
