Request to demolish the Residential Building - 160 Bathurst St.

Re: Fire Damage Assessment

Location: 160-162 Bathurst Street, Toronto, ON
Insured: Corrado Accaputo
Your File: AM007933/ Can-Sure file number 43929
Our File: 190274TGP
Incident Date: March 4, 2019

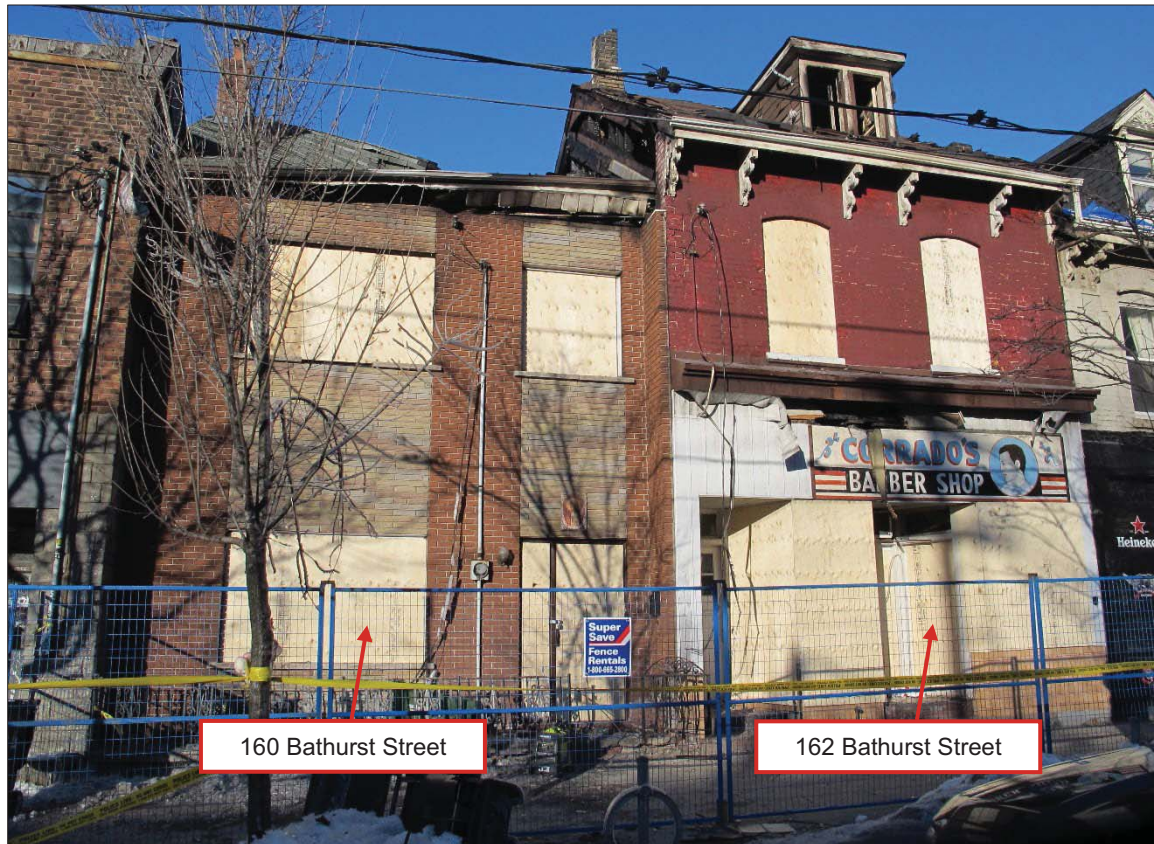
Figure 1: View of east elevation of subject building

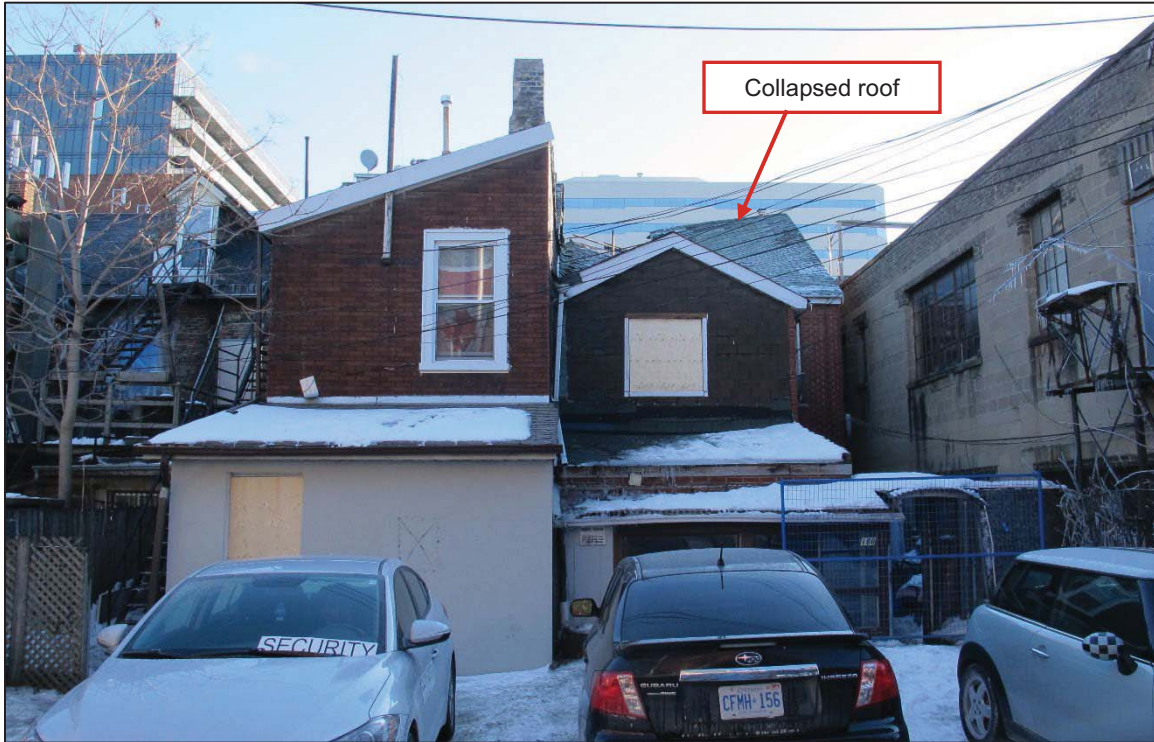
At the time of our site visit, we observed that plywood had been installed over the doors and windows, and a metal fence had been installed to secure access to the site. From the exterior of the building, we observed that the roof of 160 Bathurst Street had partially collapsed (Figure 2).

Figure 2: View of west elevation of subject building showing collapsed roof at 160 Bathurst Street

The north portion of the structure has become structurally unsound since much of the structural framing was damaged by the fire, and the roof structure has collapsed. Due to the extent of fire damage, we recommend that the complete structure be demolished.

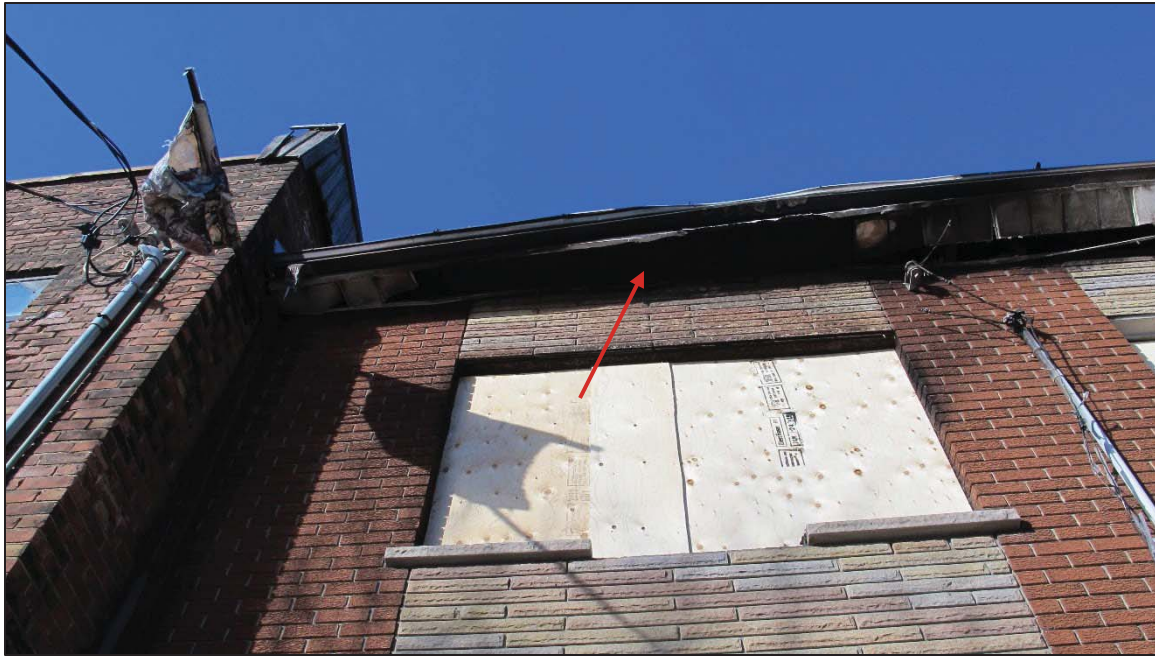
The roof soffit at 160 Bathurst Street and the soffit and fascia on the barber shop facade of 162 Bathurst Street were charred and blackened as a result of smoke and soot contamination (Figure 3 to Figure 4).

Figure 3: View of east elevation of 160 Bathurst Street showing blackened roof soffit

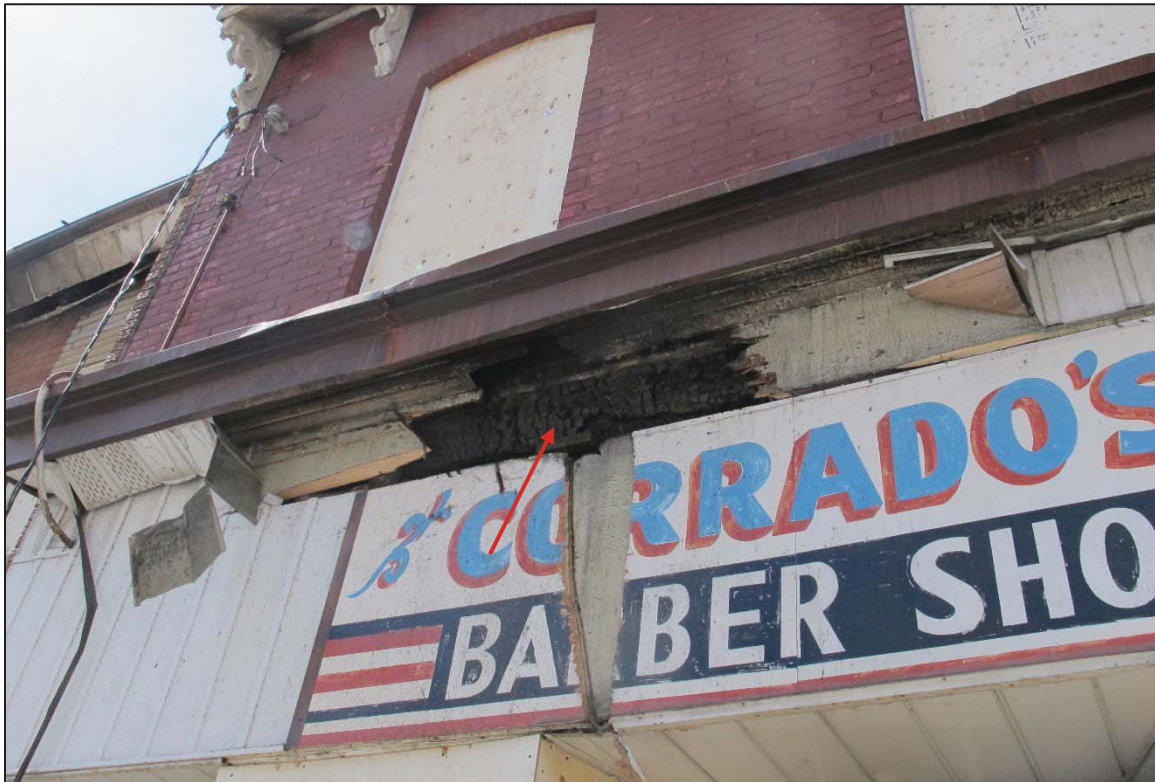
Figure 4: View of east elevation of 162 Bathurst Street showing fire damaged soffit and fascia

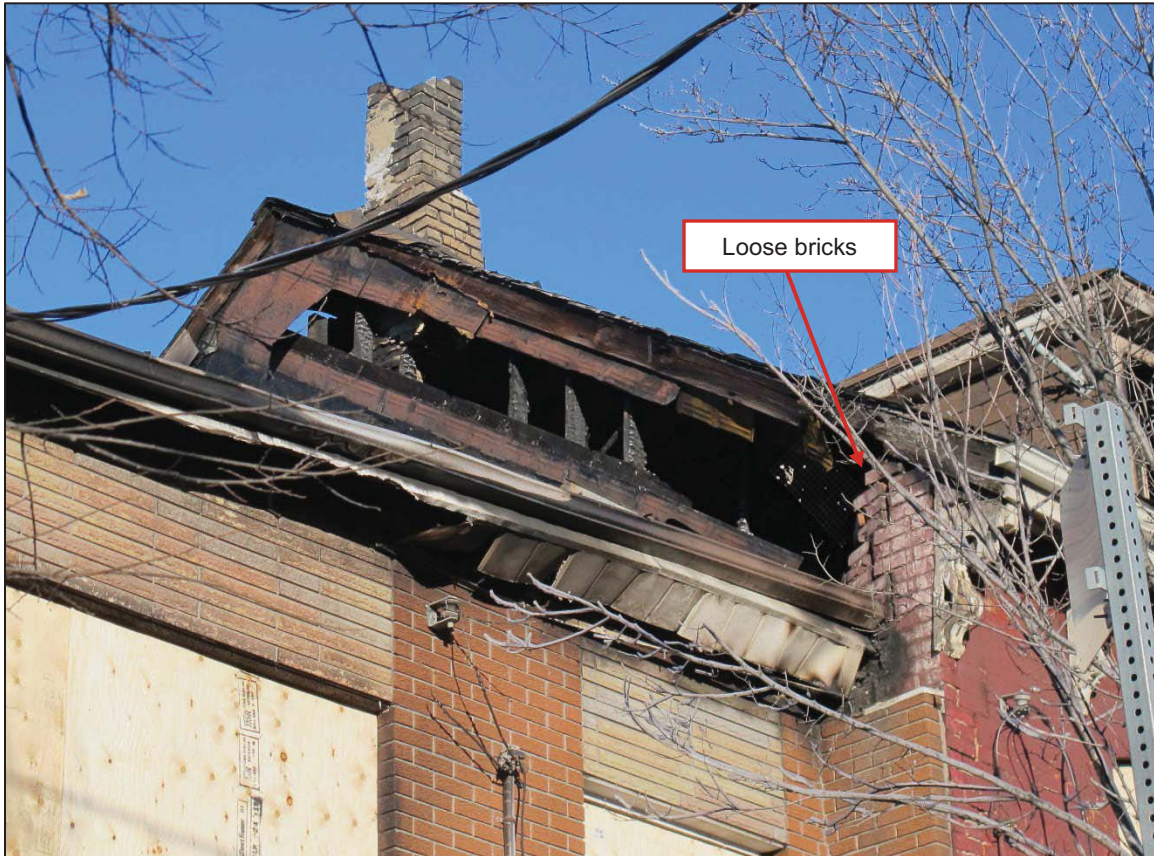
The masonry facade at the front of the building between 160 and 162 Bathurst Street was cracked, and it appeared that some of the bricks were loose. (Figure 5).

Figure 5: View of subject building showing cracked facade with loose masonry bricks

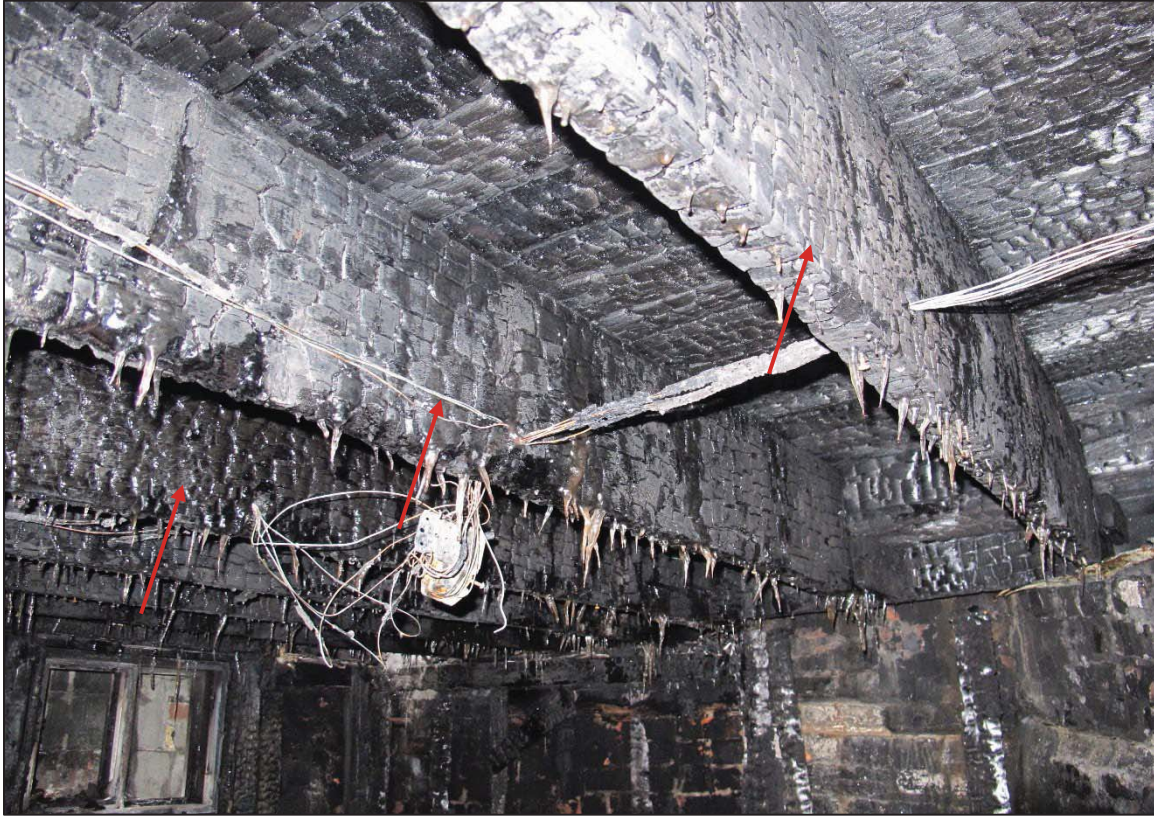
Within the basement, we observed extensive charring on a total of nine ground floor joists within the southeast bedroom, as well as on three joists within the adjacent room. The ground floor wood decking was also extensively charred in these areas (Figure 6).

Figure 6: View of ground floor framing in southeast bedroom showing extensive fire damage and charring to wood decking and wood joists

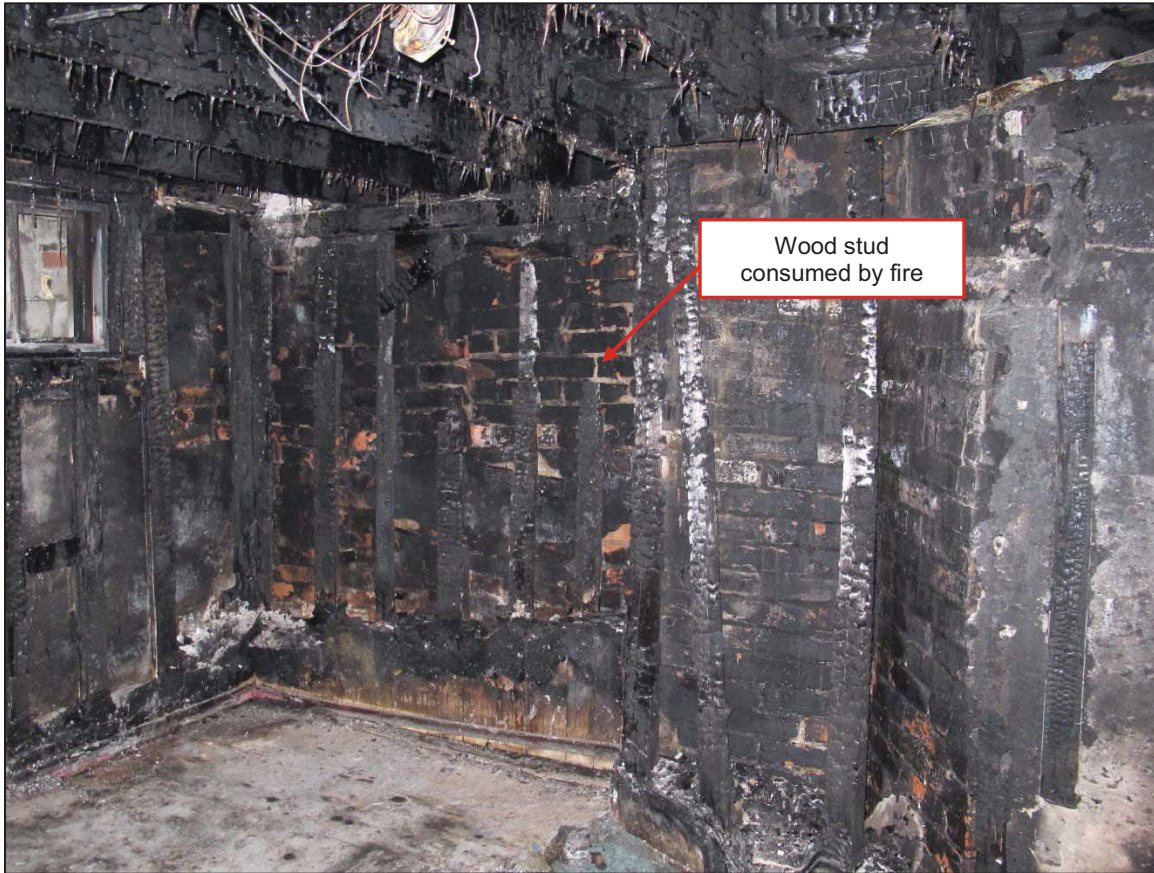
Along the east end of the south wall of the basement, the wall framing was heavily charred, and portions of the wood studs had been completely consumed by the fire (Figure 7).

Figure 7: View of east end of south wall in basement showing charred wood studs and wall framing

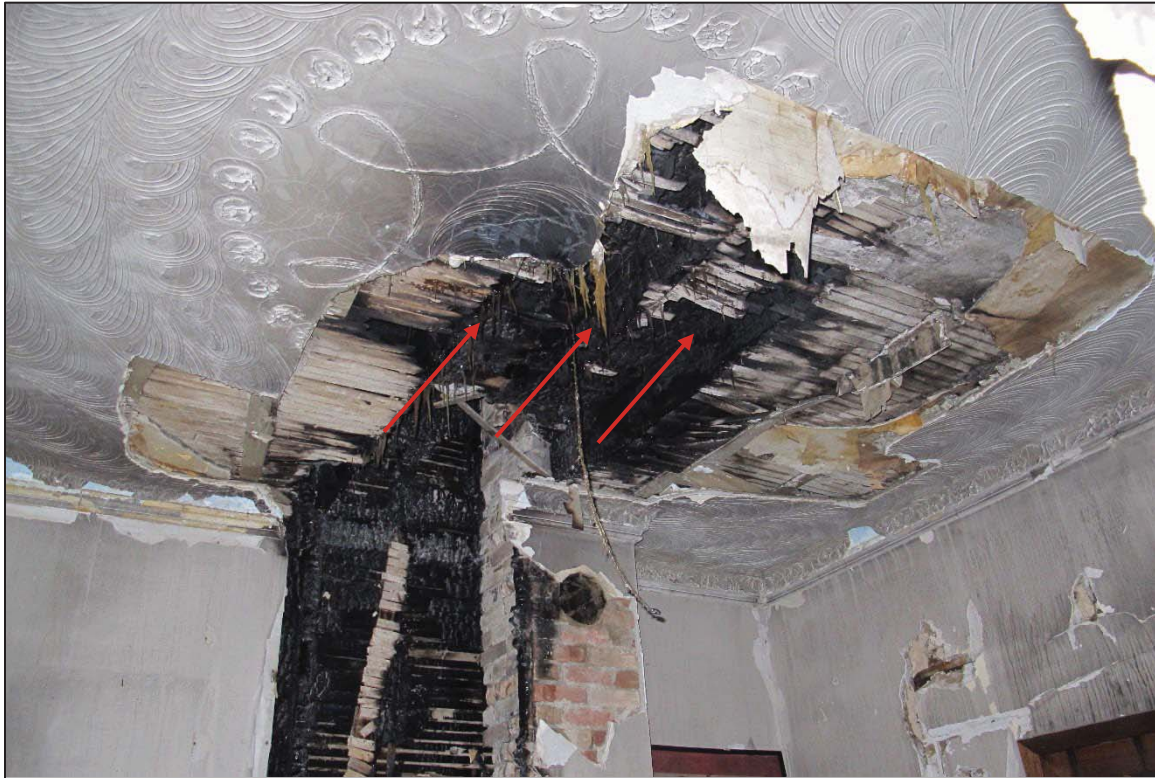
We could not physically access the southeast bedroom on the main level due to the condition of the floor structure observed from the basement level. However, based on our visual review, there was extensive charring on at least three second level support joists (Figure 8). The remainder of the ceiling finishes were intact and concealed the remaining second level joists.

Figure 8: View of charring on second level joists above southeast ground level bedroom

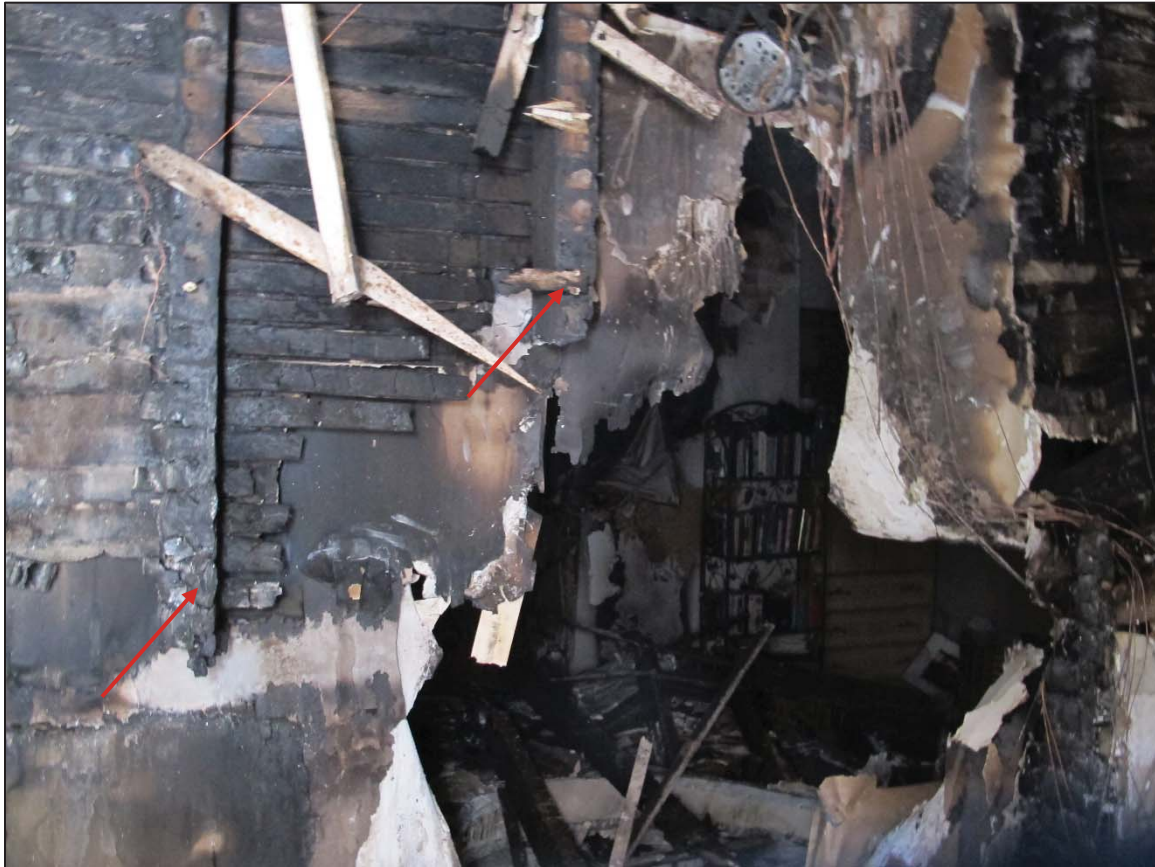
The main level loadbearing wall running midspan along the length of the structure was extensively fire damaged at its east end. At least five wall studs were heavily burnt and partially consumed by the fire (Figure 9). The east end of the north wall was also severely fire damaged, and six wall studs had been consumed by the fire (Figure 10).

Figure 9: View of fire damaged studs in loadbearing wall on ground level

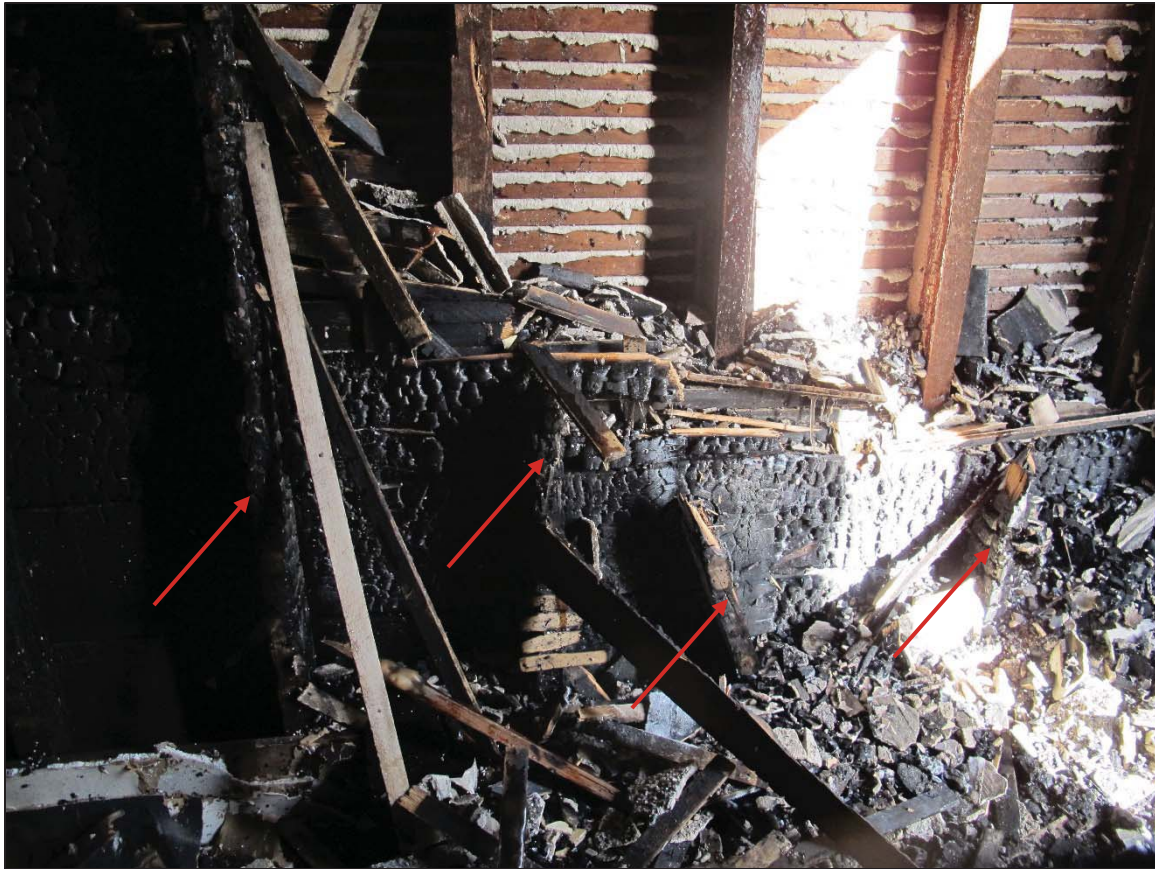
Figure 10: View of fire damaged studs in north wall on ground level

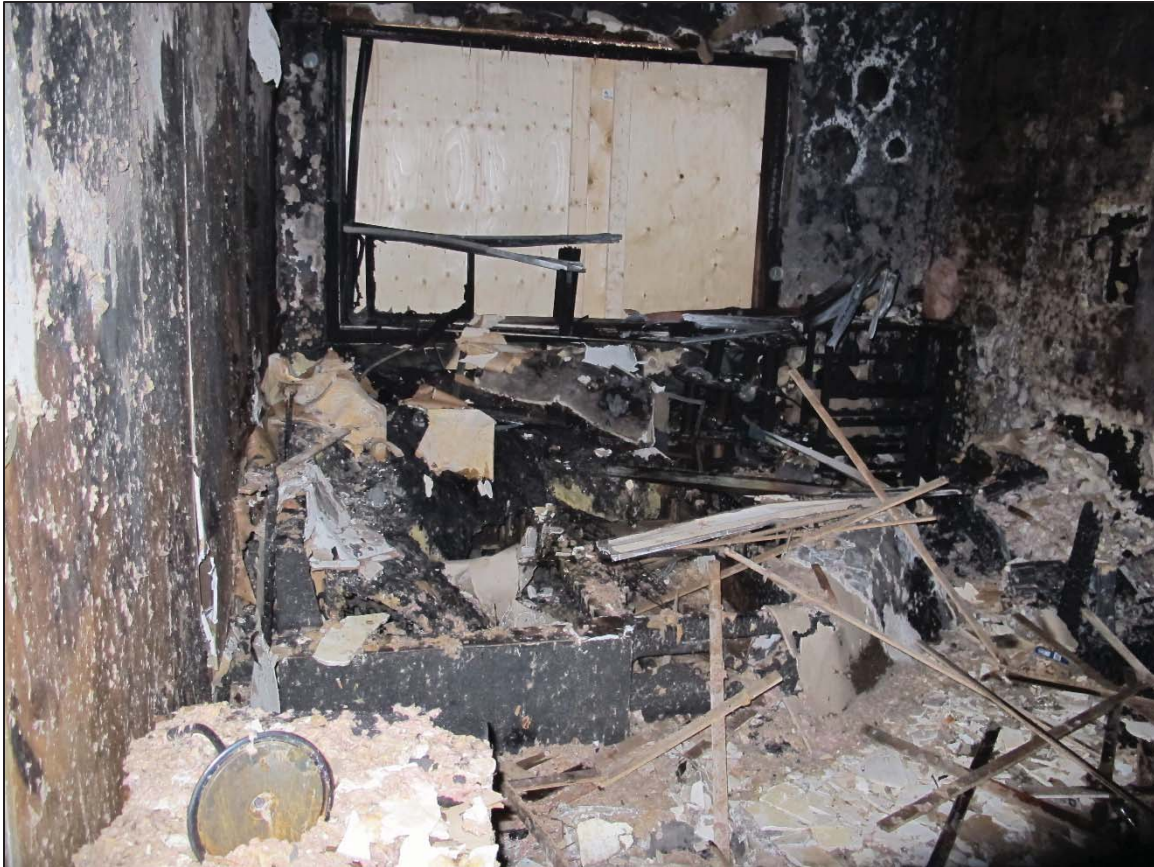
Due to the structural concerns of the floor framing, we were unable to physically access the southeast room at the second level. However, visually, the room sustained extensive smoke and soot damage (Figure 11).

Figure 11: View of southeast room at second level showing extensive smoke and soot damage

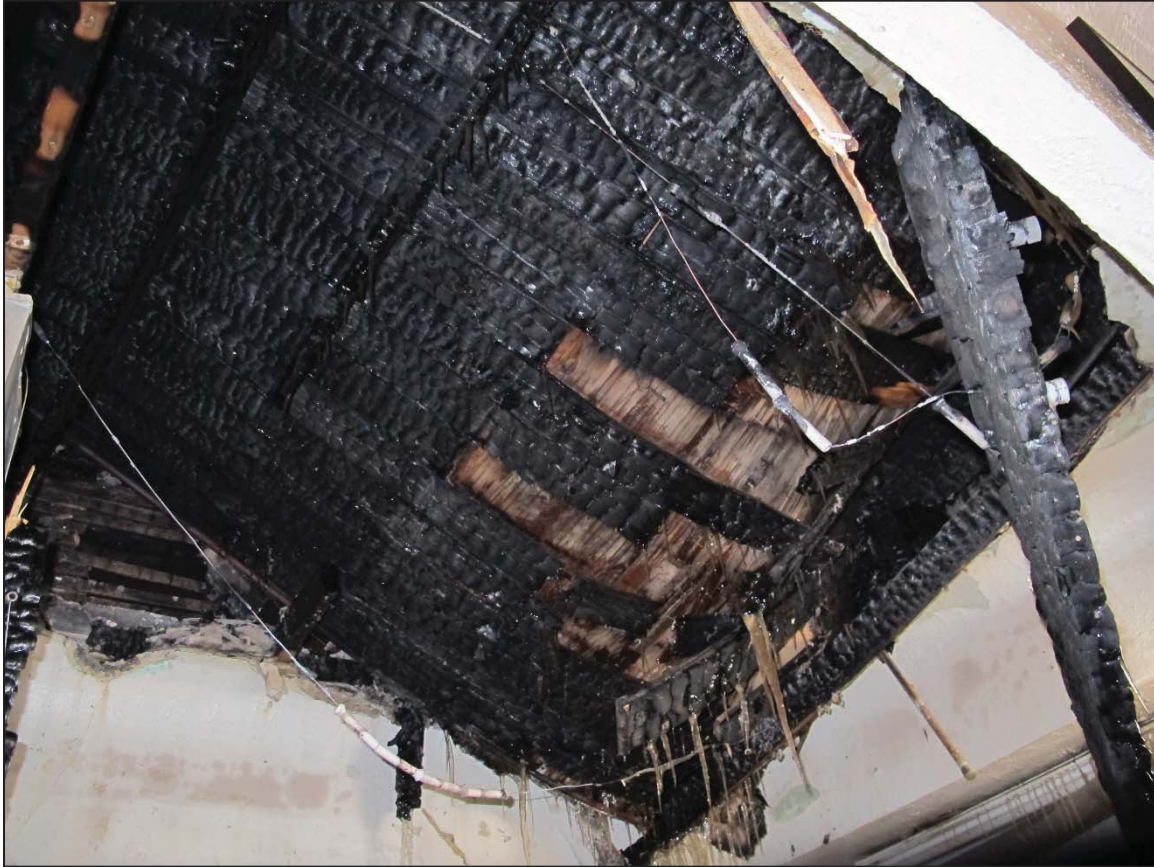
From the main level, we observed that the northeast corner of the floor framing on the second level had collapsed and a total of ten joists, and the wood decking, were charred as a result of the fire (Figure 12).

Figure 12: View of collapsed portion of second floor level in northeast corner

Based on our observations at the time of our site visit, it is possible for this structure to be salvaged. However, extensive temporary shoring will need to be installed at multiple locations throughout the structure to reinstate it and to remediate the unsafe conditions. Demolition of select areas will be required including the third level walls and roof structure, as well as the portion of collapsed second floor framing. Once the structure is shored and is deemed to be structurally sound, all fire damaged components will need to be removed and replaced, and all remaining smoke and soot contaminated components will need to be cleaned and treated. However, this would be a labour-intensive and likely a cost prohibitive option.

Alternatively, based on the extent of fire, smoke, soot, and water damage, and the original construction methods (i.e., balloon framing with full height wall studs),³ the most cost-effective method to remediate the unsafe conditions would be to demolish and rebuild the structure.

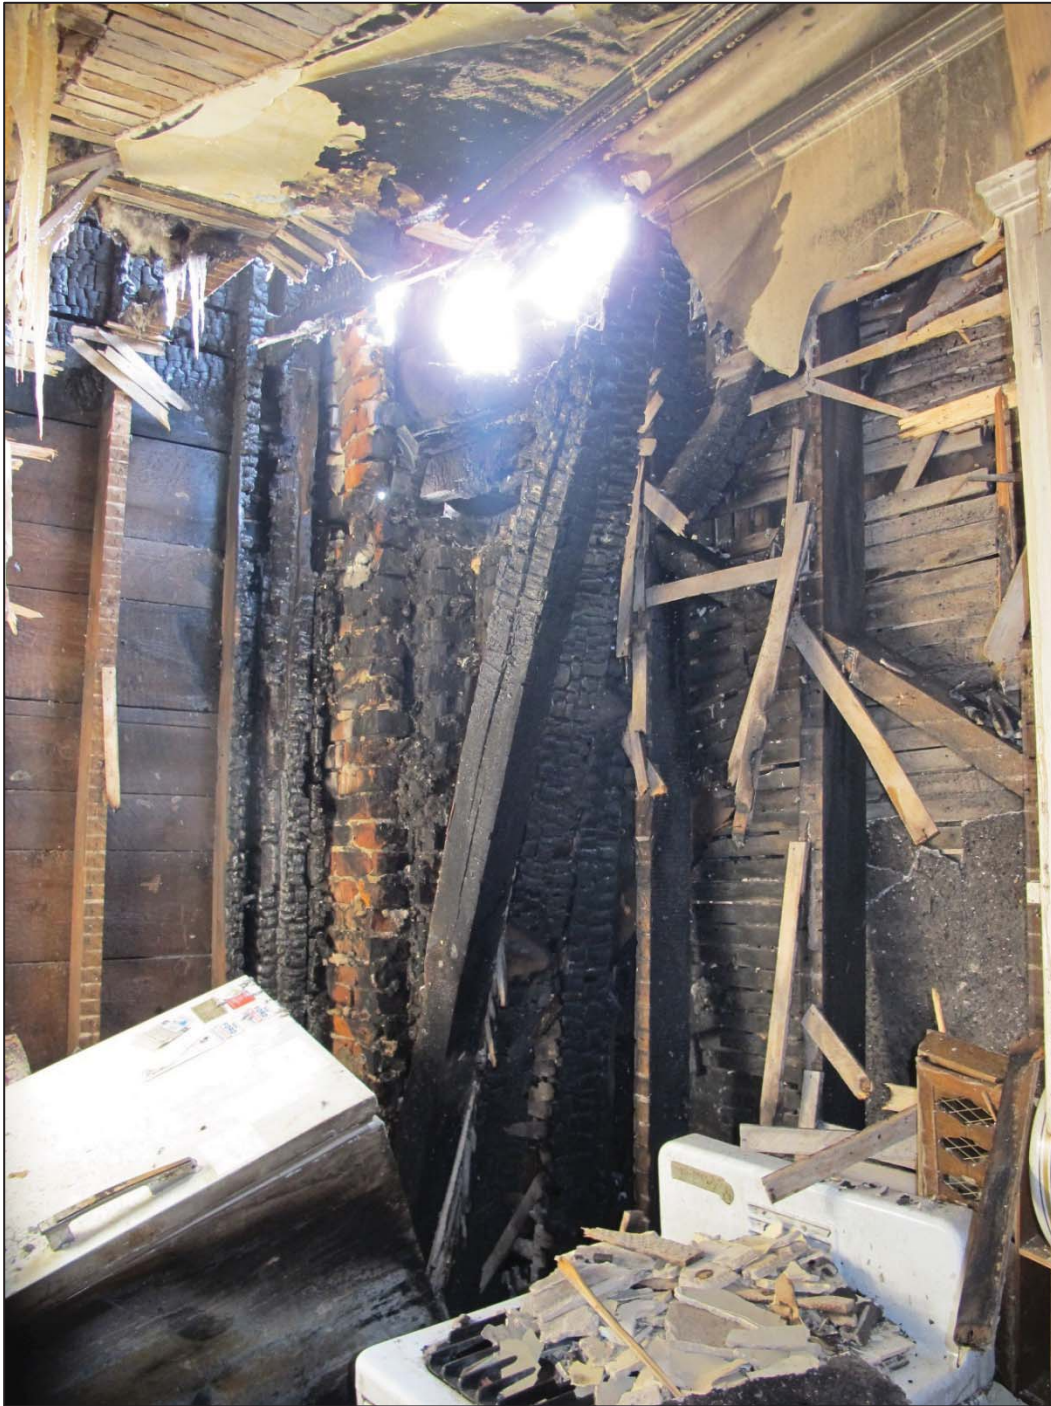
At the second level, the wood studs at the east end of the south wall that separated this residential unit from the adjoining unit, were heavily charred, and portions of the studs had been consumed by the fire (Figure 13).

Figure 13: View of south party wall at second level showing fire damaged wood studs

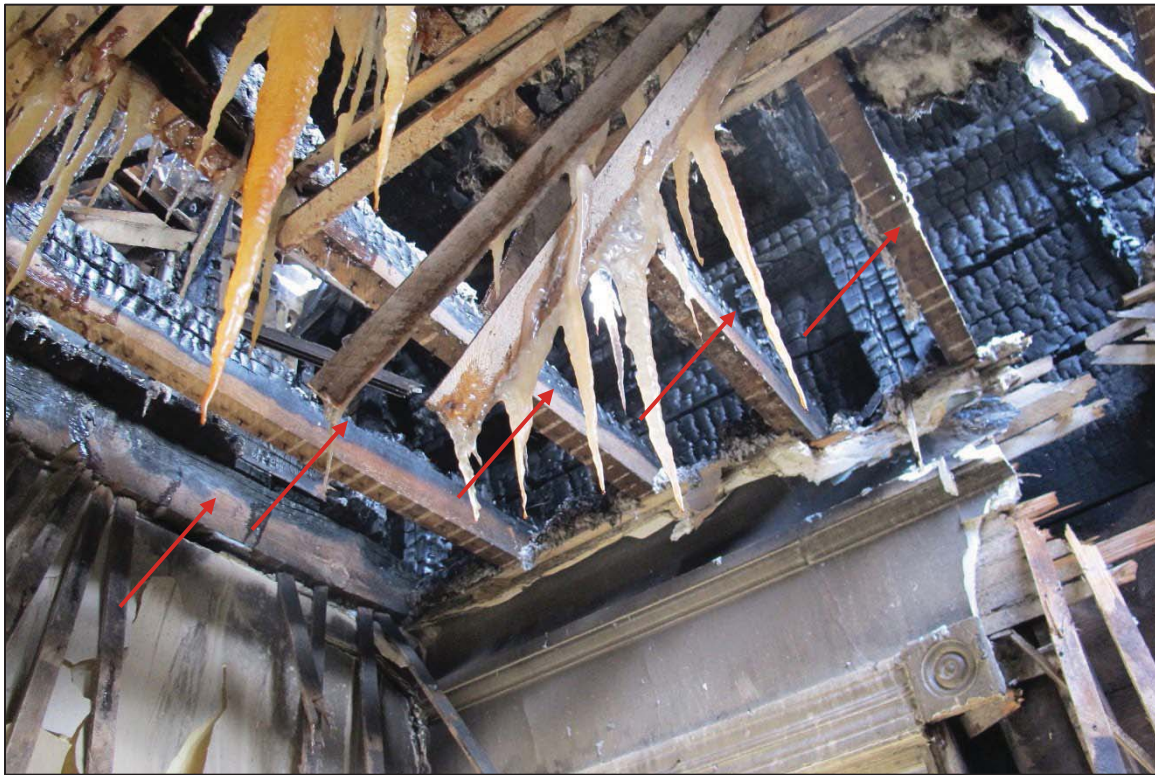
The third floor level joists above the second level kitchen were extensively charred (Figure 14).

Figure 14: View of charred floor joists above second level kitchen

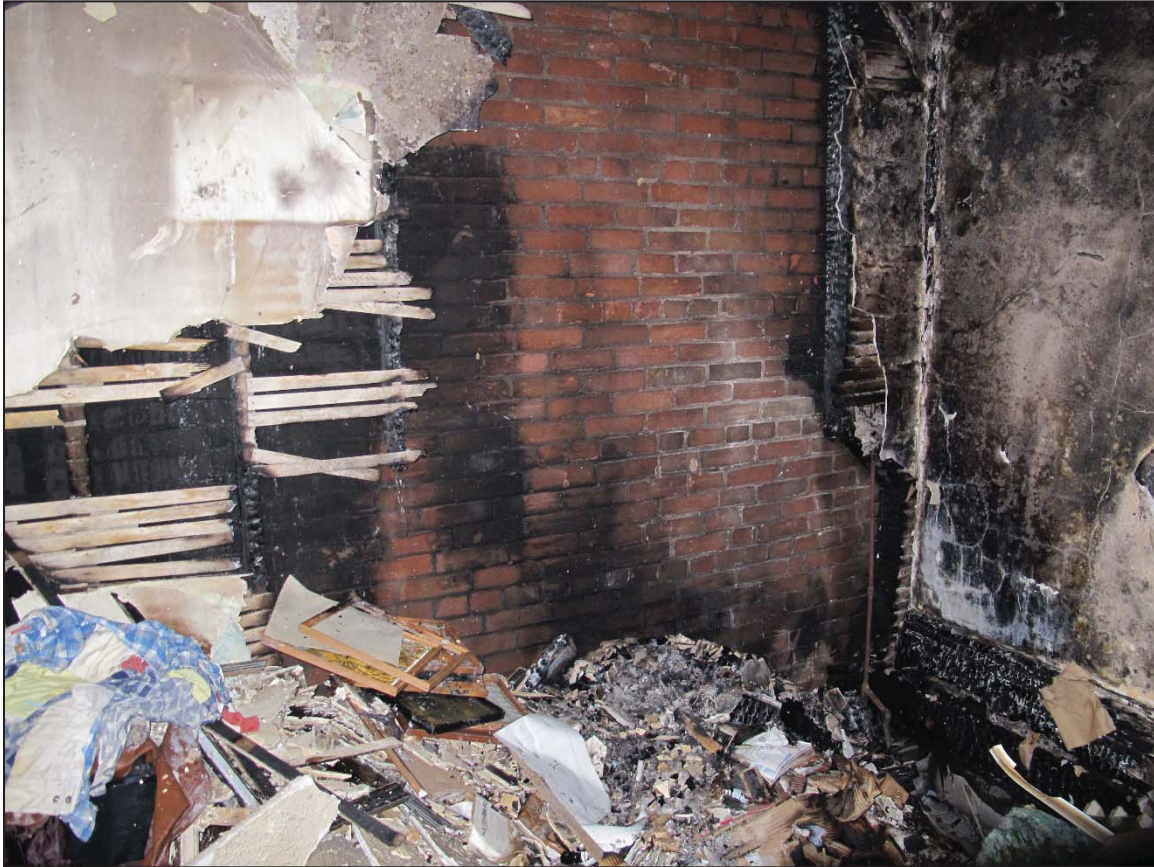
Within the northeast bedroom of the third level, the north wall framing had been consumed by the fire, and the masonry wall of the neighbouring building was blackened with soot (Figure 15).

Figure 15: View of north wall at second level showing burnt wood studs and blackened neighbouring masonry wall

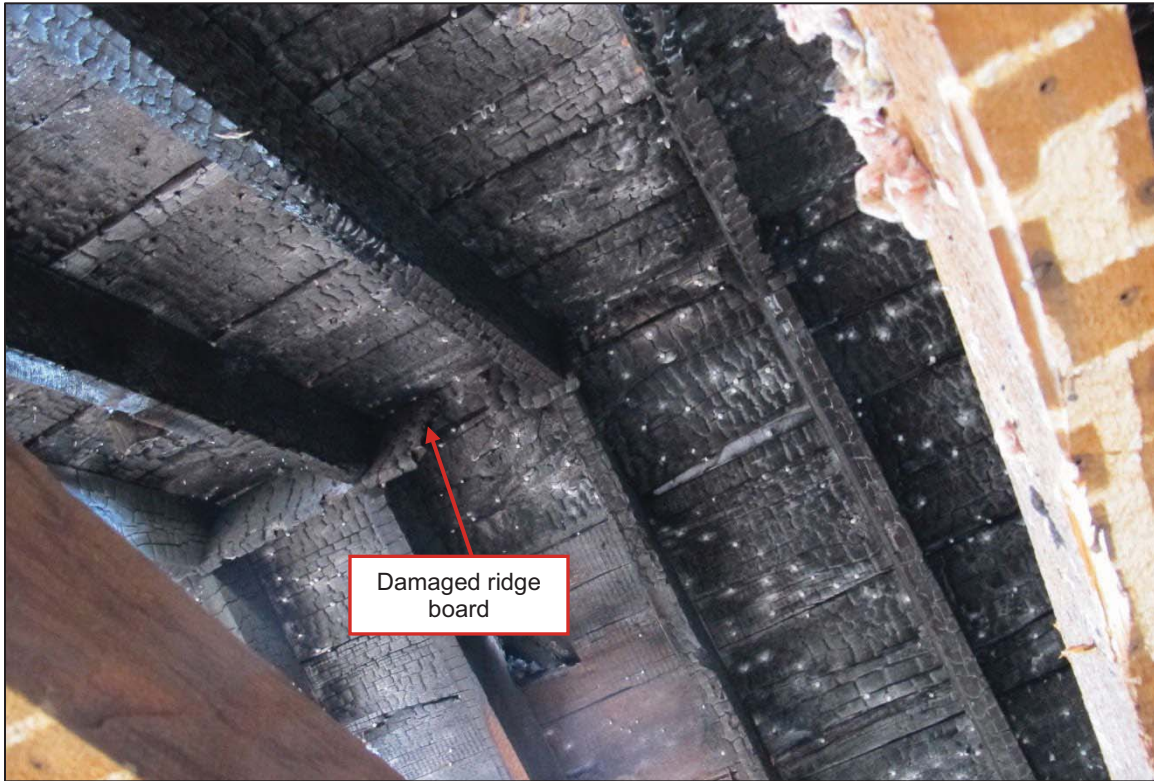
The roof rafters and sheathing had also sustained extensive charring and the ridge board had been partially consumed by the fire (Figure 16).

Figure 16: View of roof structure showing burnt rafters and partially consumed ridge board

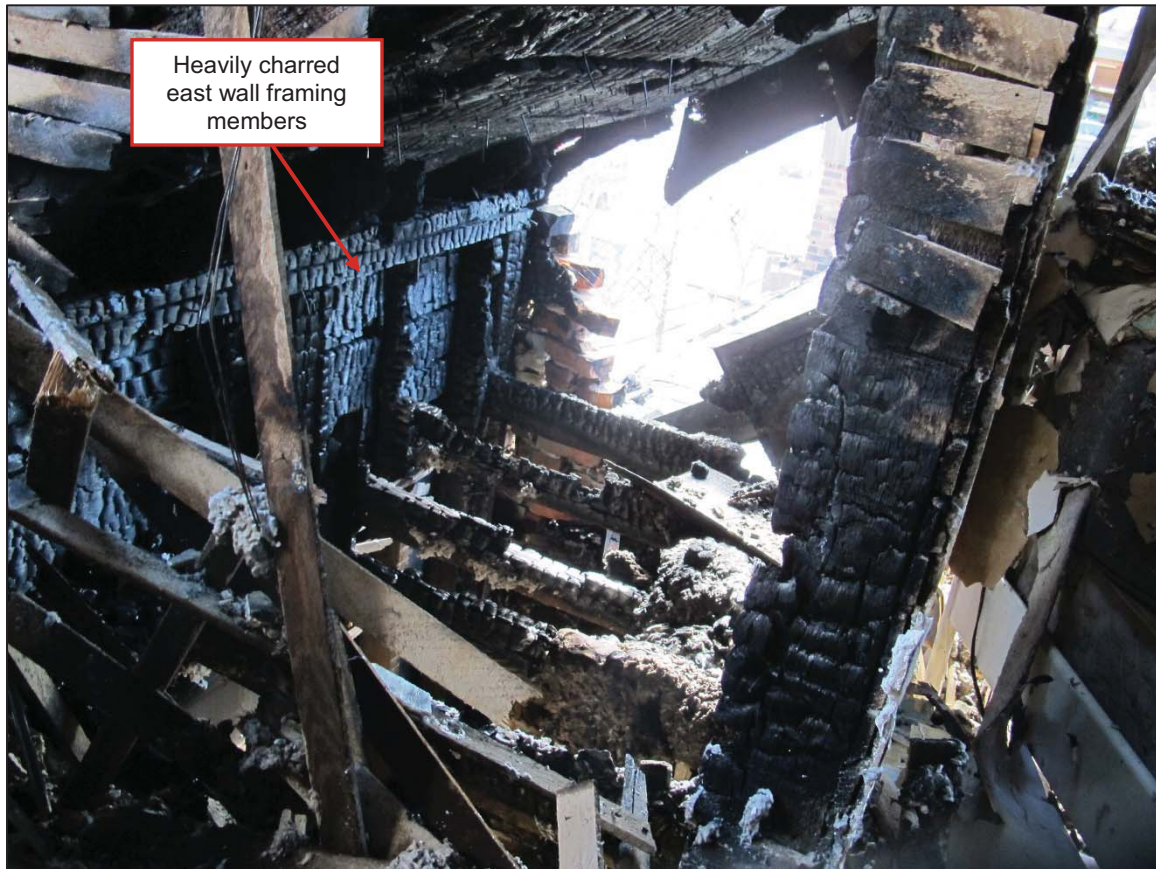
The south wall structure of the third level had been entirely consumed by the fire, and the framing members along the east wall were heavily charred (Figure 17).

Figure 17: View of southeast corner of third level showing fire damaged framing members

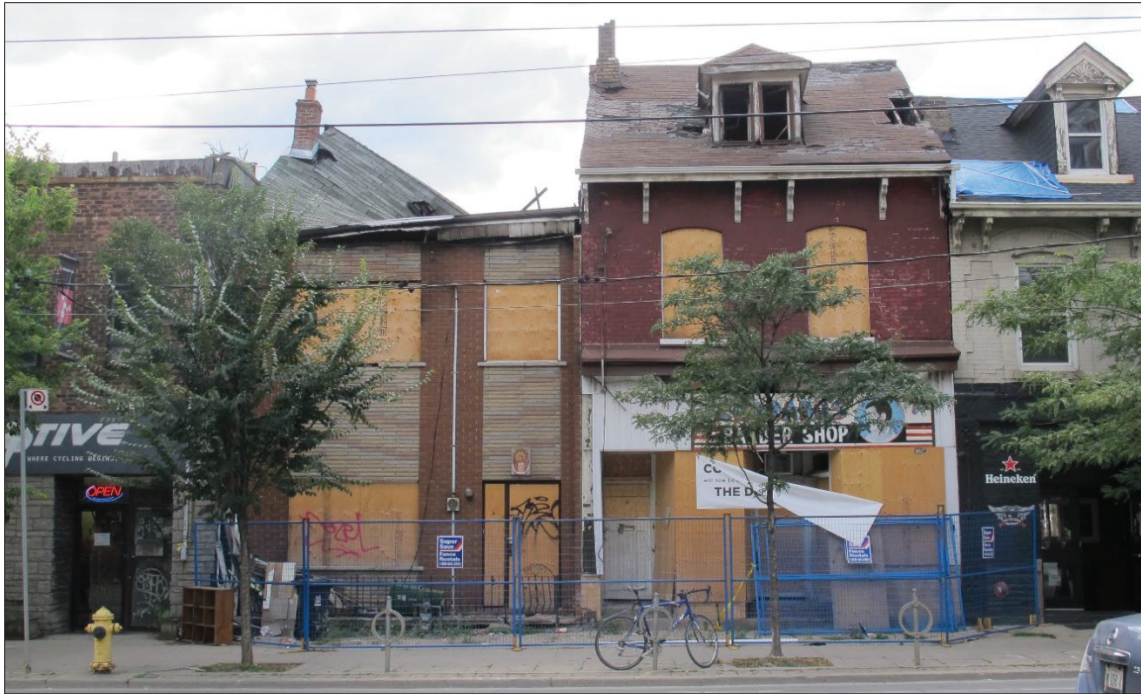
This letter is to confirm that, to date, both buildings have been secured. The window and door openings have been boarded, and the building perimeters have been fenced off using 6 ft. high fence to prevent access, in accordance with Article III of Chapter 363 of the City of Toronto's Building Construction and Demolition by-law (Figure 1 and Figure 2). The buildings are not suitable for occupancy. As such, the unsafe conditions have been addressed and controlled as best as possible at this time.

Figure 1: View of front elevation of buildings showing secured condition

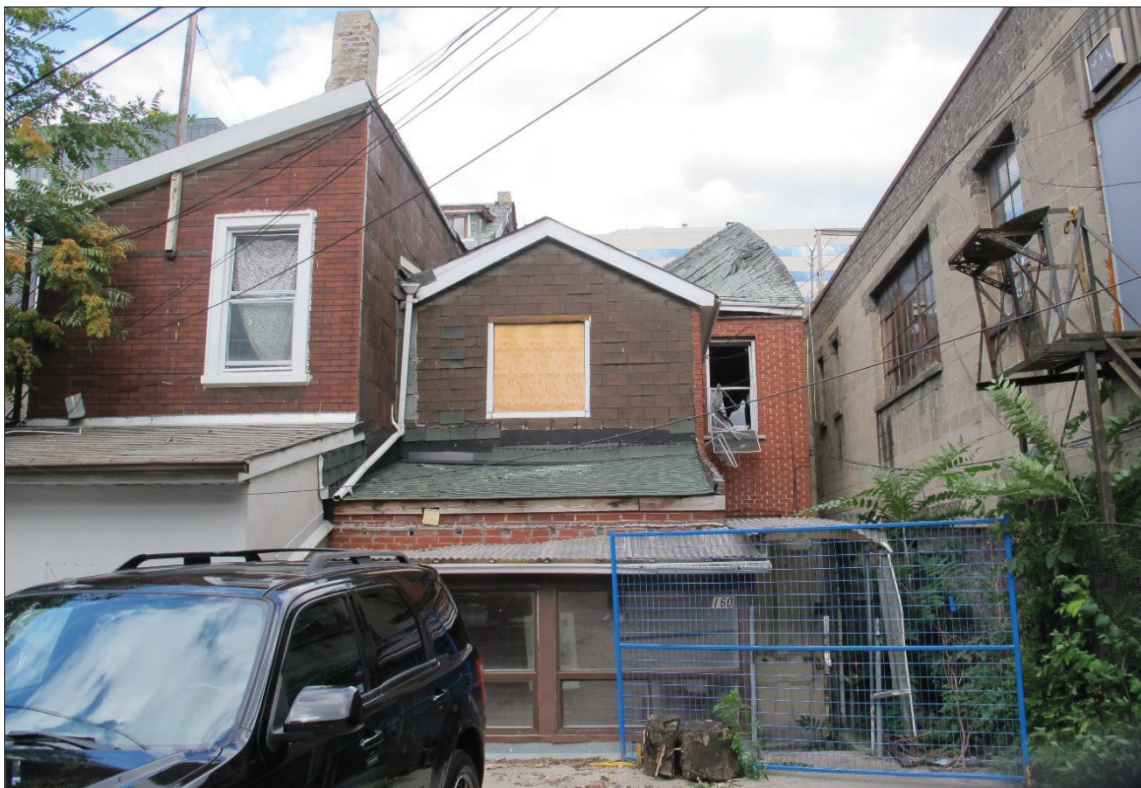
Figure 2: View of rear elevation of building showing secured condition
