CONSERVATION PLAN

8 Elm Street

Toronto, ON
(GBCA Project No: 19002)

8 November 2019

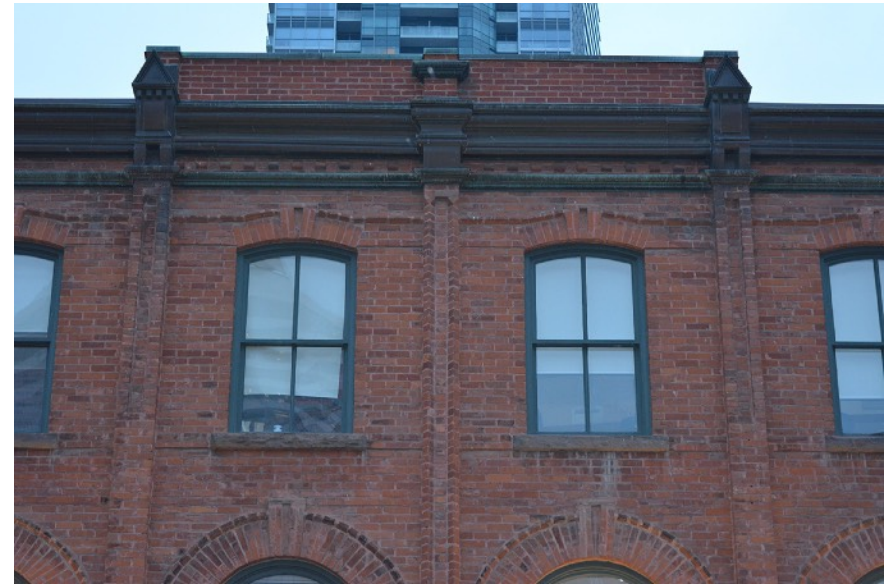
Close-up of the upper storey and the parapet wall. Note the staining due to water runoff under the sills, which themselves are soiled. Soiling is also present at the top of the brick pilasters.

- Remove ivy from masonry, including all left-over tendrils, and clean surface where necessary with low-pressure wash.
- Repair or replace bricks and repoint mortar joints where indicated on the drawings

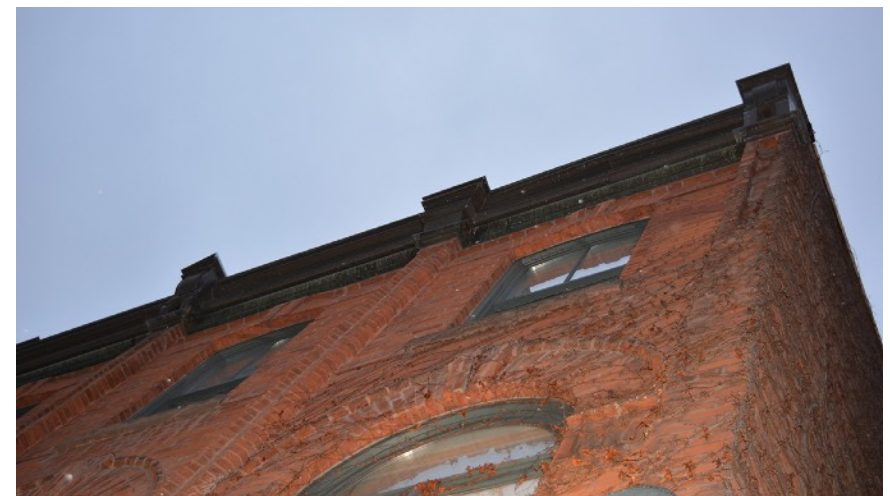
Remnants of ivy branches are present at the southeast corner , and cover the entire east side wall.

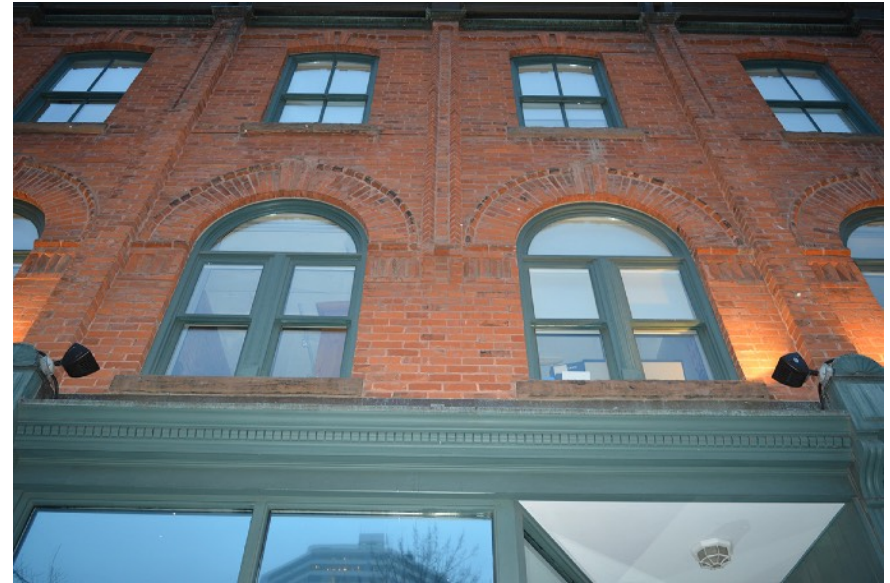
- Windows are of wood. All windows are in good condition and their design / materiality are compatible with the heritage character of the building

Close-up of the upper storey windows. At the second storey, the windows consist of a pair of double hung windows separated with a thick mullion at the center, and topped with a fixed semi-circular transom. At the third storey, windows are double hung, with a vertical muntin bar on each sash.

- Remove all windows and store in controlled environment for repair and maintenance
 - Removal is required for installation of retention structure to go through existing window openings.
- Reinstall existing windows in original openings following removal of retention structure.

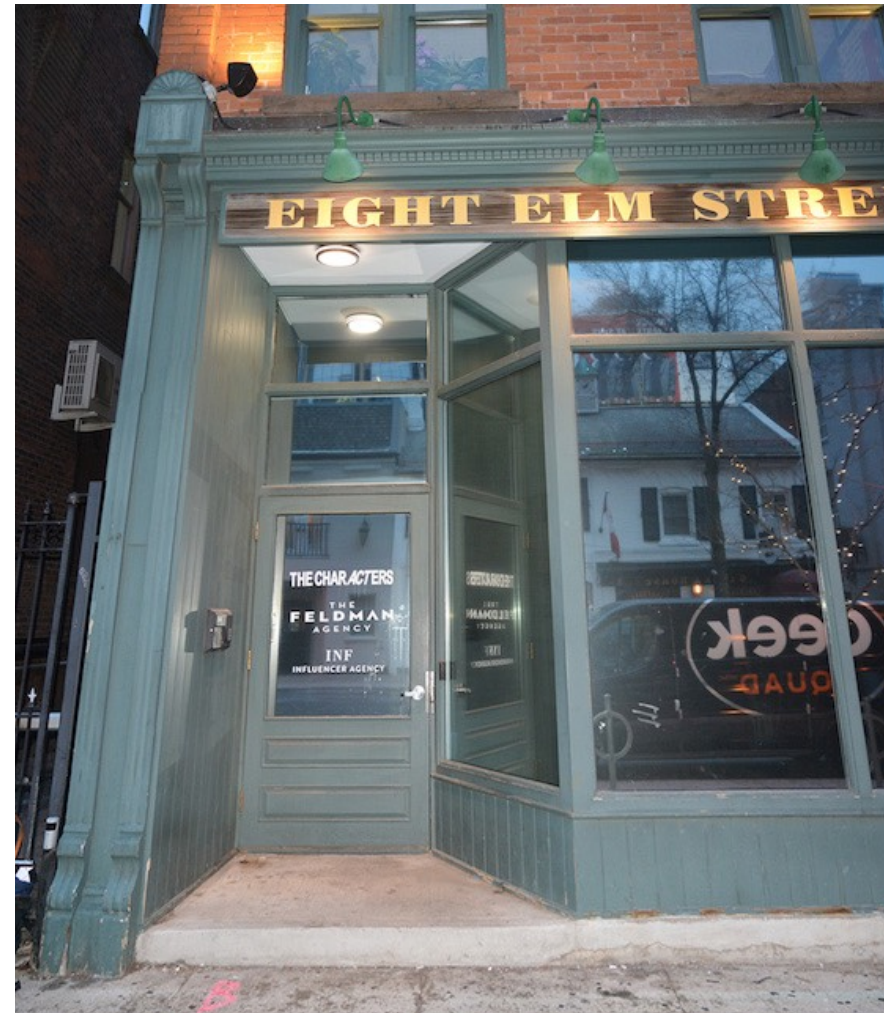
- Existing storefront consist of wood elements (bases, pilasters, brackets and signage bands).
- The storefront is not of original design
- Condition of storefront wood elements is generally good to fair.
- Paint is flaking in localized areas
- Windows are of wood frame and double glazed.
- Doors are of wood
- Entryways are not universally accessible as a step is required from the sidewalk to access the ground level

Close-up of the storefront's western entrance. Note the flaking paint near the edges of the bases as they touch the ground as well as at edges overall. These conditions are typical throughout the storefront.

- Preserve current storefront design and retain all storefront elements
- Remove all flaking paint from wood surfaces, apply wood treatment and repaint (maintain existing colour)
- Repair damaged wood surfaces with dutchman repairs or epoxy treatment, as required.
- Replace damaged metal flashing with new to match
- Make entrances accessible by lowering select concrete curbs
 - Alterations to the door will be required (new hardware and equipment)

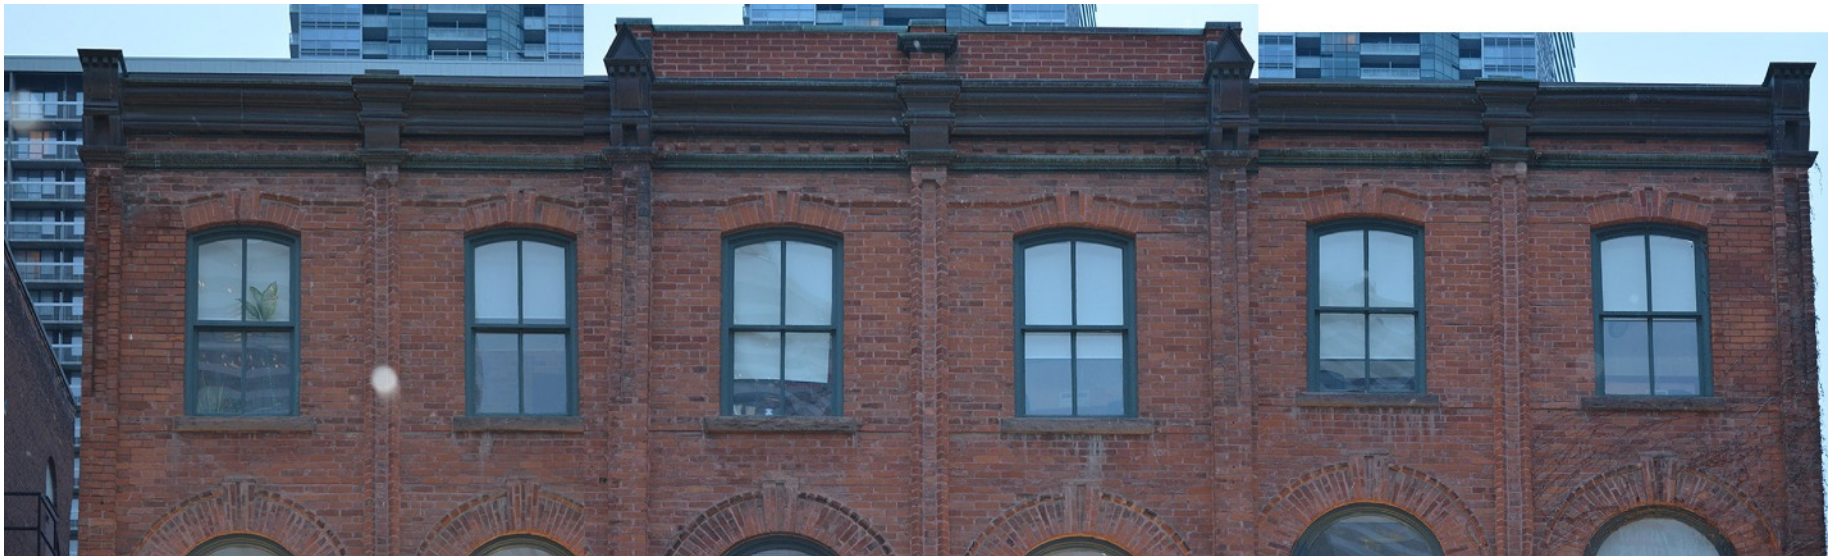
- Upper cornice is of pressed metal with different brackets styles ending each brick pilaster
- Brick parapet spans the two central bays and is in good condition
- No visible sign of deterioration was noted

Close-up of the upper cornice and brick parapet (collage photograph)

- Preserve current appearance of cornice and brackets
- Additional interventions may be required upon closer access (cleaning, repairs, repainting, etc.)

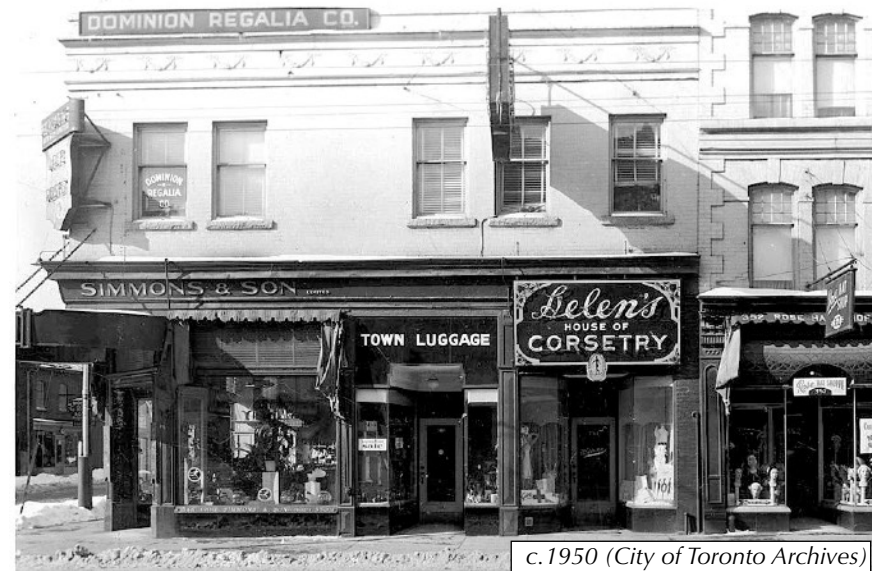
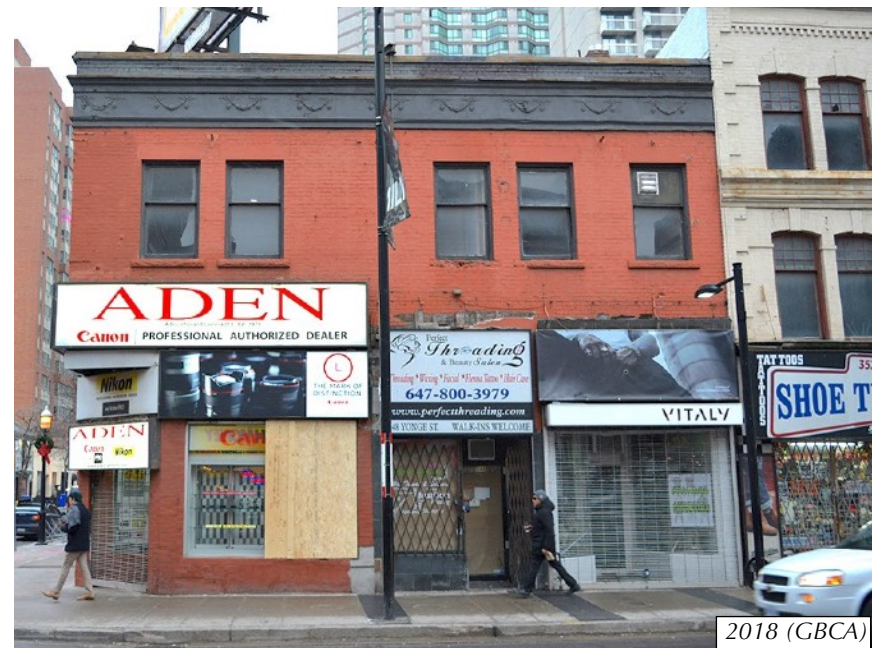
- Exterior walls observed to be 4 wythes in thickness
- Bricks are laid in common bond, with header bricks at every 6th course.
- All brick and stone surfaces are covered in successive layers of paint

- Beyond the paint the bricks may be spalled in localized areas.
- Holes are present throughout the brick surfaces (indicative of previous anchor fastenings)

- Many ferrous anchors are present near the top of the wall (location of flagpole holders)
- Localized stepped cracking in brick wall appears near lintels

- Bird droppings on top of window sills
- Sills: one is completely eroded and one is damaged
- Alterations to ground level openings are noticeable, primarily along the Elm Street facade

*Yonge Street facades of 348-350 Yonge Street
Note the highly altered storefronts, which appear to have removed much of the original fabric (cornices, pilasters etc.) two window sills at the second storey which are heavily deteriorated.*

- Remove all paint on surfaces with chemical cleaning
- Remove all ferrous materials and patch all holes with mortar to match existing colours.
- Replace damaged bricks where required
- Repair cracks in masonry and stabilize, where required
- Clean all bird droppings from sills with chemical cleaning
- Replace sill that is completely eroded and repair sill that is damaged with dutchman repair.
- Repair, replace and repoint areas of the facade as necessary following paint removal
- Include two additional window openings on the top storey of the Elm Street frontage, once panels are reinstated.

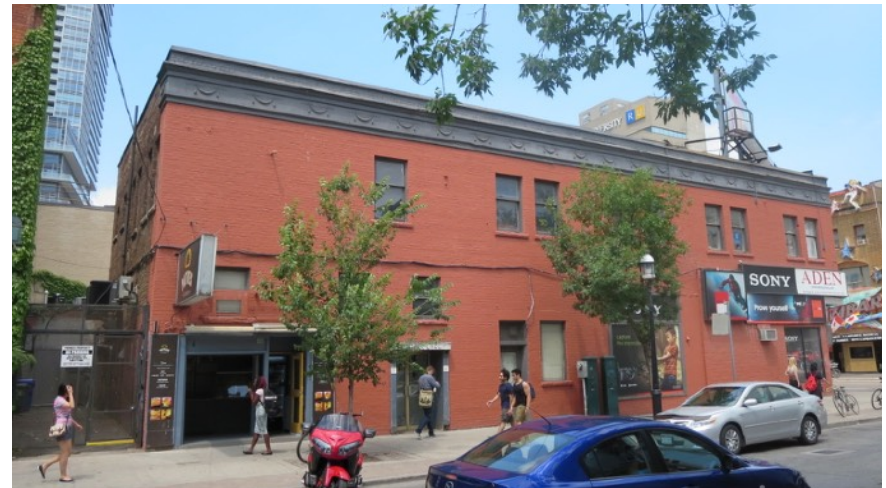
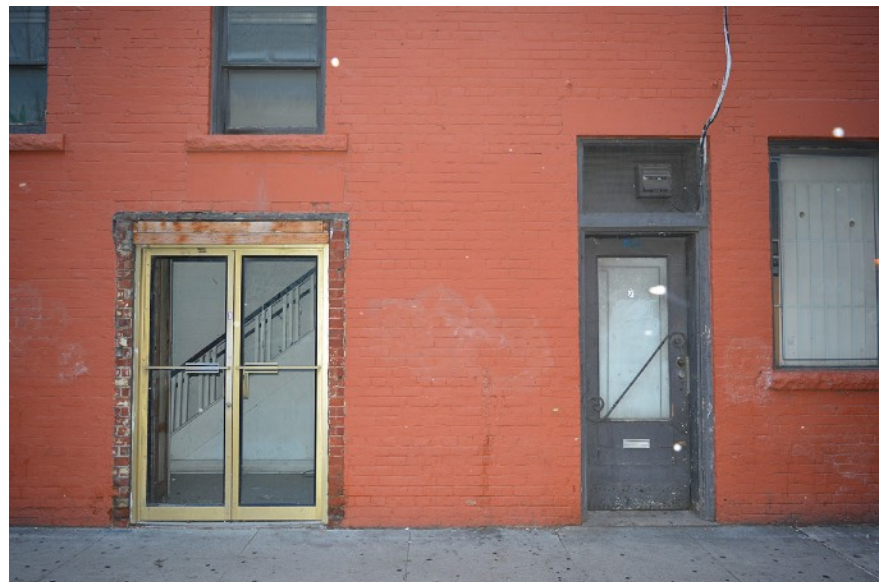
Note the double doorway in the 2018 image that was added in a previous single doorway opening (see the lintel above as a trace). The exposed unpainted brick around the doorway is shown as in fair to poor condition.

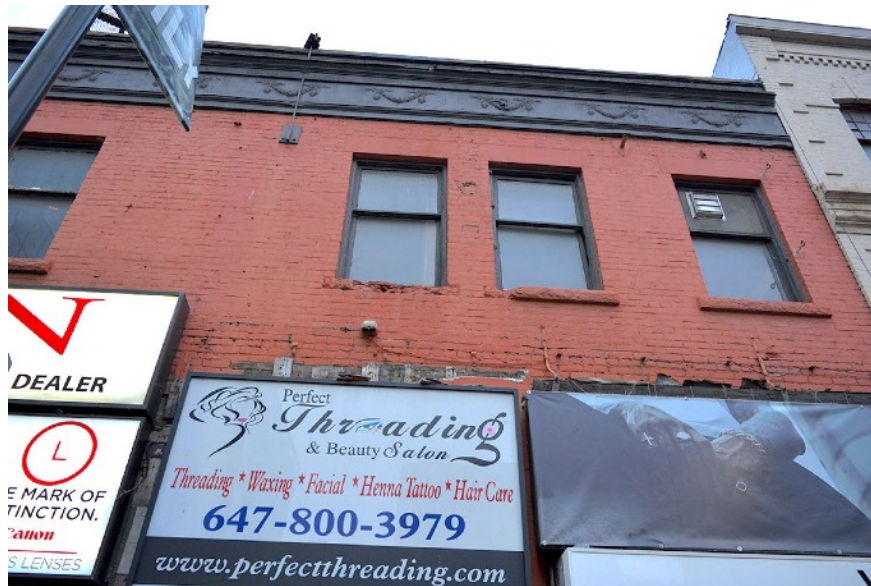
Above left:
Close-up of second storey on Yonge Street facade. Note the deteriorated window sills. The brickwork above the signage light boxes is deteriorated with eroded mortar joints and damaged bricks, likely due to alterations to the storefronts (GBCA 2018).

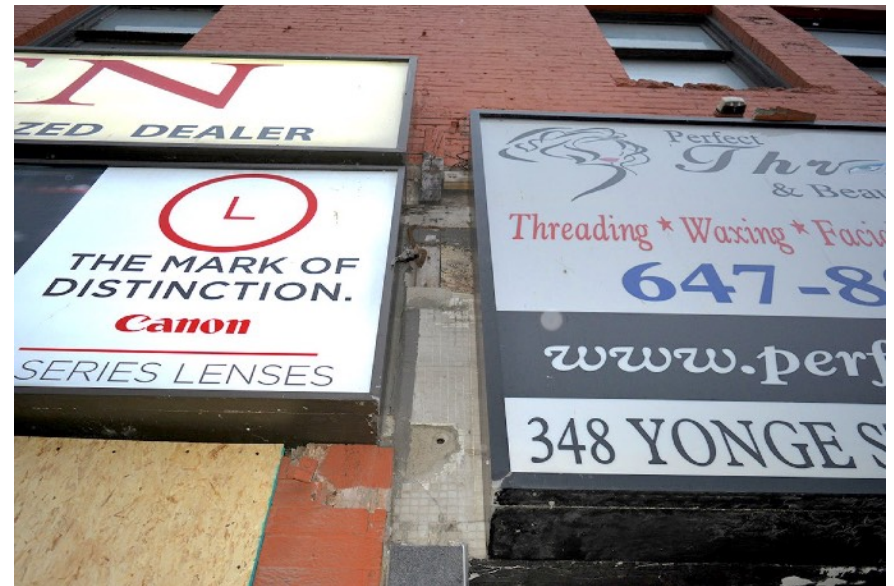
Above right:
Close-up of storefront on Yonge Street facade. Materials visible near the signage light boxes do not appear to be original and are later alterations, all of which appear to have severely damaged the brickwork. (GBCA 2018)

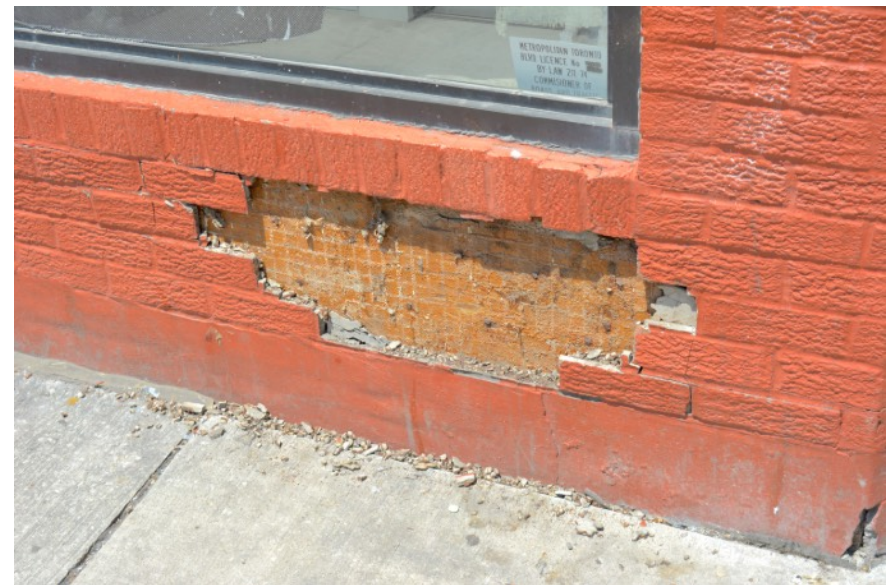
Below right:
Close-up of base of storefront along Elm Street. Finishing shown in this portion of the Elm Street facade appears to be a concrete parging to mimic the appearance of brick with plywood backing. Traces of previous ceramic tiling is evident. This finishing is applied on the easternmost portion of Elm Street, under the signage band

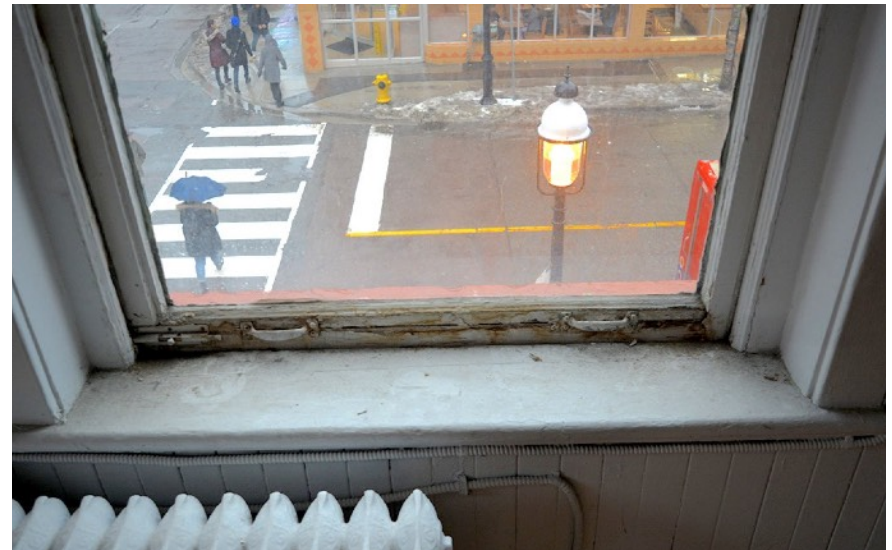
- At ground level: windows and doors are modern aluminum replacements
- At upper storey: windows are wood, double hung, single glazed and appear as original
- Original wood windows are in fair to poor condition.
- Successive layers of paint have been noted on the wood surfaces. Paint is flaking, exposing the wood

Example of a lower sash with its bottom rail heavily deteriorated.

- Remove all modern aluminum windows and doors.
 - Ground level will be redesigned with new aluminum framed windows and doors.
- Remove all upper storey wood windows and replace with new to match
 - Windows require removal prior of facade panelization strategy
 - New windows will be of wood with an aluminum cladding on the exterior and replicate the existing double-hung style and design shown.

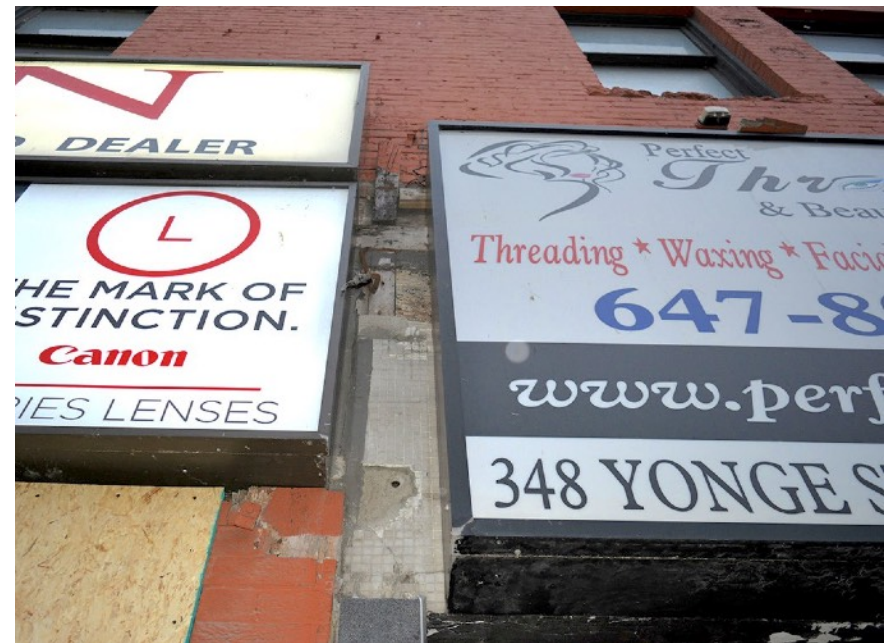
- Storefront structure not properly assessed due to amount of signage which, due to their current occupancy, could not be removed. A wood beam was visible, but its condition was not confirmed. It is expected the beam is in poor condition if it is original.

Close-up view of the condition between signage bands, showing a mix of materials resulting from successive alterations. At this location was noted a wooden beam, which appear to be original yet was not fully assessed due to obstructions of the signage bands.

- Remove all obstructions from current storefront and expose the existing structure and, if existing, any original finishes.
 - ▶ Undertake investigation and documentation of the existing condition of the structure

- ▶ Intention is to remove the wood beam (as it is expected to be in poor condition) and replace with a new structural steel beam and columns.
- Rehabilitate storefront with a new design that respects design principles of late 19th century storefronts, using new materials.

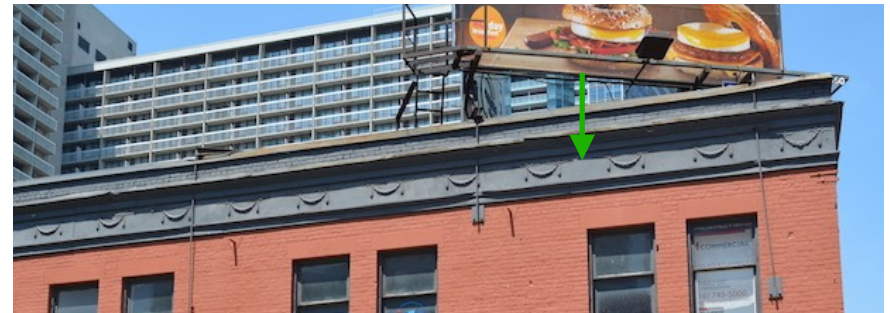
- Entablature consists of three parts:
 - a cornice in pressed metal
 - a frieze in crimped metal, which includes festoons that are possibly of metal appliques
 - an architrave moulding, in pressed metal
- Entablature is painted
- Frieze appears to have multiple layers of paint as surface is "patchy"
- Cornices and architrave mouldings are damaged in localized parts due to bending corrosion and holes
- Some festoons are damaged in localized areas
- Metal flashing over cornice is generally damaged and deteriorated

Overall view of the entablature along Elm Street. Note the metal anchors that have damaged the metal cornice and architrave moulding

- Document and dismantle existing pieces. Cut pieces in strategic locations (at existing joints) for future reinstatement.
- Remove paint with chemical cleaning
- Remove patchy areas of frieze
- Repair all damaged elements
- Replace heavily damaged metal components with new to match in gauge and style
- Repair festoons with epoxy and replace heavily damaged components with new carved elements.
- Replace metal flashing

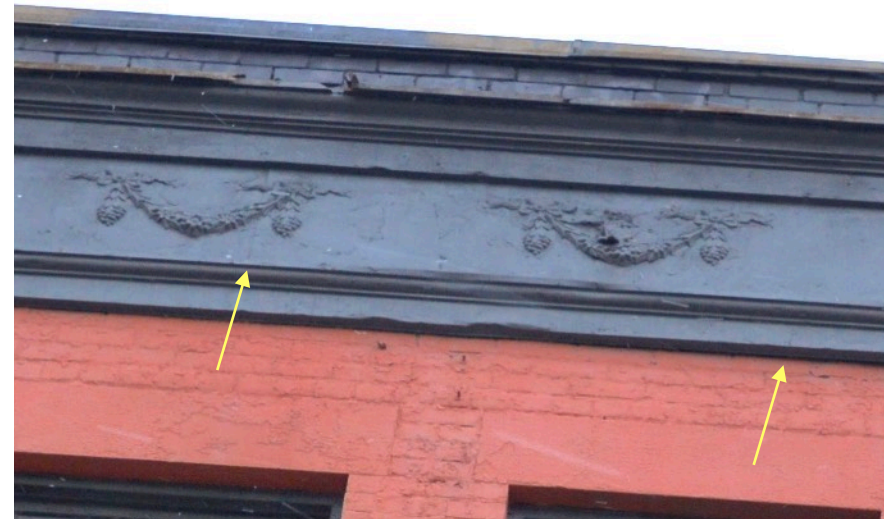
Close-up view of the entablature, showing the decorative festoons. Note the seams of the wooden frieze which vary in their locations. Removal of pieces will need to consider these conditions to avoid damage to festoons located in front of seams. There appears to be plaster or epoxy applied throughout portions of the wooden frieze to mask any potential imperfections of the wood, although the plaster is crudely applied. The metal flashing of the cornice is generally bent and corroded.

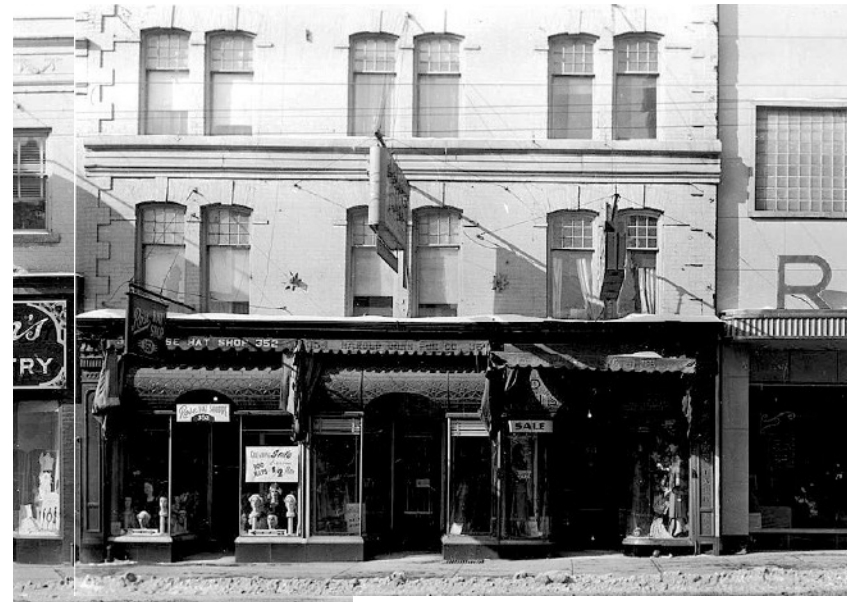
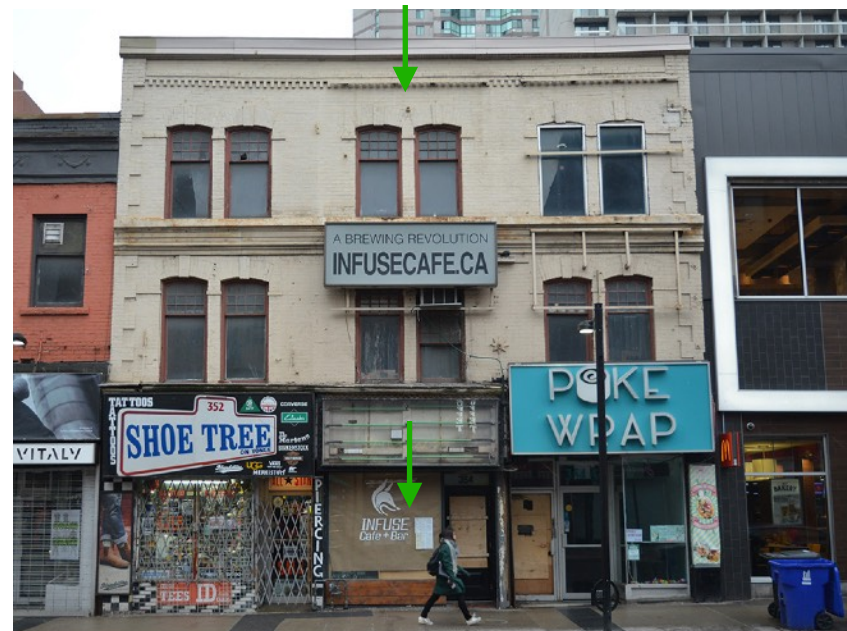
- ▶ 1950 photograph show some of the existing cracks before alterations to the storefront were made. Most likely, failure in the clip bond has been happening since before the 1950s.

- Facade stability: The facade is in very poor condition
 - ▶ Significant “shifting downwards” is evident in the center of the facade, noticeable by step cracks and the misalignment of window openings, further made clear from the interiors.

Yonge Street facade of 352-354 Yonge Street
 Top: c.1950 (City of Toronto Archives). Bottom: 2018 (GBCA)
 Note the “depression” at the middle of the wall, likely due to the changes in the storefront design (green arrows indicates approximate direction of depression).

- Document the facade through detailed pictures and drawings
- Dismantle façade and rebuild in kind
 - ▶ Facade is too deteriorated and the shifting in plane is significant.

- ▶ While it is possible to stabilize the facade in its current "shifted" state, this strategy is not recommended as it will make rehabilitation challenging and inefficient, where the final product will not have an appealing appearance. Significant repairs and non-reversible interventions to the facade will be required, such as structural bracing, and reinforcement with ties.

- ▶ Good quality salvaged bricks and sills, where available, will be re-used for the rebuilding.
- Replace top metal flashing, as required.

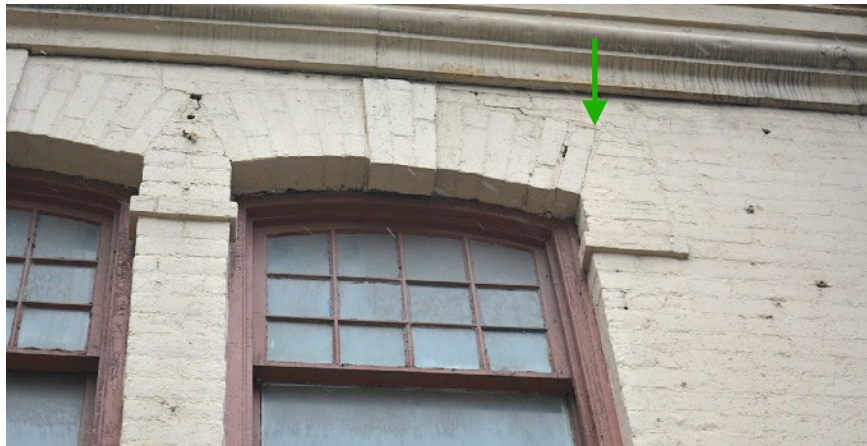
View of a second storey window showing the visible displacement of the lintel (green arrow). Stepped cracking is also notable above the lintel. Note the many holes on the facade, previous locations of anchors to secure signage.

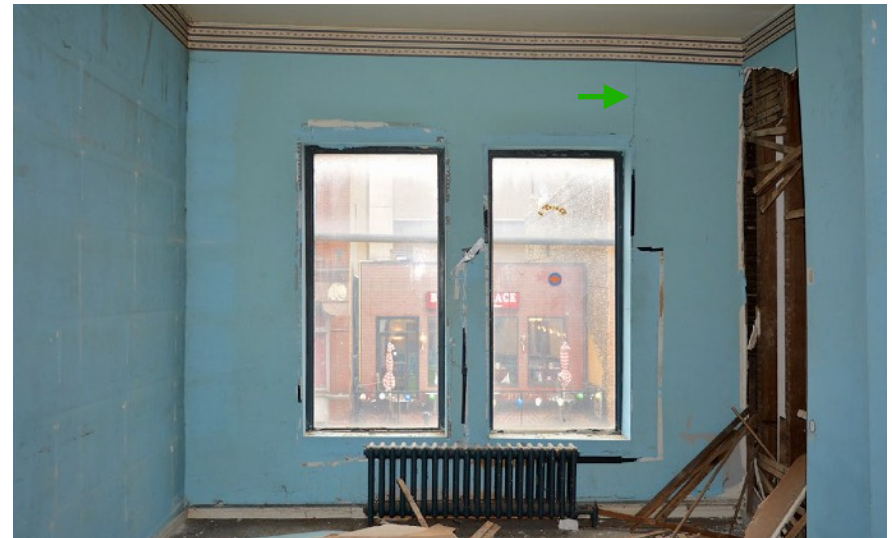
3rd storey interior view. Note the cracking above the window (arrow) and the visible displacement of the wall towards the right (center of the facade).

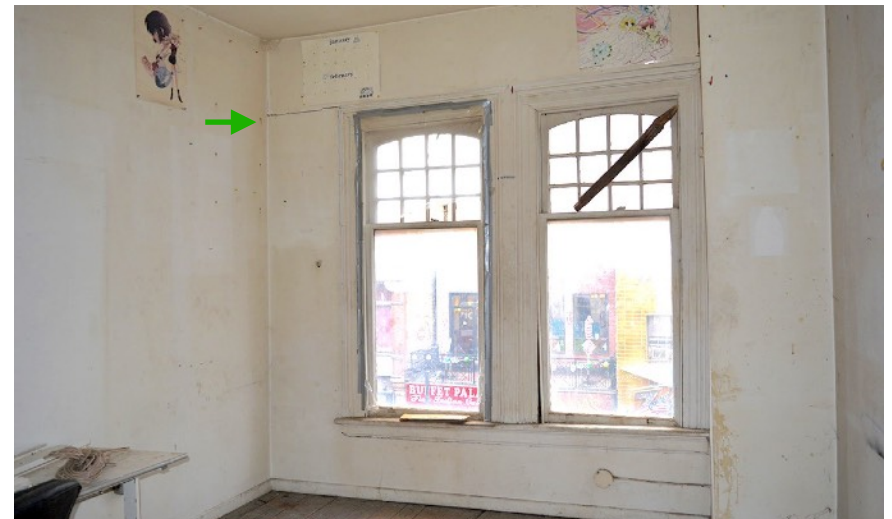
3rd storey interior view. Note the cracking above the window (arrow) and the visible displacement of the wall towards the left (center of the facade), evident by the sloping window sill.

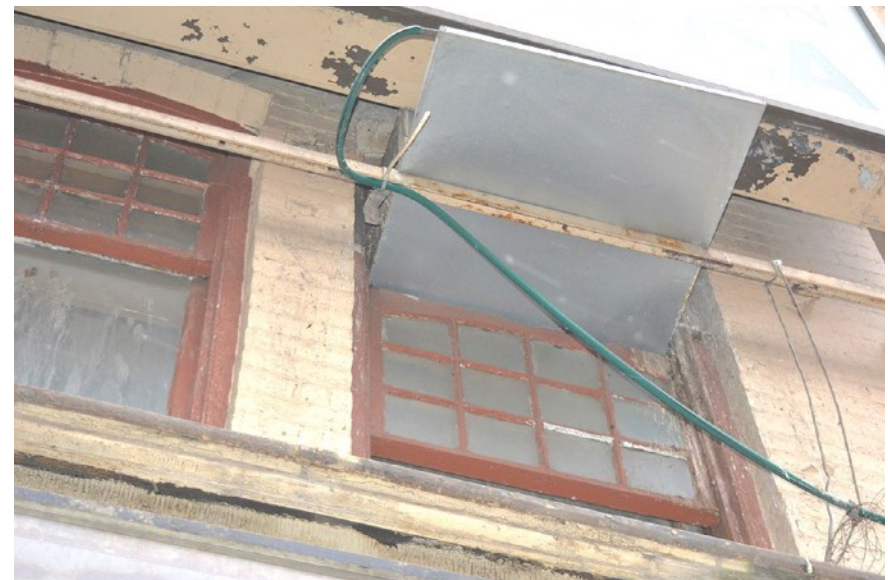
- Of the 12 windows, 10 are original in wood and 2 are aluminum replacements
- The original windows are double hung, with the upper sash of smaller size and consisting of 12 lites.
- Original windows are generally in fair to poor condition
- Successive layers of paint have been noted on the wood. Paint is flaking and exposing the wood.
- Bird droppings are present on windows
- Glass is broken on one of the lites. Windows are single pane.

View of second storey windows. The upper sash has been lowered to include what appears to be an air conditioning unit. Note the bird droppings on the glass and the painted wood surfaces.

- Remove all wood windows for restoration to an off-site location
 - Window restoration will consist of:
 - paint removal and repainting
 - repair of damaged wood units and replacement of heavily damaged items
 - Interventions to address glass efficiency may consist of one (or a combination) of the following strategies:
 - removal of all glass panes, retention of sashes and frames and replacement with new insulated glazed units (only possible if sashes can accommodate an increase in glass thickness)
 - retention of existing glass and inclusion of new interior storm sash windows
 - replacement of lower sash with new wood sash and new insulated glazed units
- Replacement of 2 non-original windows with new wood windows to match.

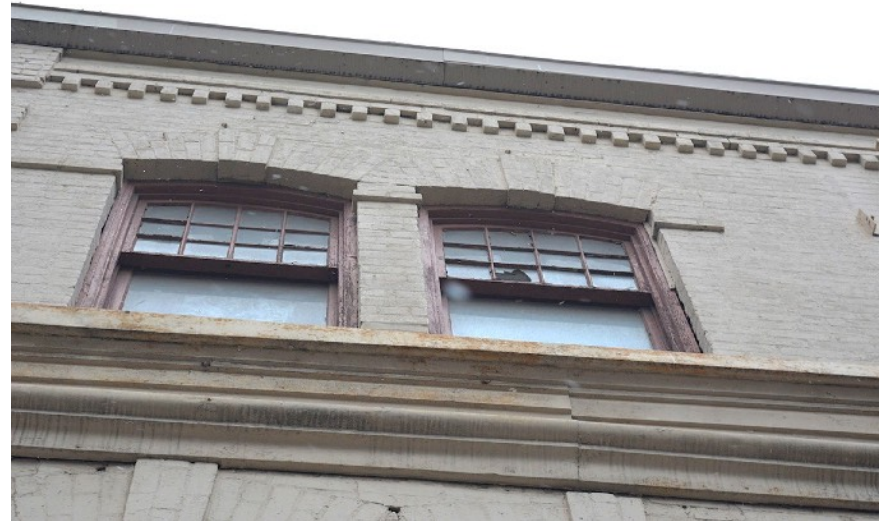
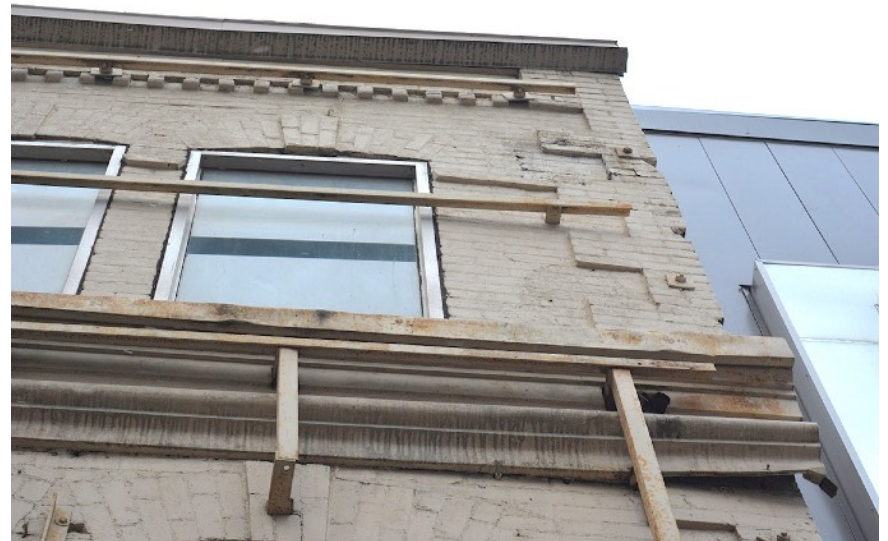
- Located between the second and third storeys
- Painted in the same colour as the bricks on the facade
- Cornice is in fair to poor condition
 - ▶ Signs of rust in many areas
 - ▶ Metal is damaged with holes for signage structure
 - ▶ Presence of dirt throughout the surface

Close-up views of pressed metal cornice between the second and third storeys, which is punctured in some locations for signage structure. The cornice is bent, dirty and corroded at the top.

- Remove cornice for restoration off-site. Restoration will include
 - ▶ Cleaning of surface
 - ▶ Repair and patch holes
 - ▶ Replace severely damaged metal pieces
 - ▶ Repaint surface to match existing colour.
 - ▶ Replace top metal flashing and lookout wood support, as required.
