08 December 2020

Re: Façade Review at 8 Elm St., 348-350 Yonge St. (including 2-6 Elm St.), 352-354 Yonge St.

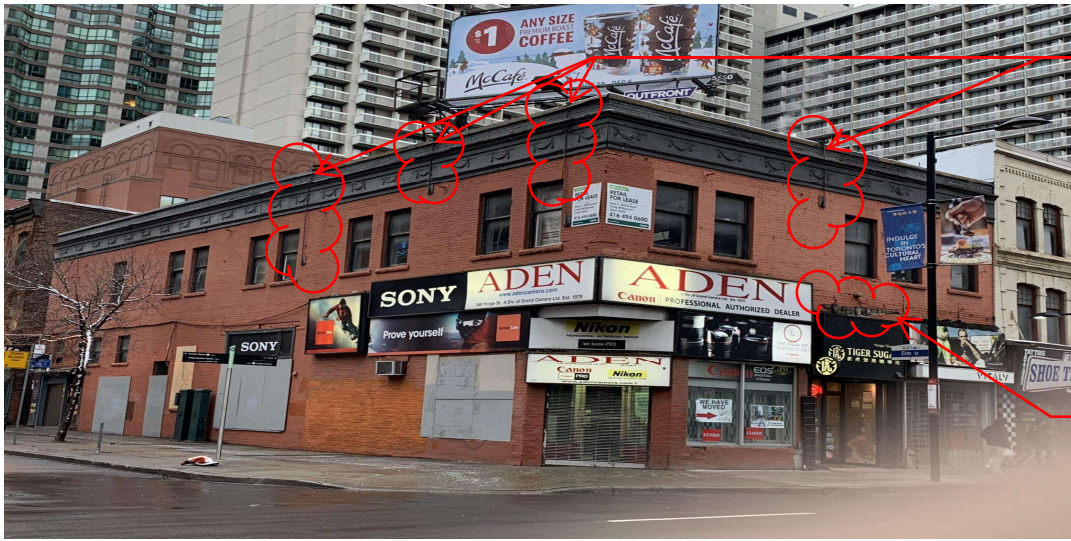
- Our review of the portion of the façade slated for retention in the Conservation Plan is in much poorer condition than observed in the 2019 report. The signage tie-down strap system (see photos 1&2) has created damage to the façade. This damage ranges from crushing the metal frieze profiles to excerpting large loads on the masonry load bearing walls. The traditional brick and lime mortar masonry walls were never intended nor designed for this application and as such this condition has caused movement and stress on the wall surfaces.

Photo #1:
Roof signage strap
anchors

Visible open joints
at support beam
location

Upon the findings of the meeting, the parties agreed that the façade retention noted should be amended for a panelization approach. The panelization approach will ensure better quality and ease of repair, restoration, or replacement of the main support beam. This approach will allow for a concealed reinforcing of the original heritage fabric to rectify the damage caused by the tie-down roof signage anchors. This approach will also ensure that the corner façade, which is most at risk by crane activities during the new build, is removed from the site during construction activities and reinstated. This approach will reduce the risks associated with exposure of the back side (interior underfired brick) from the elements. I have included a proposed panelization sketch (see Photo #4).

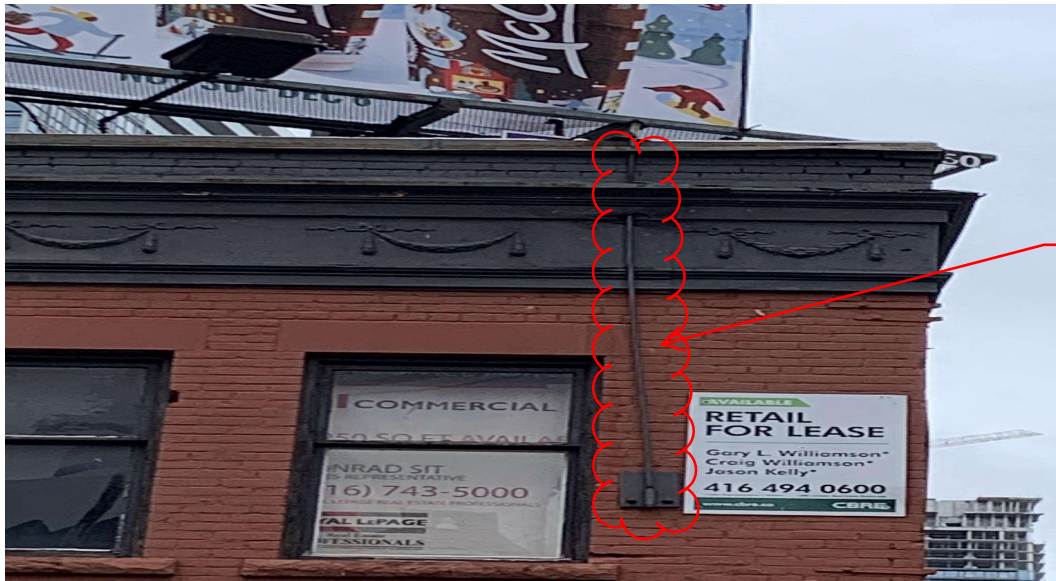
Photo #2:
View of strap
anchor showing
damage to heritage
surfaces

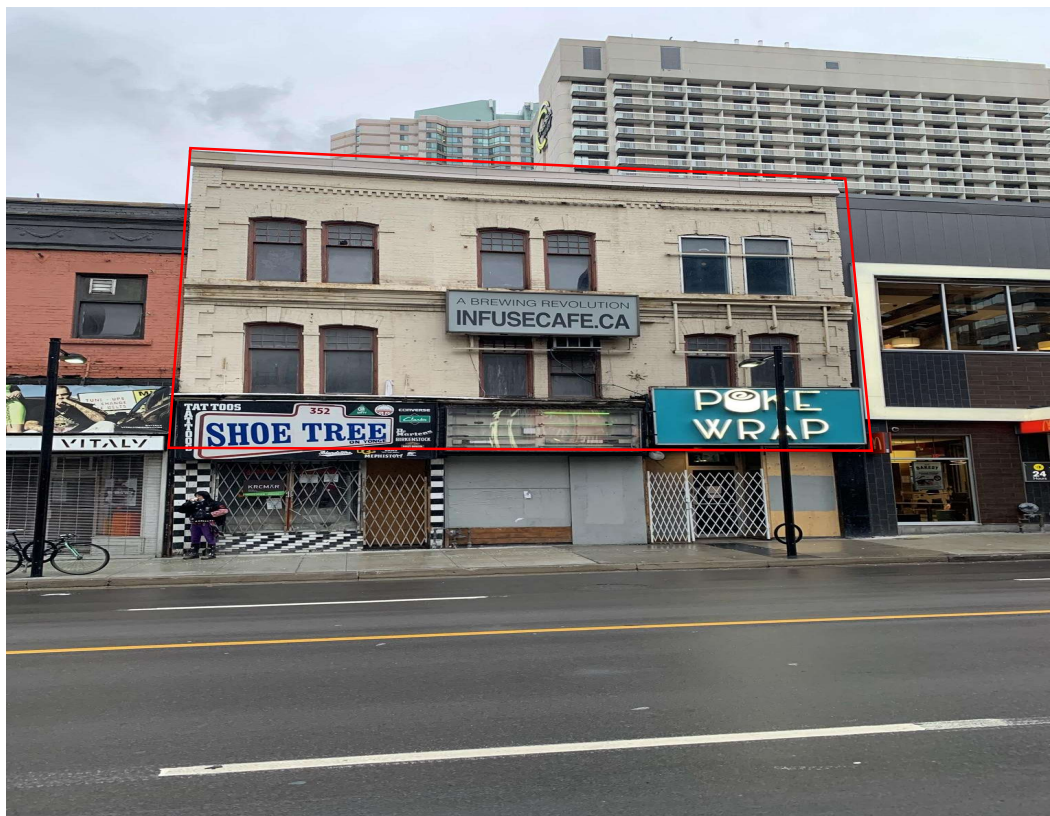
Photo #3:
Bowling of wall is not
well reflected in
photo, but on site
visual review
conducted shows a
50-75mm bow
vertically and
75-100mm bow
horizontally.
