## **Emergency Non-competitive Contract with OJCR Construction Ltd., to Repair a section of the East Don Sanitary Trunk Sewer**

**Date:** March 12, 2021

**To:** General Government & Licensing Committee

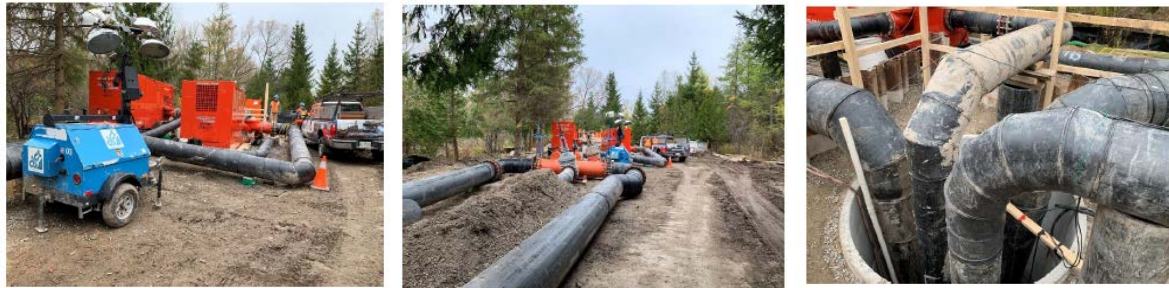
**Figure 2: Large scale sewer bypass system**

In order to begin the repairs, a sewer bypass system needed to be constructed to divert the sewage from the damaged trunk sewer. With the access road completed, sub-contractor Aquatech (specializing in dewatering and bypass pumping) mobilized at the site and engineered and constructed a large scale sewer bypass system (see Figure 2) to divert the flow of sewage away from work area and the failed 15 metre STS.

The large scale sewer bypass system was commissioned on October 29, 2019, and the contractor began the sewer repair. The bypass diverted 17 million litres per day of sewage and was in operation for the duration of the repairs.

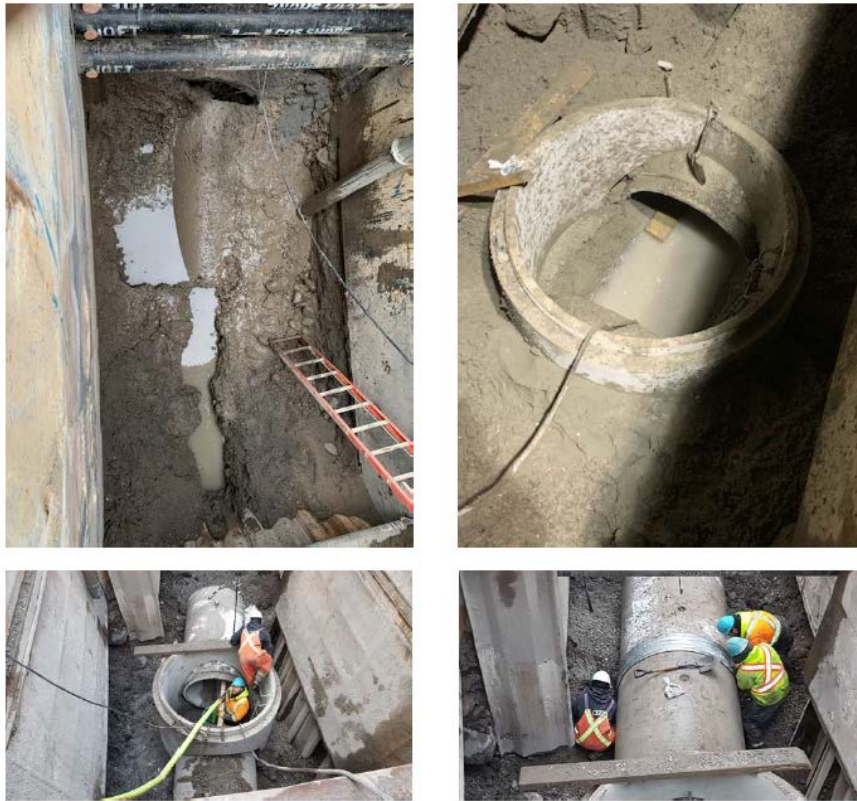
**Figure 3: Excavation and repair of the 15 metre STS**

TW immediately arranged for closed-circuit television (CCTV) investigation of the STS and initially determined that a 15 metre (nearly 50 feet) section had structurally failed directly below the sinkhole. Trunk sewer standard service level of inspection for preventative maintenance is once every 10 years. A CCTV inspection was completed on this section of the STS in 2016 and at that time no major defects were observed.

Once the bypass was in place, the site was excavated and the 15 metre of sewer was repaired and replaced (see Figure 3).

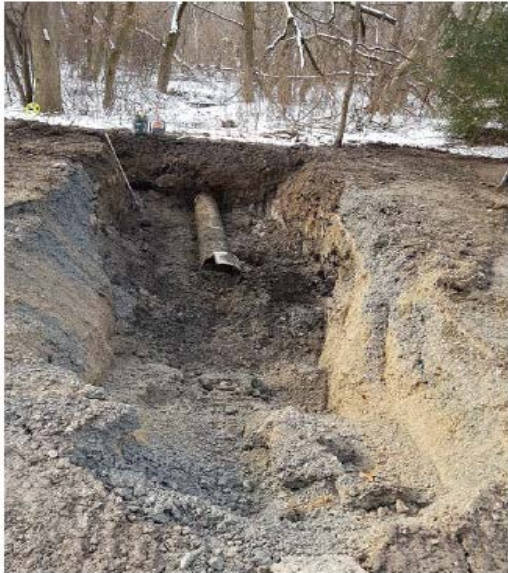
**Figure 4: Excavated culvert**

Once the initial 15 metres of the sewer was repaired, and upon further internal investigation, three additional sections of the STS were found to be structurally compromised. The investigation also found an additional collapsed culvert (see Figure 4) running perpendicular to the STS concluding that the two damaged culverts were the direct cause of the sewer failure. On November 21, 2019, Toronto Water issued instructions to the contractor to repair the additional culvert and rehabilitate the three additional compromised sections of the STS.
