**308-314 Jarvis Street**  
Toronto

(GBCA Project No: 18040.1)

## **Heritage Impact Assessment**

29 August 2019

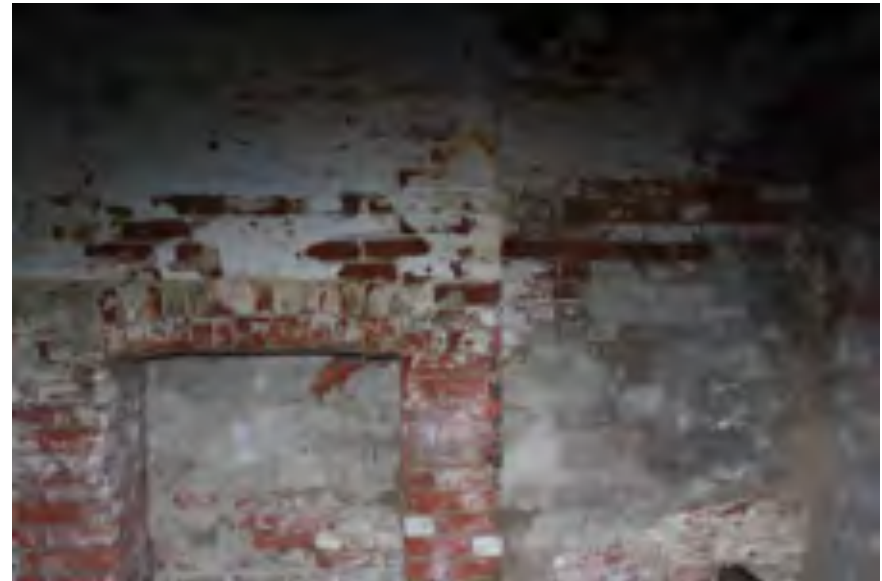
- There are 2 types of foundation wall assemblies, brick and rubble stone
- Some areas are covered with cement parging
- Some areas along the south walls are painted
- Some areas of exposed masonry foundation walls are in poor condition with heavy efflorescence and spalling brick
- Brick infill has been used in modified openings along stone foundation walls

Masonry foundation wall along south facade. Note the parking, painted bricks, efflorescence buildup and fireplace

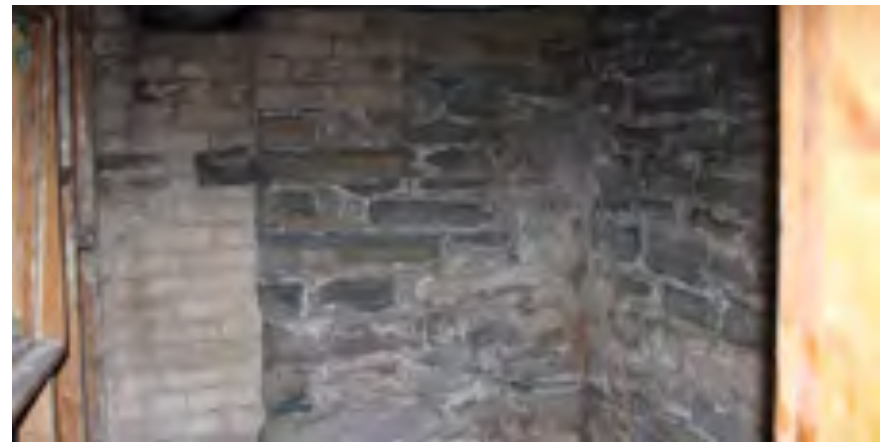
Typical rubble stone foundation wall

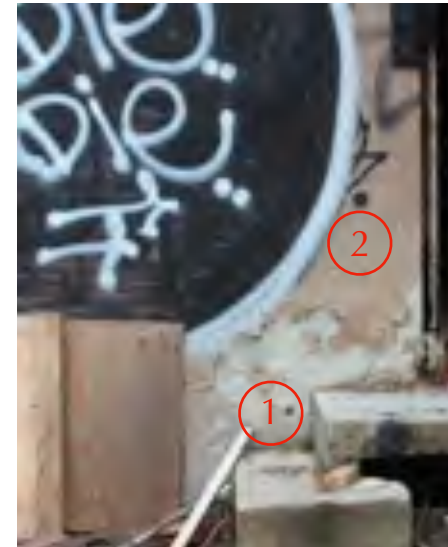
- Cement based parging and textured rendering over the brick is in fair condition with localized areas of delamination, cracking and damage
- Areas have graffiti damage
- Some stucco was improperly applied over existing wiring

Typical stucco rendering over brick note the cement parging base (1) and pink textured rendering (2).

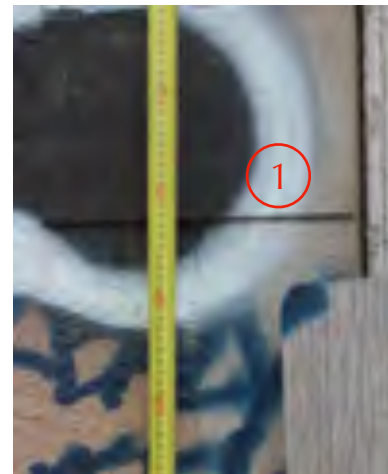
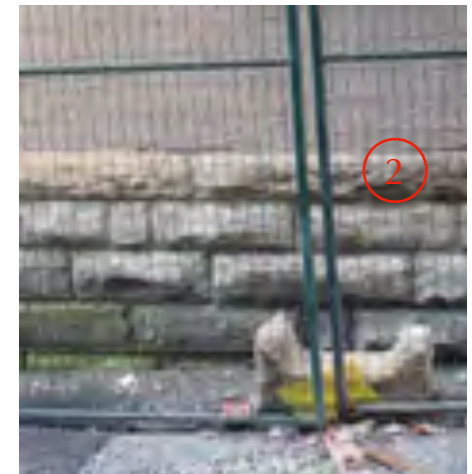
- The stones are in good condition overall, but with some exhibiting damage including chipped and cracked units and shifted stone units
- Few stone units (at front porch) are heavily damaged
- Various areas with staining - including graffiti, biological stains and other atmospheric soiling
- Areas covered with vines
- Stone has been damaged by the insertion of miscellaneous anchors and other ferrous materials
- Some areas covered with stucco (along the east facade)
- Opened mortar joints in localized areas

Typical Ashlar stones, furrowed surfaced stones used around window openings (1) and rock face stones used along the water table of the exterior walls (2).

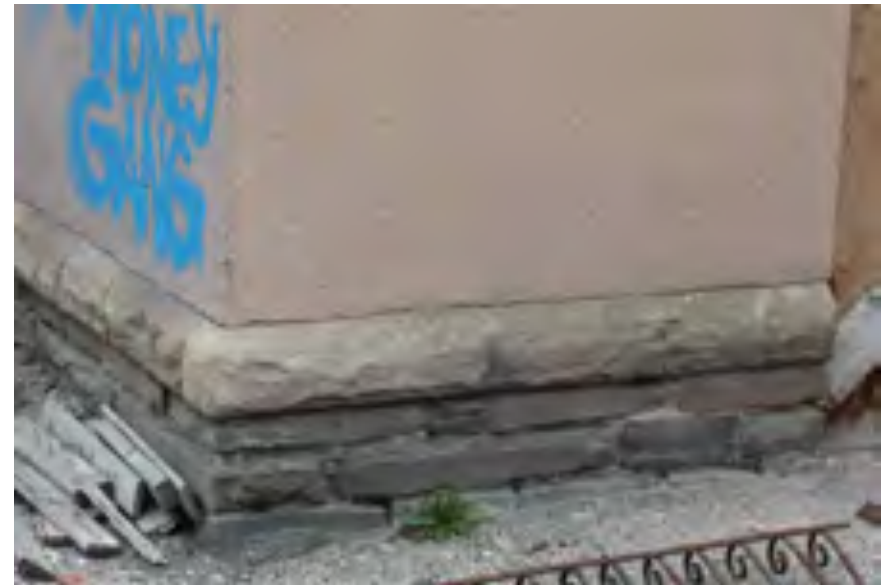
- Found along the water table of some of the rear addition walls
- Eroded mortar joints
- Soiling and biological staining

Rubble stone used along the water table of the rear addition walls

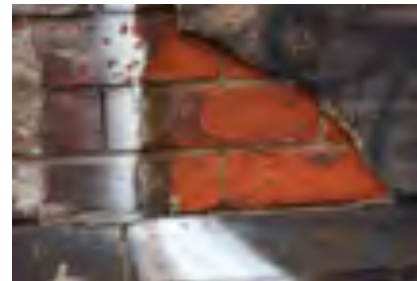
- Where visible some heavily damaged areas with loose bricks
- Cracked and chipped brick units visible at some locations where stucco has been lost
- An entire section of brick (primarily on the south facade) has been lost after the fire destroyed most of the second floor wall
- In locations where stucco has fallen off, brick face appears extensively damaged
- Poor workmanship visible on the interior of part of the south wall might suggest that exterior wythes are not stable

Damaged brick face under stucco

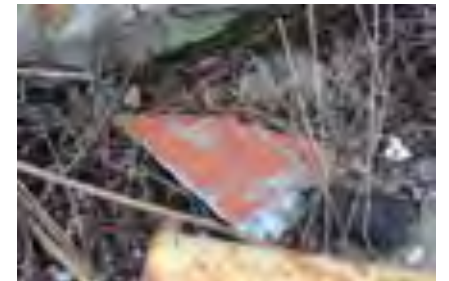
Damaged piece of stucco with brick face bonded

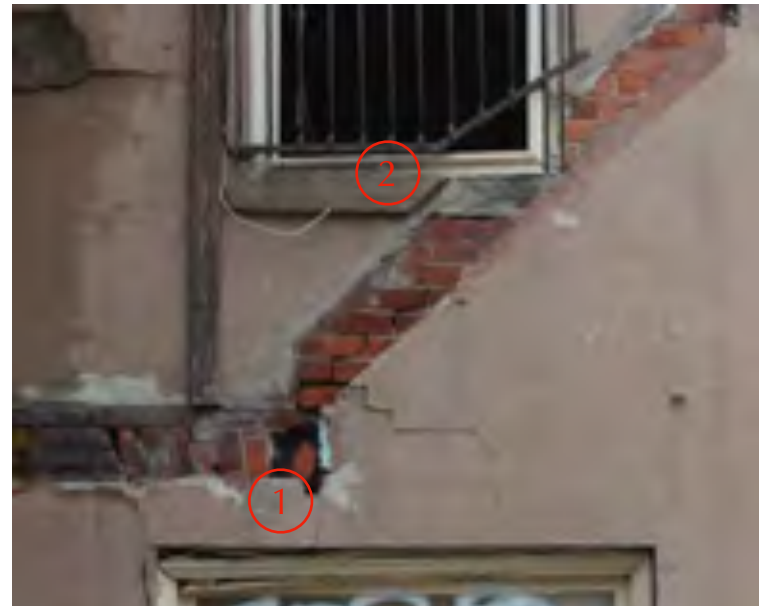
- Stone keystones over some north facade windows have been painted
- Some brick lintel arches have failed and have open mortar joints
- Areas of staining - graffiti, atmospheric soiling, bird droppings
- Some sills are cracked and damaged

Note the damaged graded brick arch lintel covered by stucco (1). Note the damaged stone sill above (2)

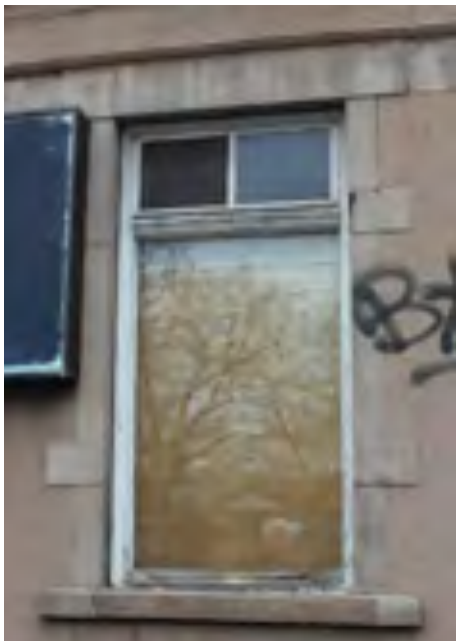
- Where visible, wood window frames are generally in fair condition with flaking paint
- The one remaining stained glass transom is in good condition
- Front door (east facade) could not be assessed due to hoarding and lack of safe access on the interior

Typical original wood window frame along the front portion of the house. Note the stain glass transom

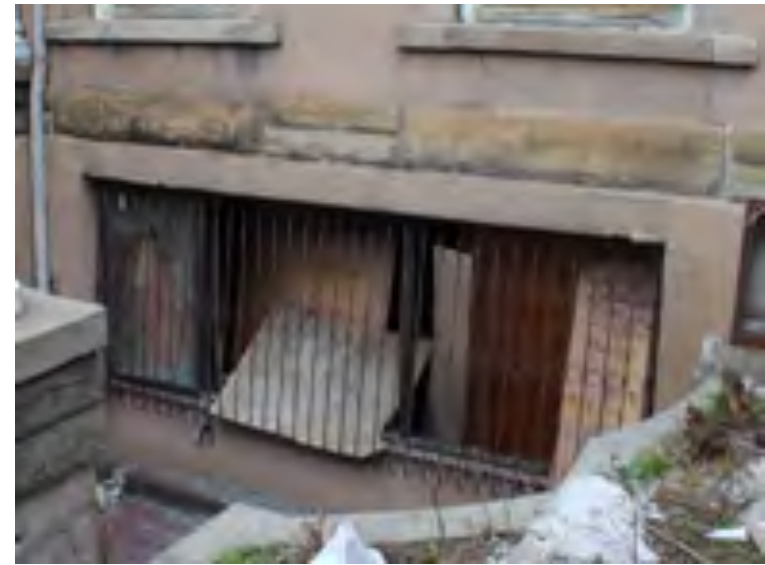
Modified basement window opening along the east facade. Note the two rock face stone lintels of the original openings.

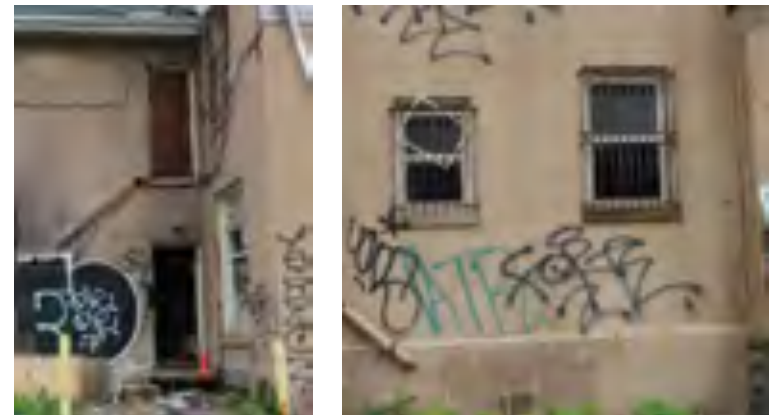
Typical windows and doors added during the 1948 renovation.

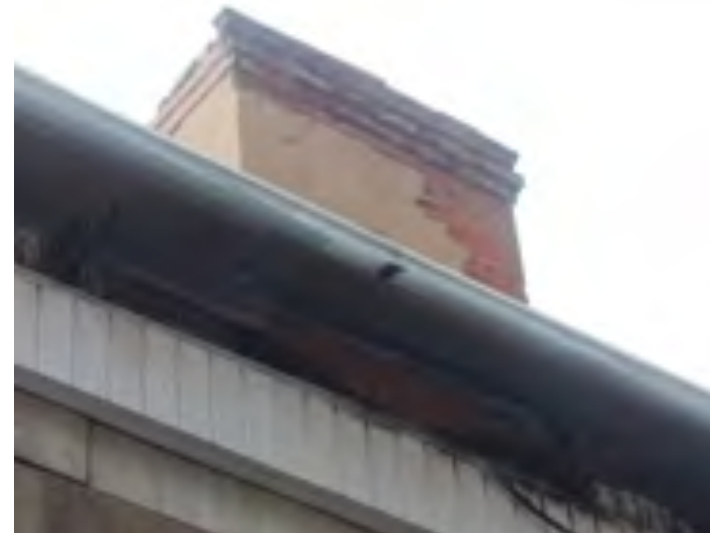
- Remnants of the north chimney are in poor condition. Bricks are deteriorated and portions of parging is in poor condition.
- The west chimney could not be assessed due to limited access and parging

North chimney note the loose bricks, damaged stucco and bricks

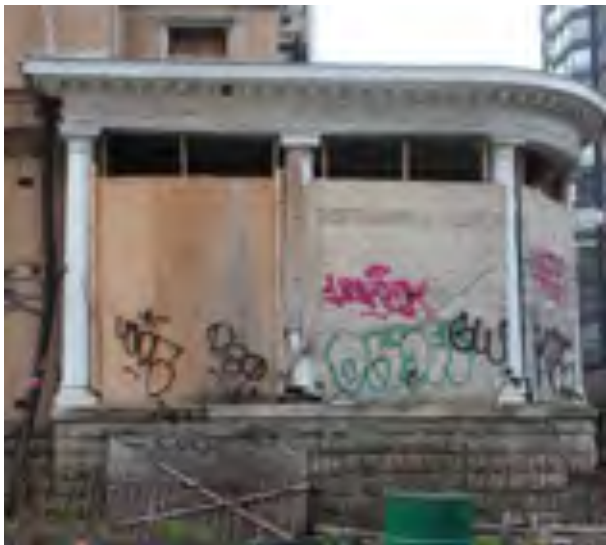
South elevation of the front porch, note the temporary hoarding

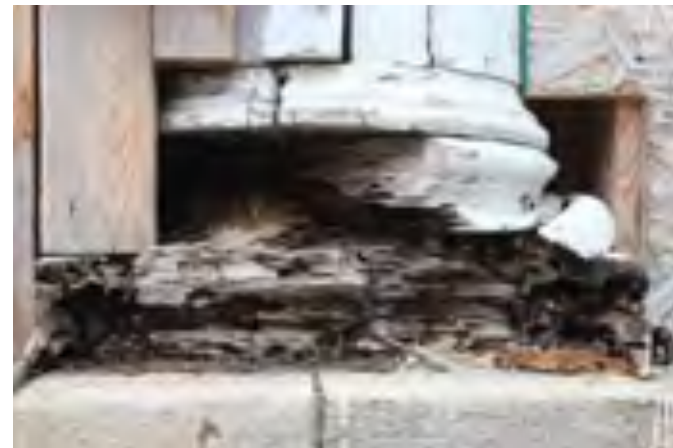
Wood rot at column base
