308-314 Jarvis Street
Toronto

(GBCA Project No: 18040.1)

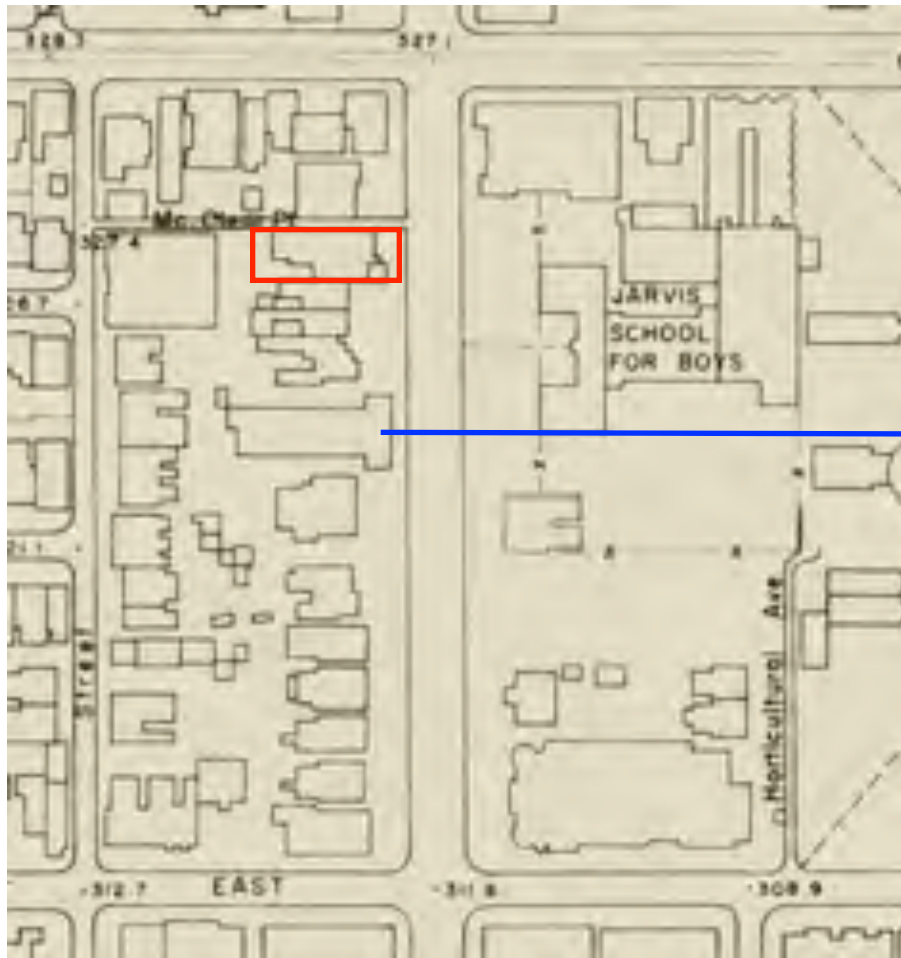
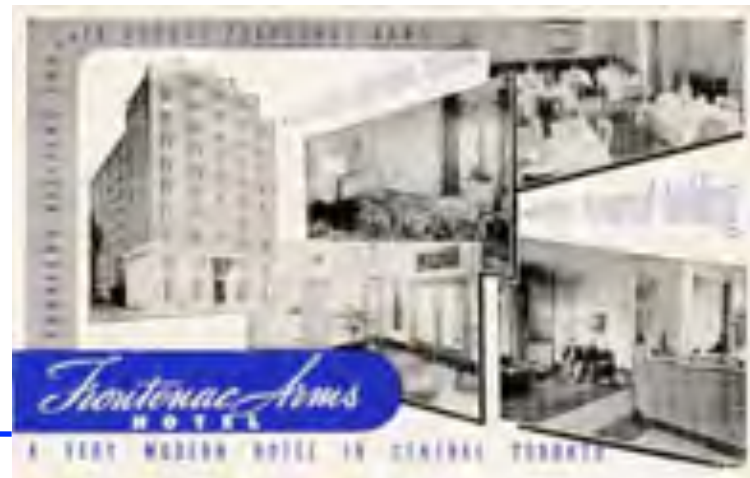
City of Toronto Planning Map, 1957-69

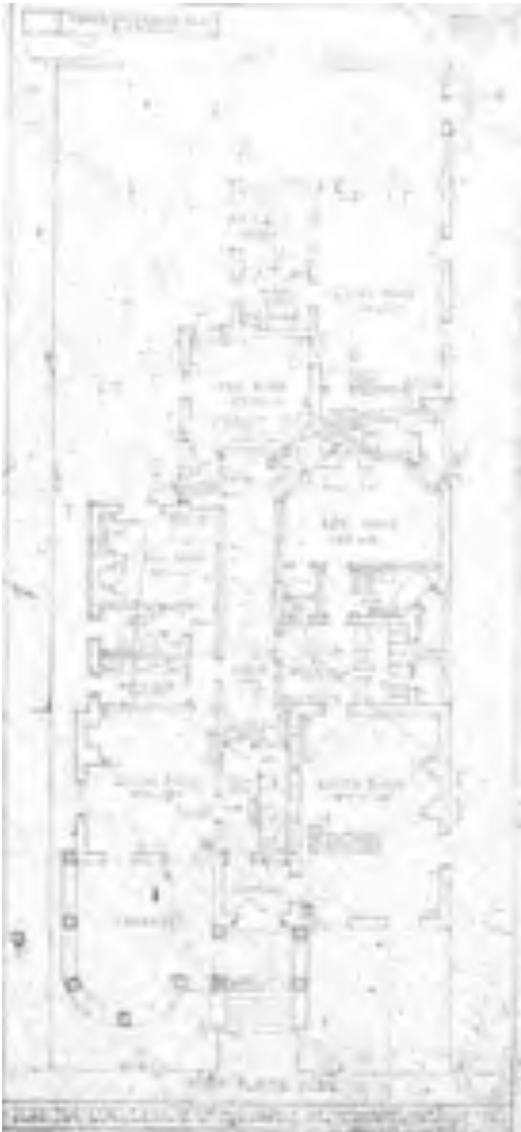
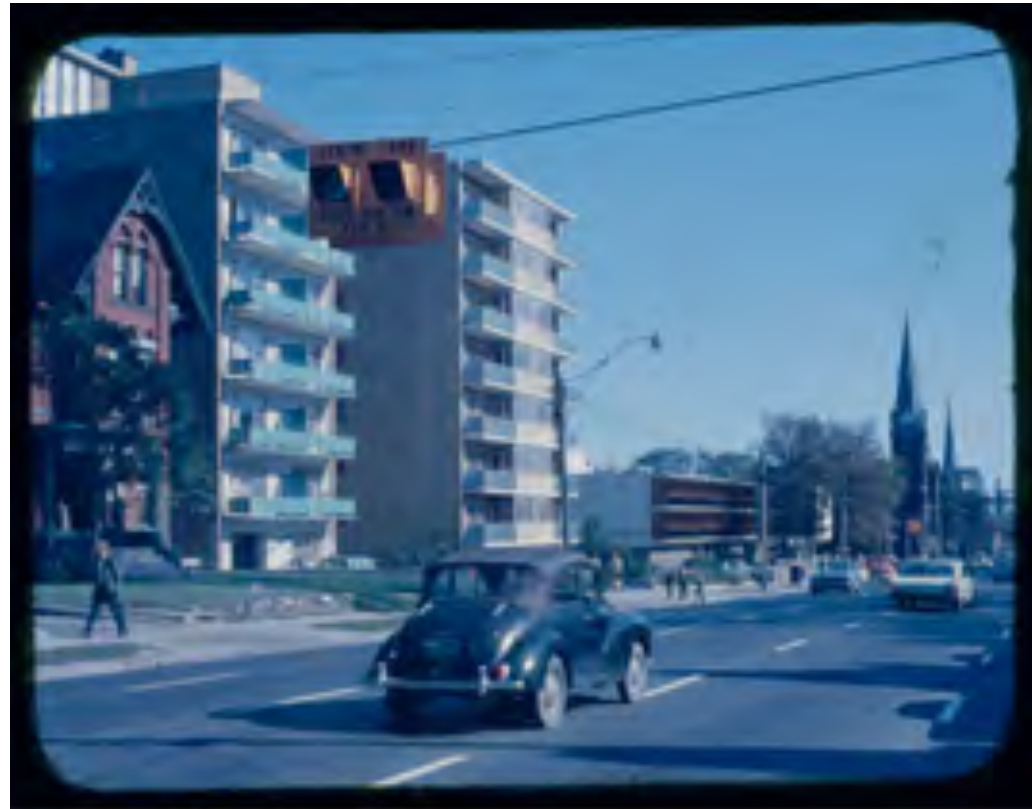
City of Toronto Archives, Photo 492, Jan 1970

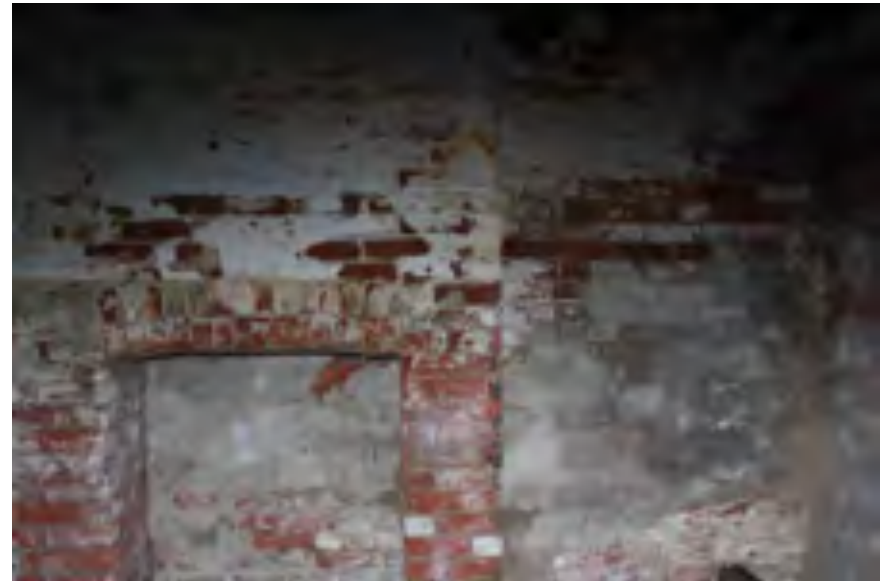
Masonry foundation wall along south facade. Note the parking, painted bricks, efflorescence buildup and fireplace

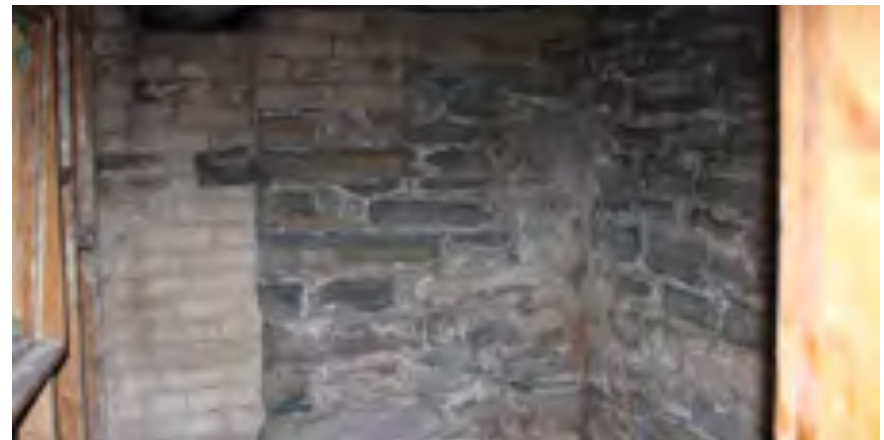
Typical rubble stone foundation wall

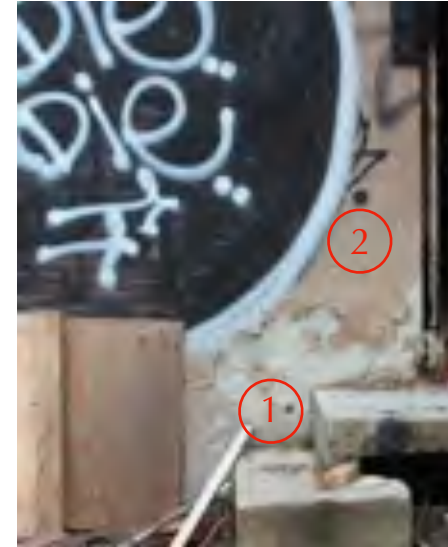
Typical stucco rendering over brick note the cement parging base (1) and pink textured rendering (2).

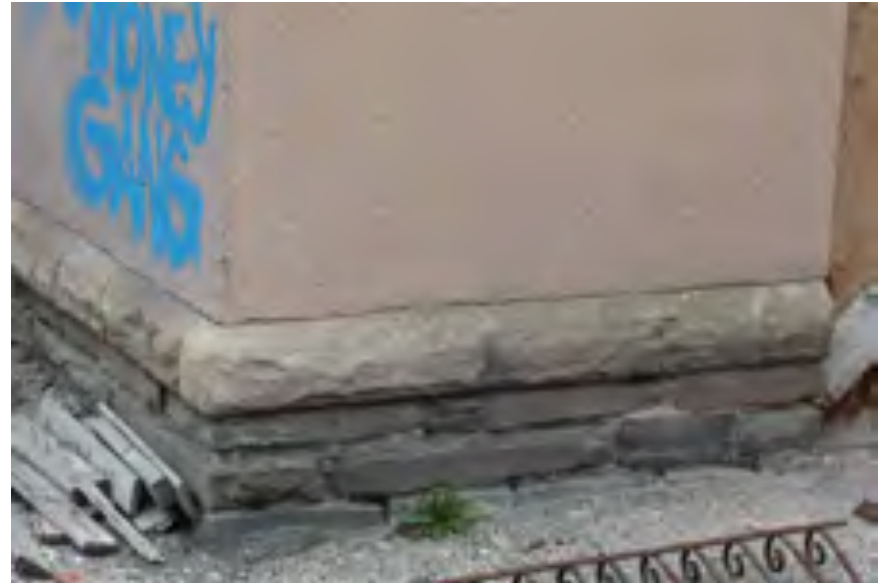
Rubble stone used along the water table of the rear addition walls

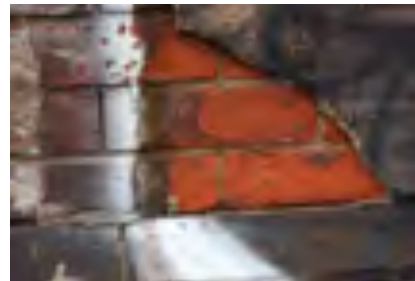
Damaged brick face under stucco

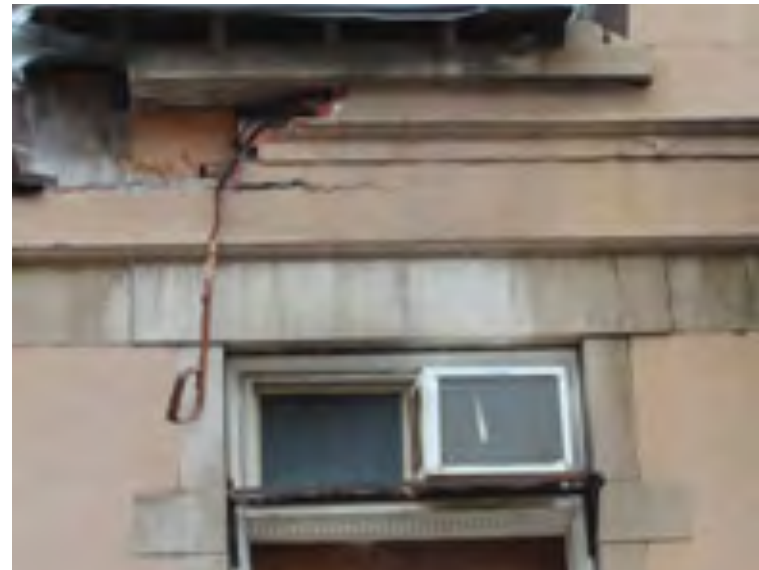
6.4 Windows and Doors

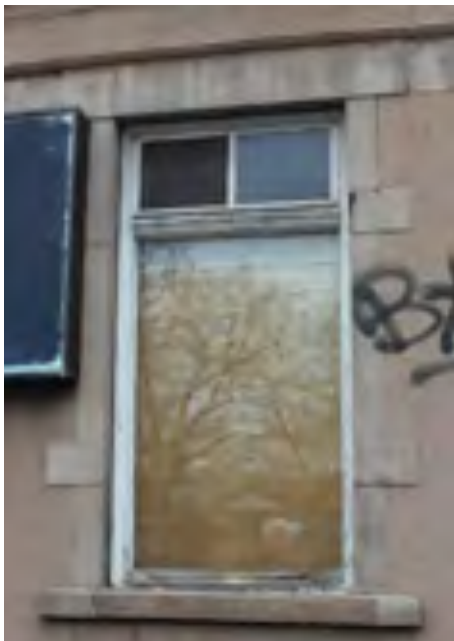
Typical original wood window frame along the front portion of the house. Note the stain glass transom

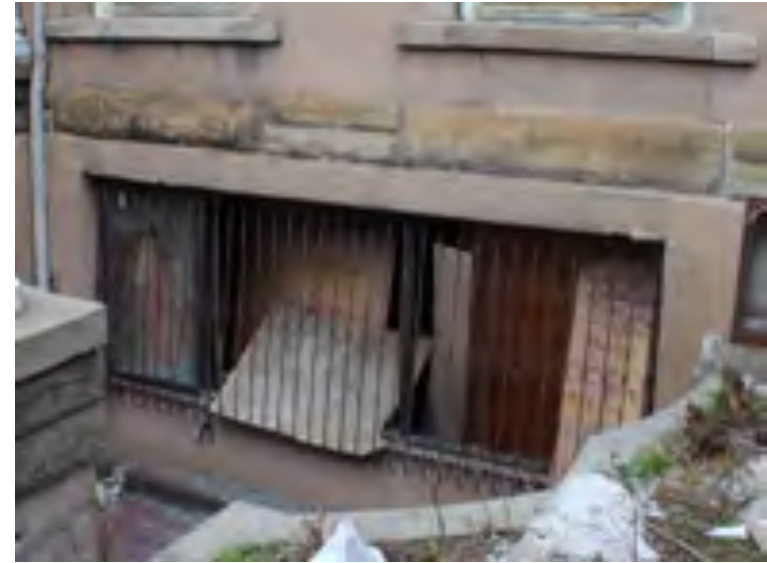
Modified basement window opening along the east facade. Note the two rock face stone lintels of the original openings.

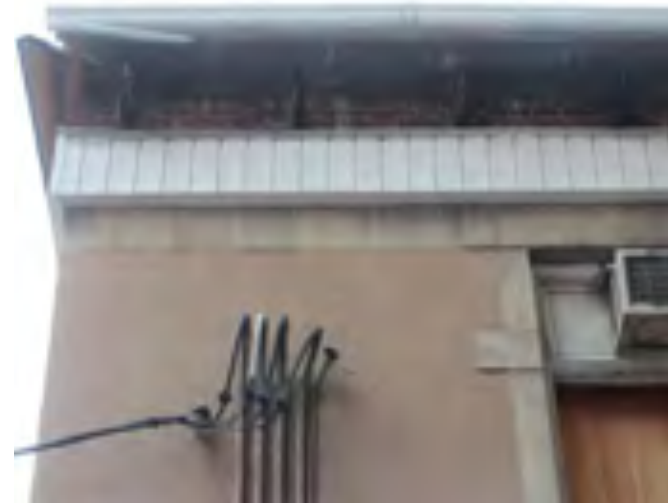
Burnt and damaged lookout rafters along the north facade. Temporary roof structure above.

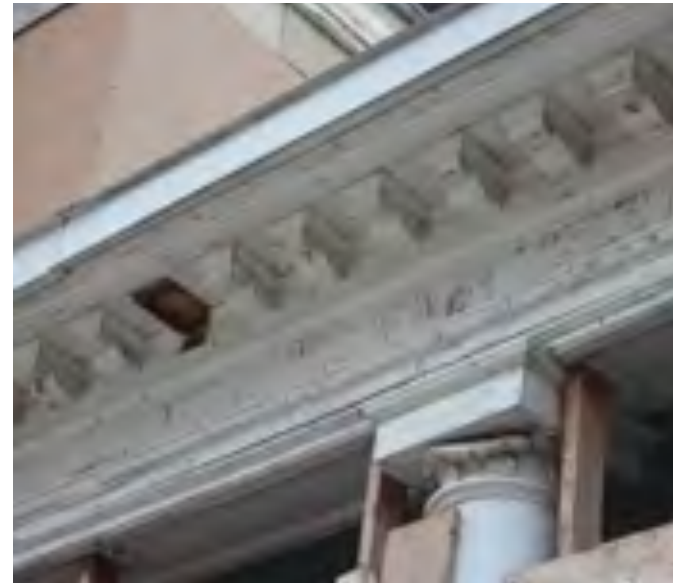
Front porch cornice. Note the flaking paint, missing bracket, improper replacement at column capital and metal flashing at top of the cornice

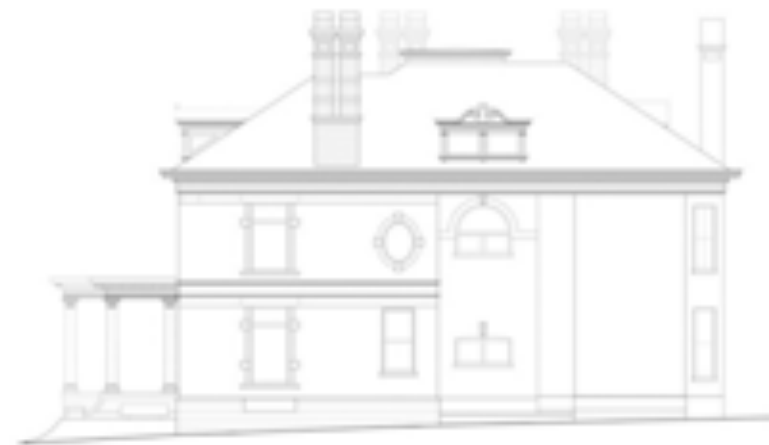
4.3.3.33 - Removing a non character-defining roof or roof element, such as a later dormer, dating from a period other than the restoration period.

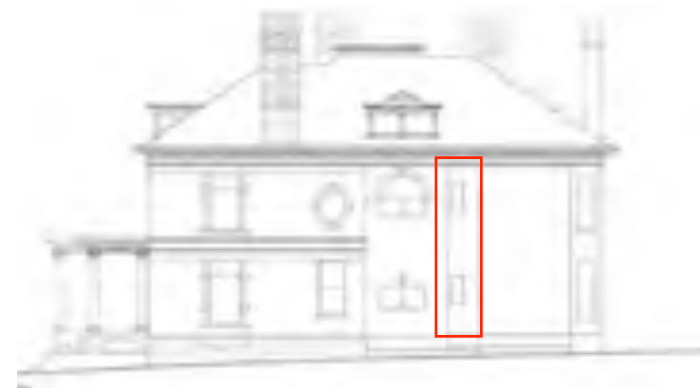
Non-original windows will not be reinstated - exterior wall will be repaired

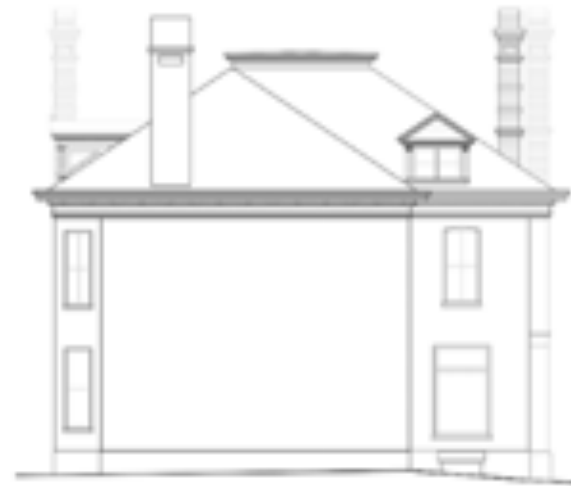
4.3.4.11 - Replacing in kind extensively deteriorated or missing parts of exterior wall assemblies where there are surviving prototypes.

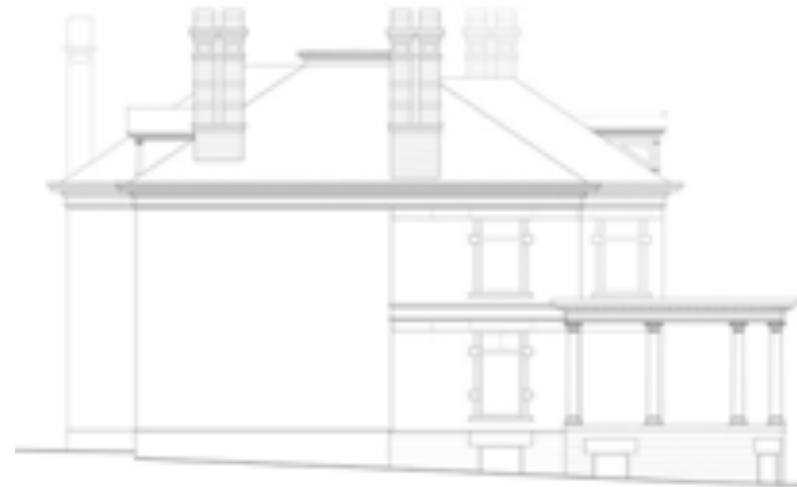
4.3.6.30 - Replacing in kind an entire entrance or porch that is too deteriorated to repair, using the physical evidence as a model to reproduce the assembly.

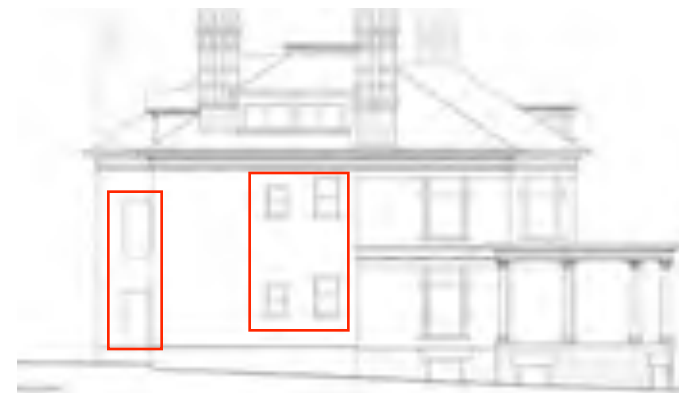
Non-original windows, doors and dormer window will not be reinstated - exterior wall and roof will be repaired

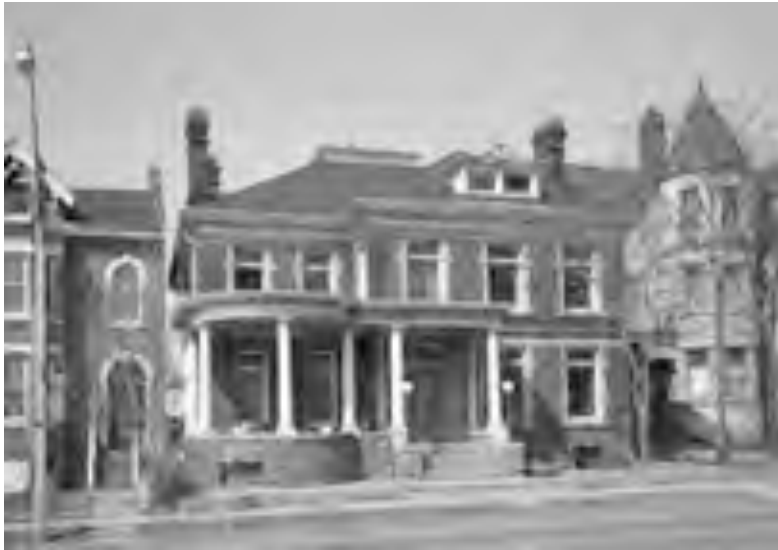
1970s - the house prior to the application of an exterior stucco

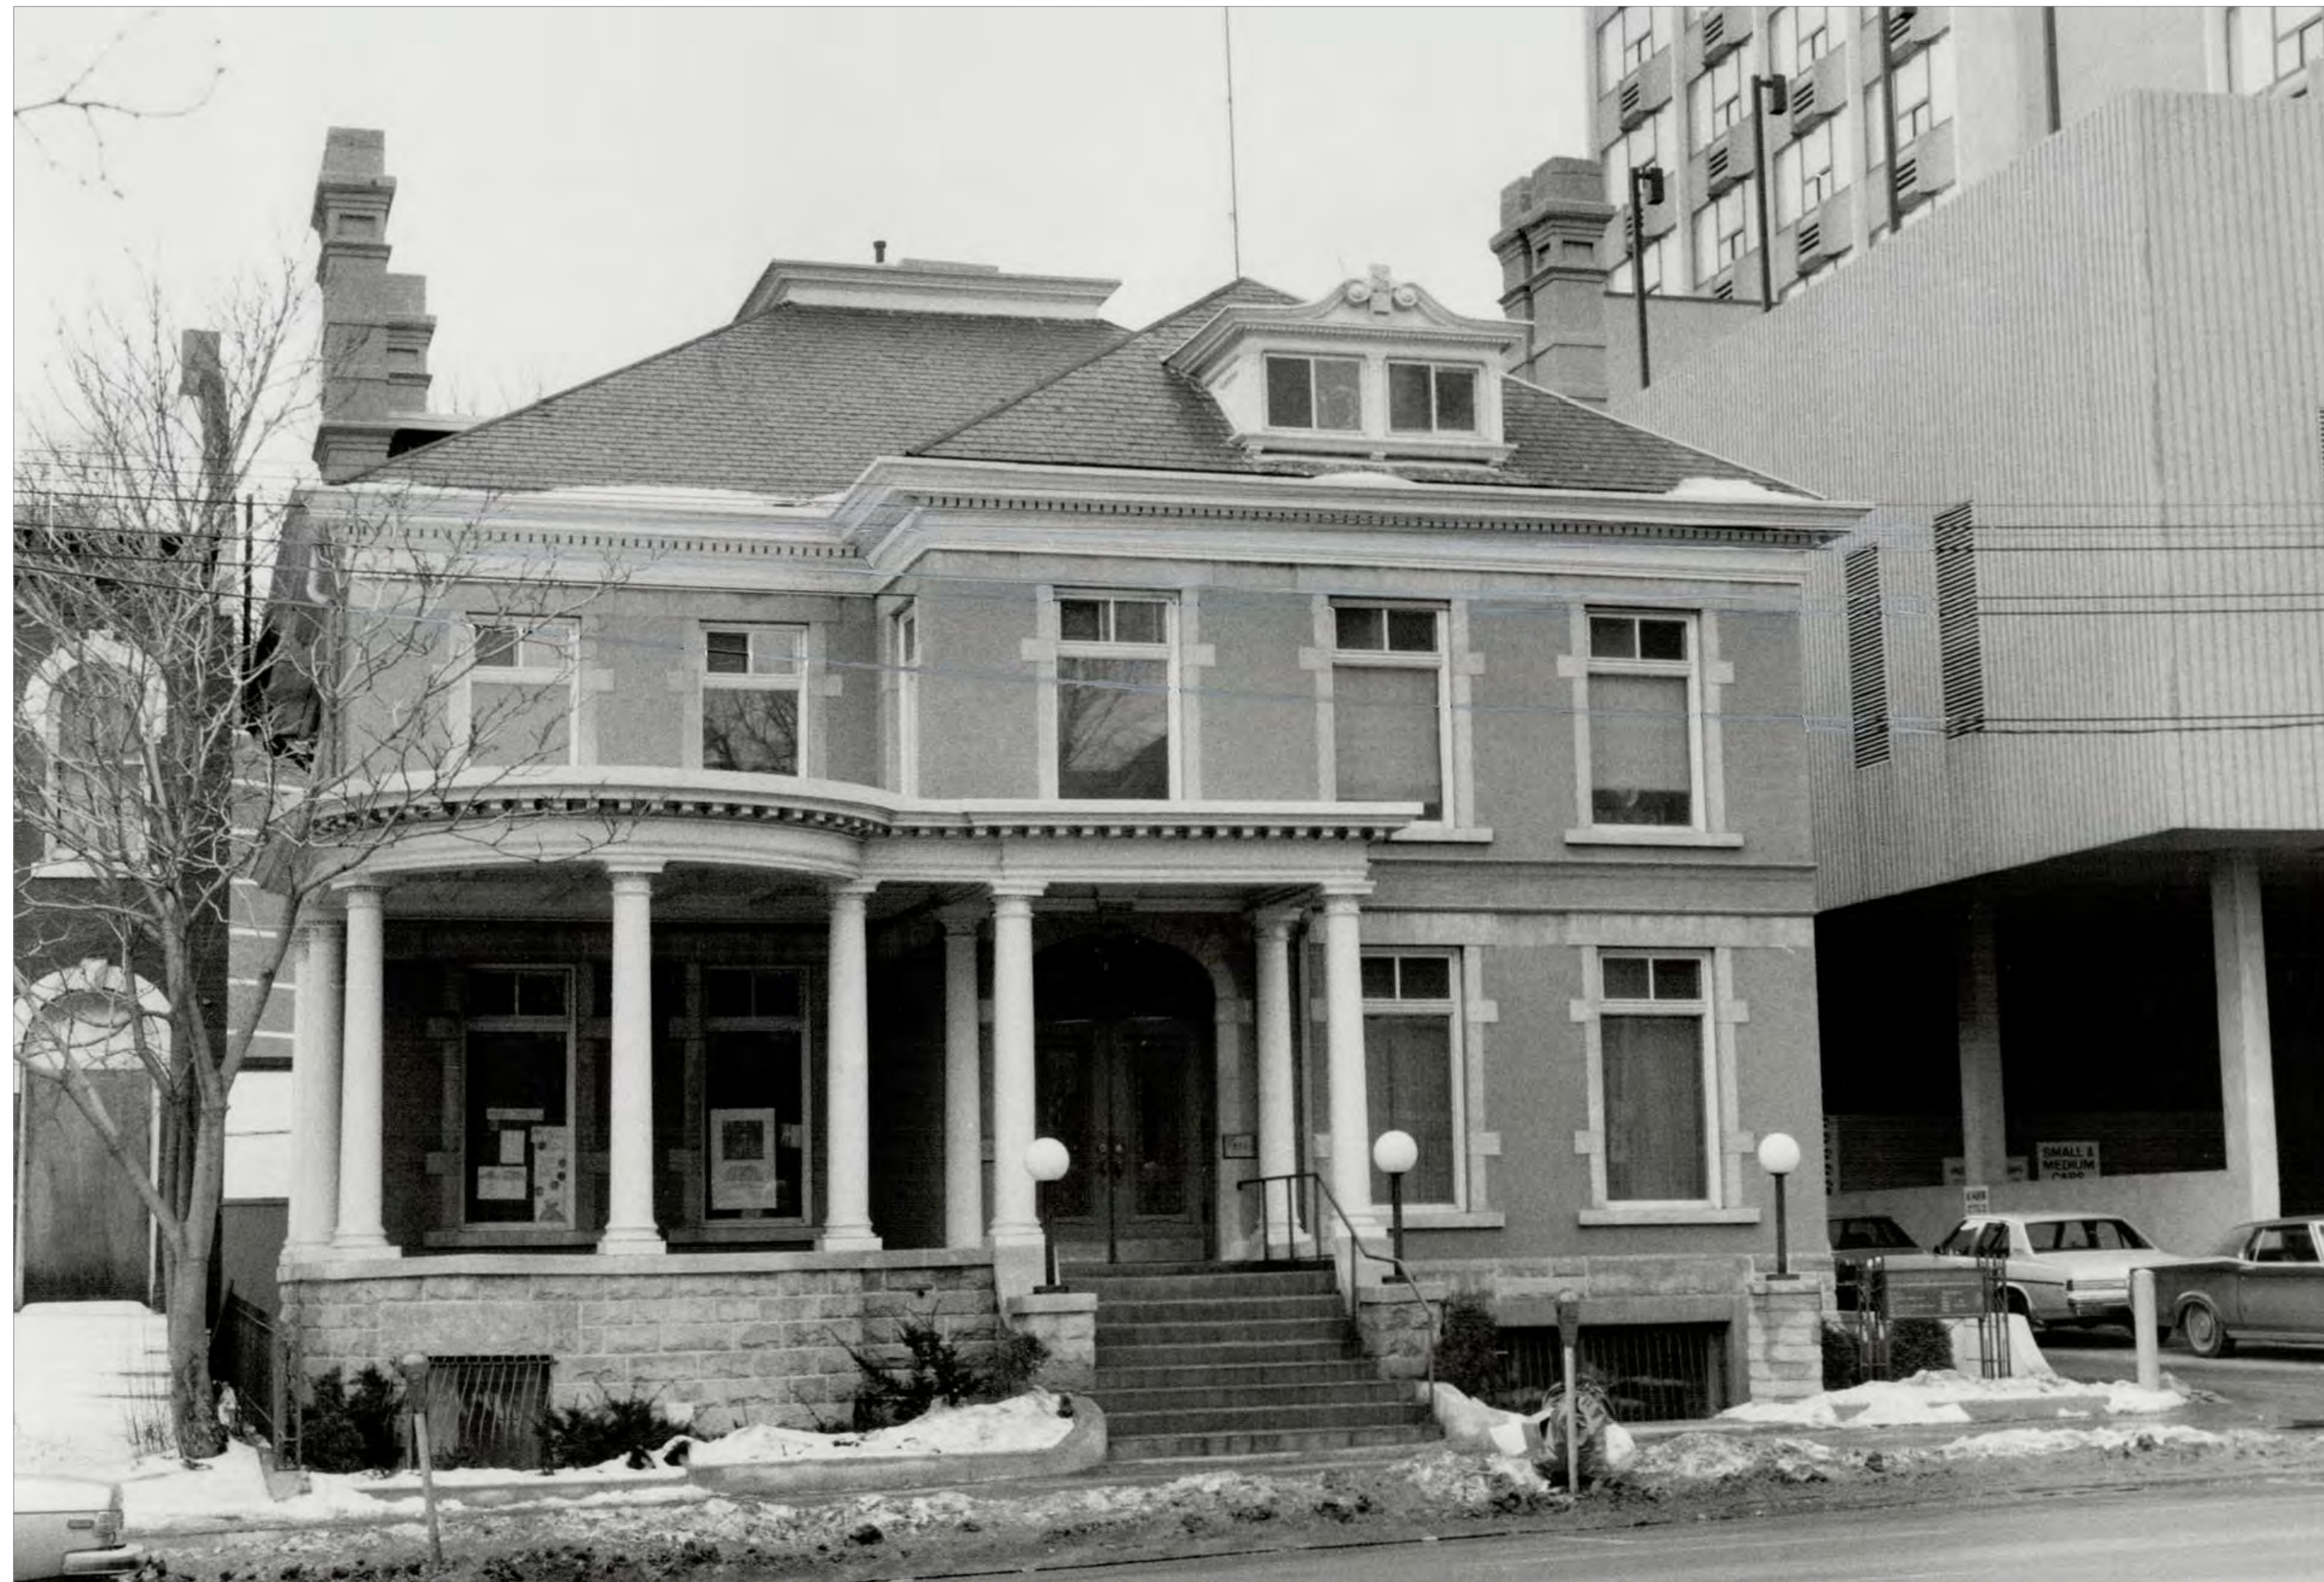
TORONTO, ONTARIO
BUILDING ASSESSMENT

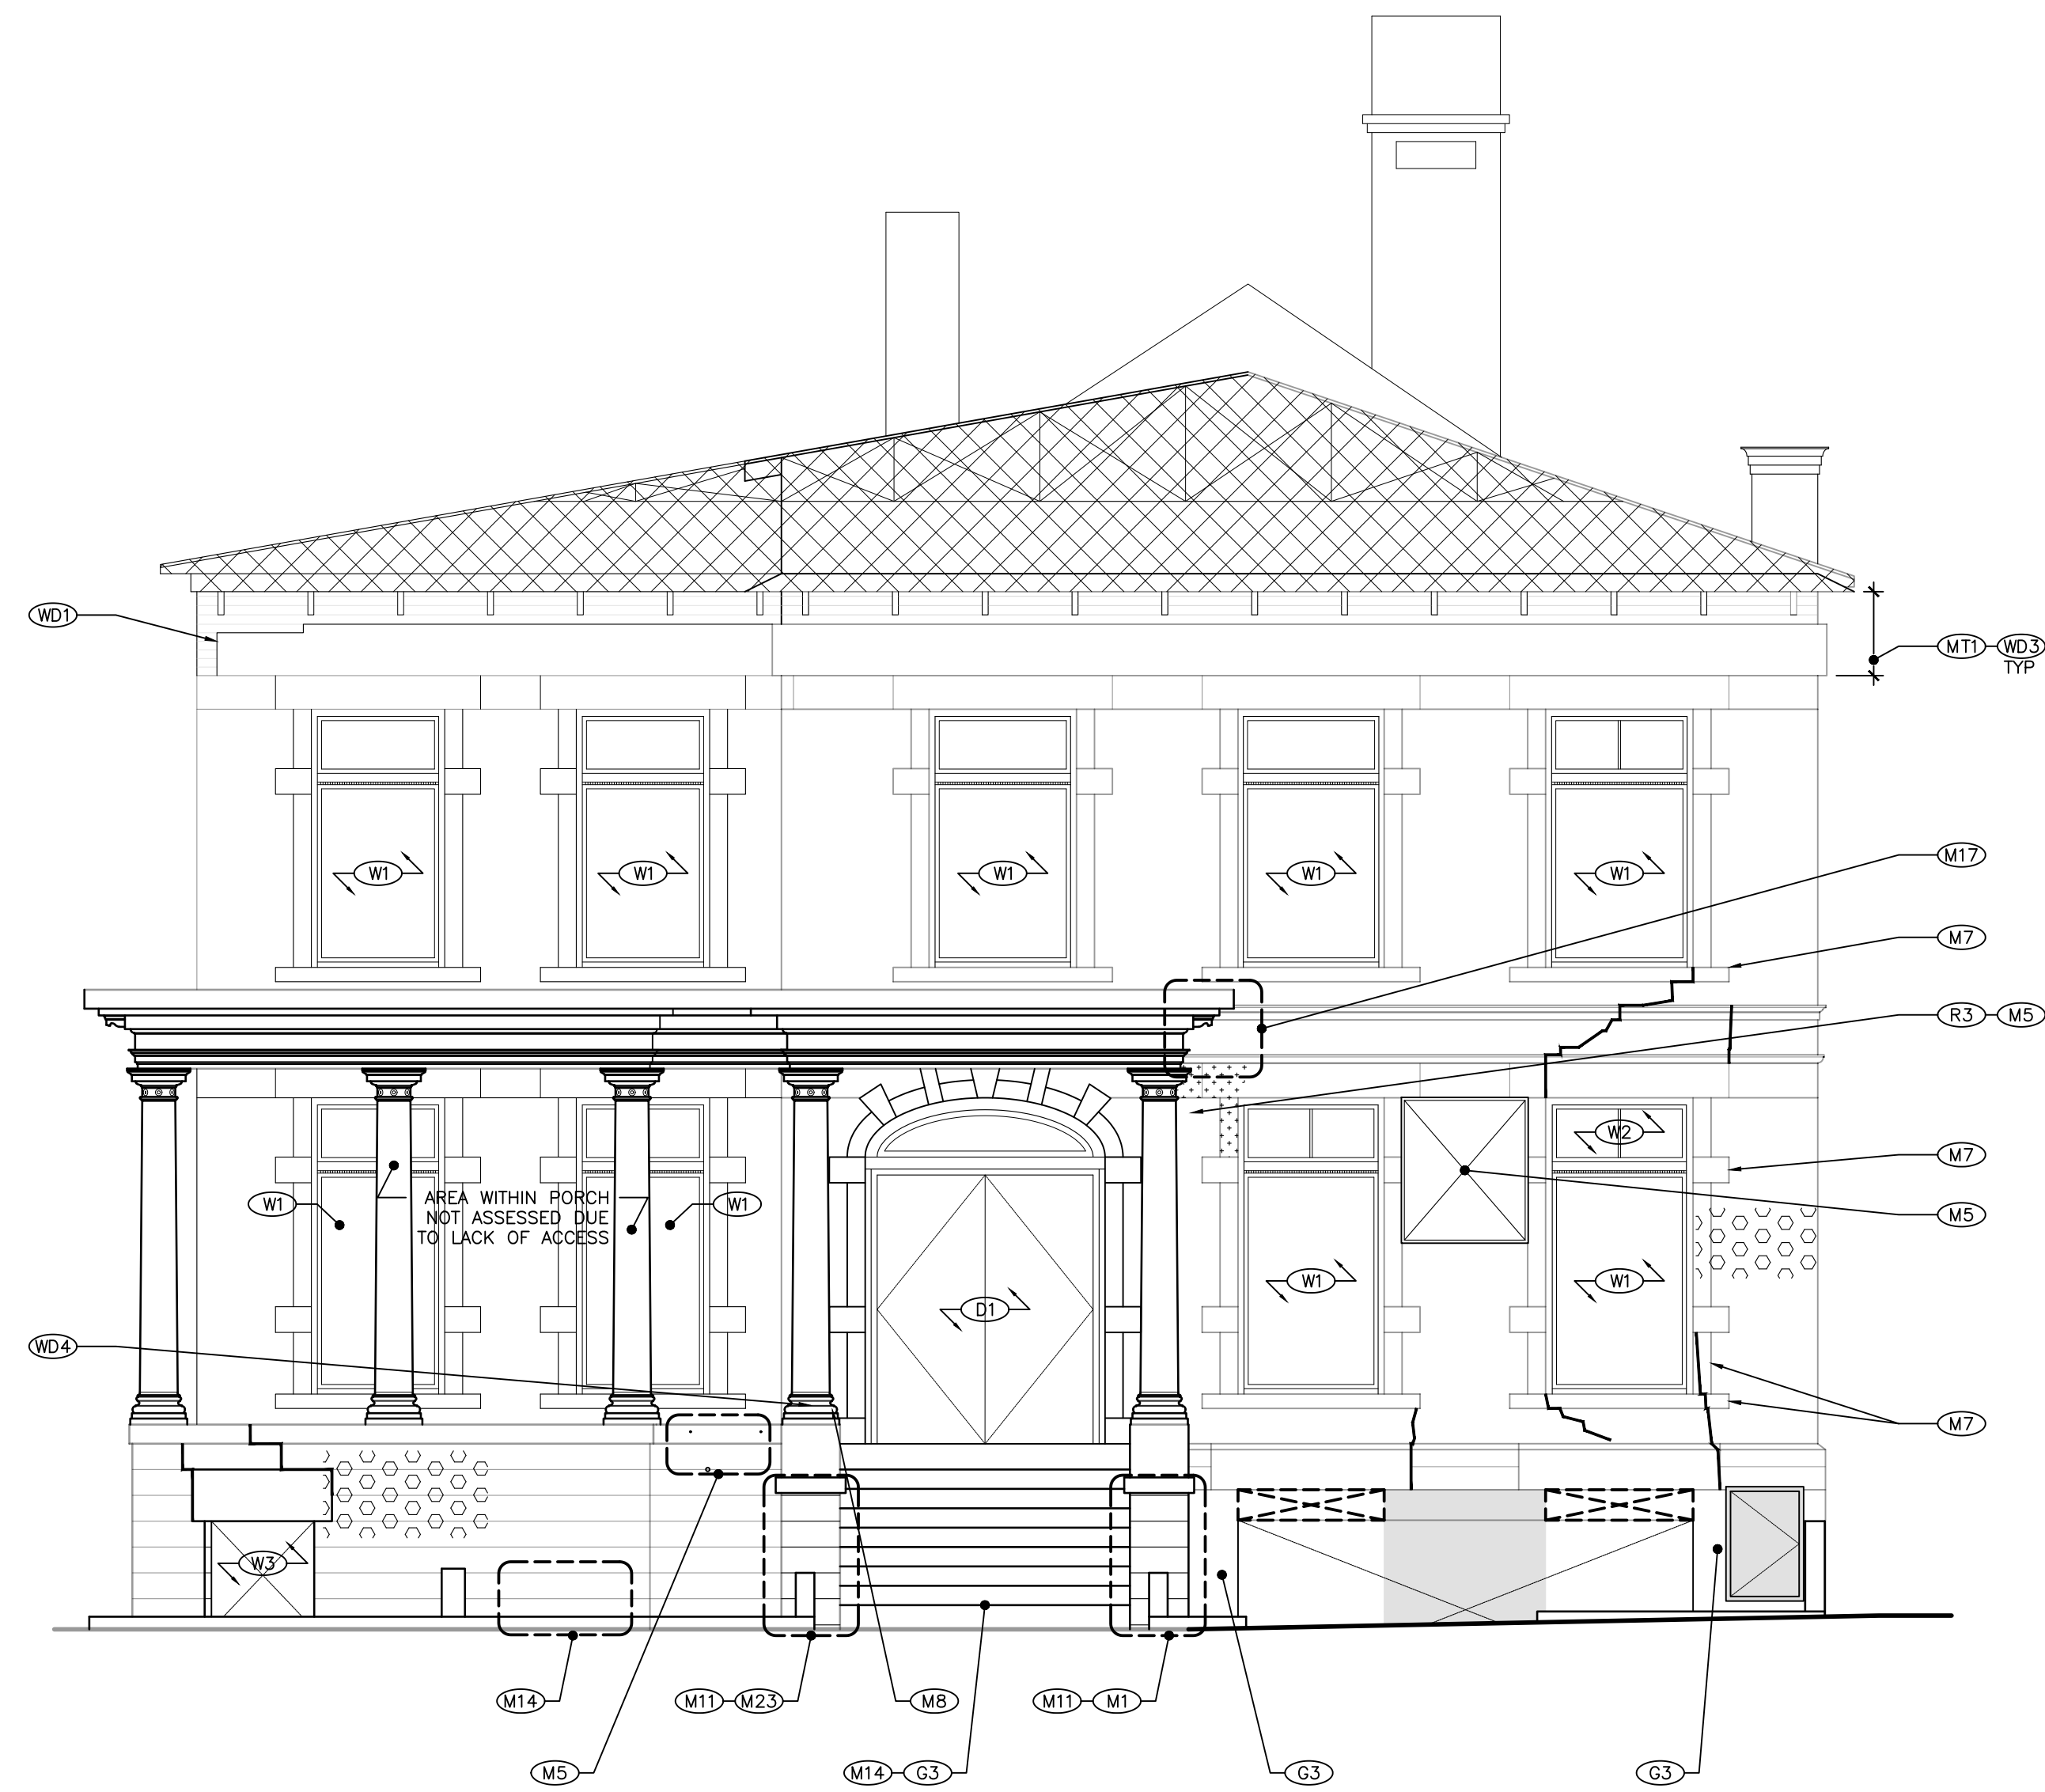
01 EAST ELEVATION CONDITION ASSEMENT (314 JARVIS)
SCALE: 1/50

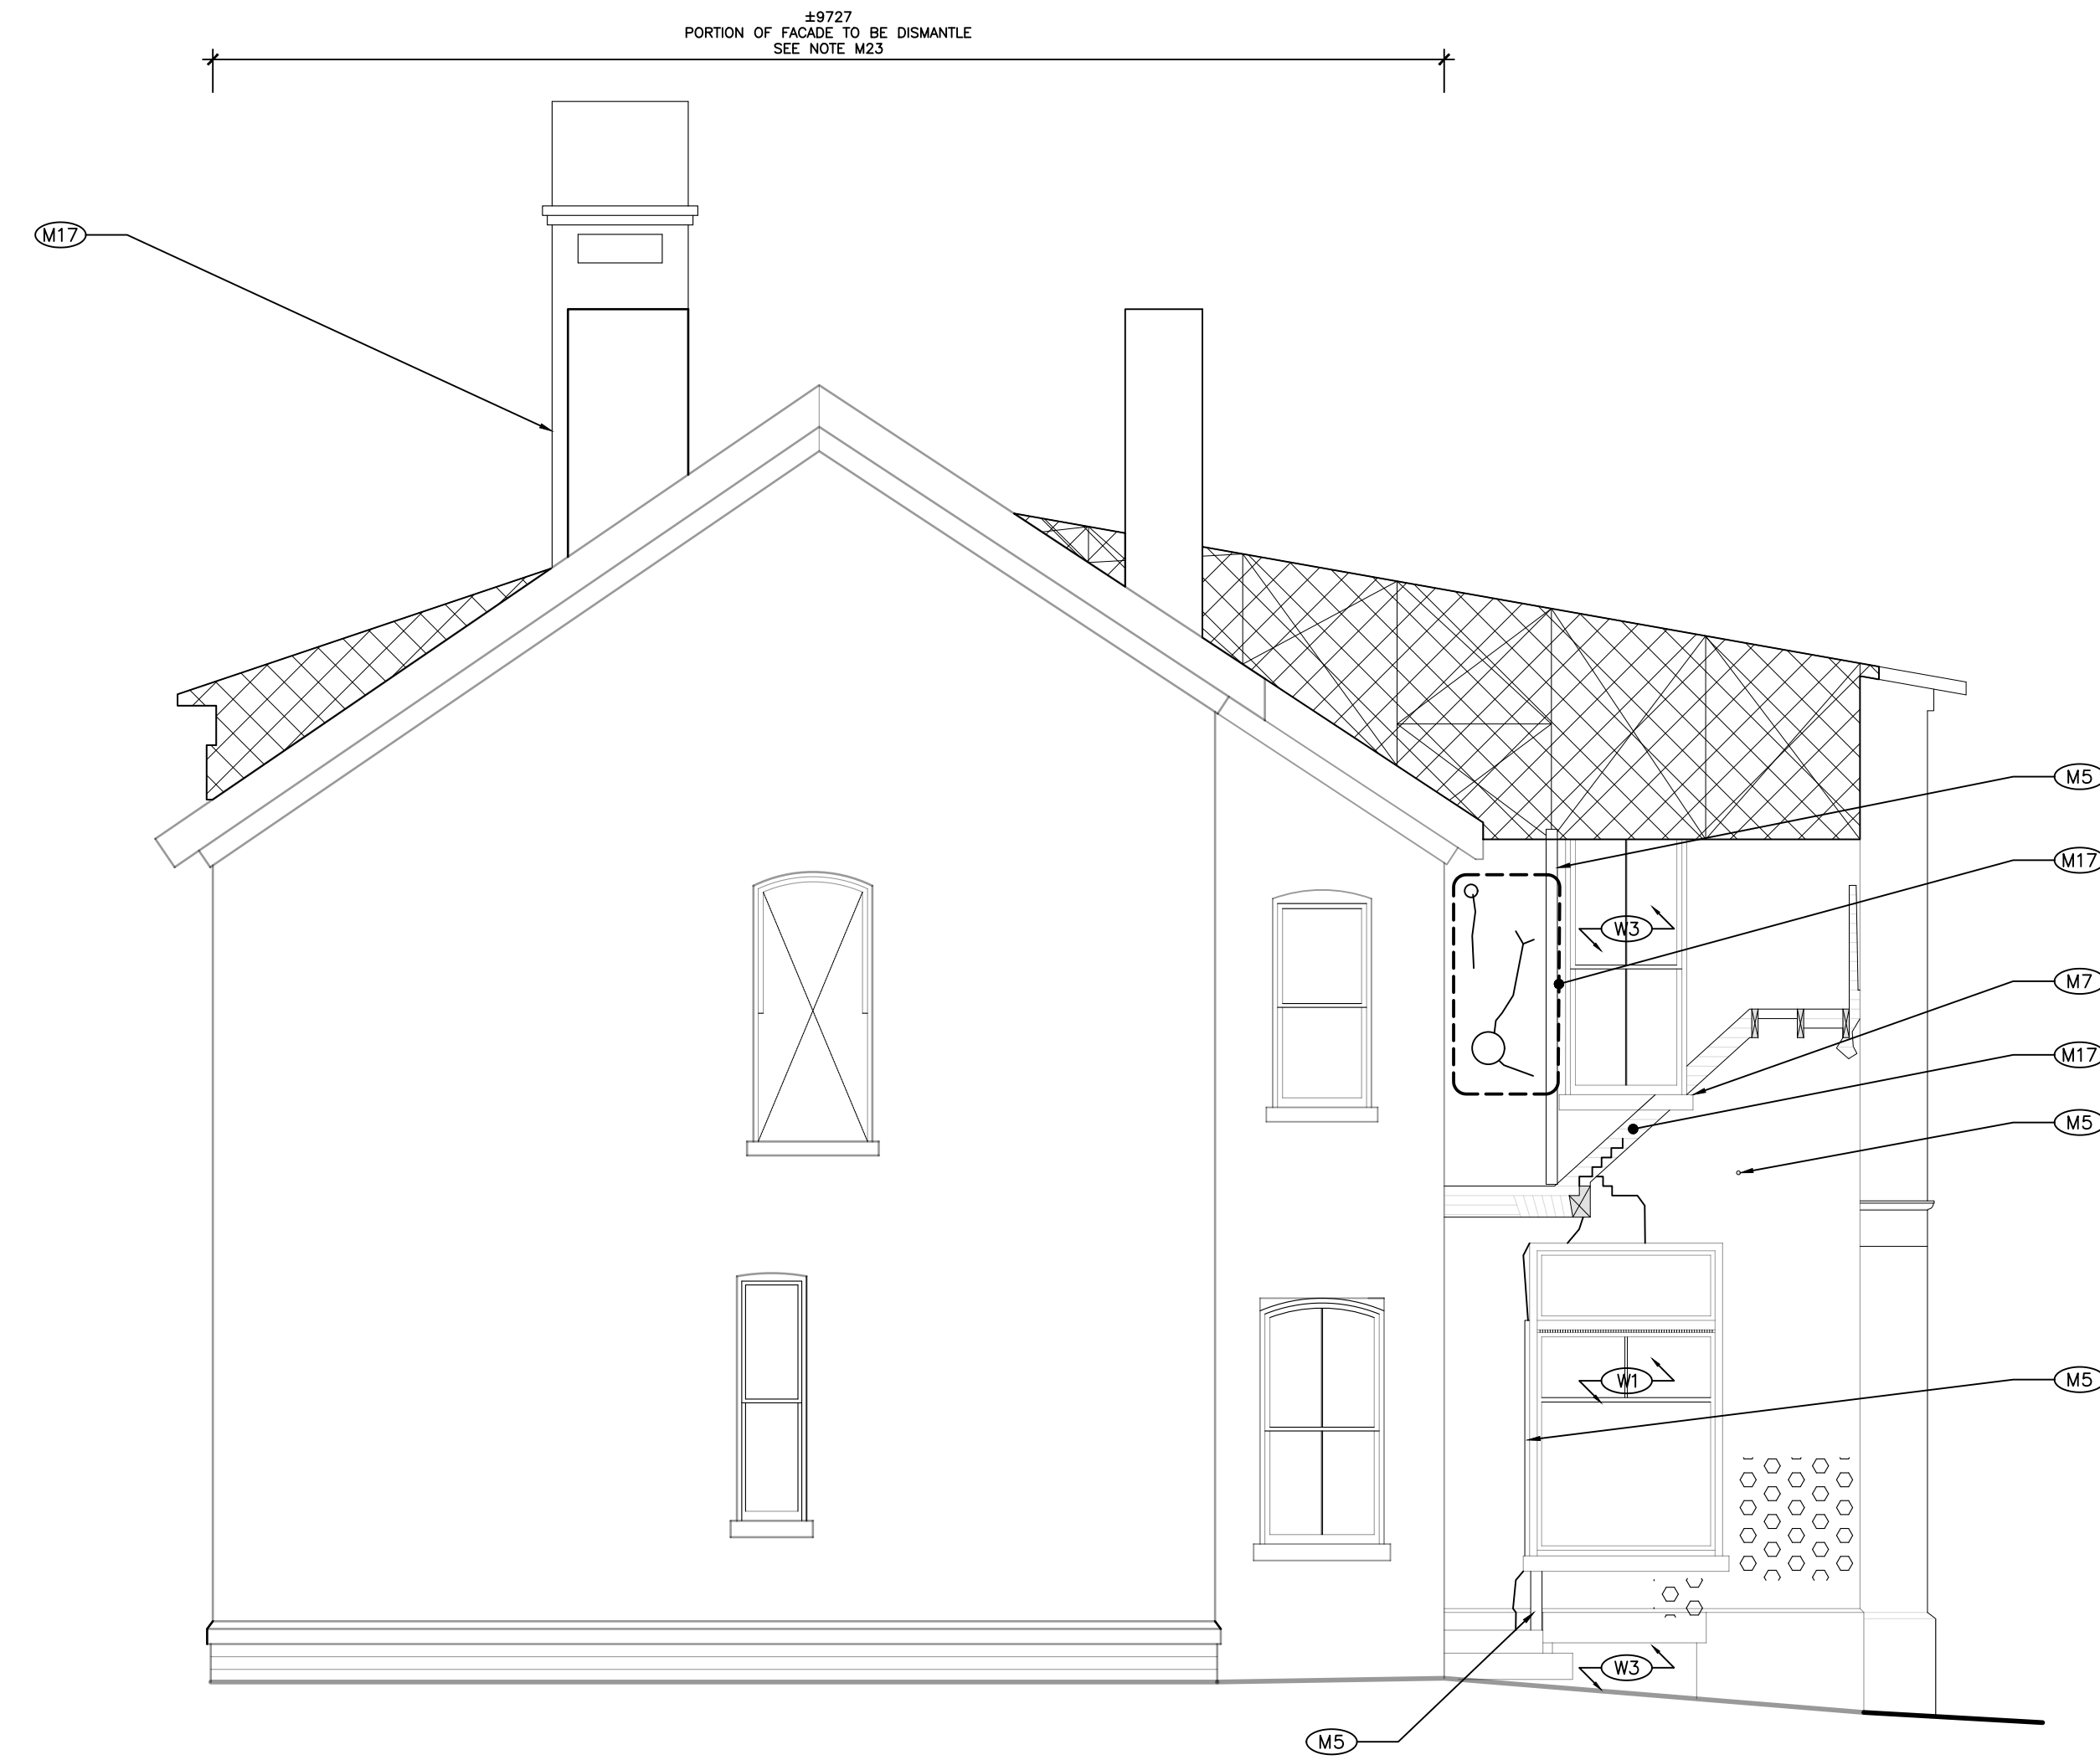
02 WEST ELEVATION CONDITION ASSEMENT (314 JARVIS)
SCALE: 1/50

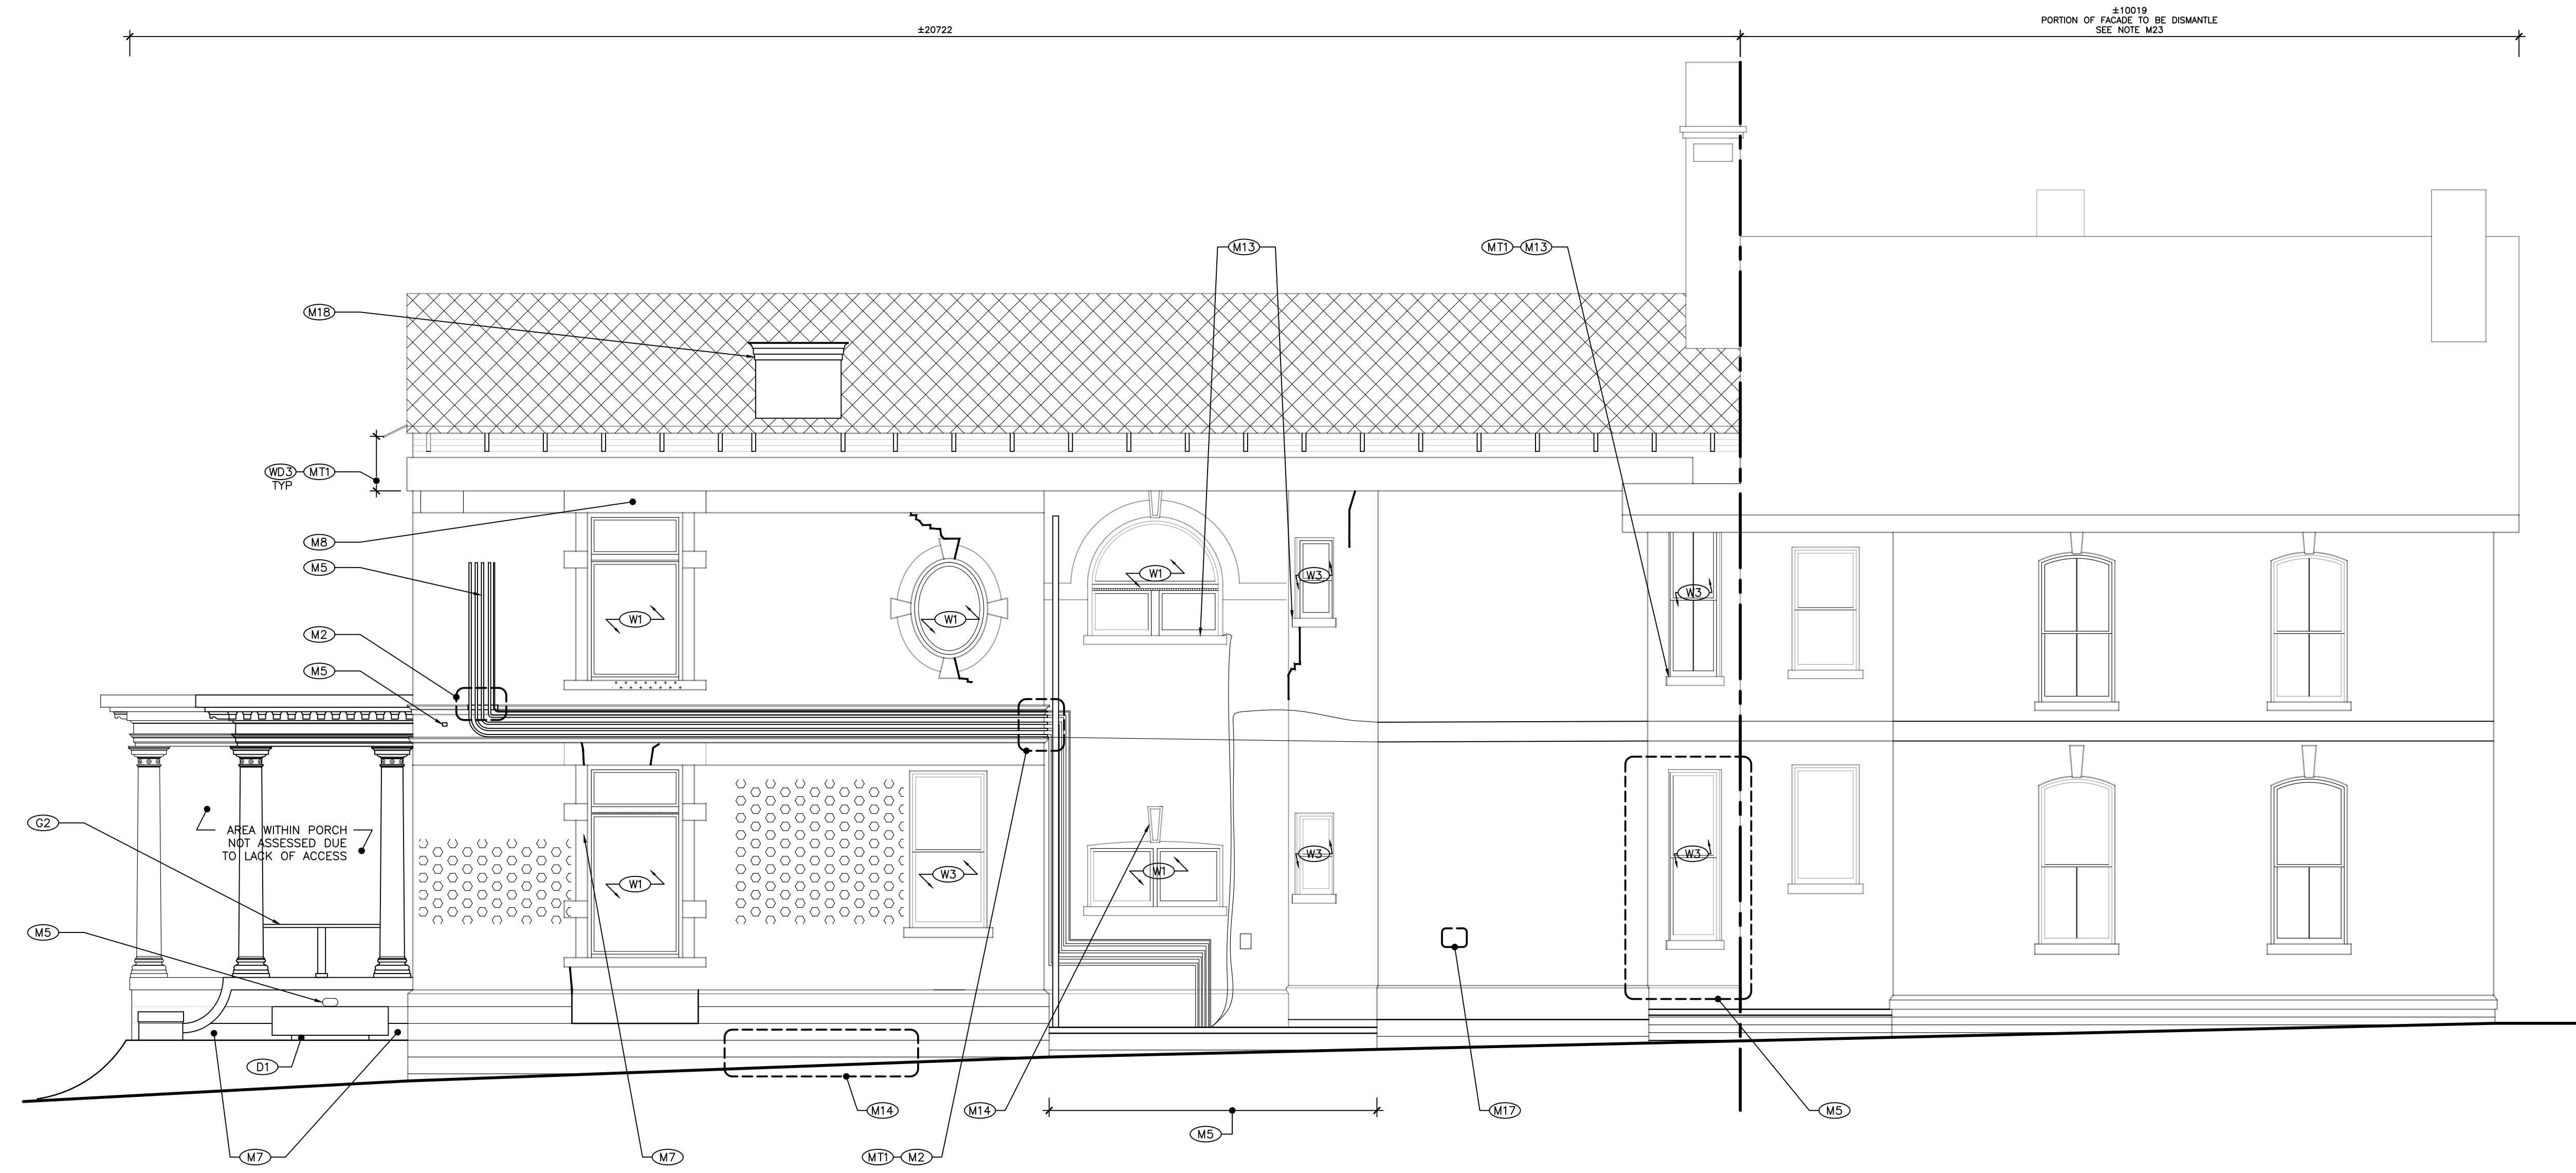
01 NORTH ELEVATION CONDITION ASSEMENT (314 JARVIS)
SCALE: 1/8"
