308-314 Jarvis Street
Toronto

(GBCA Project No: 18040.1)

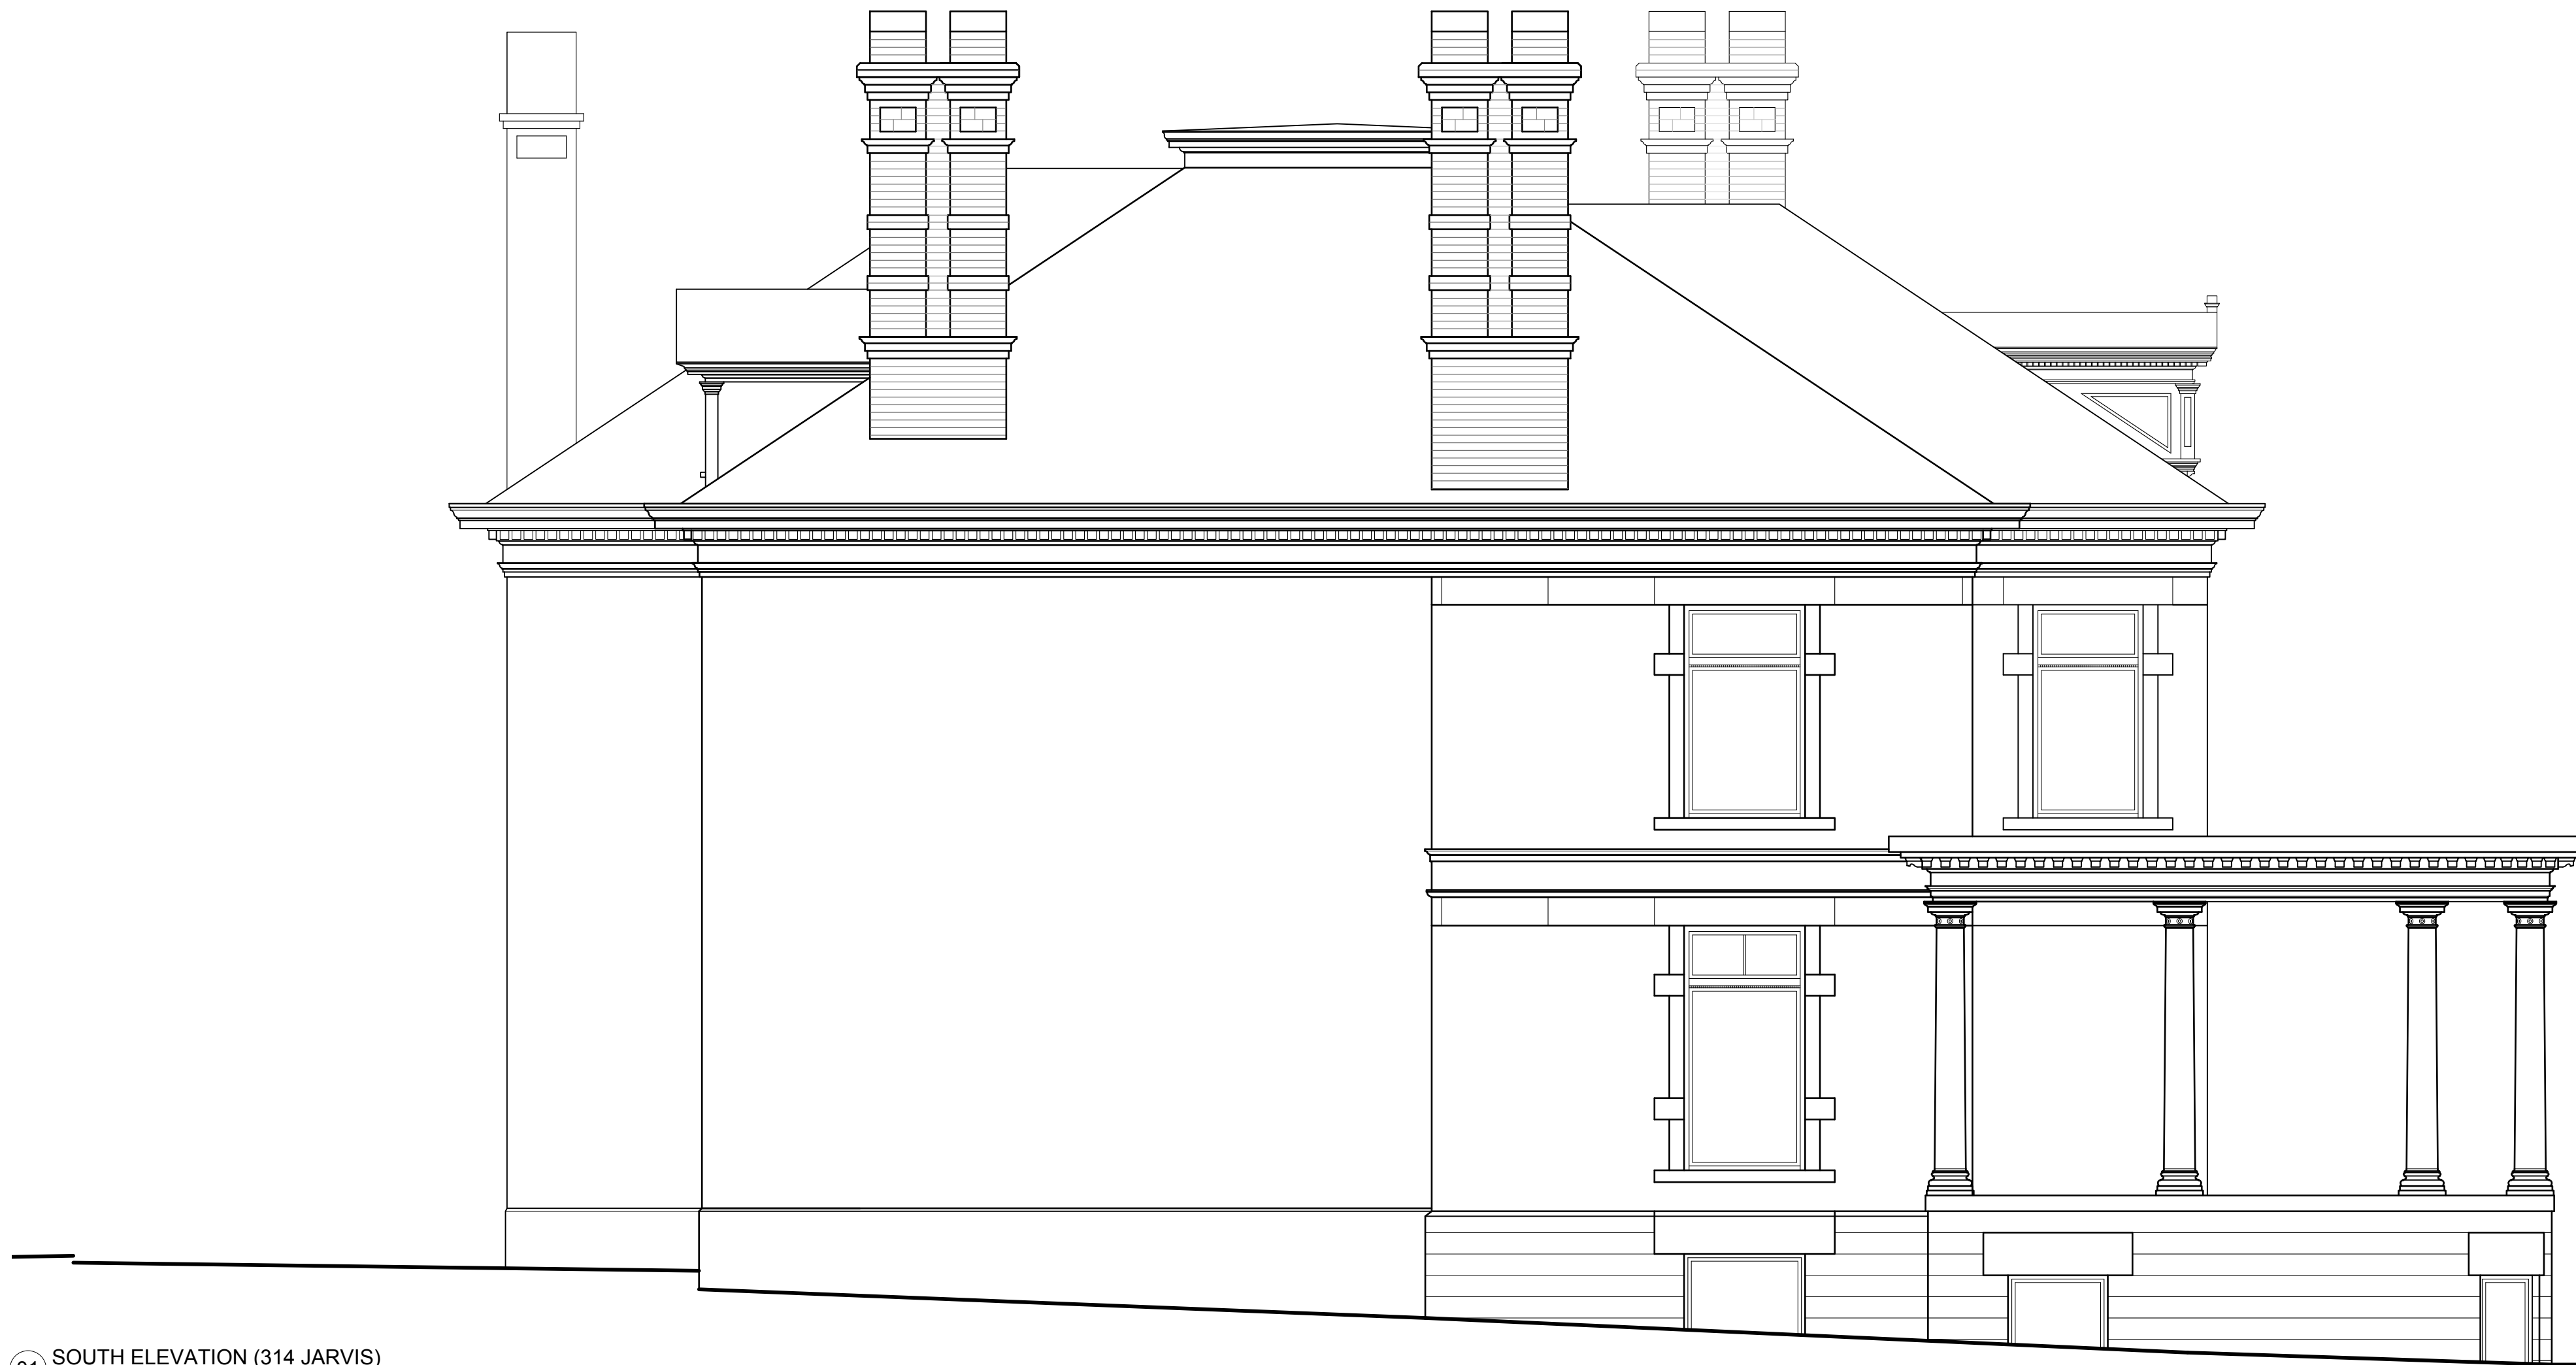
01 SOUTH ELEVATION (314 JARVIS)
SCALE: 1/50
