8.2 Impact Mitigation Strategy

APPENDICES

A Condition Assessment

11.2.1 West Elevation

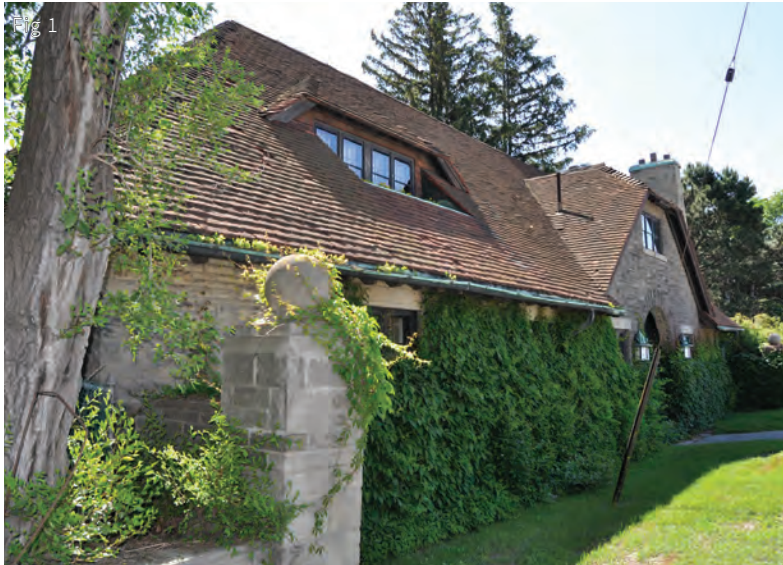
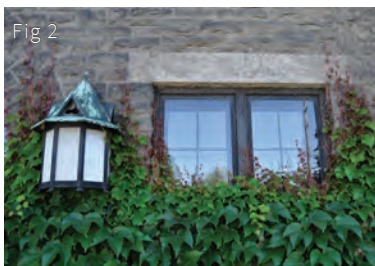
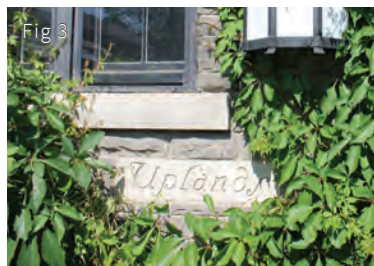
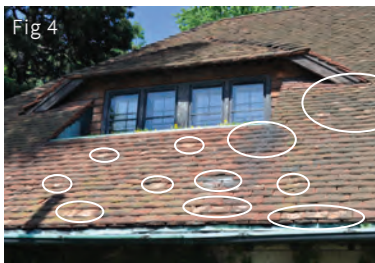
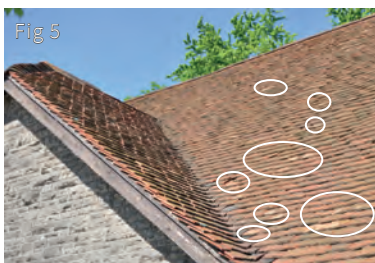
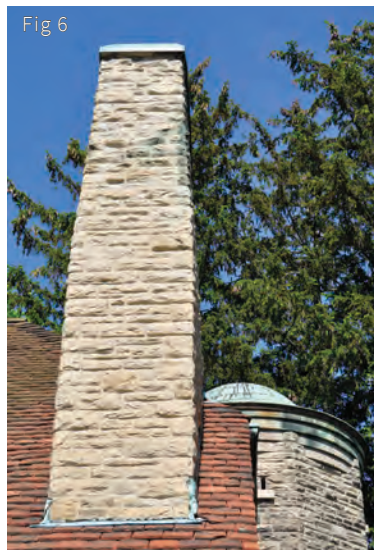
- Vines covering most of west elevation exterior masonry walls made assessment difficult; however, exposed Credit Valley stone wall in overall good condition (Fig 1).
- Masonry lintel and sills at openings in good condition (Fig 2, 3).
- Granite gate "bumpers" on either side of arched opening covered in vines. Corresponding east elevation "bumpers" in good condition.
- Terracotta roof in fair condition (Fig 4, 5). Localized spalling, missing tiles, and discolouration on select areas, especially on northern half of roof (Fig 4).
- Credit Valley chimney in fair to good condition, with some staining/discolouration from copper flashings (Fig 6).
- Inset stone lettering on north side of arched gate opening reading "Uplands" in good condition (Fig 3).

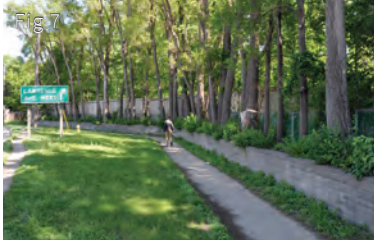
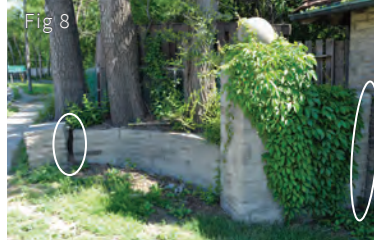
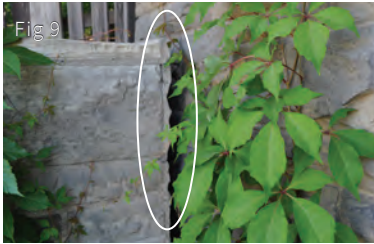
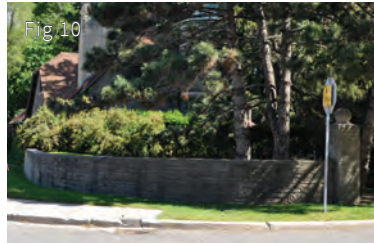
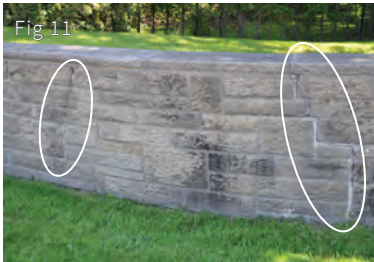
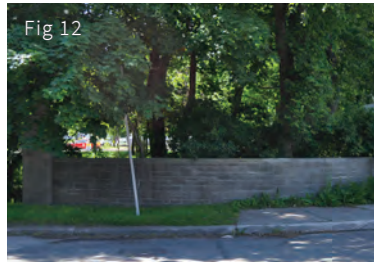
- Section of stone retaining wall running north-south to north-west corner of house in overall poor condition. Advanced age of elms behind retaining wall at this location has pushed the wall out of plumb (Fig 7).
- At north-west corner of house, retaining wall in poor condition (Fig 8, 9). Masonry has deflected significantly at corner and where wall meets the house (Fig 9).
- Section of retaining wall south house on north corner of intersection in fair condition, with some localized cracking (Fig 10, 11).
- Section of retaining wall on south corner of intersection in good condition (Fig 12).

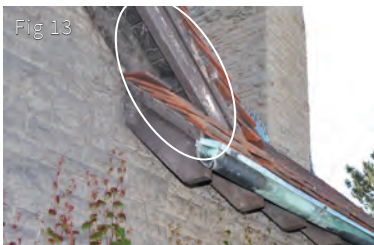
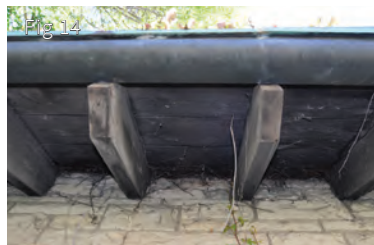
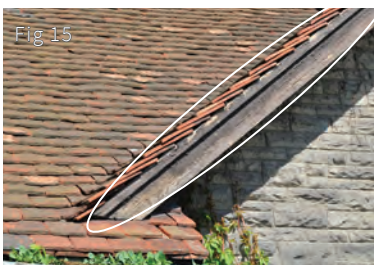
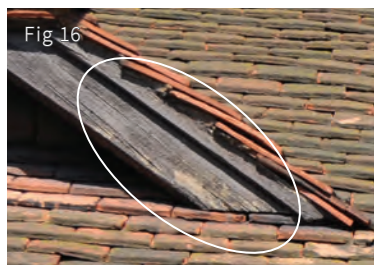
- Wood overhang, fascia, and brackets are deteriorating and in poor to fair condition (Fig 13-16).
- Paint is flaking and there is localized damage to wood substrate, particularly at cut ends (Fig 15, 16).

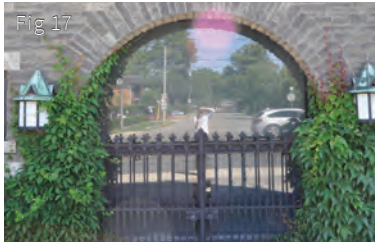
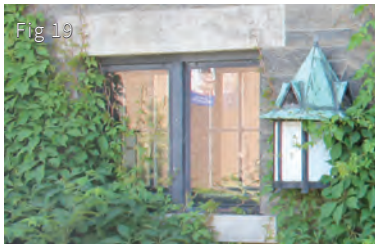
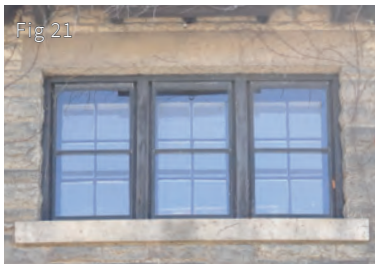
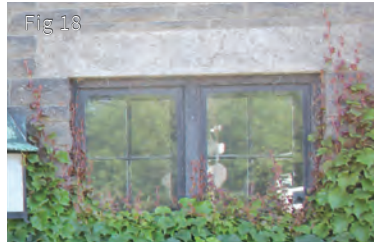
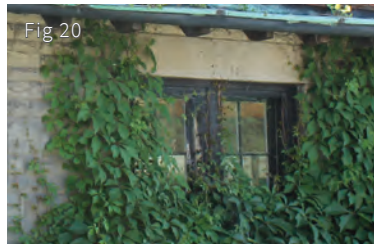
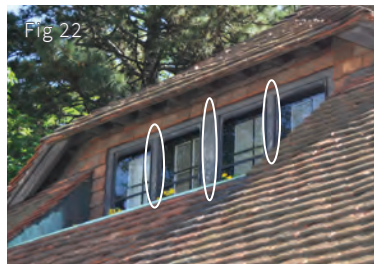
- Original wood windows on ground floor and upper storey are in fair condition (Fig 18-22)
- Wood window units have been retrofitted with exterior storms (Fig 18-22).
- Wood window surrounds are in poor condition; paint is flaking in localized areas (Fig 22).
- Carriage-way has been retrofitted with frosted glass picture window (Fig 17). Masonry opening was unmodified in this retrofit.

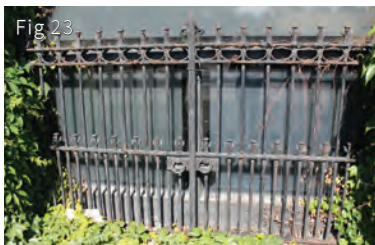
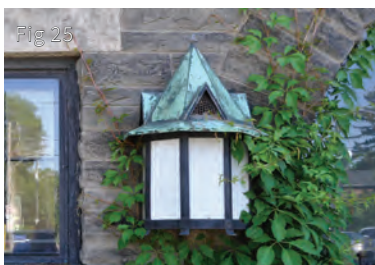
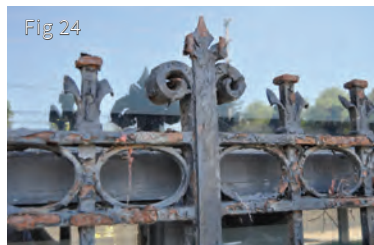
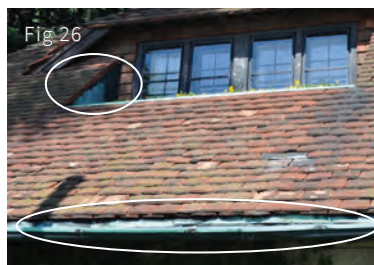
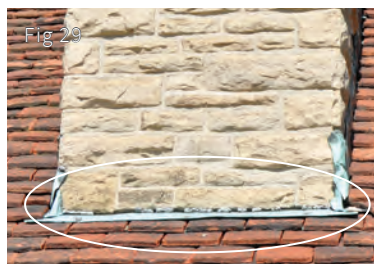
- Cast-iron gate at carriageway is in poor condition (Fig 23, 24).
- Paint is flaking off gate's metal surfaces and exposing underlying substrate (Fig 24).
- Copper-clad sconces on either side of carriage-way are in good condition (Fig 25).
- Copper flashings around second storey window are in good condition (Fig 26).
- Copper eaves troughs are in poor condition; metal is bent/distorted and in several locations plants have sprouted in the trough (Fig 26-28).
- Copper flashings around west side of chimney are in fair condition. Caulking deteriorated at joint between masonry and flashing (Fig 29).

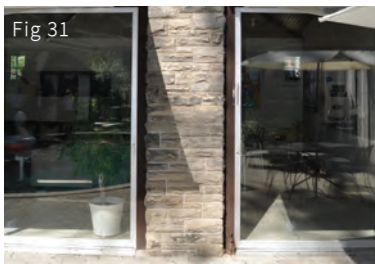
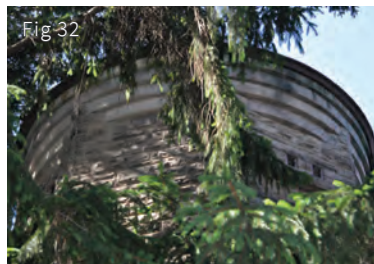
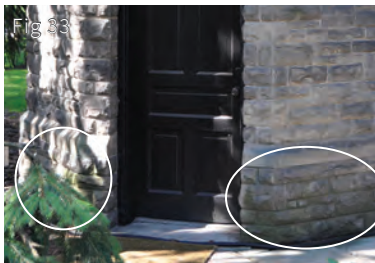
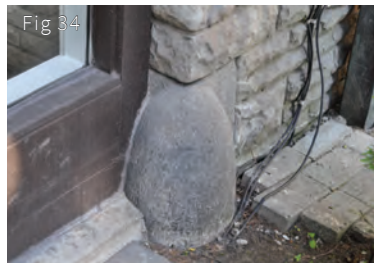
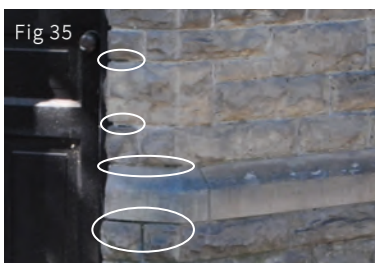
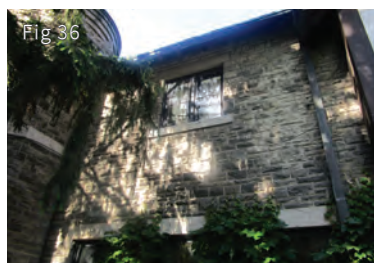
- Masonry elements on east elevation are in good condition overall (Fig 31-36).
- Indiana limestone water table on tower on south-east corner is in good condition; however, Credit Valley stone below limestone band is discoloured (Fig 33).
- Localized mortar loss and receding mortar joints near door opening on tower (Fig 35).
- Granite gate “bumpers” on either side of carriage-way opening in good condition (Fig 34).
- Masonry lintels and sills in good condition (Fig 36).

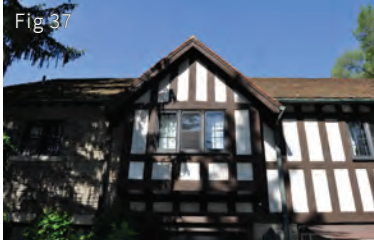
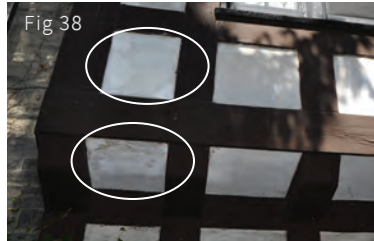
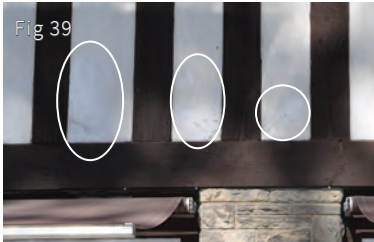
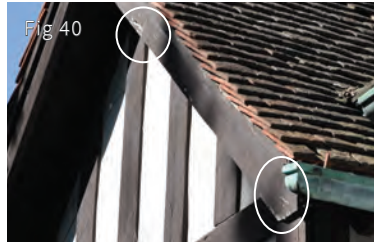
- Wood overhang, fascia, brackets, and applied decorative wood on the facade are generally in fair condition (Fig 37-40).
- There is localized paint flaking on the wood fascia (Fig 40).
- Stucco is in fair condition (Fig 37-40).
- Localized areas of stucco show signs of deterioration and some areas have been patched (Fig 38, 39).

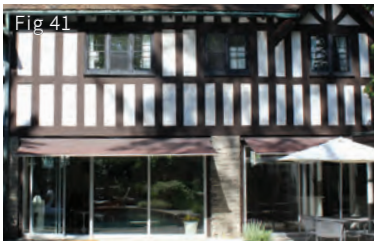
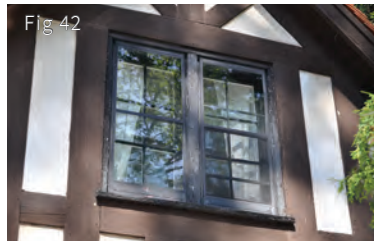
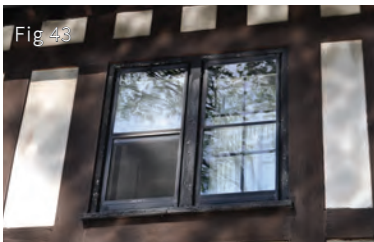
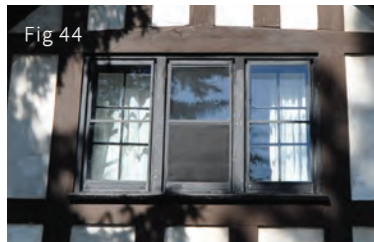
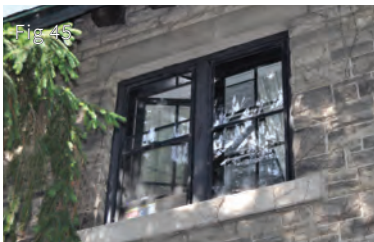
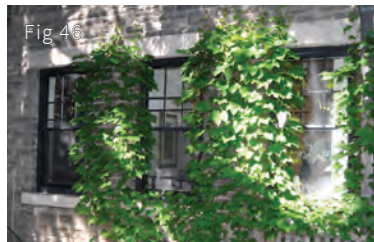
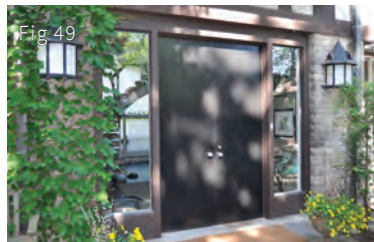
- Original wood windows on ground floor and upper storey are in fair condition (Fig 41-47).
- Wood window units have been retrofitted with exterior storms (Fig 41-47).
- Wood window surrounds are in poor condition; paint is flaking in localized areas (Fig 42-44).
- Wood door to tower is in good condition (Fig 48).
- Carriage-way has been retrofitted with modern double doors and side lights (Fig 49). Masonry opening was unmodified in this retrofit.

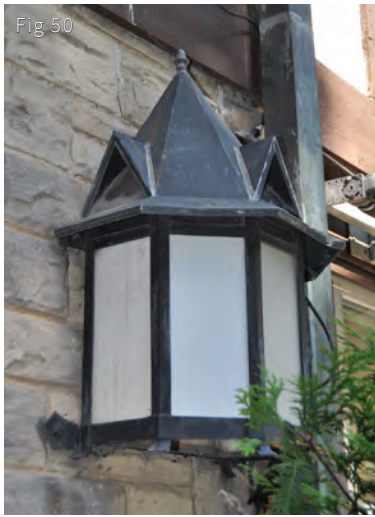
- Copper-clad sconces on either side of carriage-way are in good condition (Fig 50).
- Copper eaves troughs and downspouts are in fair condition; rusting has occurred in several localized areas (Fig 51-54).

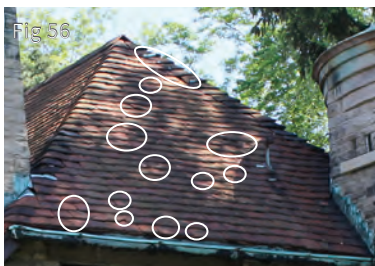
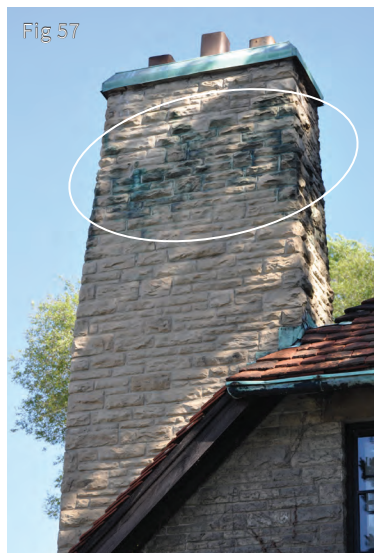
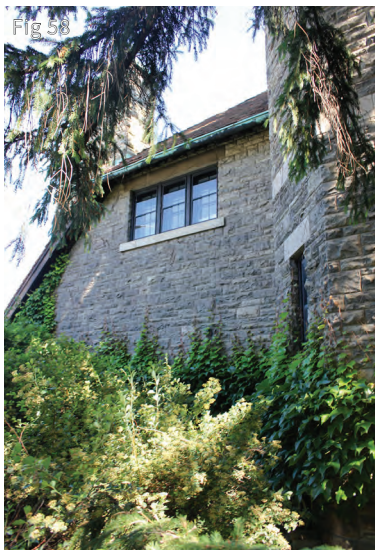
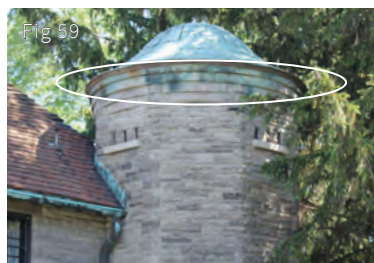
- Vines covering lower half of south elevation exterior masonry walls made assessment difficult; however, exposed high grade Credit Valley stone wall in overall good condition (Fig 55, 57-59).
- Masonry lintels and sills at openings in good condition (Fig 55, 58).
- Terracotta roof in fair condition. Localized spalling, and discoloration on select areas (Fig 56).
- Credit Valley chimney in fair condition, with some staining/discolouration from copper flashings (Fig 57).
- Indiana limestone decorative banding at top of tower discoloured from copper roofing above (Fig 59).

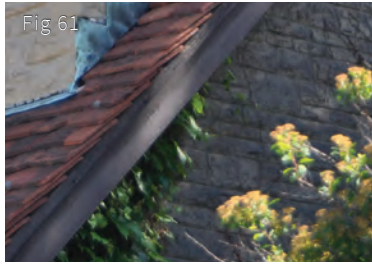
Fig 60

- Wood overhang, fascia, and brackets are in fair condition (Fig 60, 61).

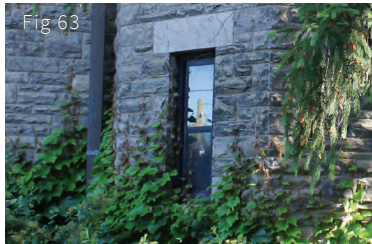
Fig 62

- Original wood windows on ground floor and upper storey are in fair condition (Fig 62, 63).
- Wood window units have been retrofitted with exterior storms (Fig 62, 63).
- Wood window surrounds are in poor condition; paint is flaking in localized areas (Fig 62).

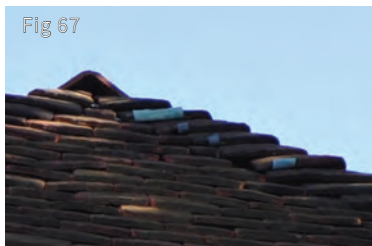
- Copper flashings at top of chimney and copper roof on tower are in good condition (as observed from the ground) (Fig 64, 65).
- Copper flashings around bottom of chimney are in fair condition (Fig 66).
- Copper flashings under terra-cotta tiles at top of roof are exposed from previous repairs (Fig 67).
- Copper eavestrough and downspouts are in fair condition.

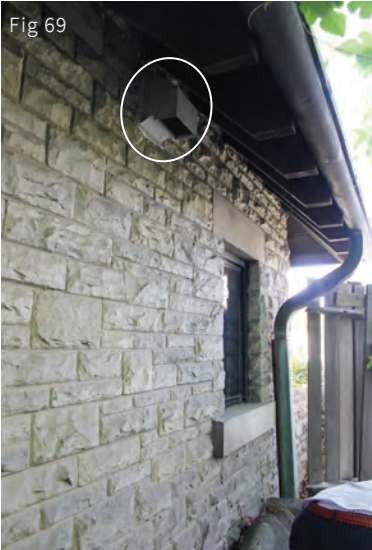
Fig 69

- High grade Credit Valley stone wall in fair condition (Fig 69-72).
- Localized mortar loss, receding mortar joints, and efflorescence near grade (Fig 71, 72).
- Masonry lintel and sill at opening in good condition (69, 72).
- Terracotta roof in fair condition. Localized spalling, missing tiles, and discolouration on select areas (Fig 70).

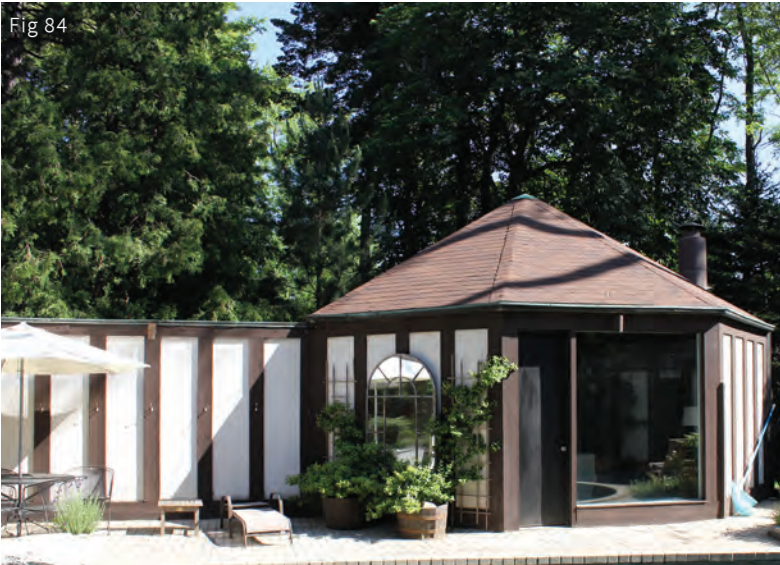
Fig 84

- Octagonal modern extension in good condition overall (Fig 84-88).
- Stucco and wood in fair condition. Minor staining of stucco near grade (Fig 87, 88). Localized flaking of paint on wood (Fig 87, 88).
- Asphalt roof in good condition.
- Copper flashings and eaves troughs in good condition.
- Openings in good condition.
