St. Lawrence Centre for the Arts – Condition Assessment

City of Toronto
+VG Architects (Toronto) Ltd.

December, 2016

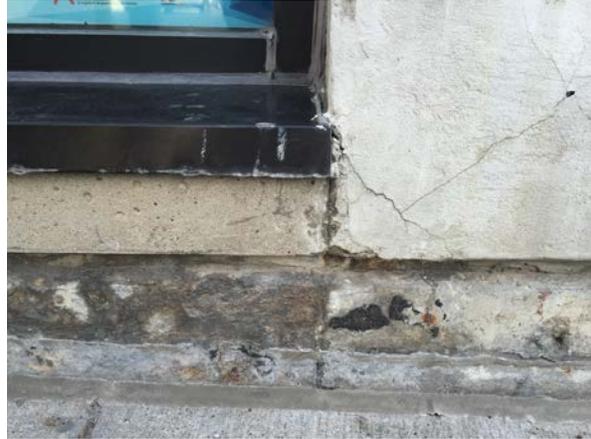
Deteriorated sill flashing and bottom of wall

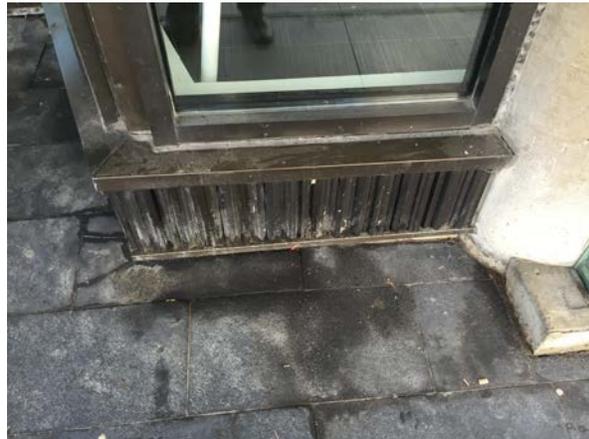
Deterioration of slate paving, and metal surfaces of siding, sill and windows

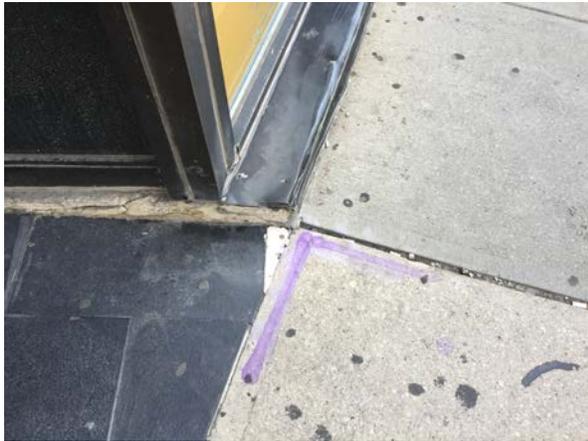
The exact cause of the sag and cracking is unknown; we can anticipate it is probably the heaving action of freeze/thaw cycles, possibly coupled with an insufficient or inadequate drainage of the substrates below the slabs. Further, according to the reviewed set of documents we note an existing underground vault adjacent to the north-west corner of the building which (we would anticipate) is covered by a concrete slab roof. The sub-grade elevation of the vault's roof is unknown, but cracks in the sidewalk could be the result of differential settlements of the sidewalk, where sidewalk spans across the roof of the vault.

Sag and cracking of exterior paved surfaces at Scott and Front Street

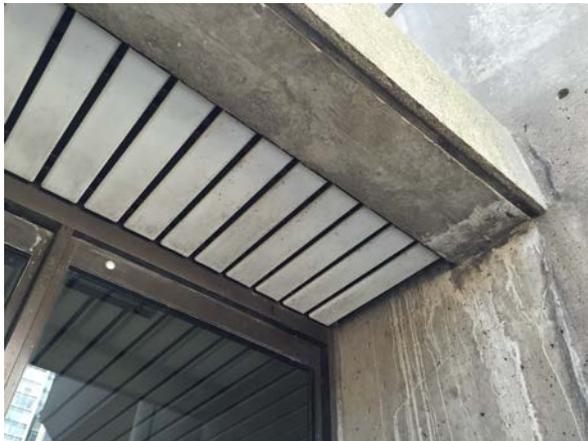
Roof water run-off and damage at east entrance on Front Street

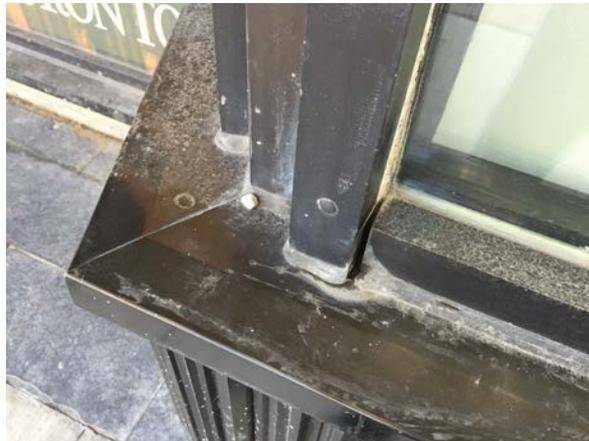
Old sealants and flashing no longer weathertight

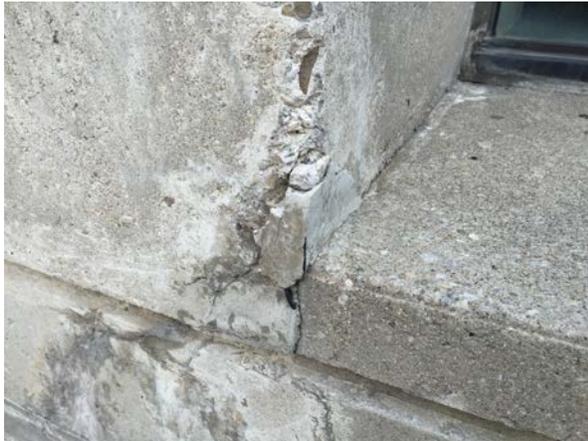
Spalling of concrete surfaces at window sills

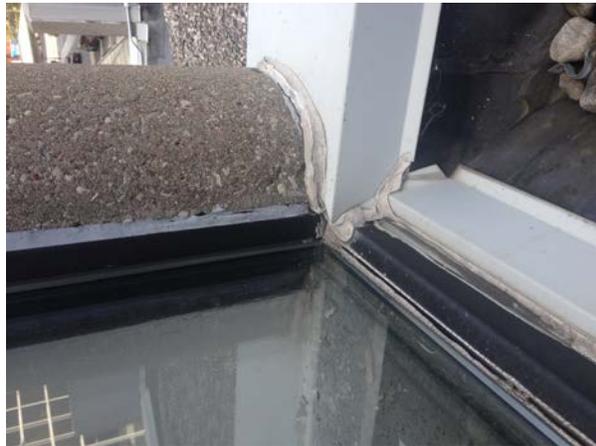
Deteriorated sealant and flashing at clerestory's curb

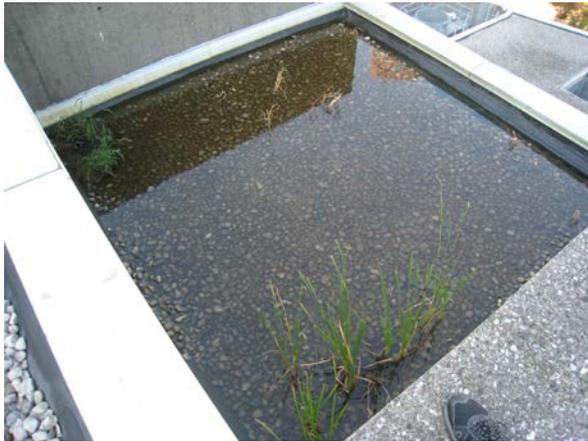
Water ponding over high roof area

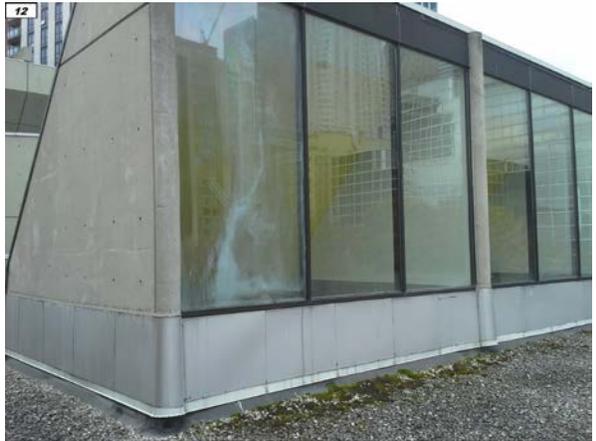
Failure "Fogging" at clerestory insulated glass unit

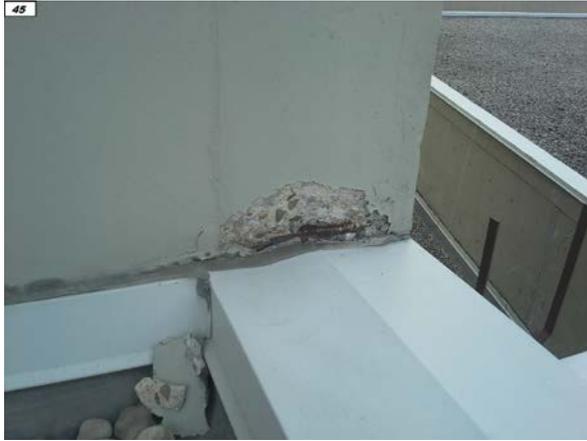
Spalling of concrete surfaces at curbs abutting concrete walls

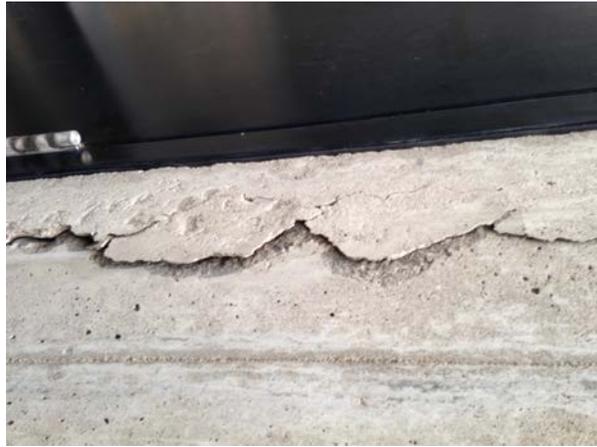
Spalling of concrete surfaces at clerestory walls

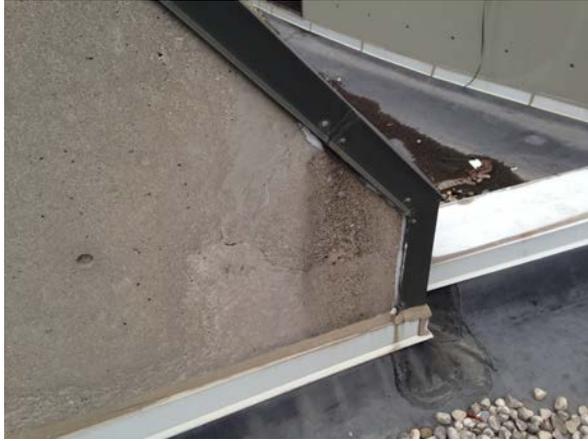
Old and deteriorated sealant/flashing at clerestory

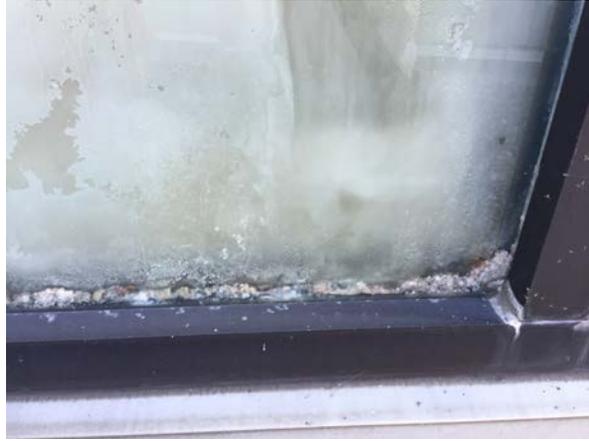
Failure of insulated glass unit at clerestory windows

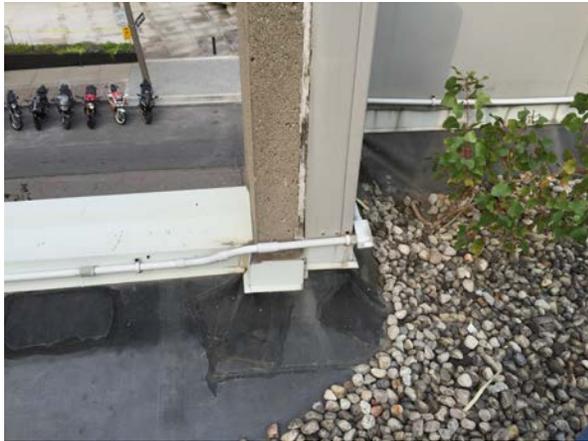
Extreme tenting of roofing membrane and vegetation growth

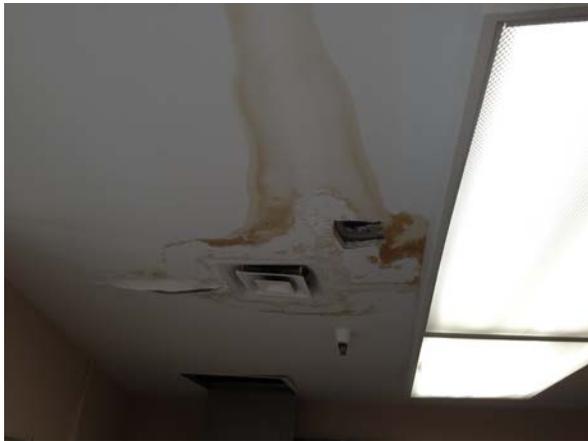
Water damage at drywall ceiling

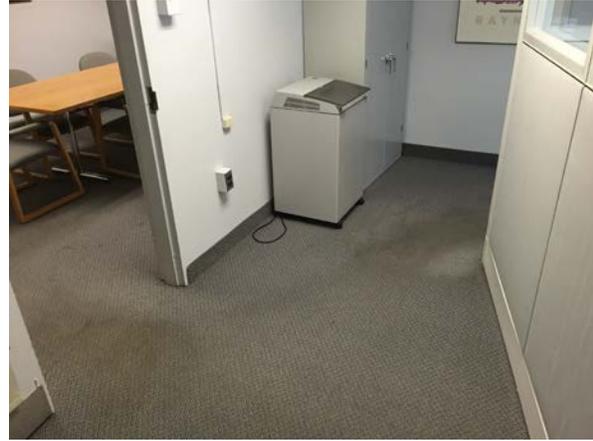
Worn and stained carpet flooring in admin offices

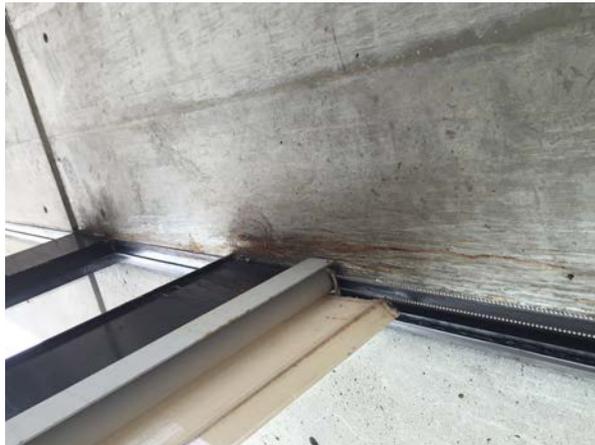
Water stains at interior concrete surface due to moisture condensation

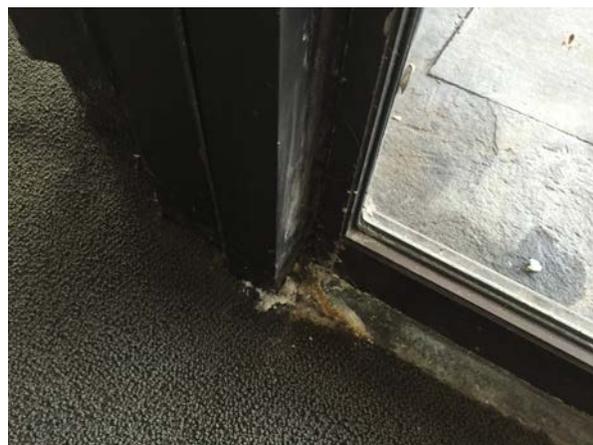
Damage from salts at bottom sill of window

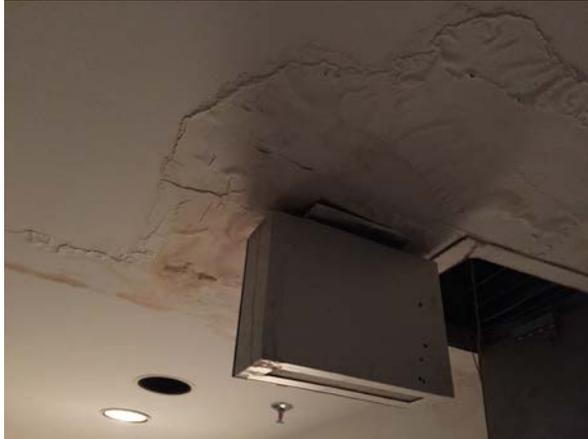
Water damage at drywall ceiling

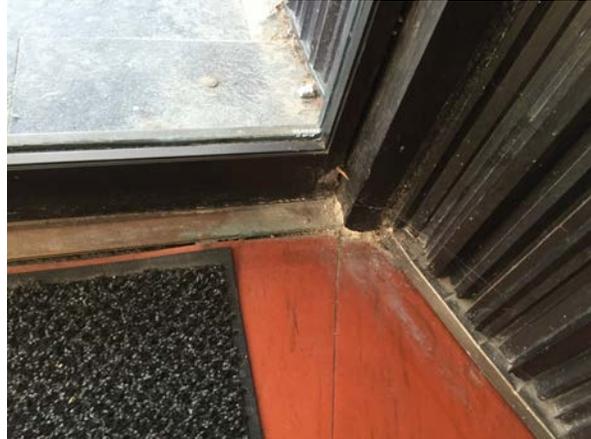
Damage from salts at bottom sill of window and deteriorated flooring

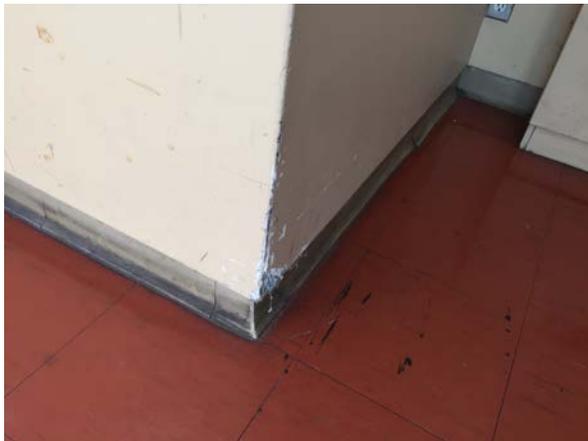
Damage drywall finish at corner

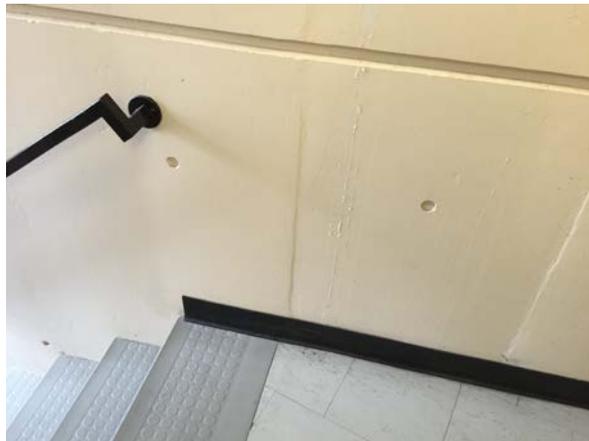
Handrail does not extend over the top landing

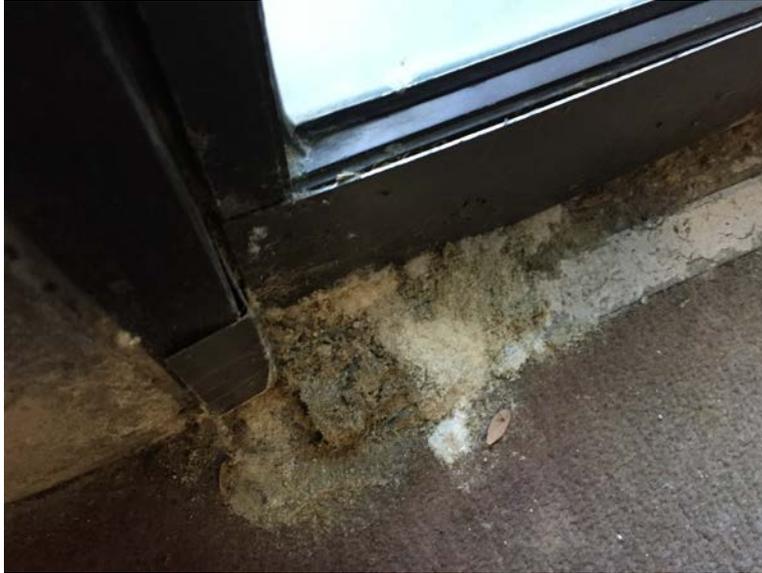
More damage at bottom sills of doors and windows

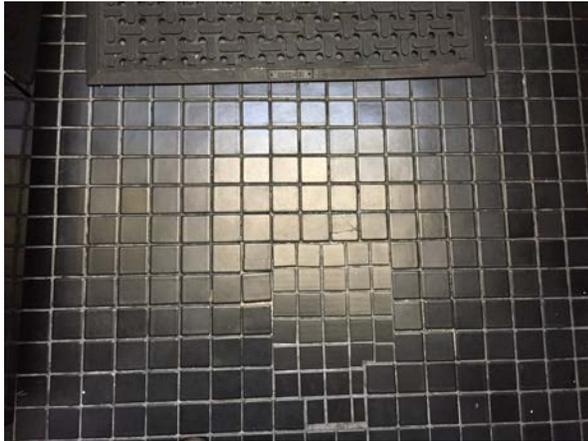
Signs of previous repair at ceramic tile flooring

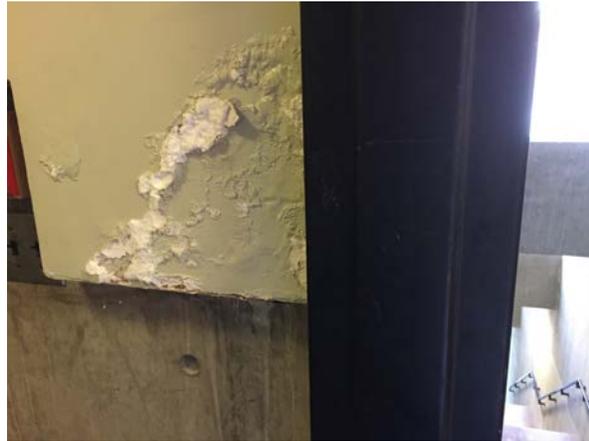
Damage at drywall surface from water infiltrations

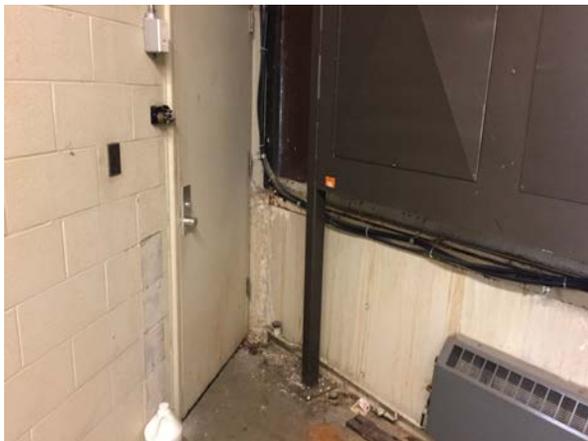
Substantial water infiltration and damage to substrates

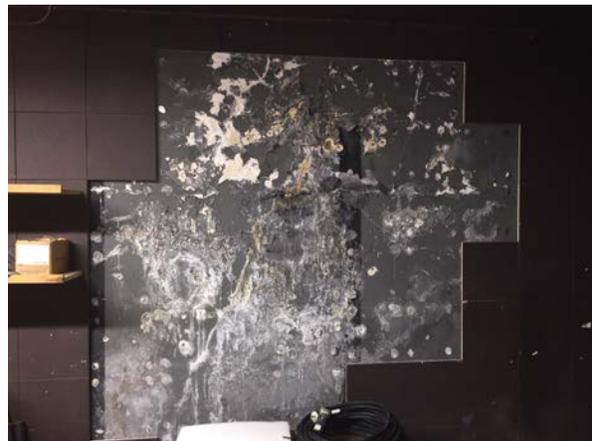
Water damage observed over interior concrete wall surfaces

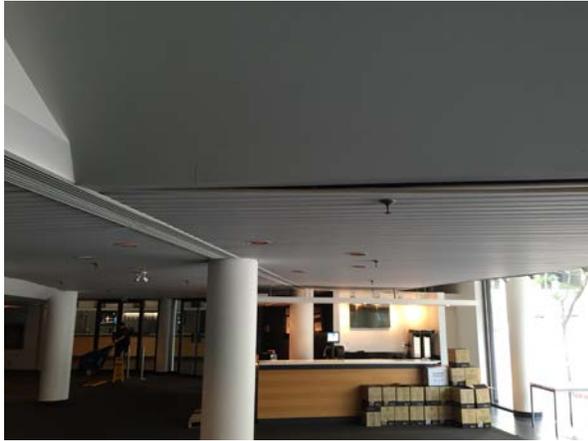
Detached metal ceiling

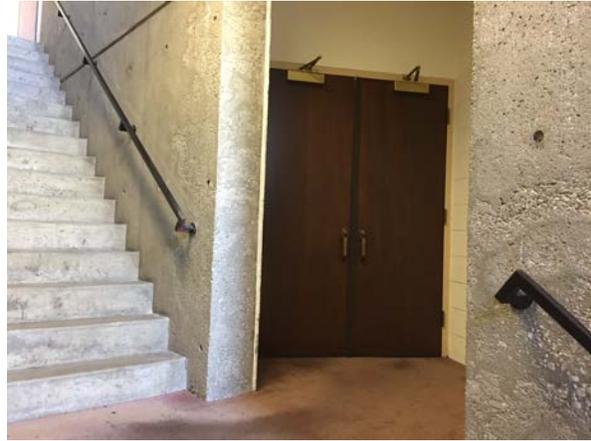
Worn and stained carpet flooring

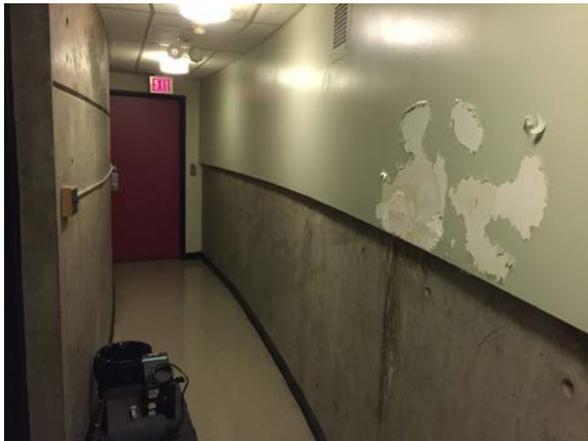
More drywall damage due to water infiltration

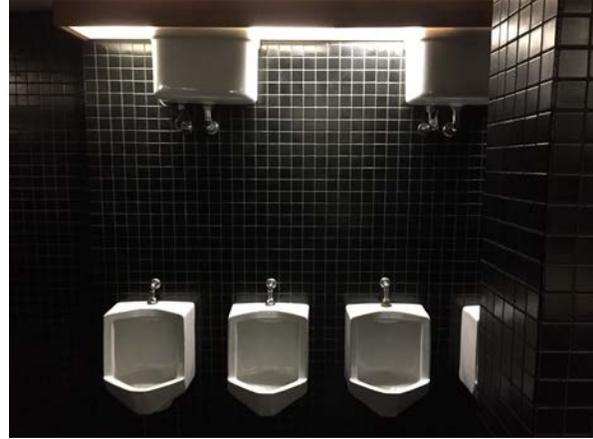
Old and deteriorate fixtures in public washrooms

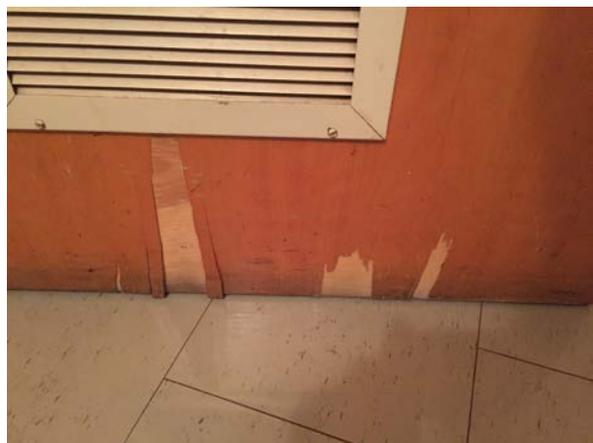
Deteriorated door at dressing room

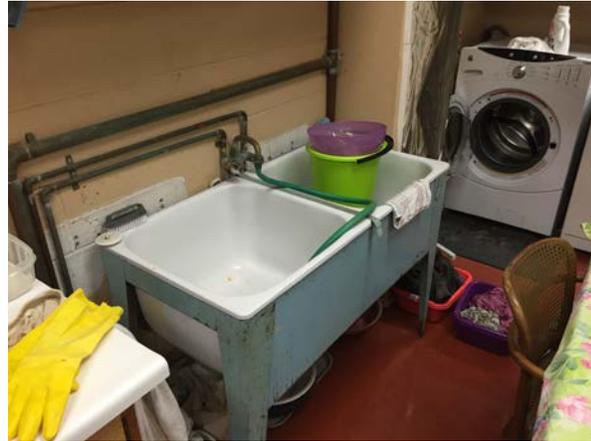
Old and deteriorated equipment

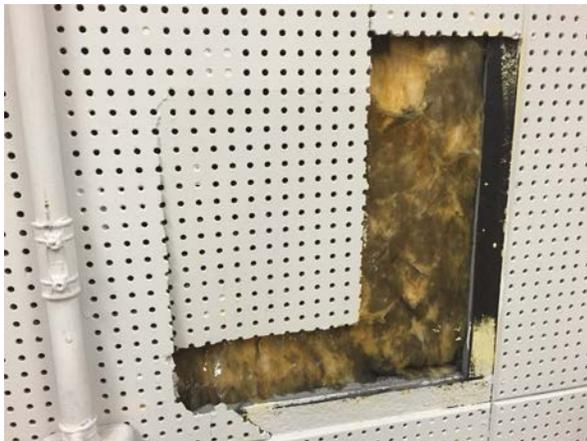
Old and deteriorated wall-mounted acoustical material

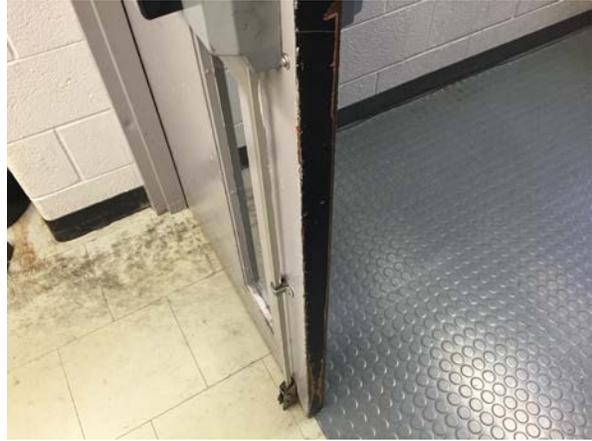
Worn flooring and door

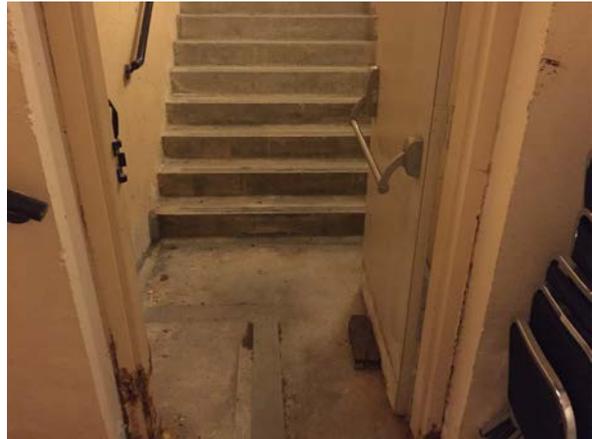
Fire door propped open with weight and deteriorated flooring

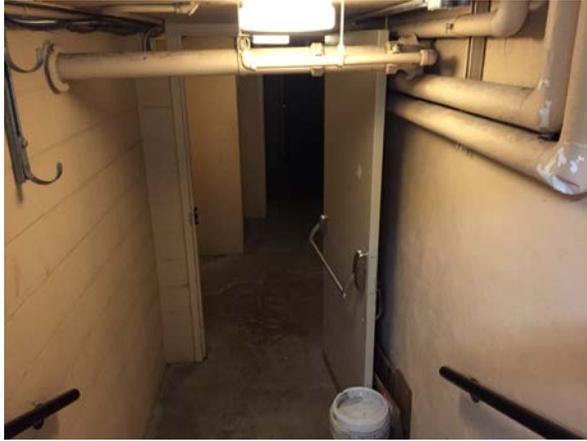
Fire door propped open with weight

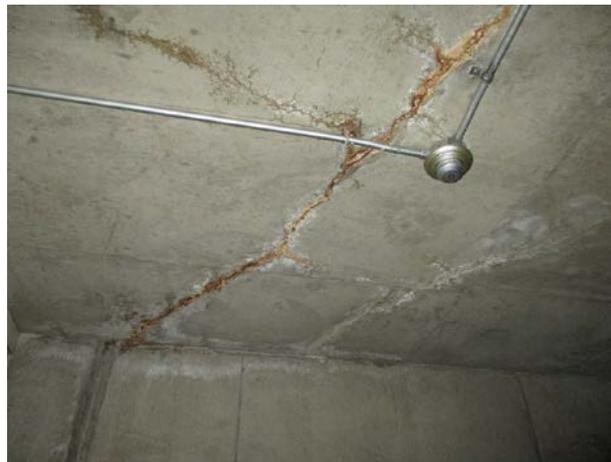
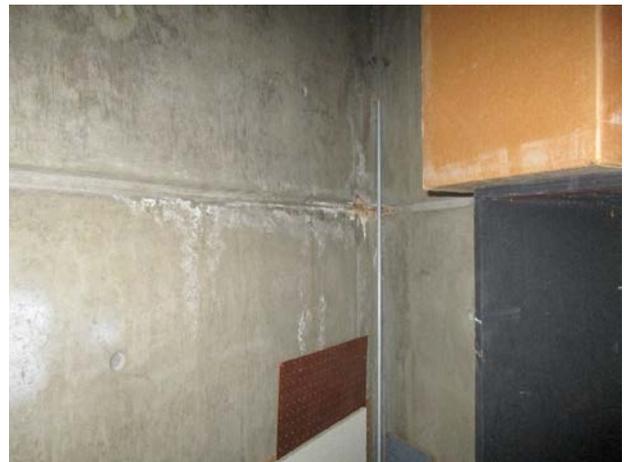
S.5: Water ingress through clerestory wall cross from stage manager's room (production rooms above VIP lounge).

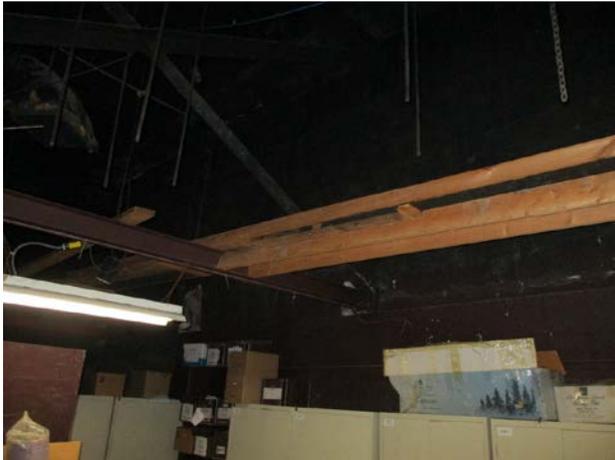
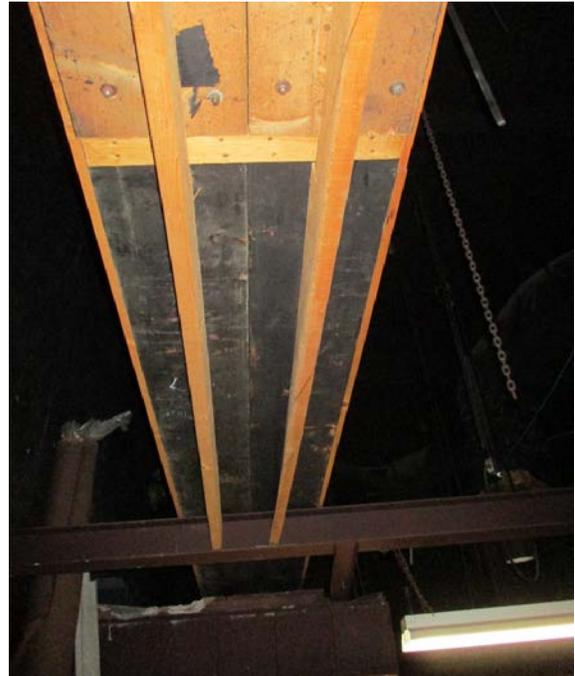
S.6: Roof of the storage room adjacent to the sound control and projection rooms has been leaking.
