**Project No.: 2021-248**

***Re: Review of Demolition of Existing Structure***  
**971 Weston Road, Toronto**

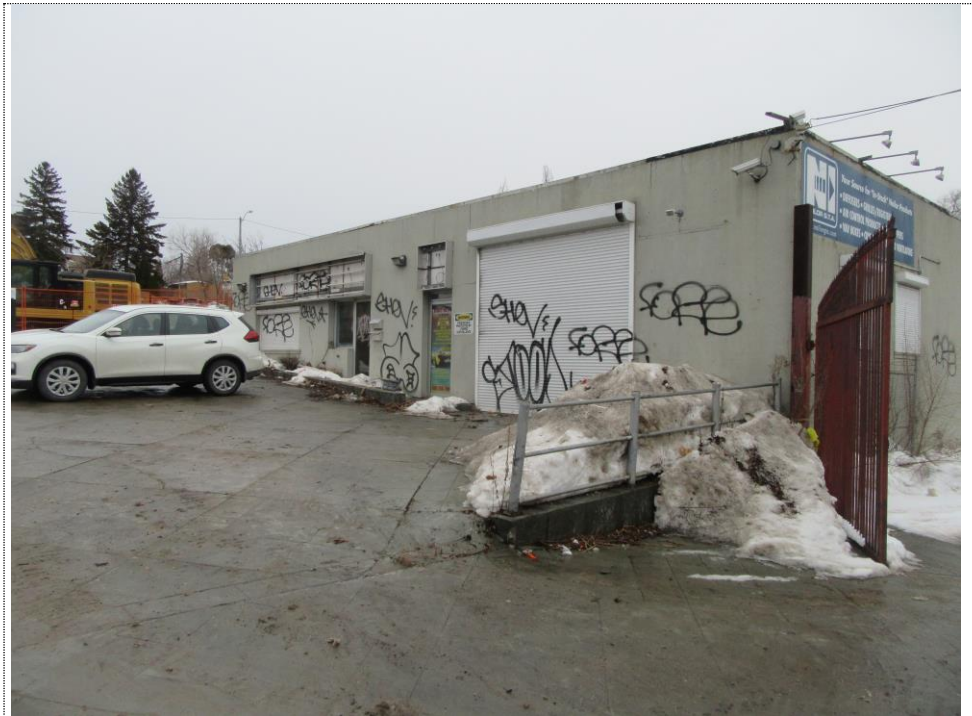
**PHOTO NUMBER 1:** Front view of 971 Weston Road

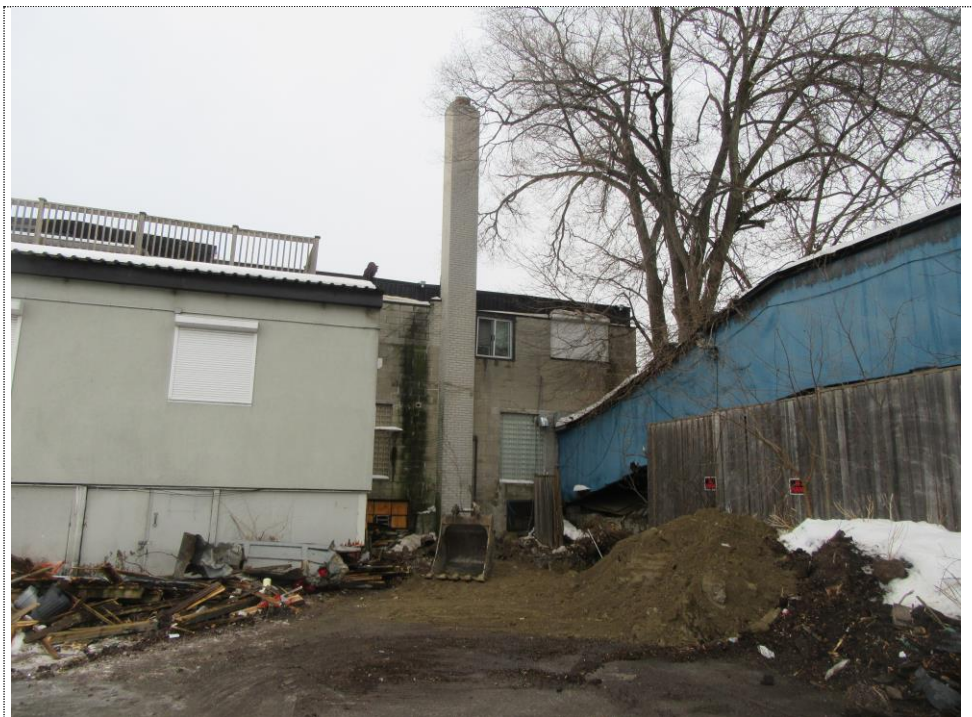
**PHOTO NUMBER 2:** Rear (east face) of building and abandoned covered walkway.

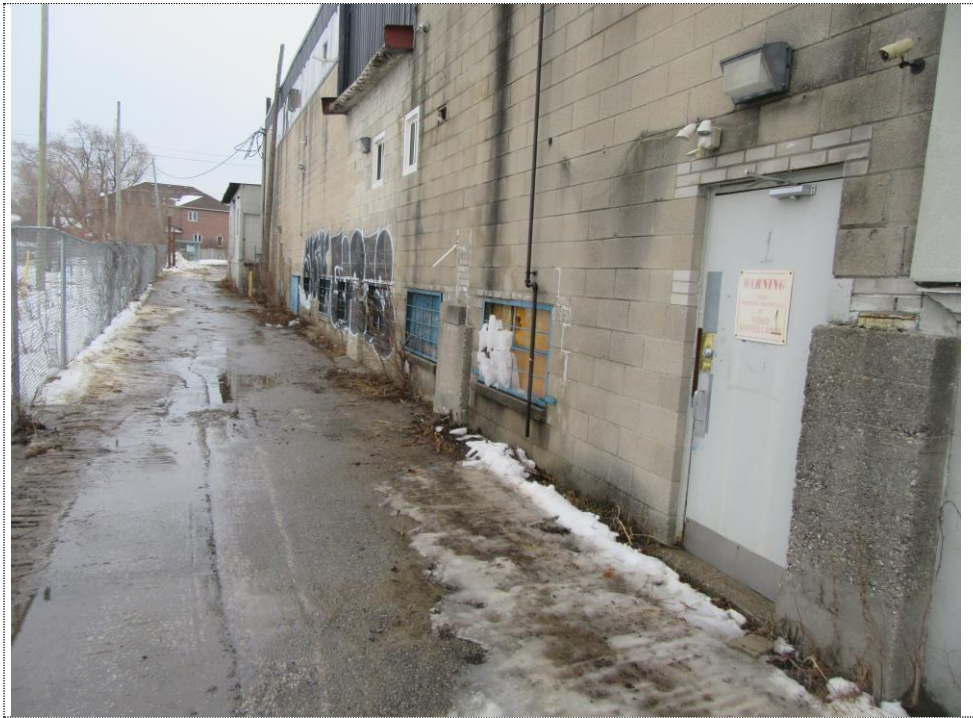
**PHOTO NUMBER 3:** South side of building

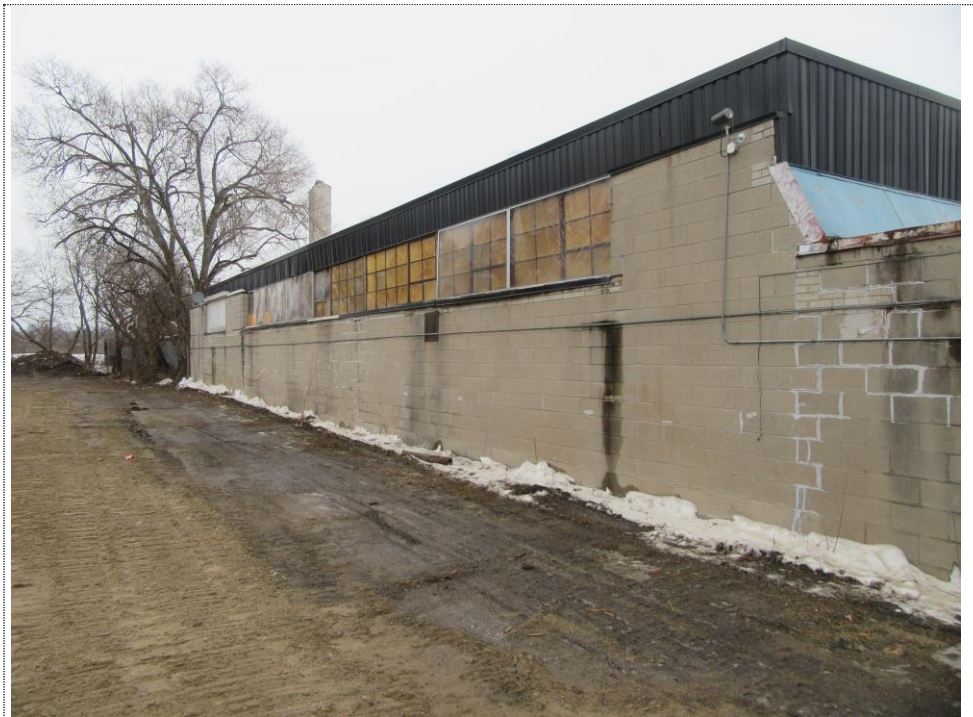
At the rear of the property there is an abandoned covered walkway covering approximately 75 square metres (refer to photograph numbered 4).

**PHOTO NUMBER 4:** North side of building

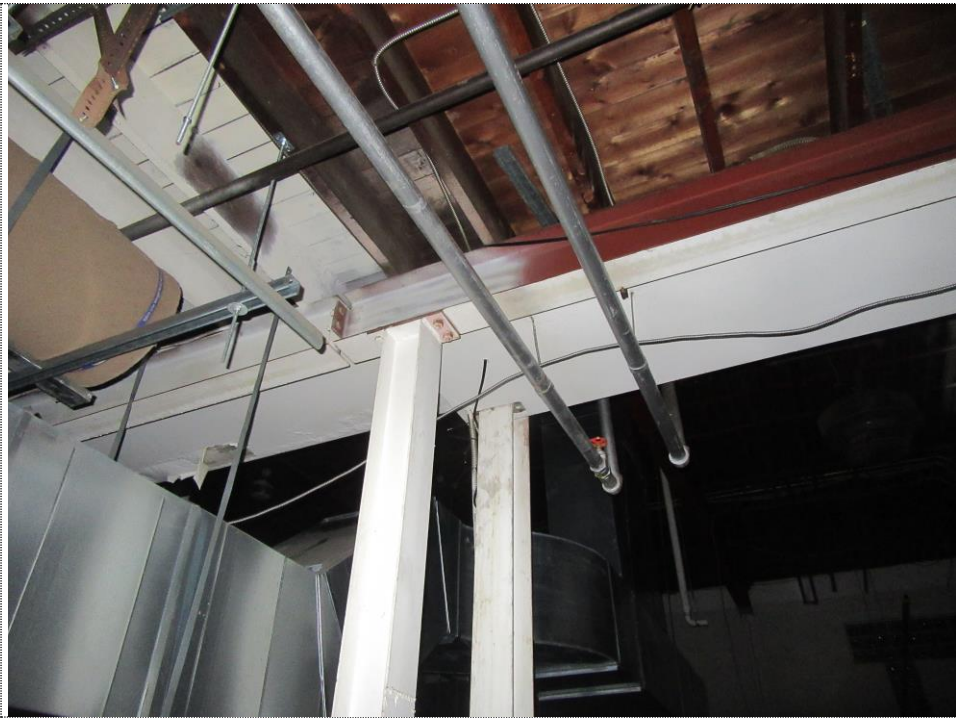
**PHOTO NUMBER 5:** Underside of west portion of roof structure.  
**NOTE:** Wood joists and wood decking

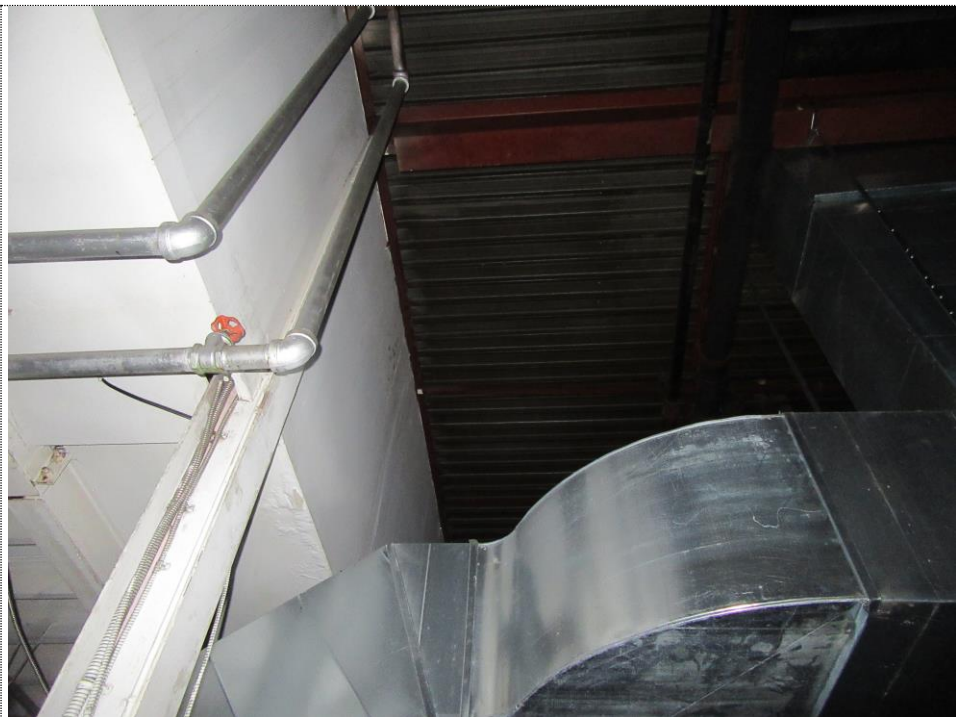
**PHOTO NUMBER 6:** Underside of east portion of roof structure.  
**NOTE:** Open web steel joists and metal decking

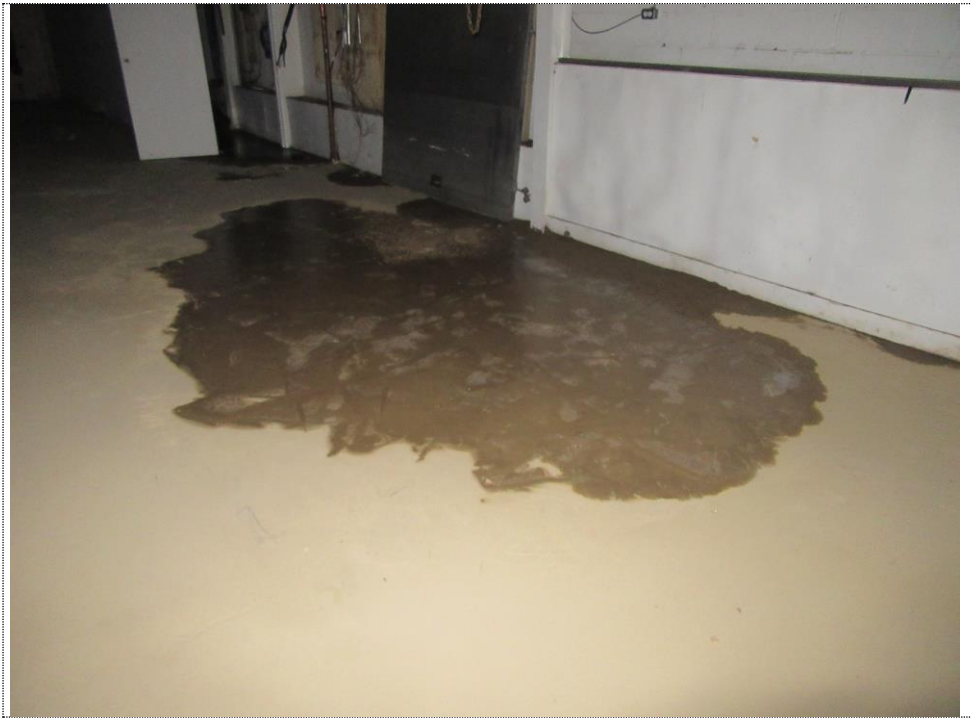
It appears that the building has been vacant for an extended period of time. There are many areas of water ingress through the roof and exterior walls with areas of ponding of water on the floor slab (refer to photograph numbered 7). There are areas of mold growth on the wood elements forming the roof structure.

**PHOTO NUMBER 7:** Slab on grade  
**NOTE:** Ice present on slab on grade from flooding.

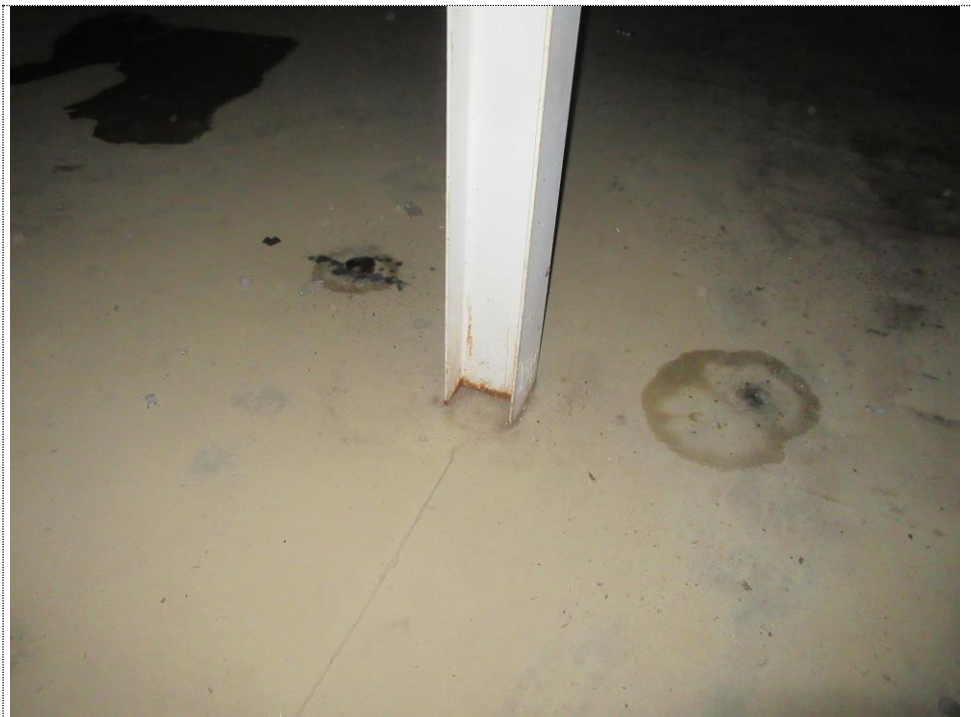
In addition, we understand that a pipe burst due to cold temperatures, flooding the basement. The underlying soil would have been saturated and then froze, exerting uplift on the foundation walls

and footings. In addition, the structural steel posts are now deteriorated (corroded) due to the flooding of the basement (refer to photograph numbered 8).

**PHOTO NUMBER 8:** Building interior column at slab on grade.  
**NOTE:** Corrosion of base of column.
