## 8.2 Impact Mitigation Strategy

### A Condition Assessment

## 11.2.1 West Elevation

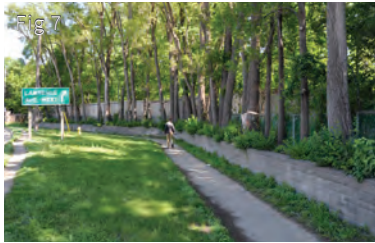
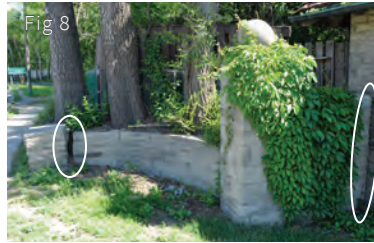
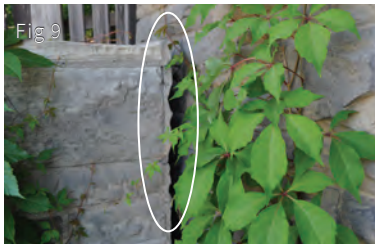
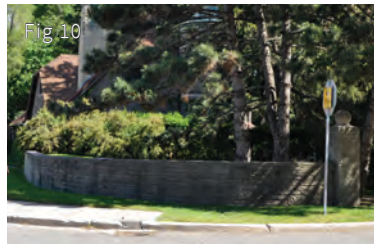
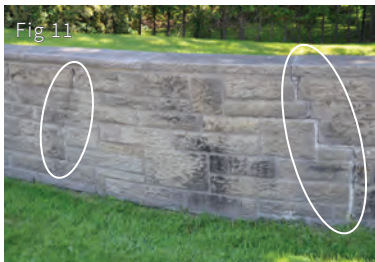
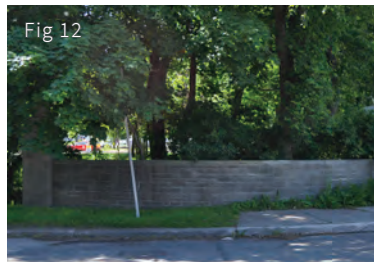
- Section of stone retaining wall running north-south to north-west corner of house in overall poor condition. Advanced age of elms behind retaining wall at this location has pushed the wall out of plumb (Fig 7).
- At north-west corner of house, retaining wall in poor condition (Fig 8, 9). Masonry has deflected significantly at corner and where wall meets the house (Fig 9).
- Section of retaining wall south house on north corner of intersection in fair condition, with some localized cracking (Fig 10, 11).
- Section of retaining wall on south corner of intersection in good condition (Fig 12).

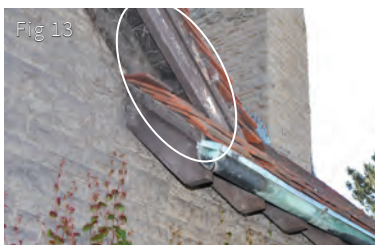
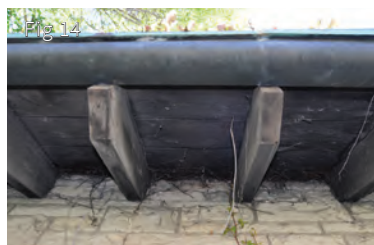
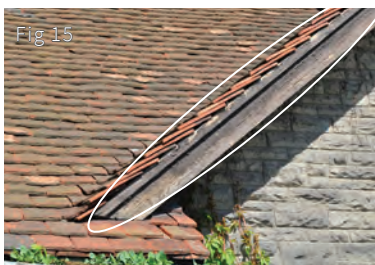
- Wood overhang, fascia, and brackets are deteriorating and in poor to fair condition (Fig 13-16).
- Paint is flaking and there is localized damage to wood substrate, particularly at cut ends (Fig 15, 16).

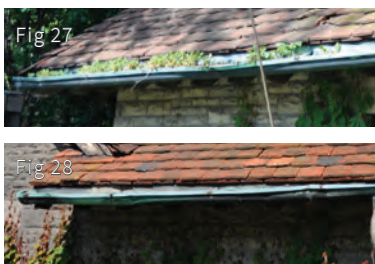
- Cast-iron gate at carriageway is in poor condition (Fig 23, 24).
- Paint is flaking off gate's metal surfaces and exposing underlying substrate (Fig 24).
- Copper-clad sconces on either side of carriage-way are in good condition (Fig 25).
- Copper flashings around second storey window are in good condition (Fig 26).
- Copper eaves troughs are in poor condition; metal is bent/distorted and in several locations plants have sprouted in the trough (Fig 26-28).
- Copper flashings around west side of chimney are in fair condition. Caulking deteriorated at joint between masonry and flashing (Fig 29).

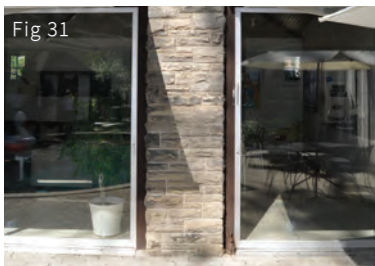
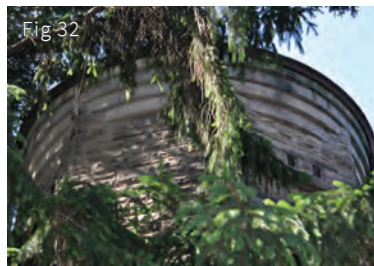
- Masonry elements on east elevation are in good condition overall (Fig 31-36).
- Indiana limestone water table on tower on south-east corner is in good condition; however, Credit Valley stone below limestone band is discoloured (Fig 33).
- Localized mortar loss and receding mortar joints near door opening on tower (Fig 35).
- Granite gate “bumpers” on either side of carriage-way opening in good condition (Fig 34).
- Masonry lintels and sills in good condition (Fig 36).

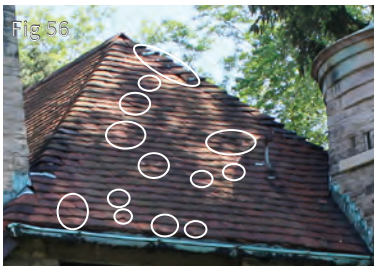
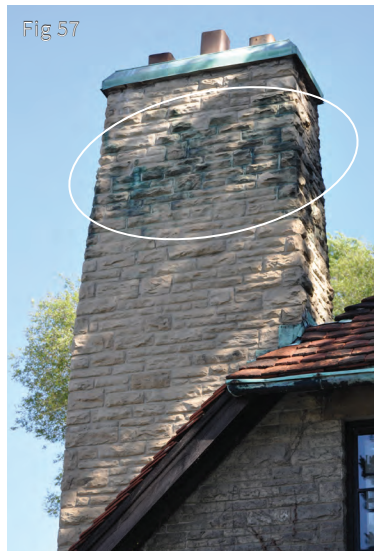
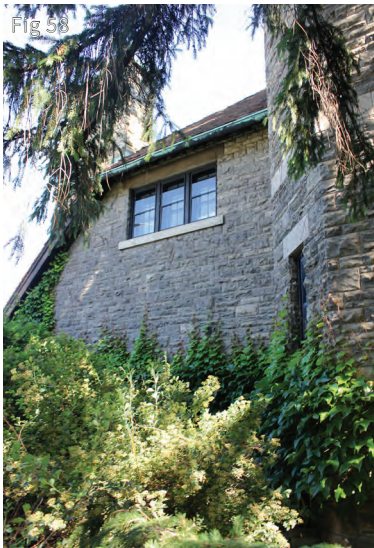
- Vines covering lower half of south elevation exterior masonry walls made assessment difficult; however, exposed high grade Credit Valley stone wall in overall good condition (Fig 55, 57-59).
- Masonry lintels and sills at openings in good condition (Fig 55, 58).
- Terracotta roof in fair condition. Localized spalling, and discoloration on select areas (Fig 56).
- Credit Valley chimney in fair condition, with some staining/discolouration from copper flashings (Fig 57).
- Indiana limestone decorative banding at top of tower discoloured from copper roofing above (Fig 59).

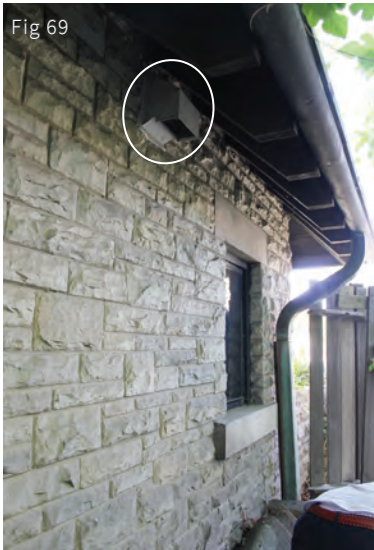
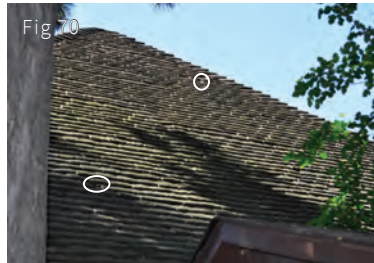
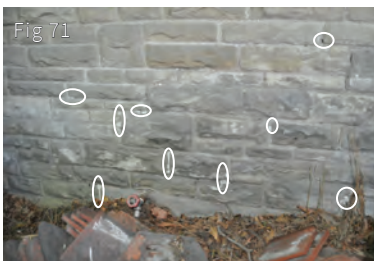
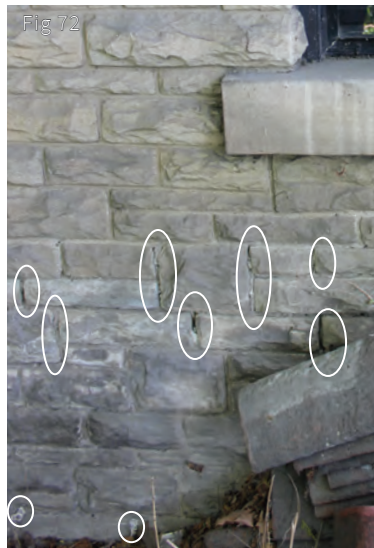
- High grade Credit Valley stone wall in fair condition (Fig 69-72).
- Localized mortar loss, receding mortar joints, and efflorescence near grade (Fig 71, 72).
- Masonry lintel and sill at opening in good condition (69, 72).
- Terracotta roof in fair condition. Localized spalling, missing tiles, and discolouration on select areas (Fig 70).

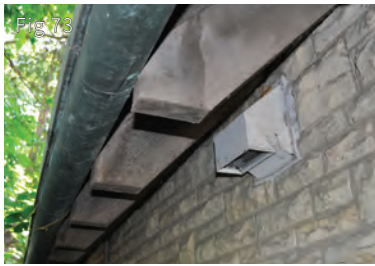
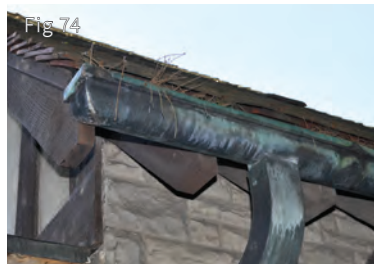
- Wood overhang and brackets area in fair to good condition (Fig 73, 74).

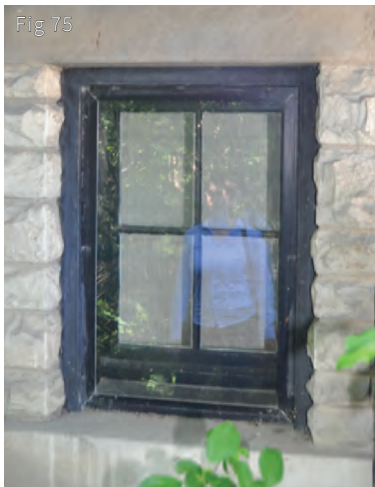
- Original wood window on ground floor in good condition (Fig 75).
- Wood window unit has been retrofitted with exterior storm (Fig 75).
- Wood window surround in fair condition (Fig 75).

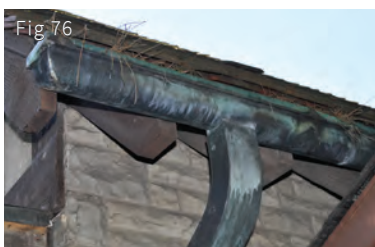
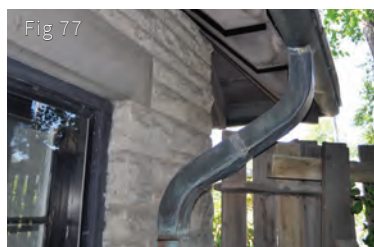
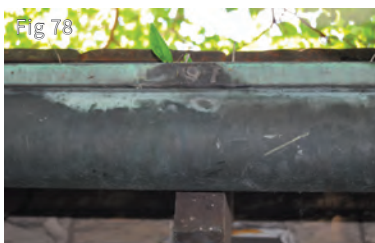
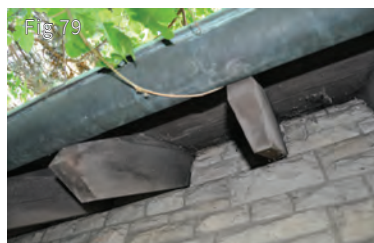
- Copper eavestroughs and downspouts are in fair condition (Fig 76-79).

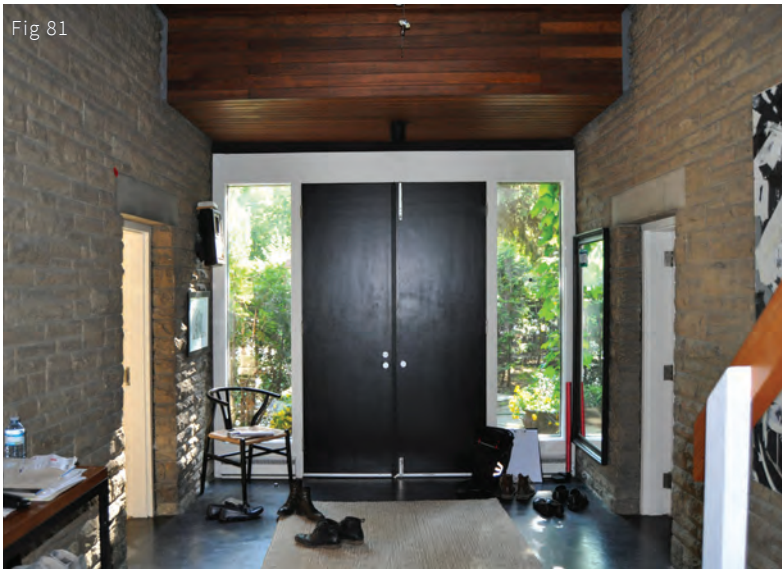
Fig 80

- Credit Valley stone walls in poor condition (Fig 80-83).
- Localized step cracking along mortar joints above both door lintels, suggesting movement in the foundation (Fig 82, 83).

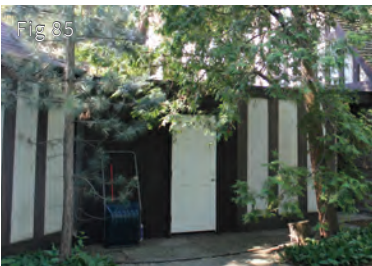
Fig 84

- Octagonal modern extension in good condition overall (Fig 84-88).
- Stucco and wood in fair condition. Minor staining of stucco near grade (Fig 87, 88). Localized flaking of paint on wood (Fig 87, 88).
- Asphalt roof in good condition.
- Copper flashings and eaves troughs in good condition.
- Openings in good condition.
