Appeal Hearing – February 28, 2022

RE: Property Standard Order dated November 25, 2021

Location: 35 Trudelle Street, Toronto

Re: Review of Balcony Slabs at 25, 35 and 45 Trudelle Street, Toronto, ON

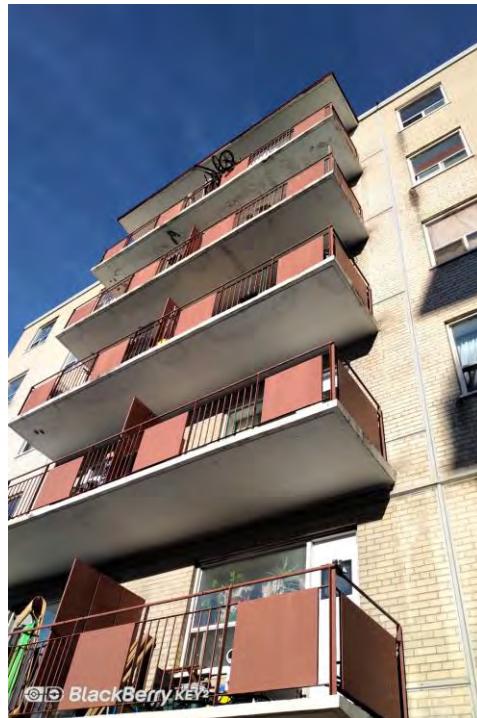
Photo No. 1: A typical balcony drop at the buildings

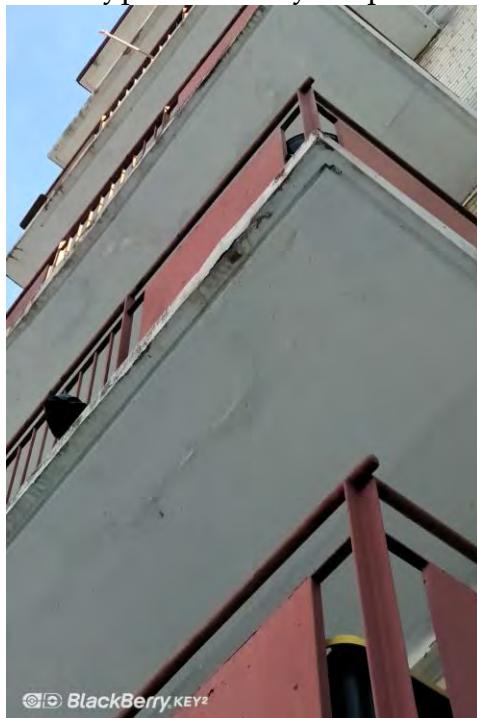
Photo No. 2: Typical concrete delaminations at balcony slabs edges

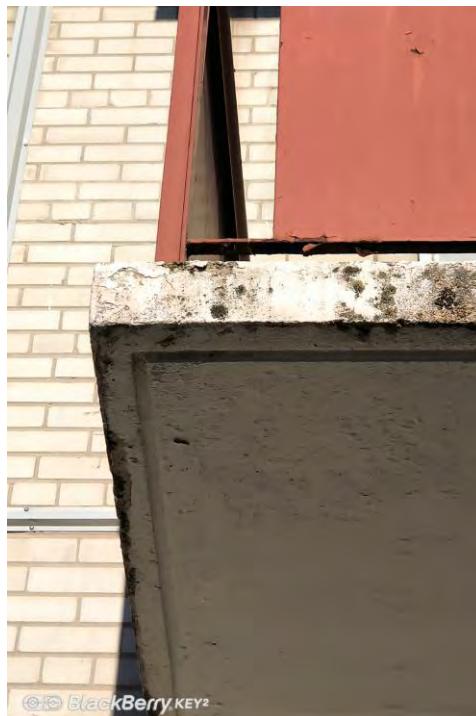
Photo No. 3: A heavily cracked slab edge

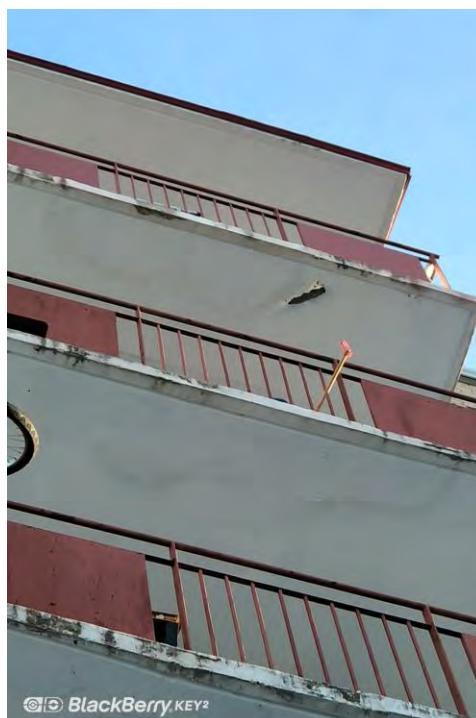
Photo No. 4: Extensive concrete delaminations at slab edges

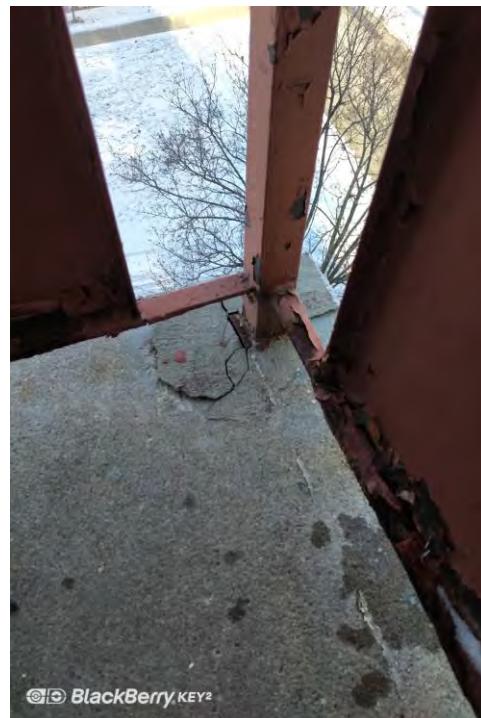
Photo No. 5: Spalled concrete around guardrail post – typical condition at numerous locations

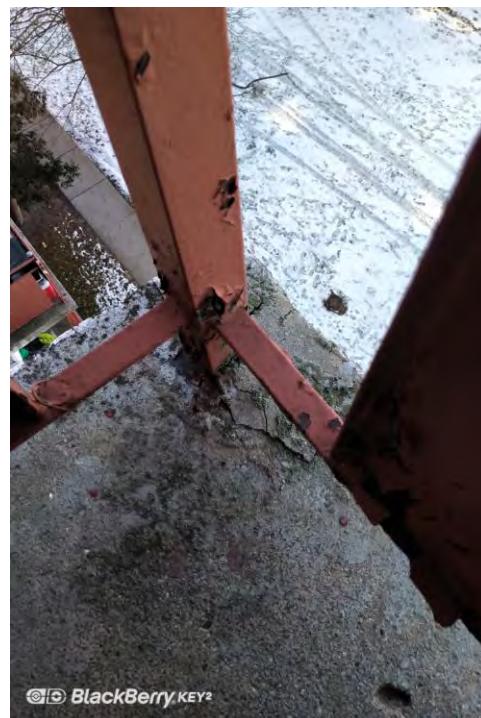
Photo No. 6: Another location showing spalling concrete around guardrail post

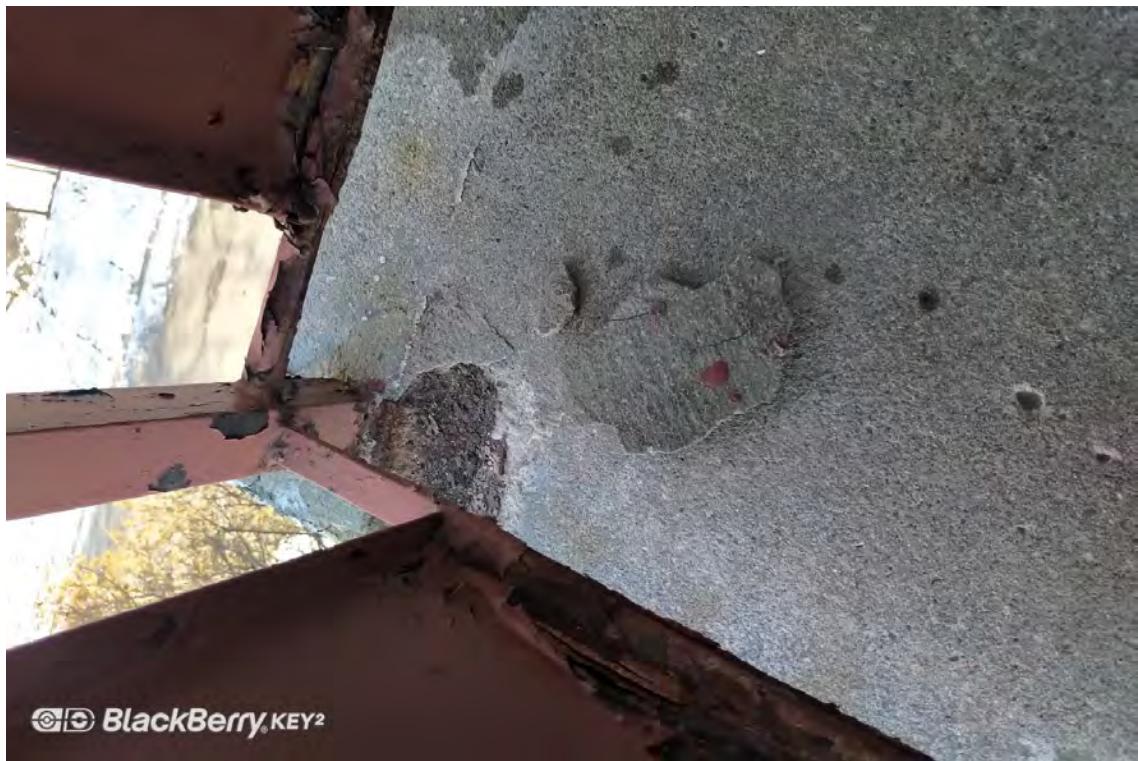
Photo No. 7: A large piece of spalled concrete separated from a guardrail post location

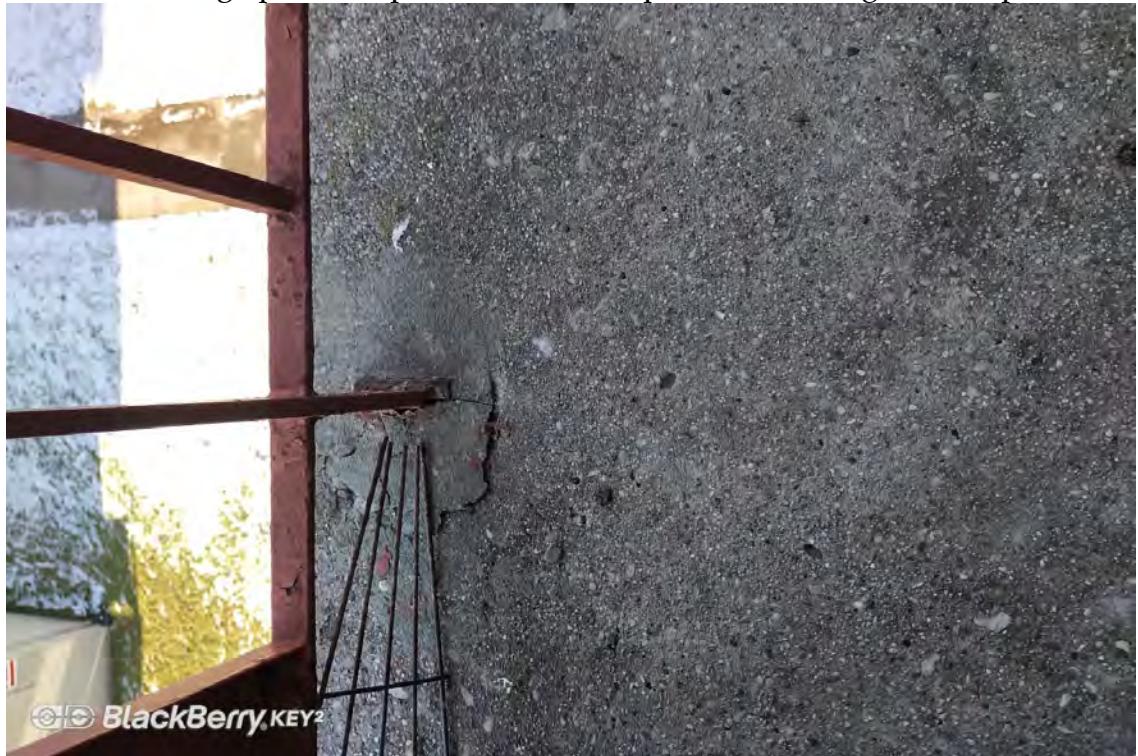
Photo No. 8: Another location with spalling concrete around guardrail post

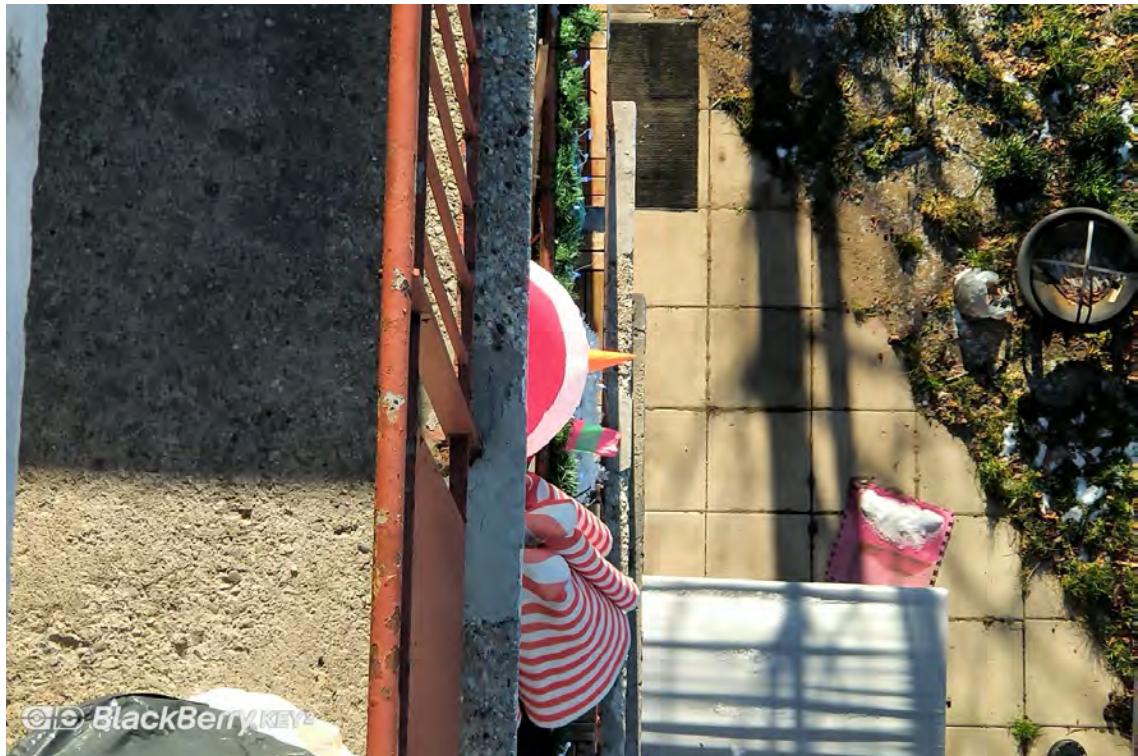
Photo No. 9: A previous repair patch at a balcony slab edge

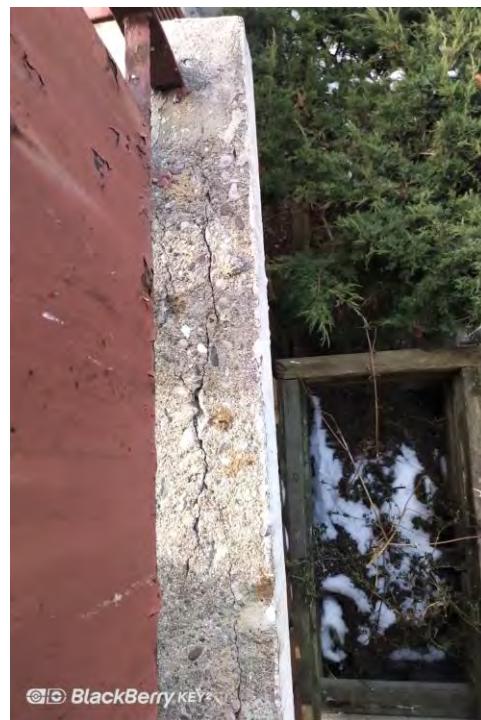
Photo No. 10: A heavily cracked balcony slab front edge

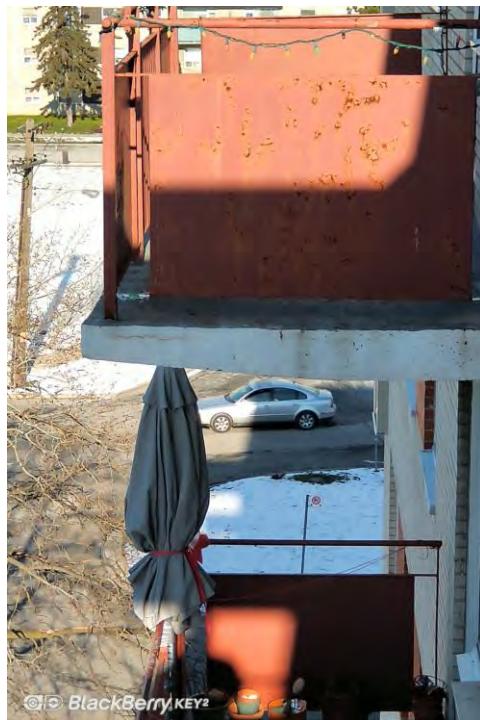
Photo No. 11: A heavily cracked balcony slab side edge

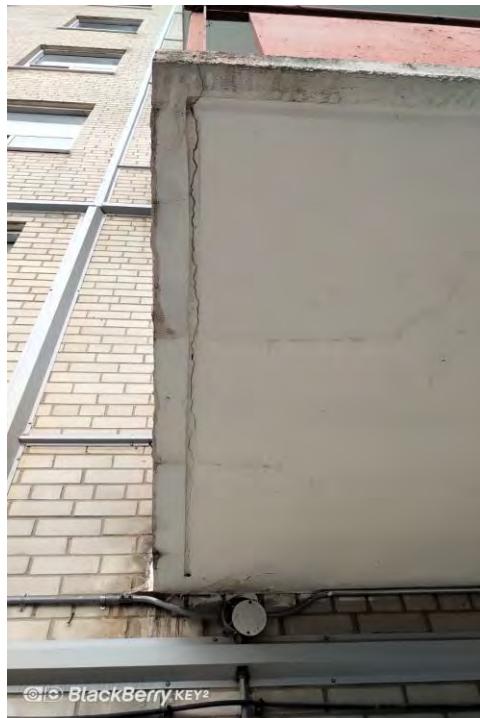
Photo No. 12: A heavily cracked balcony slab side edge

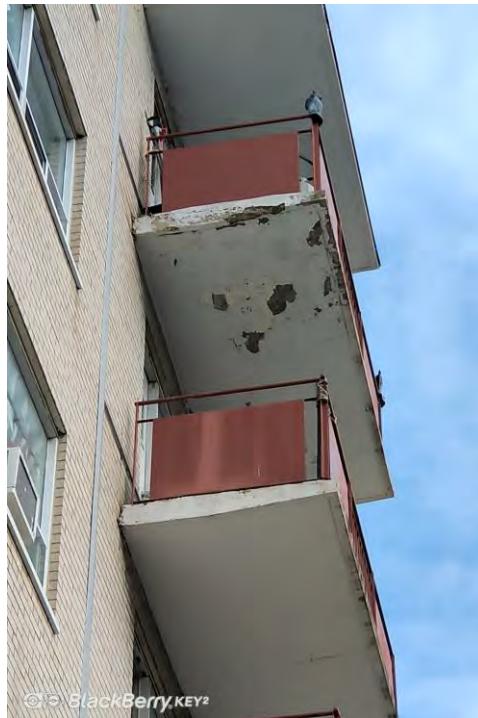
Photo No. 13: Concrete delaminations at balcony slabs edges and soffit

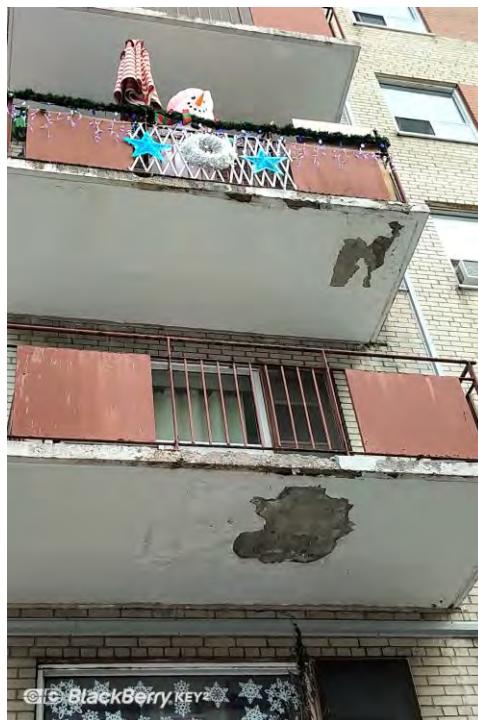
Photo No. 14: Concrete delaminations at balcony slabs edges and soffit
