## Investigation into Allegations of Wrongdoing Regarding Building Inspections of 2 Houses

**June 22, 2023**

Tara Anderson, CPA, CA, CIA, BAcc  
Auditor General

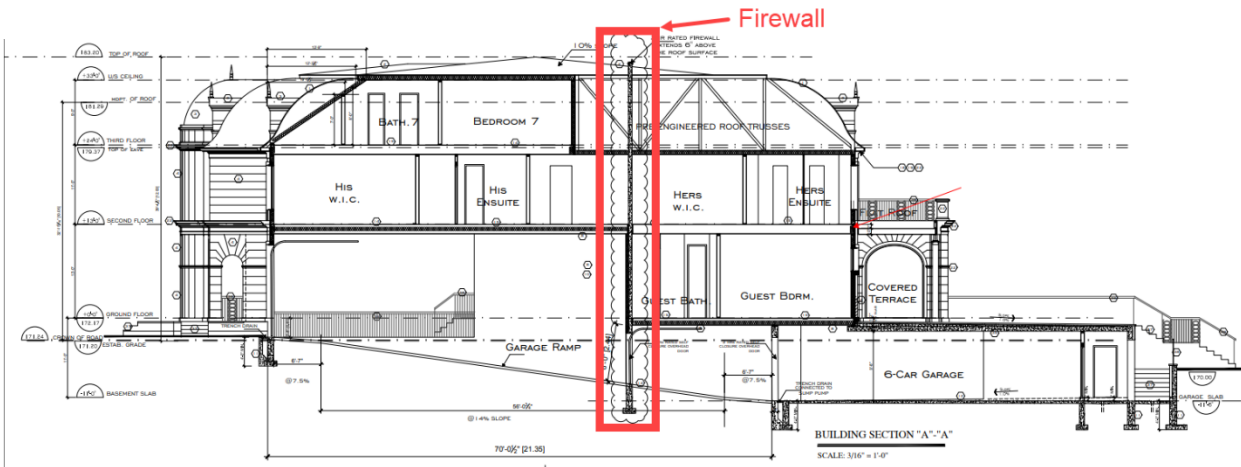
Figure 1: Firewall separating house into 2 sections – front and back

As mentioned earlier, our consulting engineer identified the change of the garage roof from concrete to wood as a material change. He also found that, in his opinion, changing the material from concrete to wood could have circumvented the function of the firewall.

*“It is our professional opinion that changing the construction of the garage roof/rear deck floor from precast concrete hollowcore panels (a non-combustible material) to wood framing (a combustible material) defeated the fundamental concept of keeping the ‘fire component’ on either side of a firewall separate. This change brought the garage roof, part of one fire compartment, into direct contact with the rear exterior wall, part of another fire compartment, with both members constructed of combustible material... We found no architectural details to show how the assembly of the wood-framed garage roof would satisfy the required 2 hr fire rating.”*

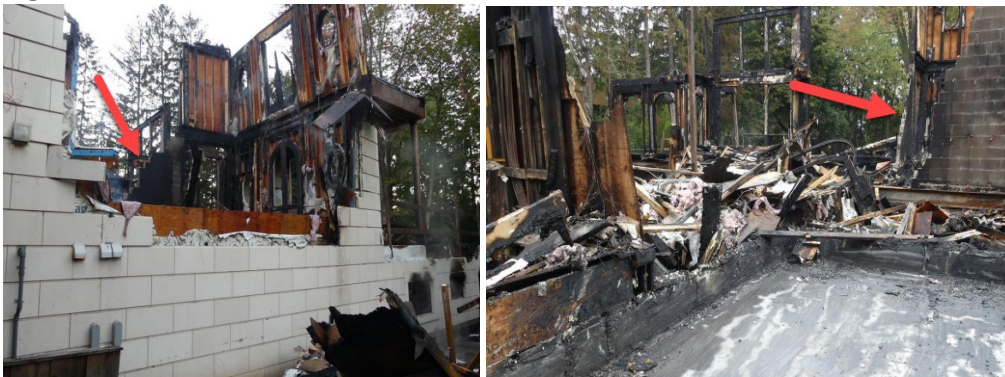
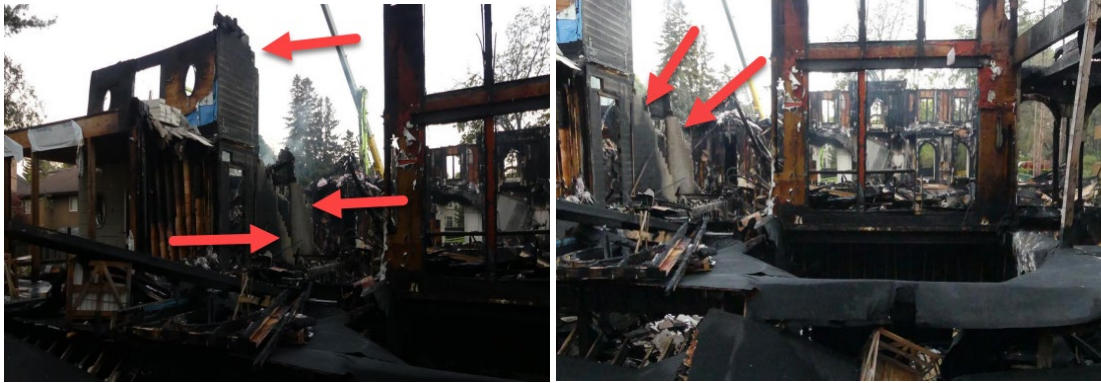
**Figure 2: Firewall remains (as shown with red arrows)**

TFS investigated the origin and cause of the fire. It was not able to determine the cause – fire investigators could not enter the house due to structural concerns and large amounts of water in the house after the fire suppression efforts. The cause of the fire in TFS' report is “undetermined”, which is a type of conclusion that TFS uses when it is unable to conclusively determine the cause of a fire. Appendix 1 has more details about the fire and TFS's investigation.

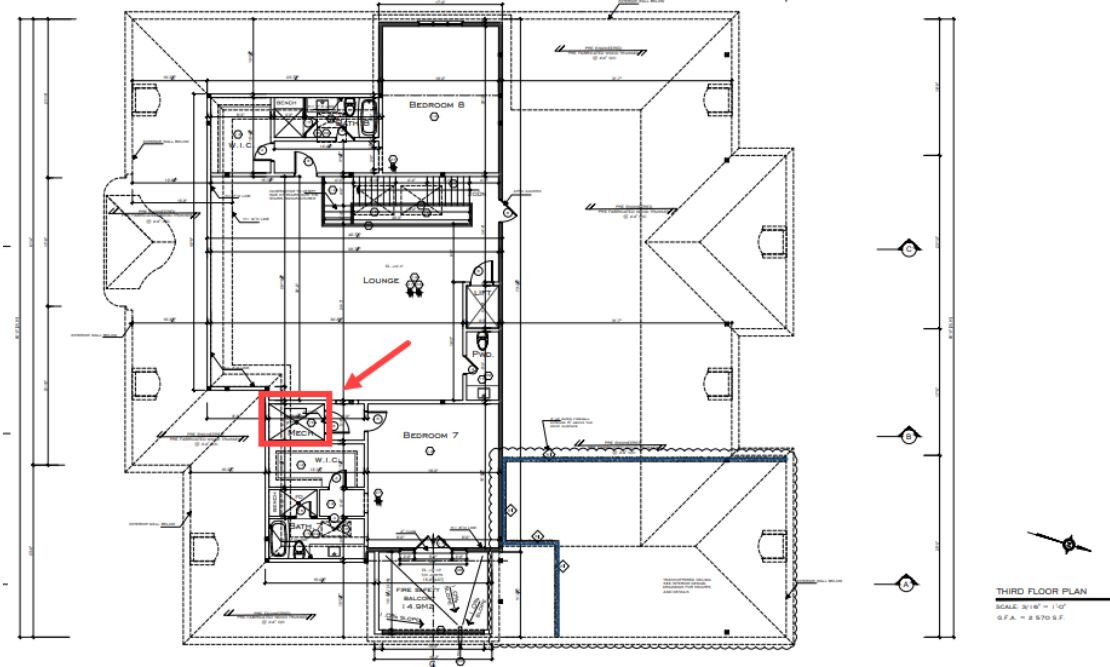
Figure 4: City-approved permit plans showing 1 mechanical room on 3<sup>rd</sup> floor

However, there was just one mechanical room on the third floor/attic in the official drawings and in the HVAC/mechanical drawings. Neither the City-approved permit plans, nor the City-approved mechanical/HVAC plans show a second mechanical room on the third floor/attic.

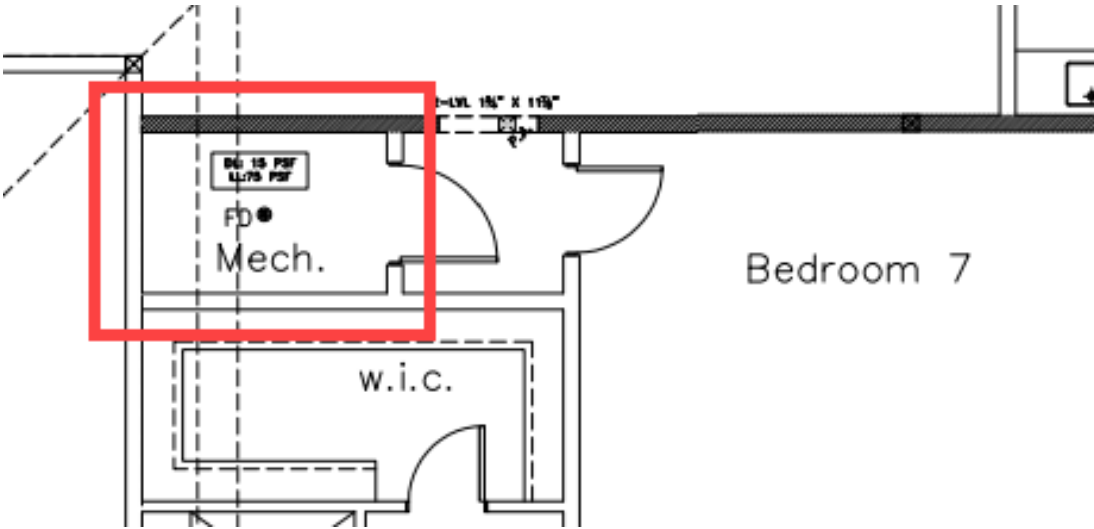
Figure 6: City-approved mechanical/HVAC plans showing 1 mechanical room on 3<sup>rd</sup> floor

Upon visiting the property in July 2021, Inspector 5 noted that there were two mechanical rooms on the third floor/attic. He noted that the extra room was not on the original approved drawings, nor was it on the revised drawings.

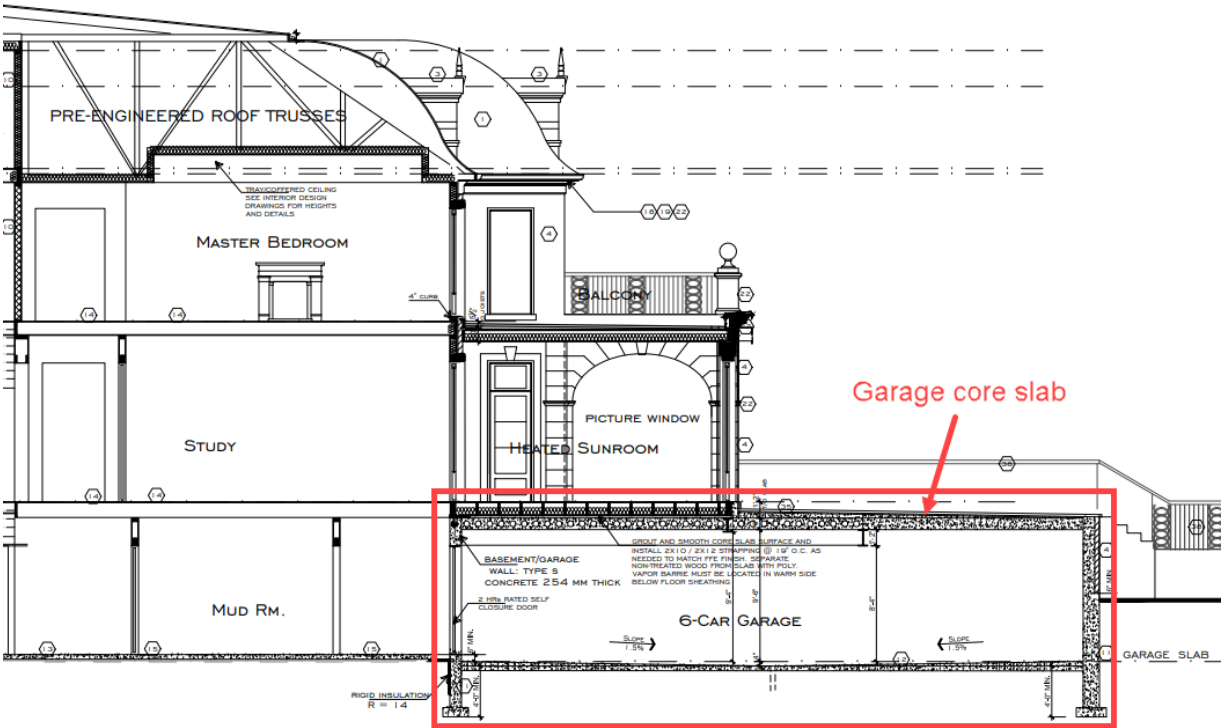
**Figure 11: Original drawings showing concrete core slab to be used for garage roof**

Upon visiting the property and after speaking with the engineer for the project, the inspectors immediately noticed many issues. Perhaps one of the biggest was that the material used for the roof of the garage was made of wood – the plans specified that it was to be made of concrete. This is a material change, and the garage was large, at about 330 square metres. There is a risk that this change could have defeated the concept of keeping the fire compartments on either side of the firewall separate for the same length of time, since it was now a wood garage coming into direct contact with other combustible material. A material change like this would require a revision to the approved plans.

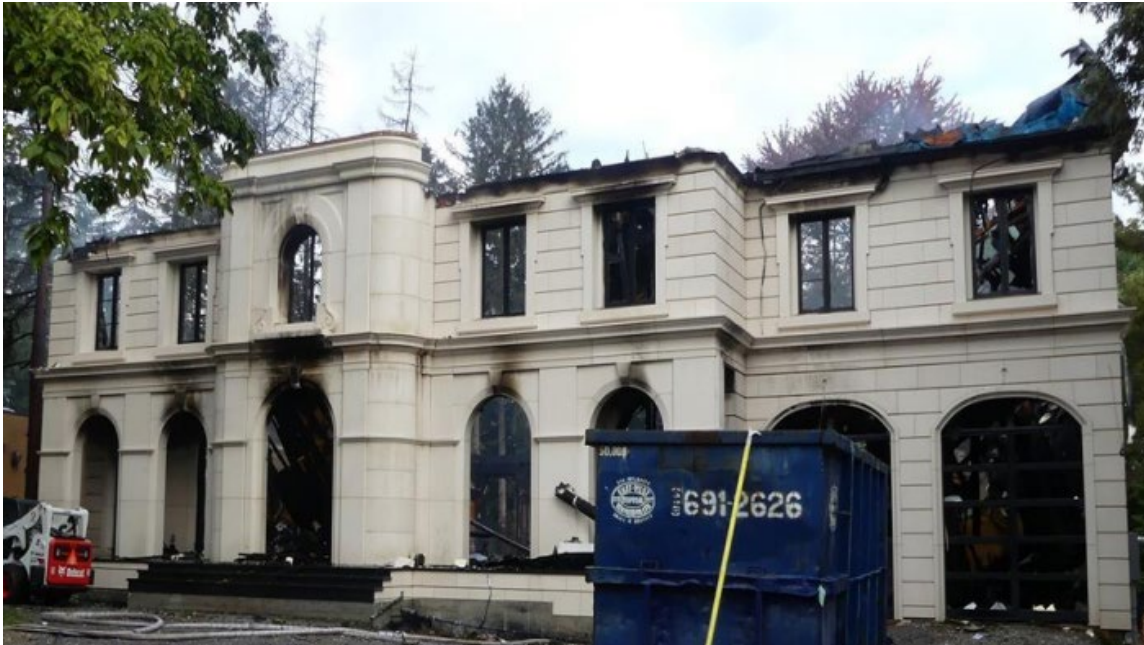
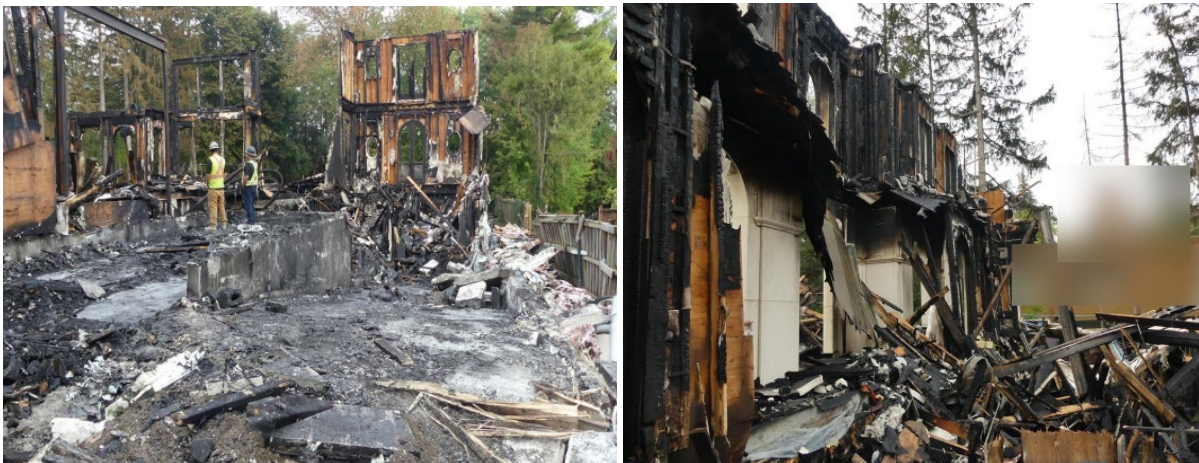
Figure 19: Photos of the fire from TFS, October 5, 2021

*“The exterior was partially collapsed. The entire roof had collapsed, the entire rear exterior walls on the north side were no longer standing, the majority of the west wall had collapsed, more than half of the east wall had collapsed, and the remaining east wall was unstable. The front (south) wall was standing but unstable. The remaining walls had soot deposits above all windows. The garage doors on the front wall were intact with all glass missing.”*

TFS determined that the fire started inside the house but couldn't determine anything more specific than that due to the extent of the fire and the damage. There were video cameras on the site for security purposes. That footage may have been helpful in better understanding the origin of the fire, but the video footage was destroyed in the fire.

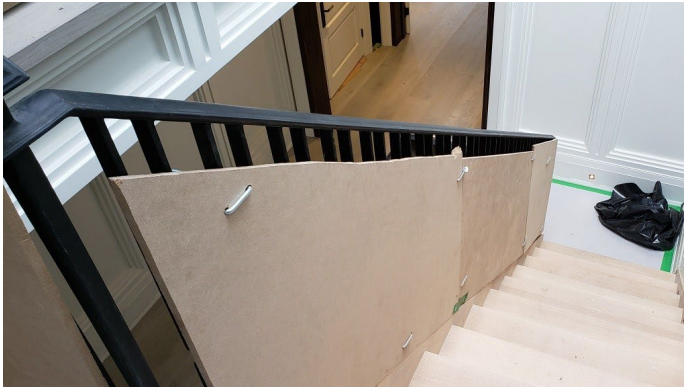
Figure 20: Stairwell railings

There was one remaining issue with the railings on the staircase in the house – they were not at the appropriate sizes in order to prevent a potential safety issue. Inspector 5 issued a letter to the purchaser and said the house passed the occupancy permit provided that any changes to the railings will require a building permit.
