HERITAGE IMPACT ASSESSMENT

505 University Avenue

Toronto, ON

Date of Issue: 22 August 2025

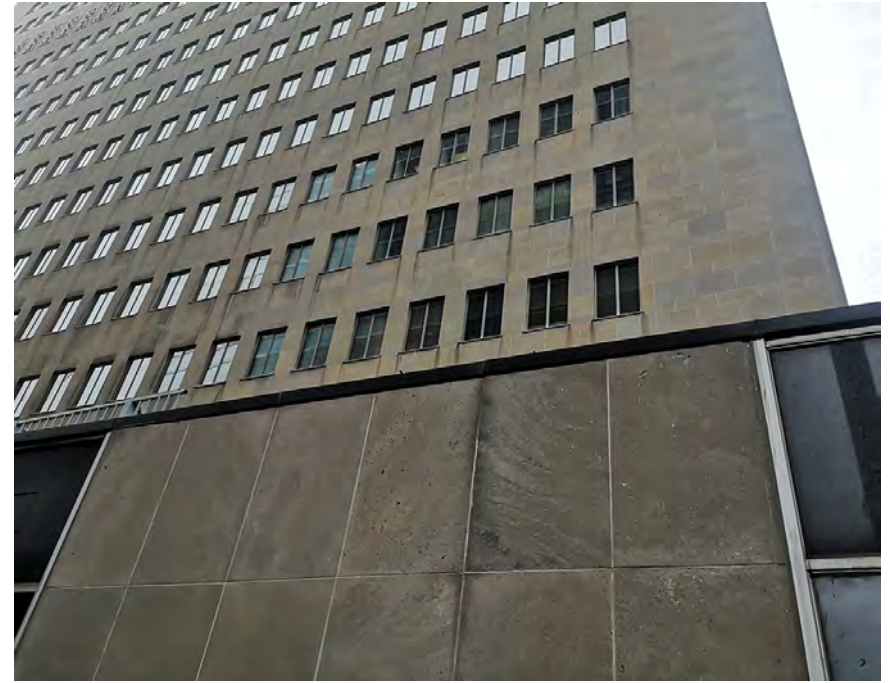
North elevation view, showing (at the bottom of the image) a portion of the one-storey volume with stone and granite cladding. Note the stone is in fair condition. Soiling is notable near the joints. Of note are some porous panels, which appears to be a natural imperfection of the stone and has not caused deterioration. On the north elevation of the tower, soiling below the window sills is noticeable at the corners, due to a lack of proper edge detailing.

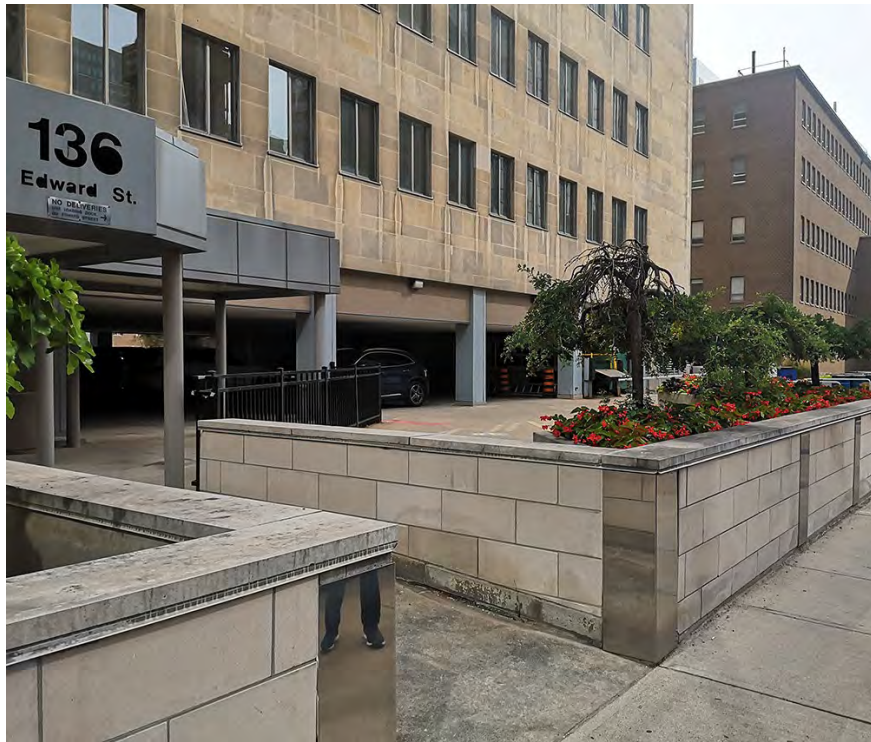
Looking east on Edward Street, showing the bottom portion of the south elevation that is set back from Edward Street. The parking garage is at grade and located underneath the second storey of the building. This parking is hidden by the one-storey base volume (not visible in the photo). The low-rise stone barriers in the foreground are later additions. Note similar conditions of the stone to that found on the north elevation, with soiling evident at the bottom of the sills.

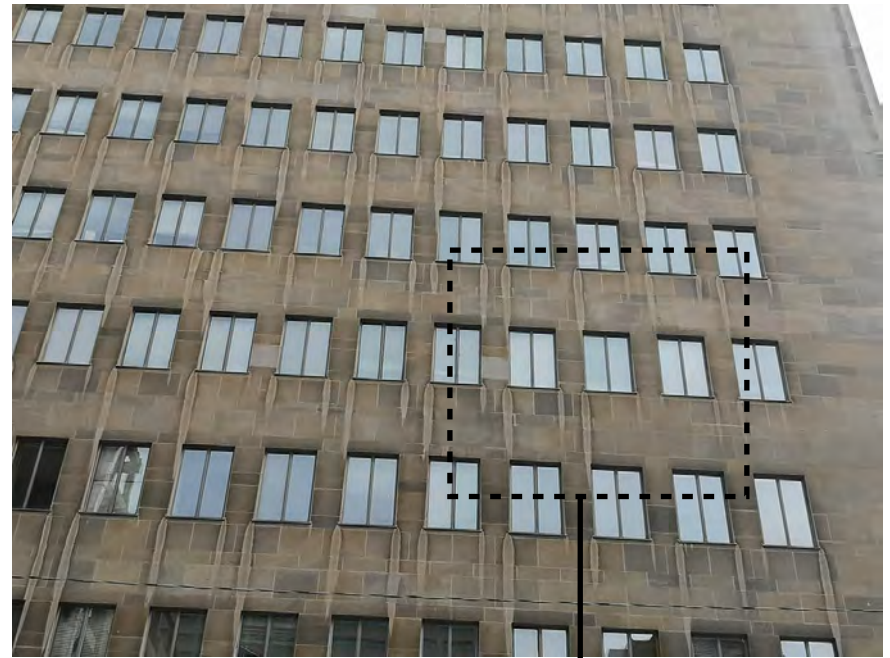
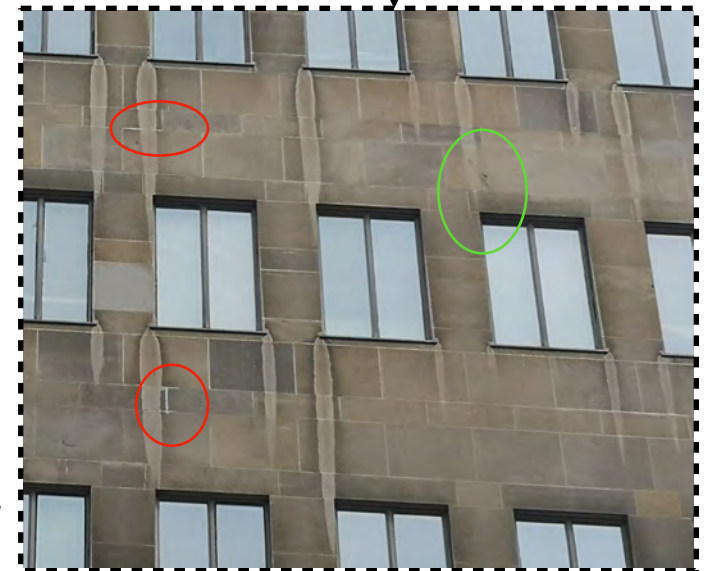
Looking towards the overall south elevation and the consistent soiling below the sills. Localized areas of mortar repointing appear to have been inappropriately completed (red circle) and some localized panels appear to be damaged (green circle)

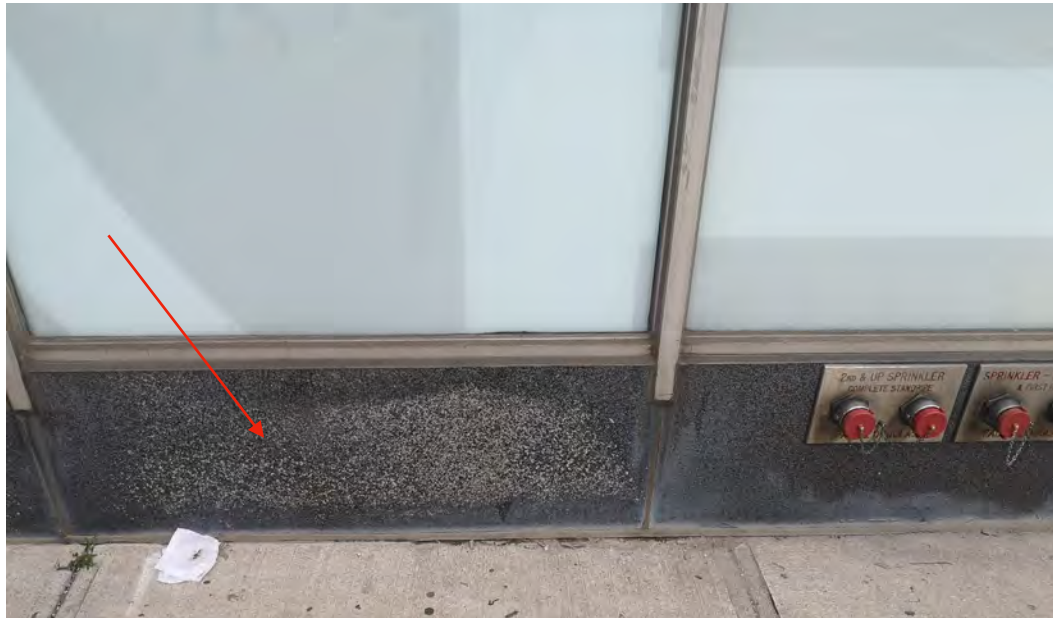
Lower portion of the one-storey volume, facing University Avenue, showing a discoloured granite panel (arrow).

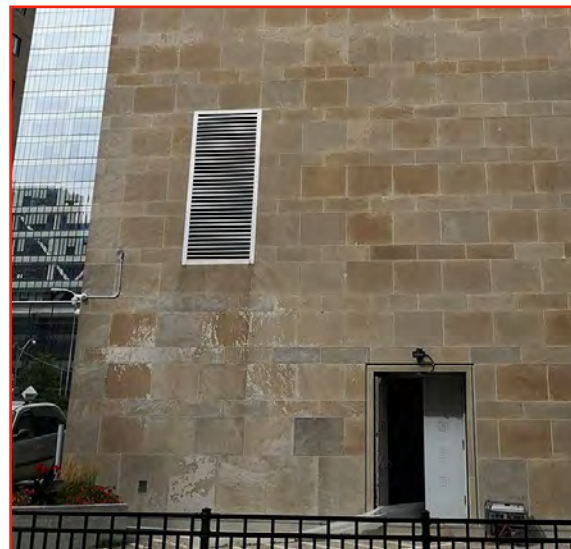
Near right: Close-up of the bottom portion of the wall, showing deteriorated stone panels immediately below a venting grille. Damage is due to freeze/thaw cycles due to condensation of exhausting interior warm air.

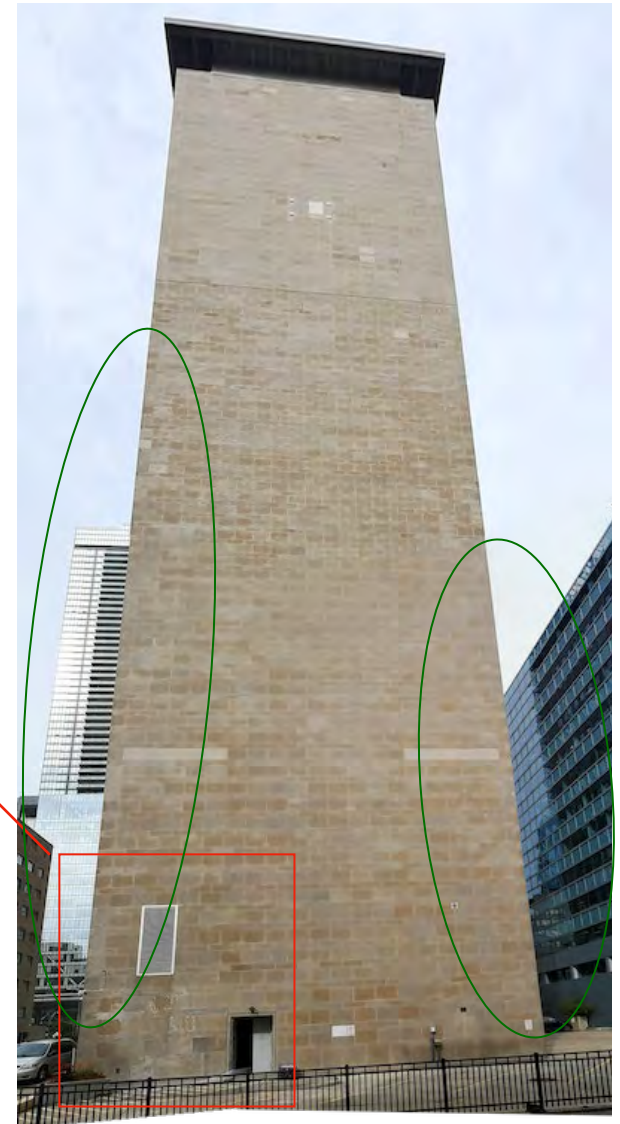
Far right: Overall view of east elevation, showing visible stone replacement (light coloured Indiana limestone). Ovals represent extent of corner cracking which was originally thought to be oxide jacking of embedded steel at the bottom of the wall but, with more detailed engineering analysis, appears to be caused by torquing of the building under load. A detailed view of the southeast corner is found on the following page.

A review by GBCA and Clifford Restoration Limited revealed cracking for over five storeys at the northeast, southeast and southwest corners of the facades as noted above. It has been determined that the masonry facade is very stiff and contributes to the lateral stiffness of the building. This was not considered in the original design. Seismic¹⁰ loads and heavy wind loads on the long walls put pressure on the structure¹¹ and are resisted by the masonry rather than the structural moment frame system, the latter of which is not fully engaged before the loads are absorbed by the masonry. While Toronto is in a low-level seismic zone, minimal provisions for seismic movement were made in the original design. As the building is thin in the north to south direction, there is less stiffness in the end walls than the long walls. The result is that the building is subject to torsional, or twisting, loads with the bending most severe at the corners at the lower portion of the tower. Movement induced by these loads results in observed cracking, typical for masonry in these conditions, which has already been repeatedly repaired.

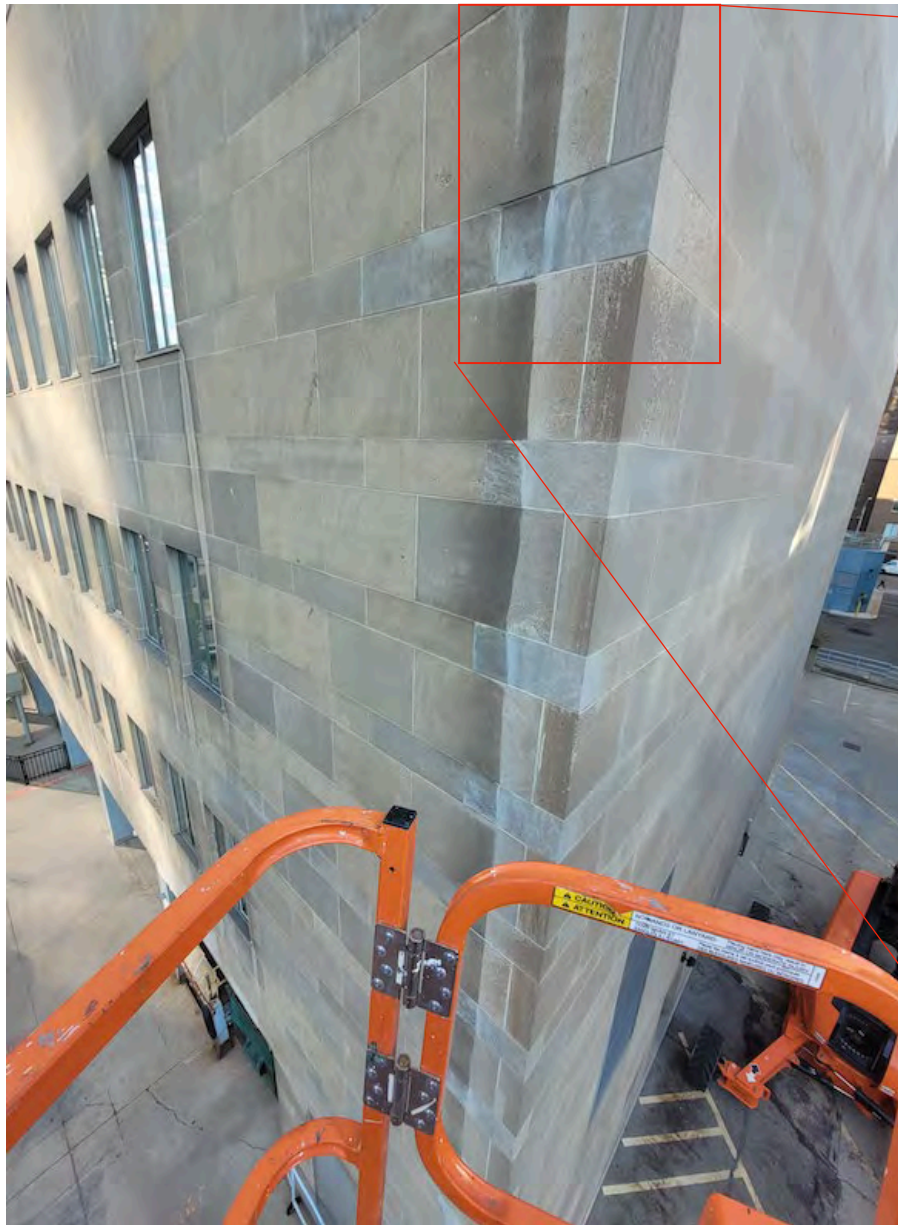
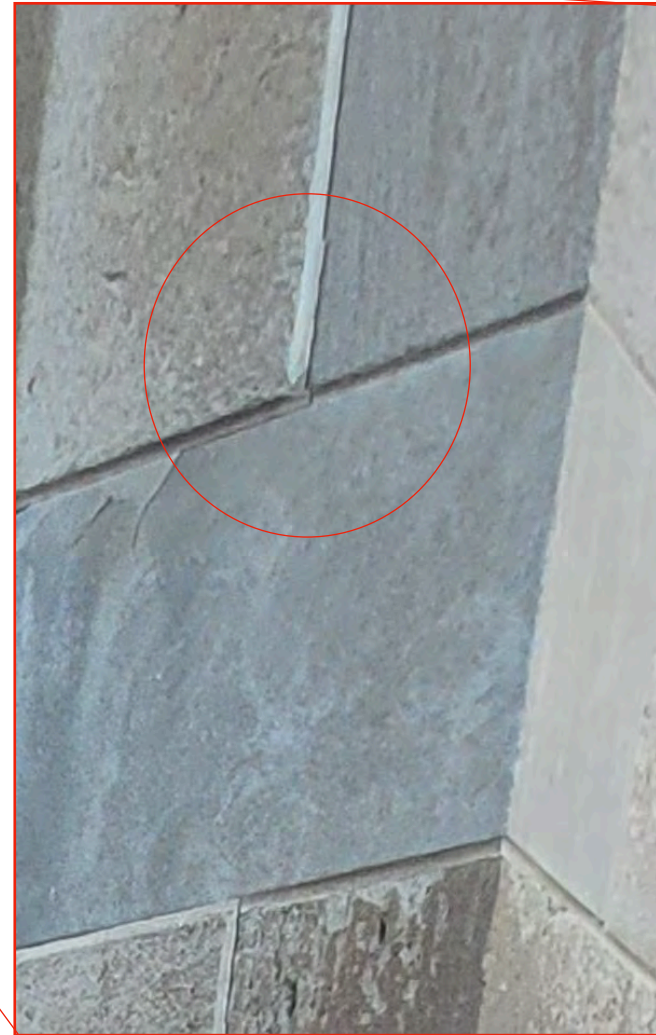
Cracking at southeast corner (4th Floor extending to grade). Joint repairs within the past 20 years are again opening up (circle in the magnified detail. Similar conditions occur at other corners (particularly the northeast and southwest although the base of the building at the west is partially constrained by the podium causing less damage at the west corners).

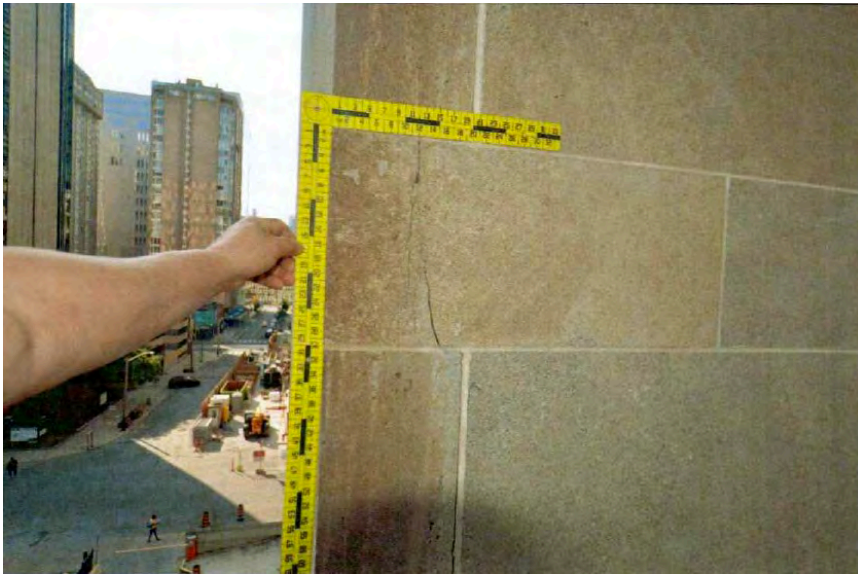
Above - Through-stone cracking at northeast corner (3rd floor)

This cracking, repaired previously, extends from the 5th floor to grade and includes outward displacement of stone by as much as 8mm.

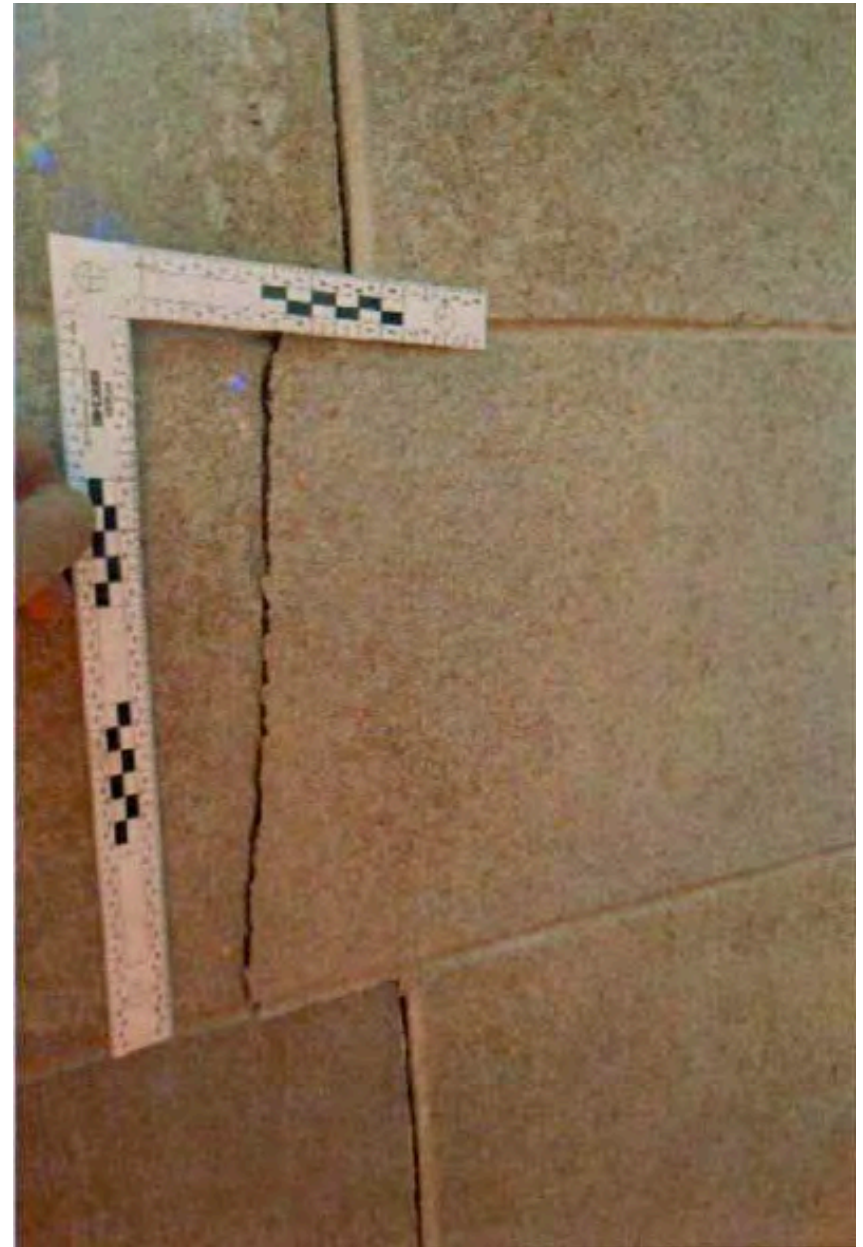
At right - Through stone crack and joint de-bonding (4th Floor).

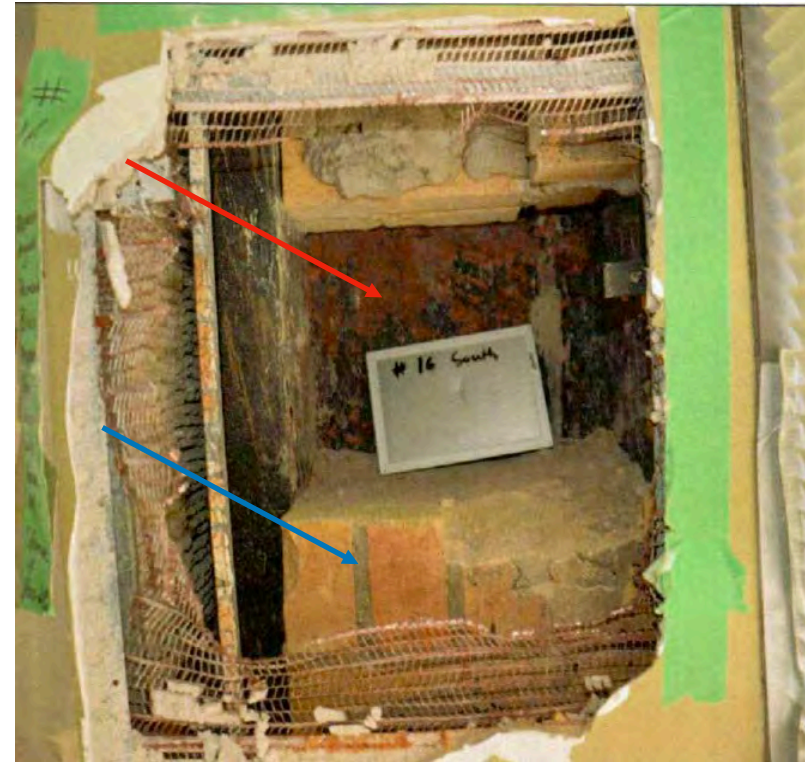
Illustration from the Clifford Restoration report. The red arrow points to the web of a steel H column into which masonry (blue arrow) has been built. The masonry is built tight to the flanges and web of the column. The steel is corroding at this middle level floor – lower floors will see greater levels of corrosion due to ponding of water.
