505 University Avenue, Toronto- Site investigation report

Prepared by:	Donovan Pauly, MSc, CAHP, APTi (Architectural Materials Conservator)
Prepared for:	Sam Trigilia
Location:	505 University Avenue, Toronto, Ontario
Date of site visit:	September 16-25

Objective

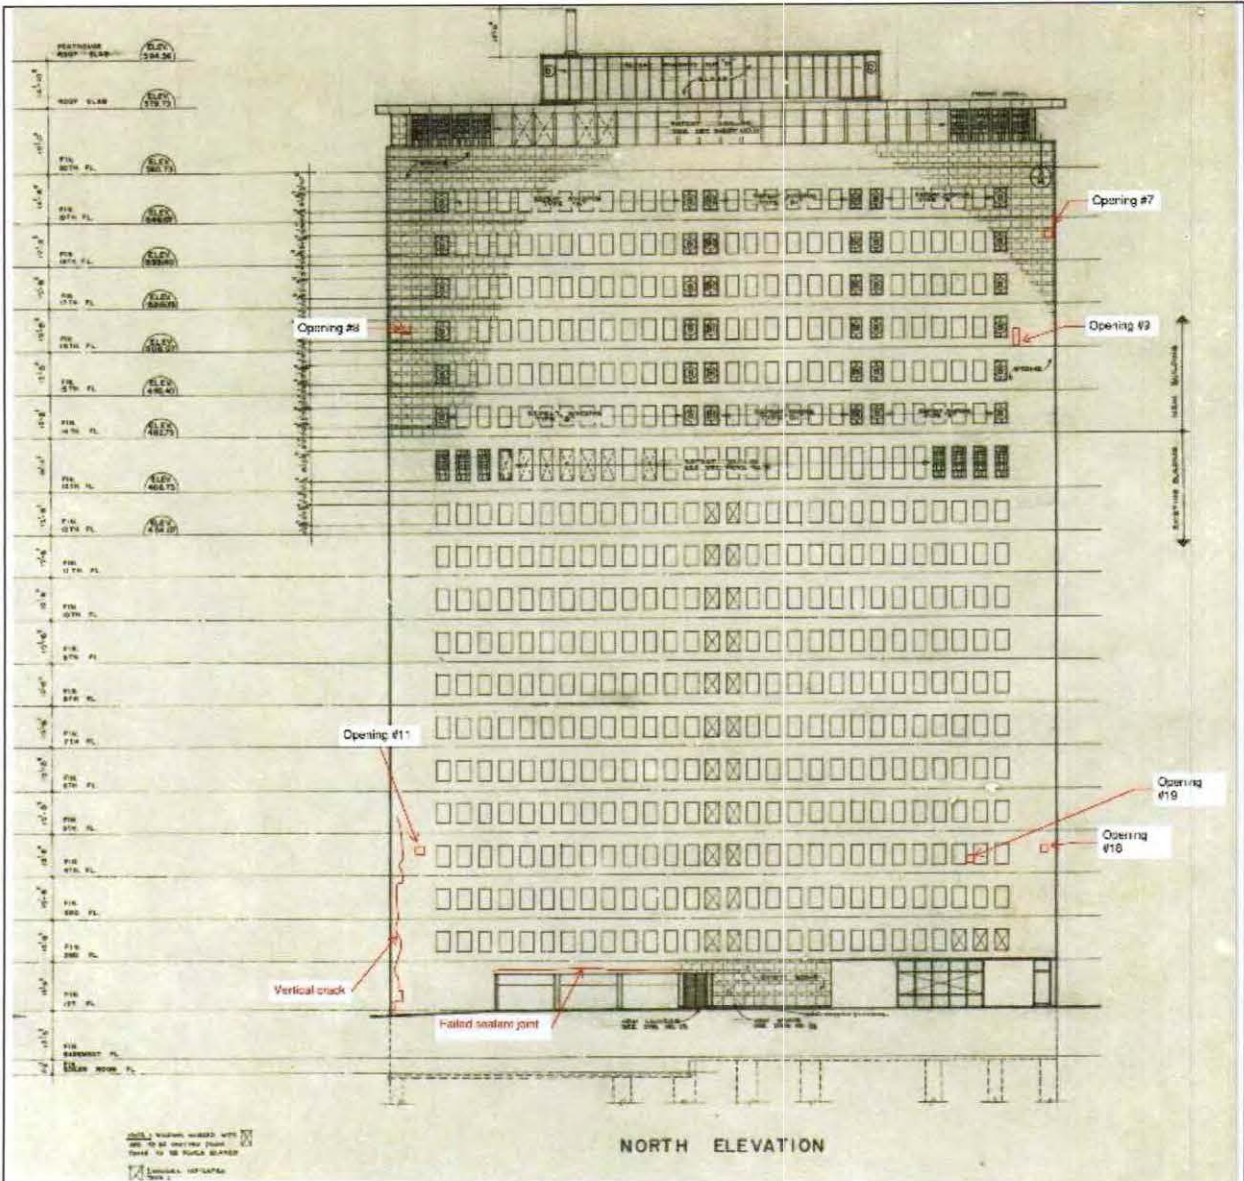
Figure 2 Excerpt of scanned drawing 11A with markup North elevation.

There are two areas where some significant vertical cracks have occurred. The most serious of these is at the northeast corner, primarily on the north side. There is a structural movement that appears in the cladding at grade and travels upward in a relatively straight line to the middle of the 5th floor. There is a slight displacement out-of-plane toward the north at this crack +/- 6mm at the lowest stone and to a lesser degree above. It is difficult to determine the cause of this movement and cracking as there may be several factors involved, including building settlement, thermal movement or perhaps some internal corrosion of embedded metals stressing the cladding (it was not possible to investigate this internally as there is a large boiler or incinerator flue directly behind this area).

This cracking and displacement are a concern, and some movement appears to have occurred more recently, evidenced by a spreading mortar joint that appears to have been repointed previously (not original). This crack is also open to the elements, passes directly through some bonder (12" high) stones and certainly allows water runoff to enter the wall assembly. This defect should certainly be monitored and should be repaired as soon as possible to limit additional decay and potential worsening. It would be prudent to carry out an investigation in this area and below grade to determine the cause of this and repair and remediate it to restore structural cohesion in this corner.

The primary recommendation currently is to carry out some additional investigation at the northeast corner where the vertical cracking is most severe. This should include some excavation to confirm the condition of the foundation and below-grade areas at this corner as the lowest ashlar block on the north is displaced down and outward here and this could be a sign of foundation settlement issues. It would also be beneficial to remove some stone units higher up on the structure (2nd-4th floor areas) to determine if there is a metal corrosion issue there stressing the cladding and forcing it outward.

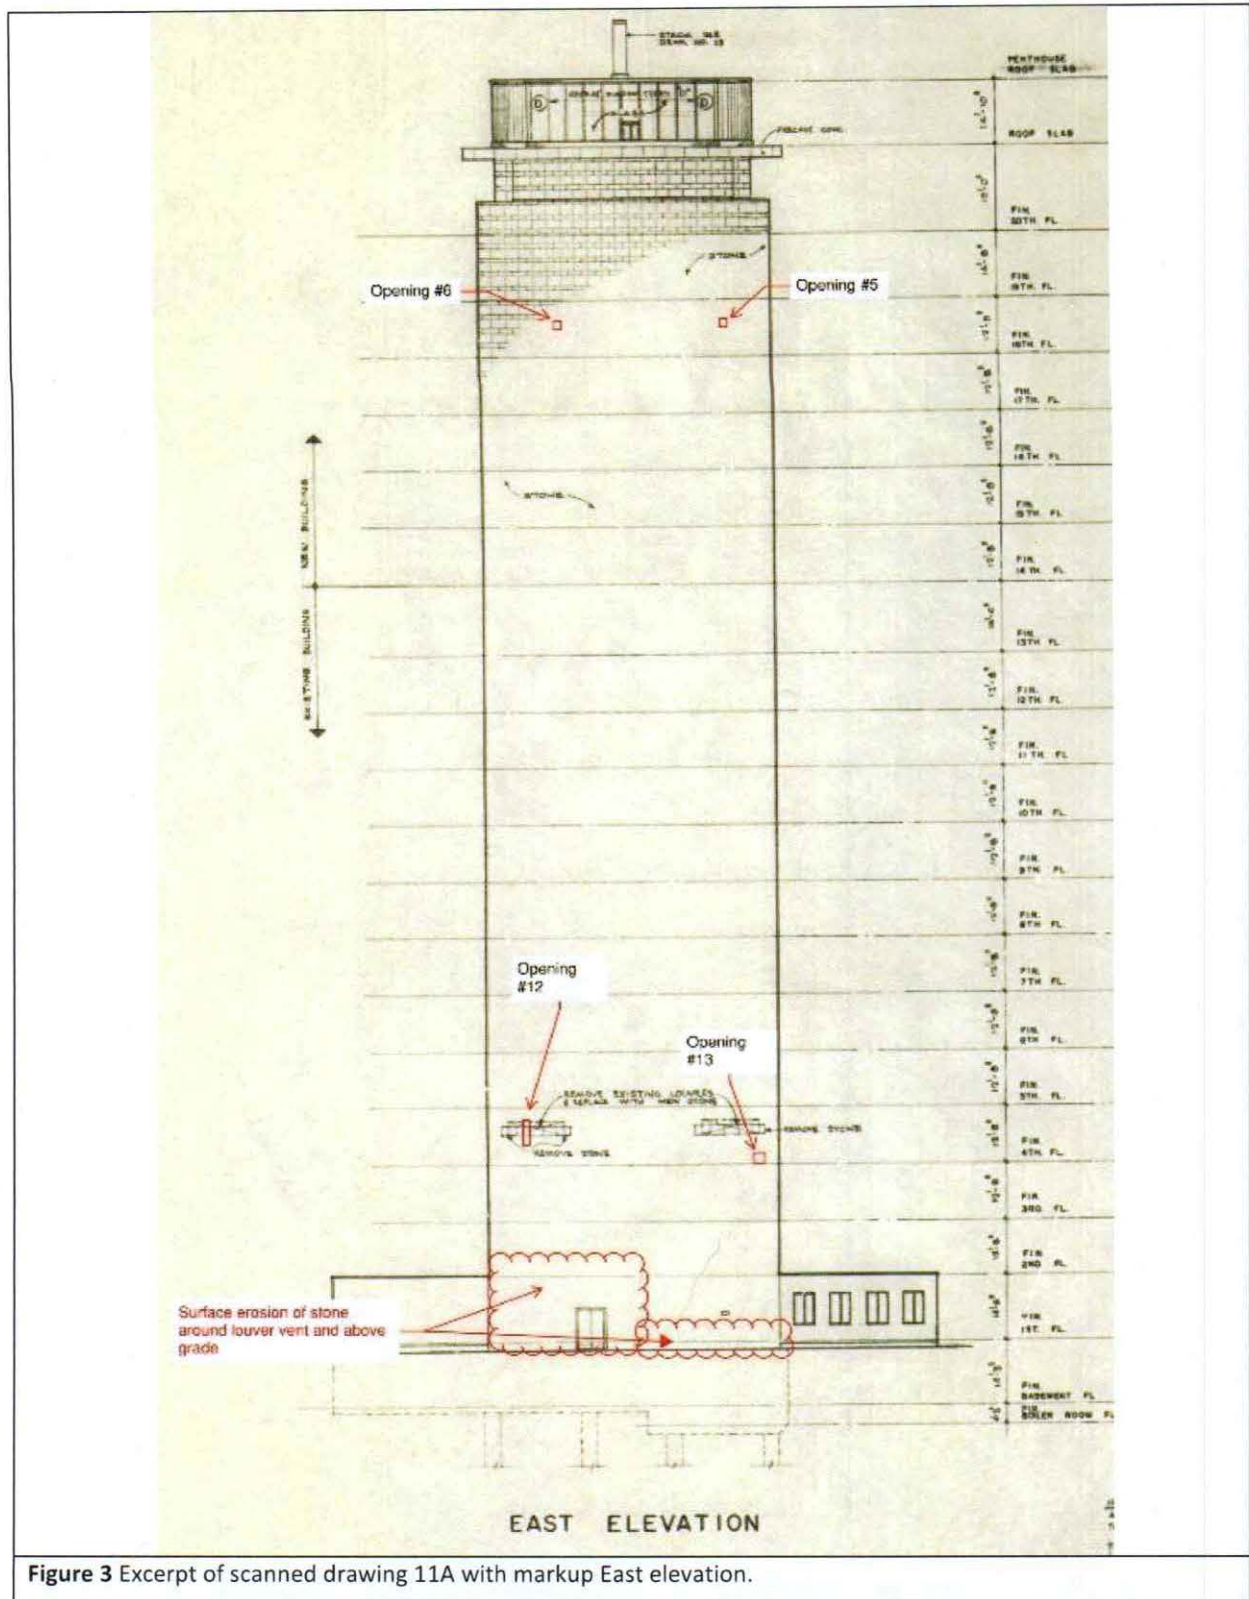
Figure 3 Excerpt of scanned drawing 11A with markup East elevation.

There are also areas of surface loss on the east elevation above grade around the large louvred vent. This is most likely due to moisture in the expelled air from the vent accelerating the surface decay.

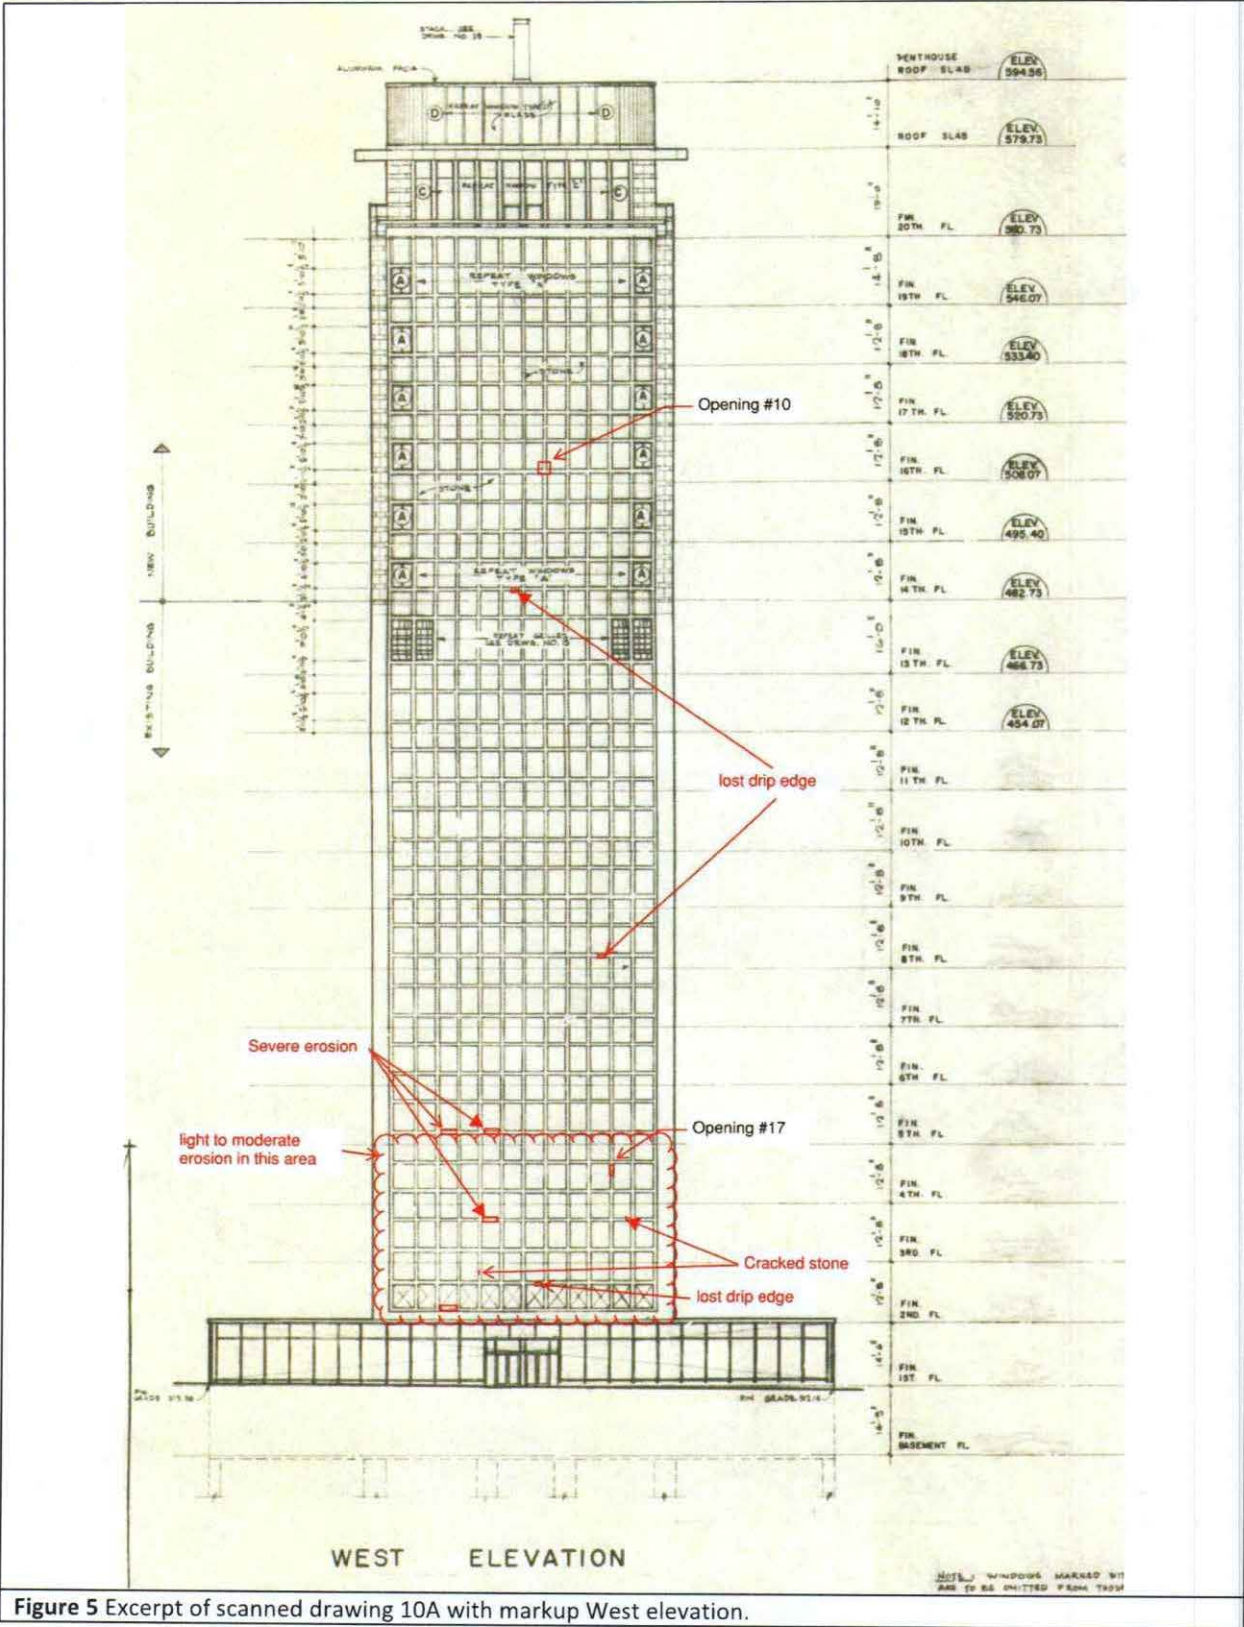
Figure 5 Excerpt of scanned drawing 10A with markup West elevation.

There are also a few stones that are cracked in isolated locations on the west elevation One is a small vertical spandrel mullion section, and one is a window lintel which appears to have been previously repaired. Neither of these cracked stones are any reason for concern at this point but, they should be monitored and repaired to ensure that they remain stable.

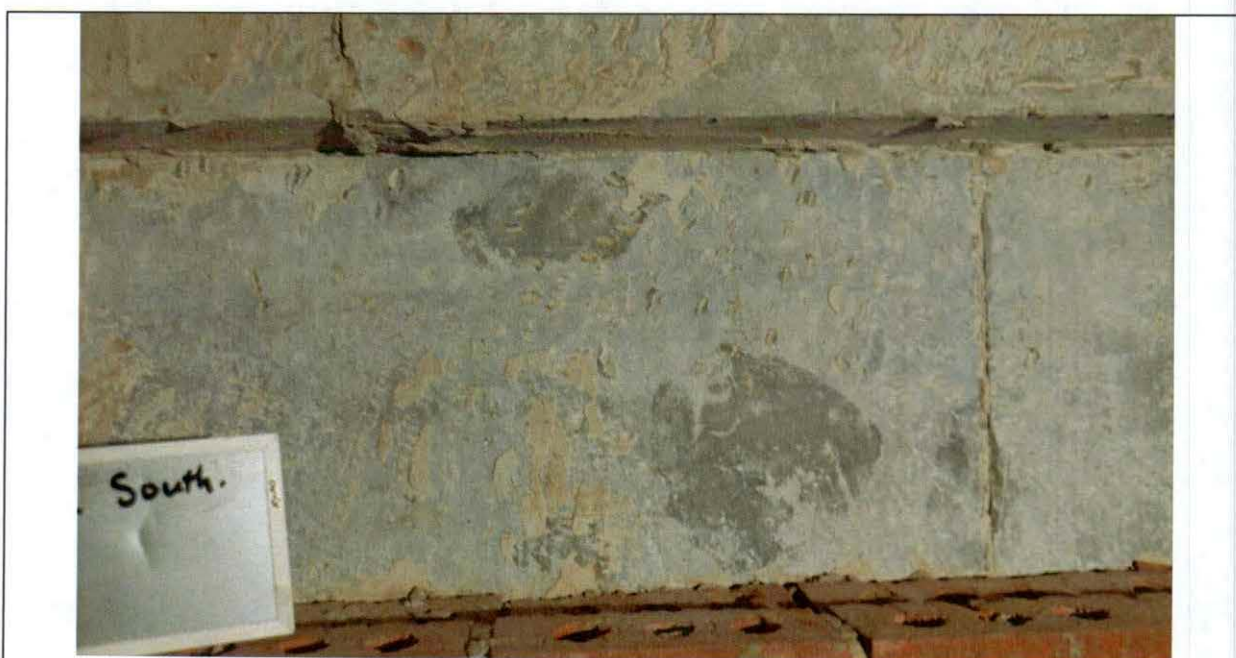
Figure 11 Investigation opening #1 Detail. Stone veneer is block bonded with brick backup. No ties were found here.

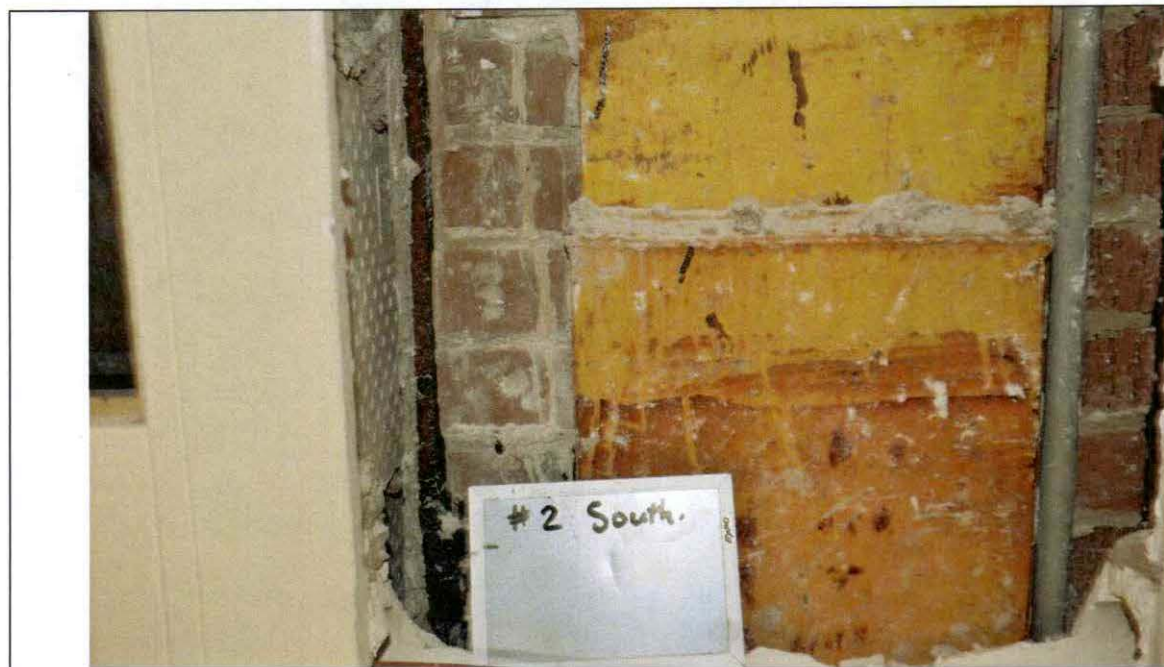
Figure 13 Investigation opening #2 Detail. Fire protection was removed. The paint coating is in good condition- very minimal corrosion was evident.

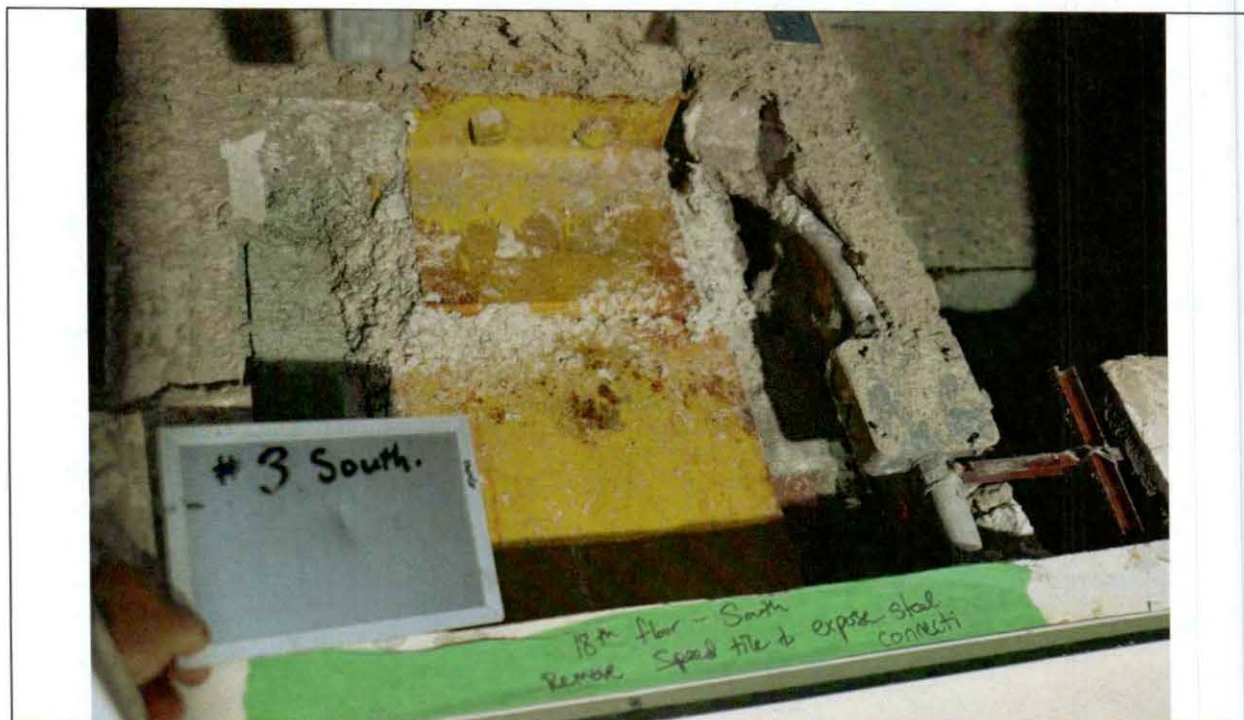
Figure 14 Investigation opening #3 at column and beam connection Fire protection was removed.

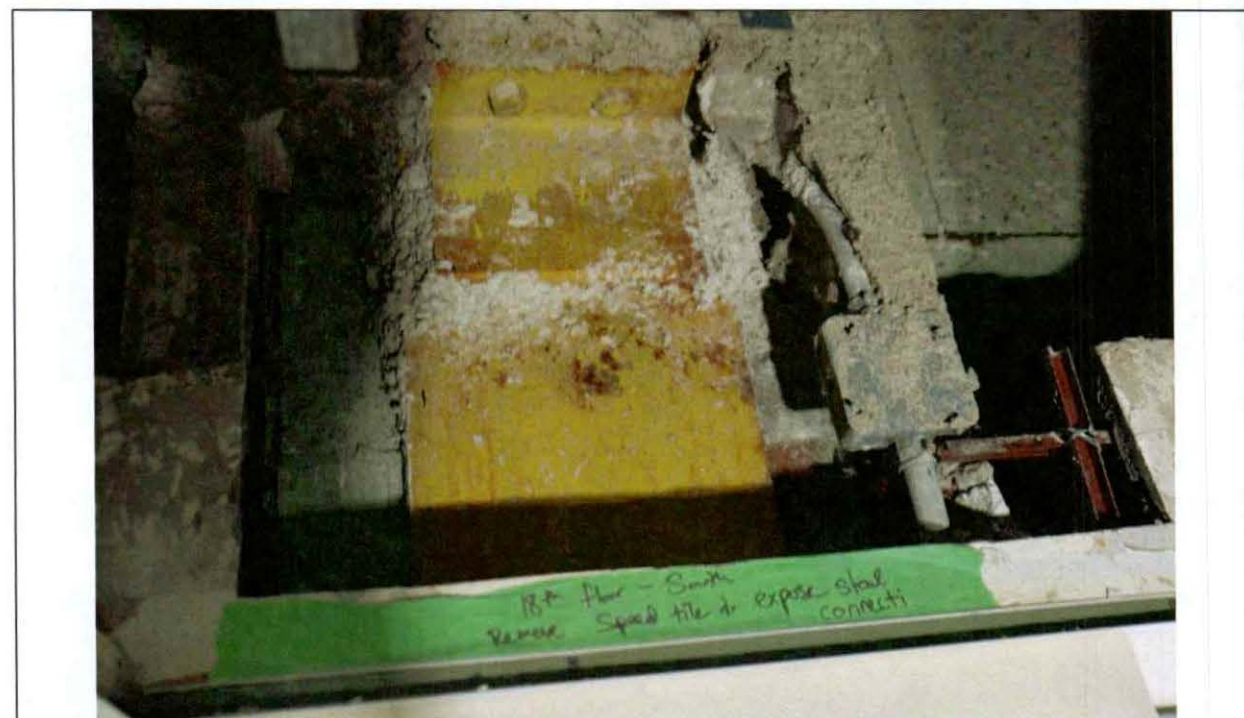
Figure 15 Investigation opening #3 Detail. The paint coating is in good condition.

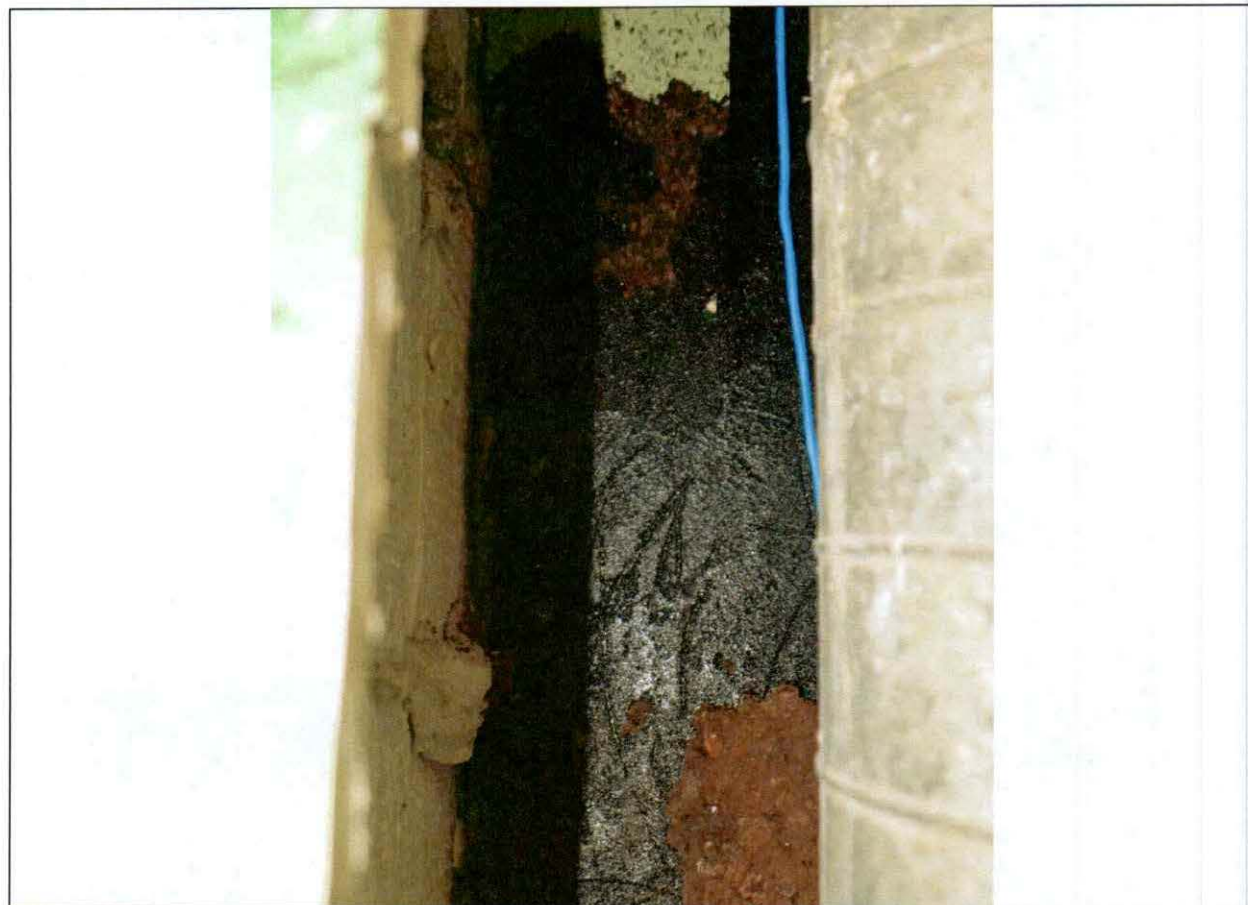
Figure 17 Investigation opening #4 Detail. The corkboard insulation was removed. A bituminous layer over parged stone masonry was found.

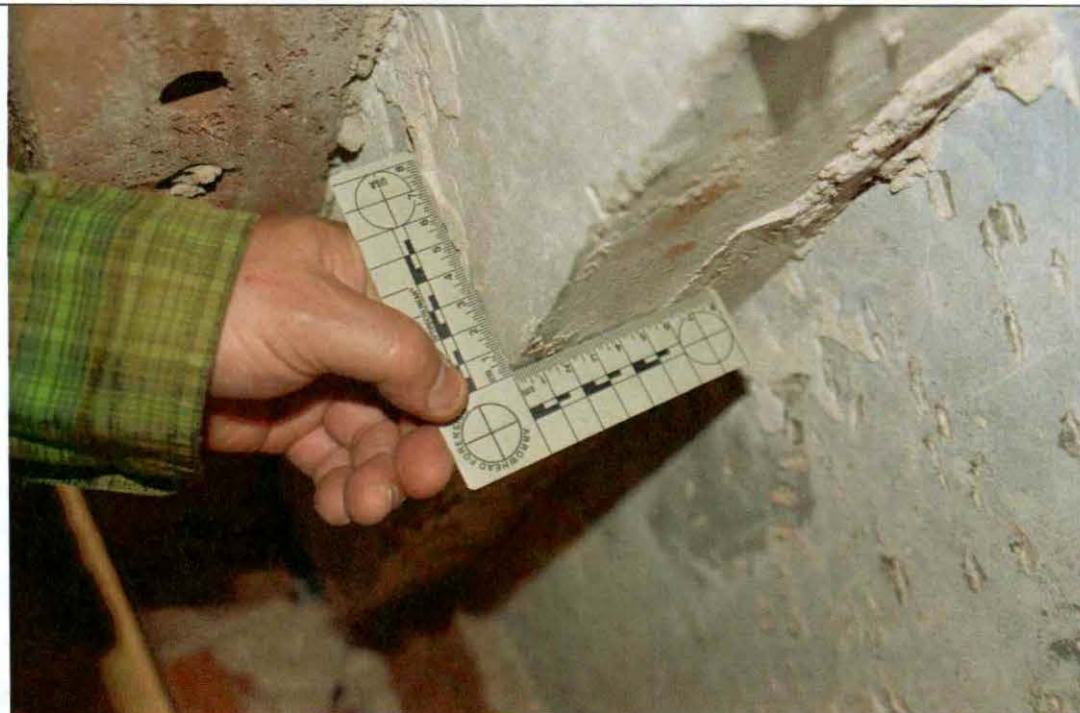
Figure 19 Investigation opening #5 Detail. Stone veneer is block bonded with brick backup. No ties were found.

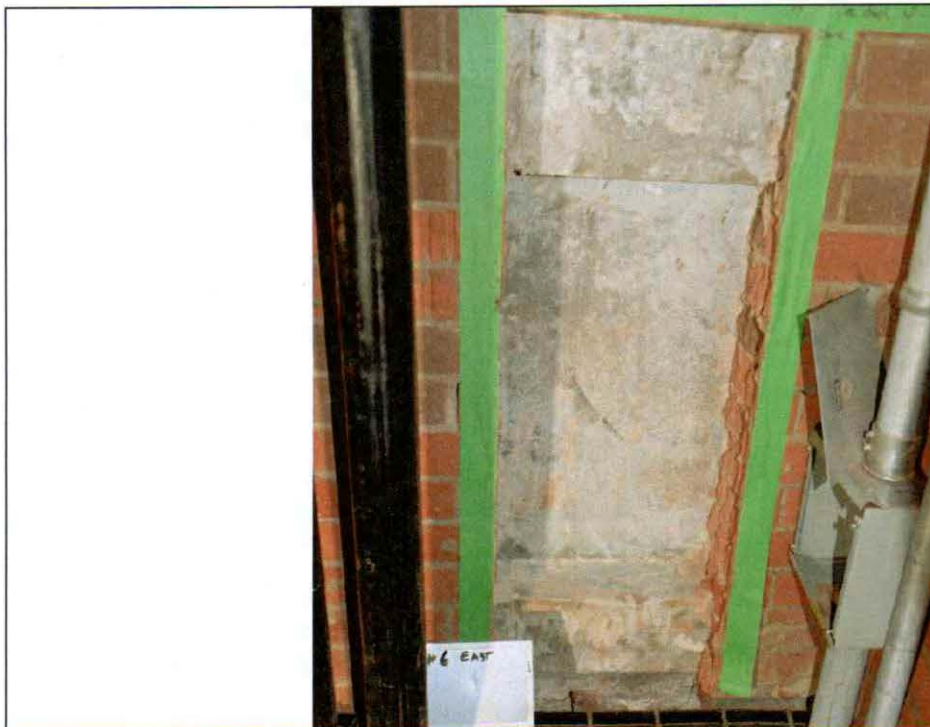
Figure 21 Investigation opening #6 Detail. Stone veneer is block bonded with brick backup. No ties were found.

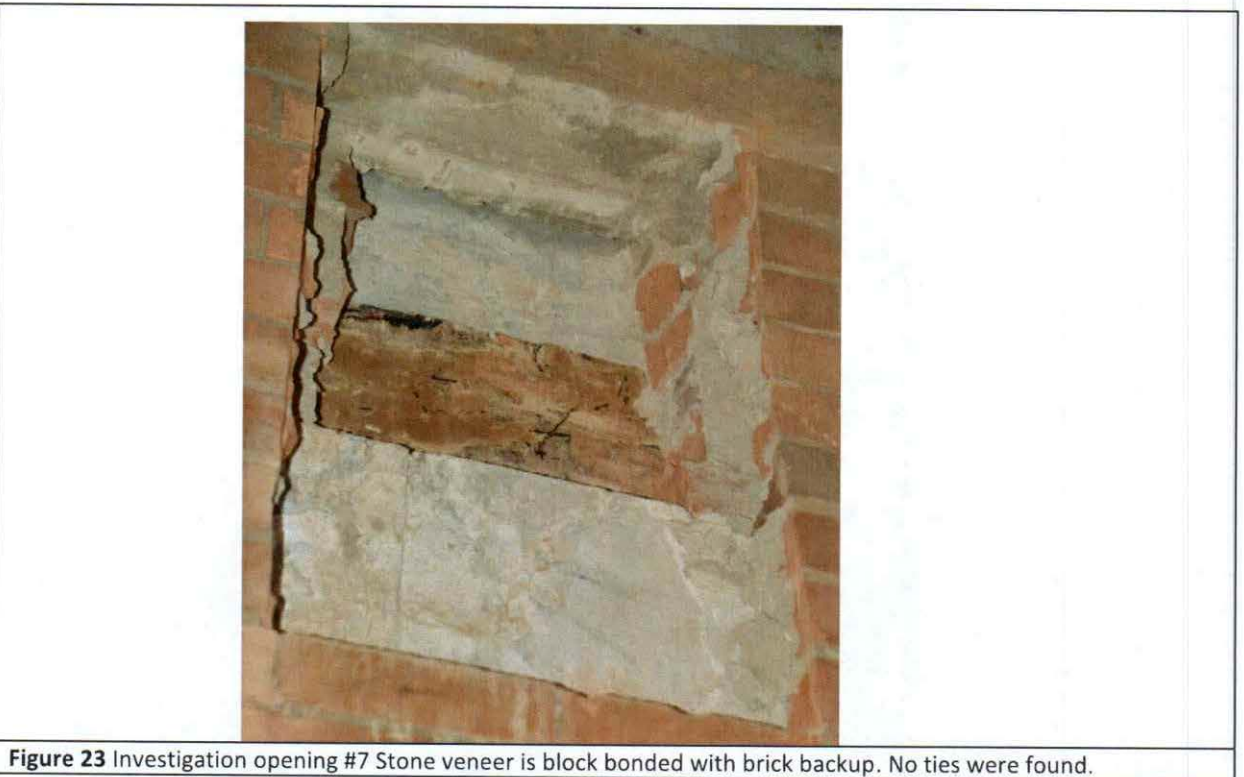
Figure 23 Investigation opening #7 Stone veneer is block bonded with brick backup. No ties were found.

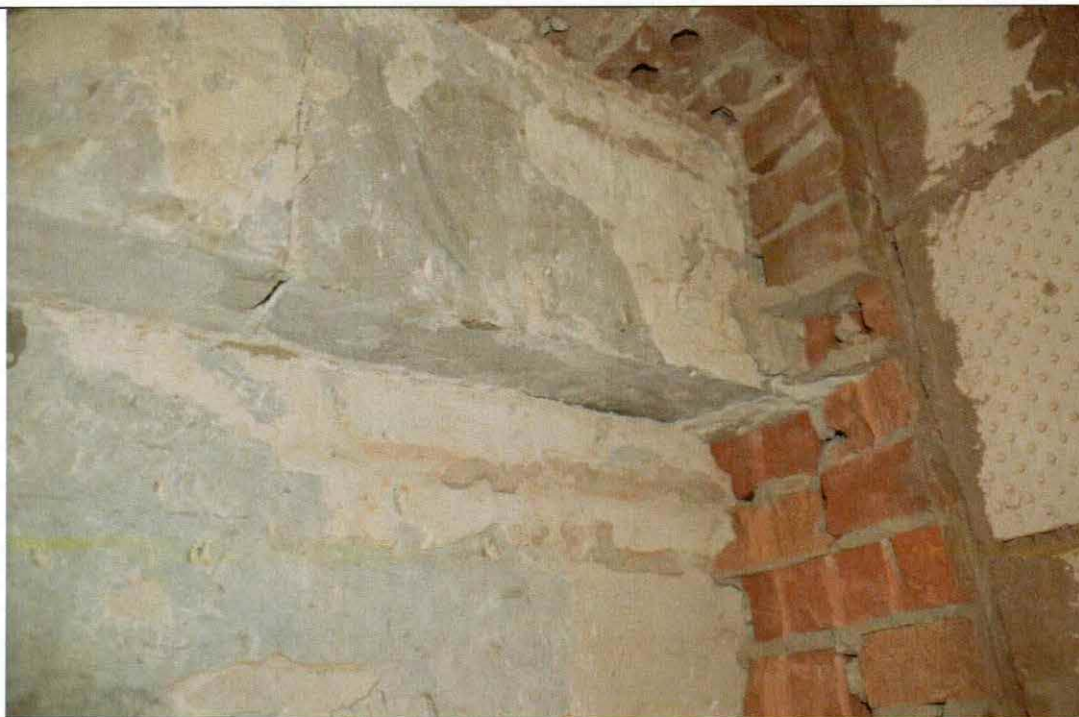
Figure 25 Investigation opening #8 Detail. Stone veneer is block bonded with brick backup. No ties were found.

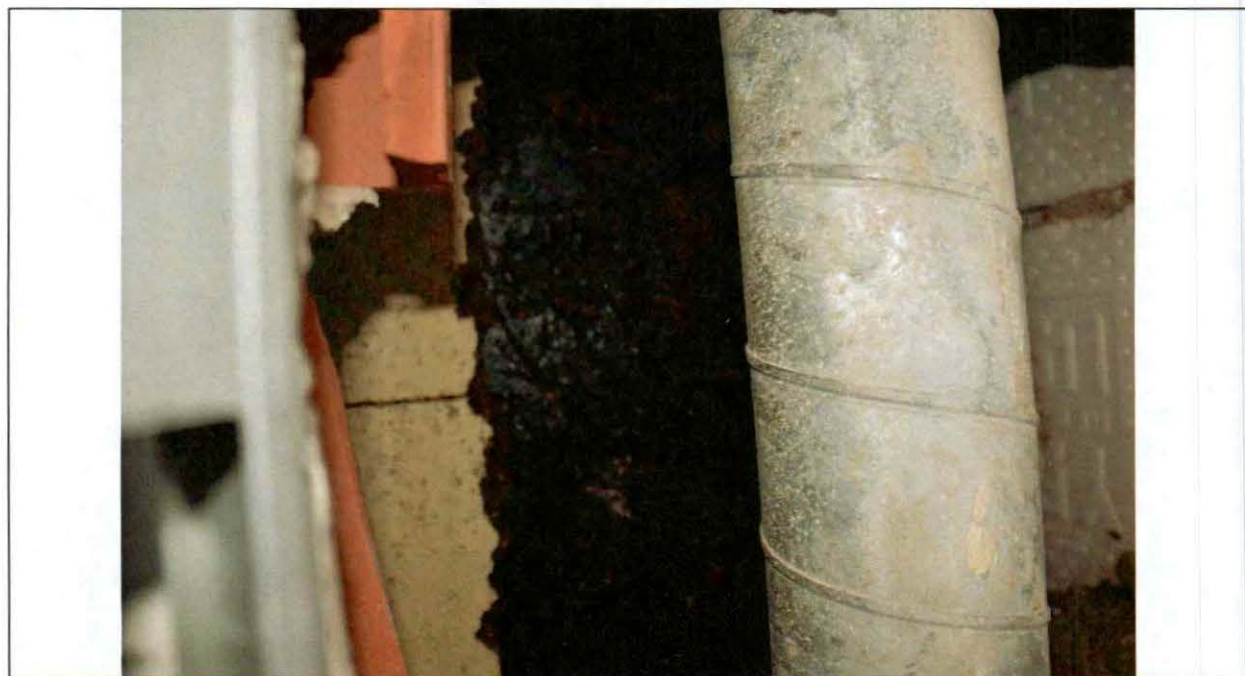
Figure 27 Investigation opening #9 Detail. The corkboard insulation was removed. A bituminous layer over parged stone masonry was found.

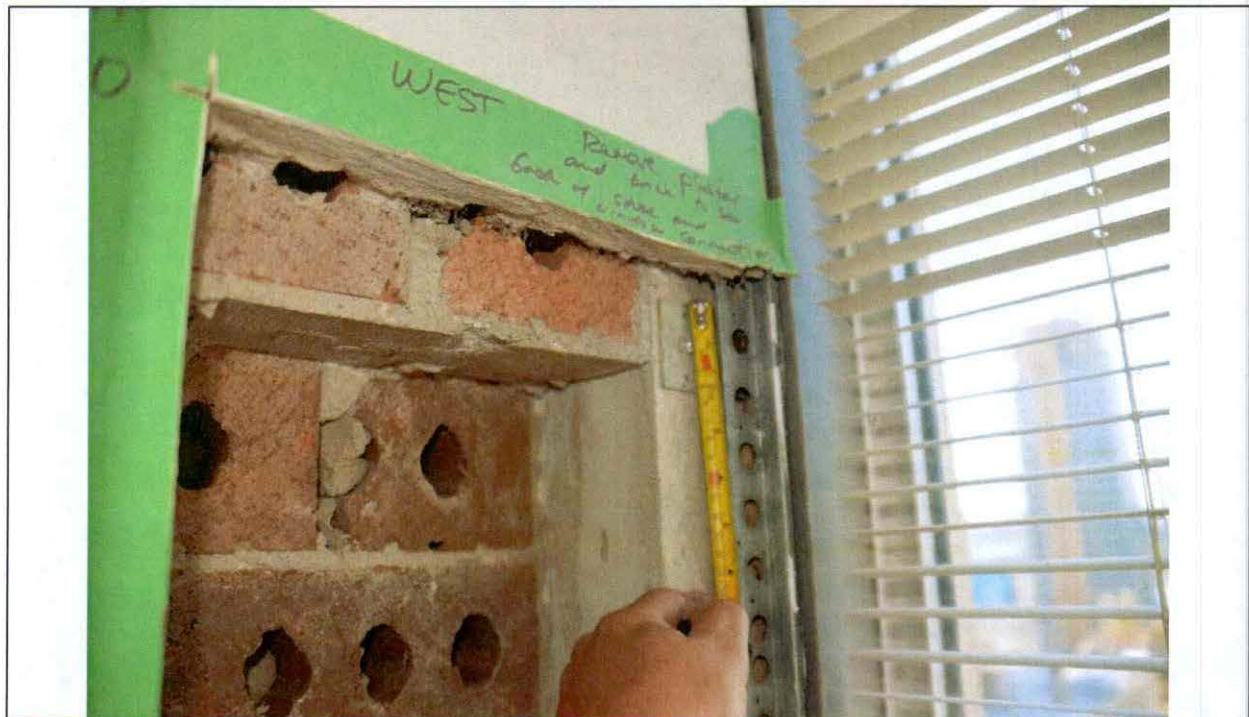
Figure 29 Investigation opening #10 Detail. Stone window reveal mullion with brick backup. Window tie anchored with #12 Galvanized screw. No moisture barrier was found.

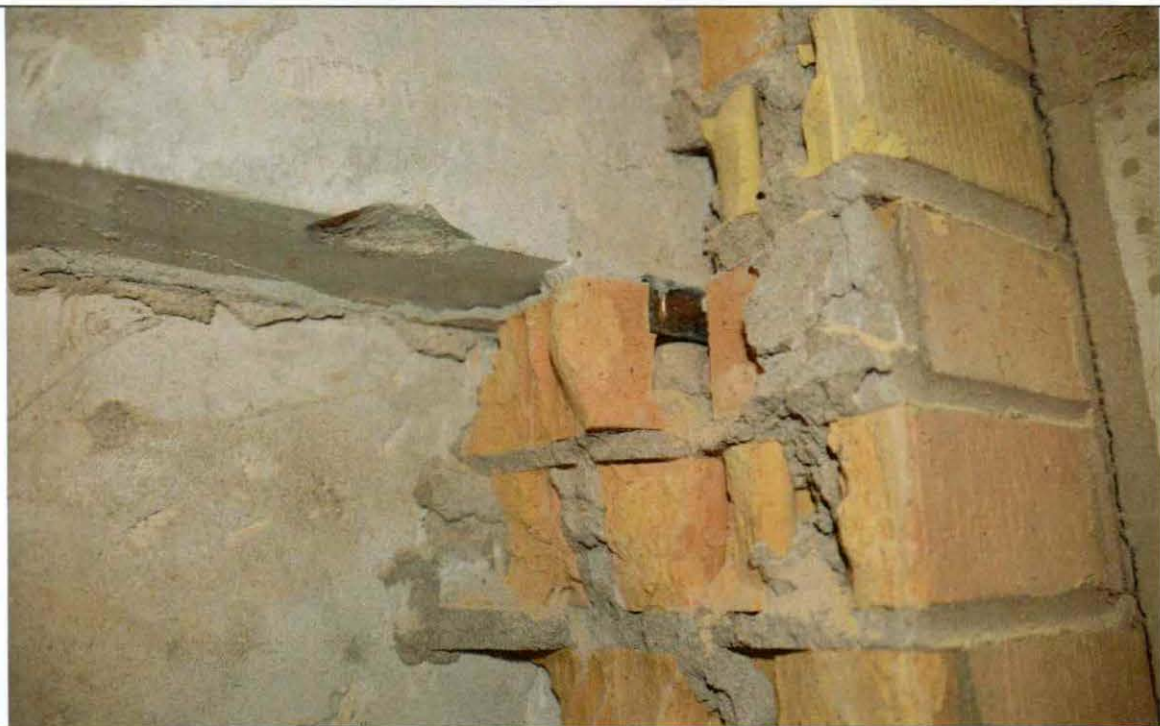
Figure 31 Investigation opening #11 Detail. Stone veneer is block bonded with brick backup. One bronze wall tie was found (RHS).

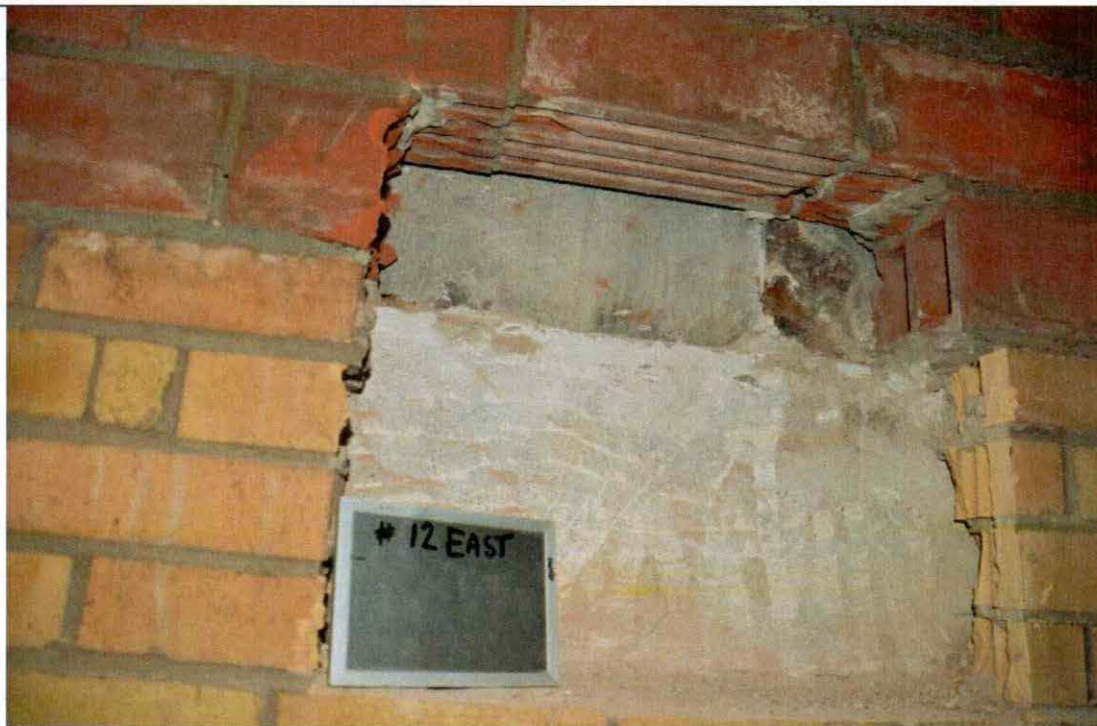
Figure 33 Investigation opening #12 in vent shaft Detail. Stone veneer with brick backup- replaced Indiana limestone (vent infill) at upper. No ties were found.

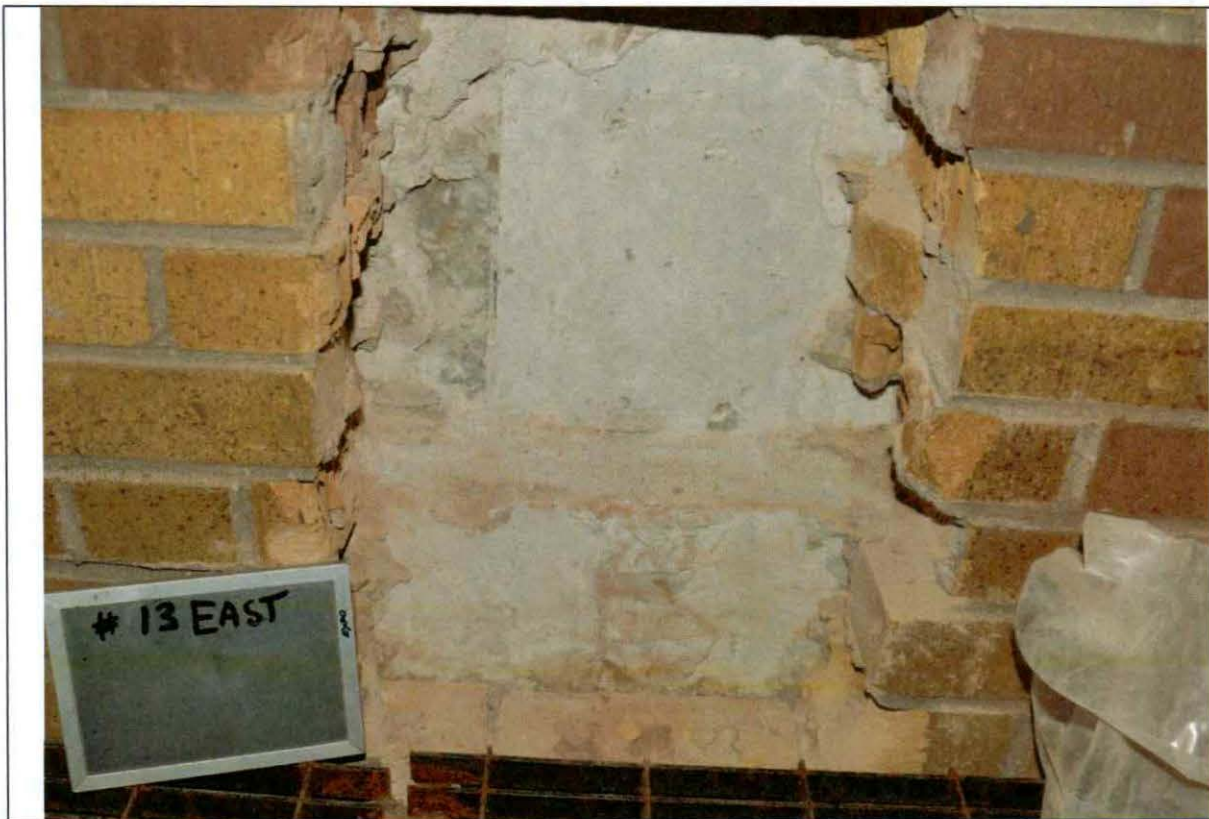
Figure 35 Investigation opening #13 in vent shaft Detail. Stone veneer is block bonded with brick backup. No ties were found.

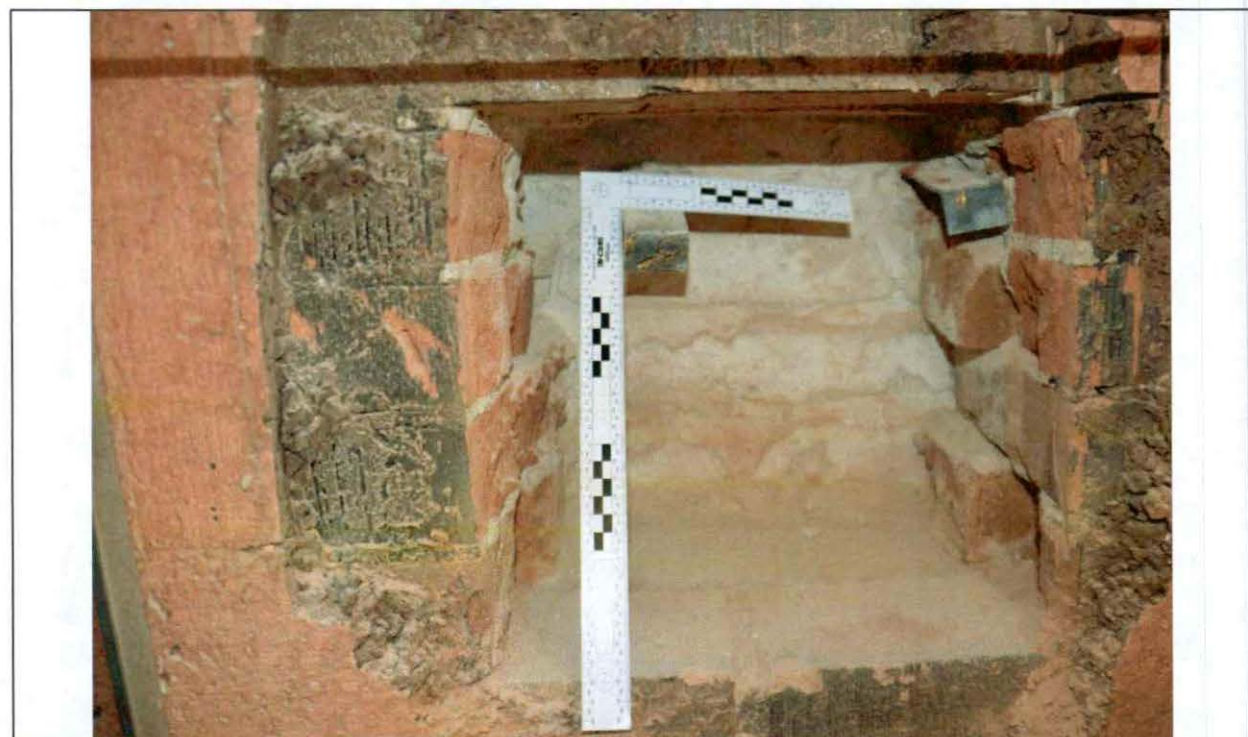
Figure 39 Investigation opening #15 Detail. Corkboard and brick masonry were removed. 2 ties were found- ties appear to be bronze (or similar copper alloy) and in good condition.

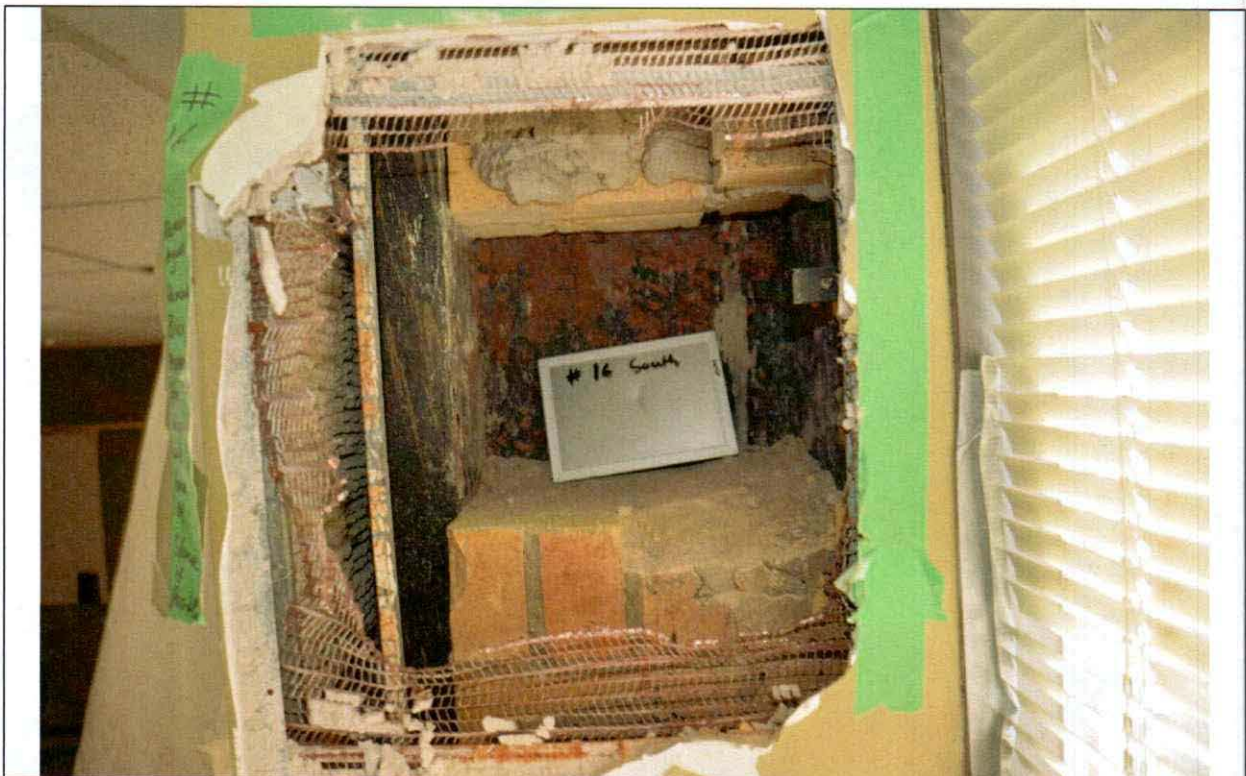
Figure 41 Investigation opening #16 Detail. The brick infill was removed. Some coating failure on steel and light corrosion are evident (black paint).

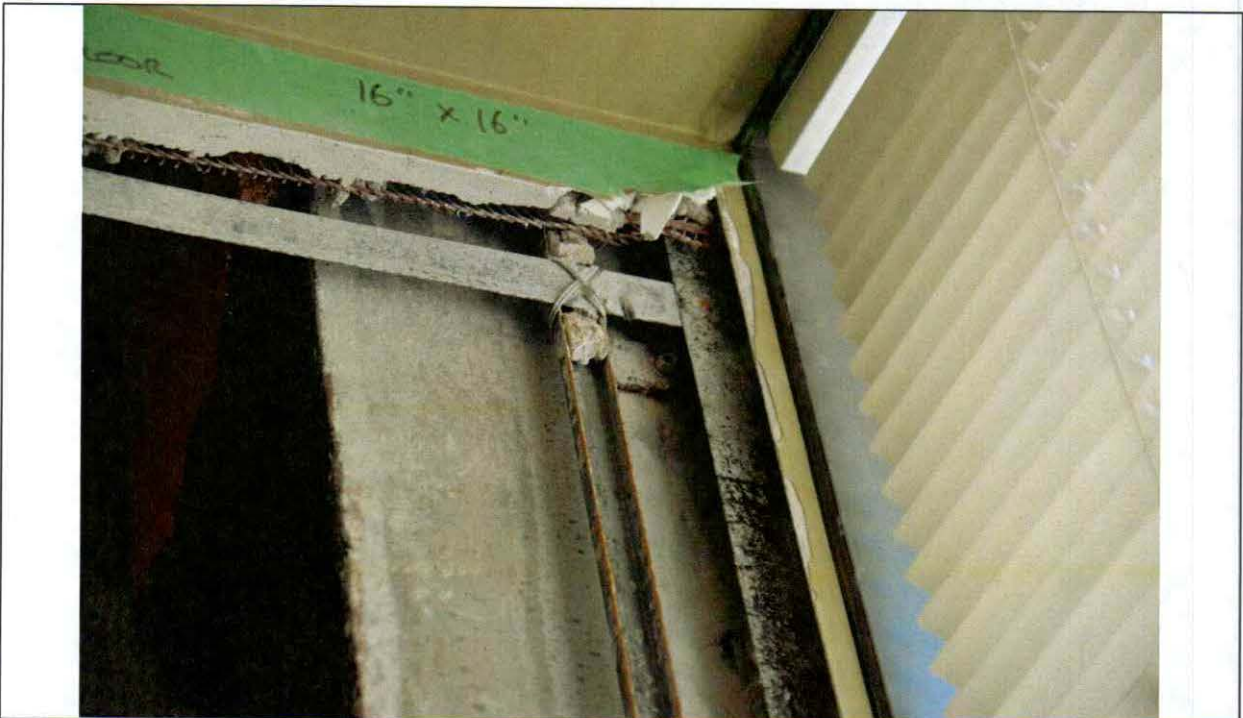
Figure 43 Investigation opening #17 Detail. Mullion stone is full depth- no backup masonry is present. Some light corrosion is evident on plaster framing elements. Window ties are anchored with #12 Galvanized screws into stone.

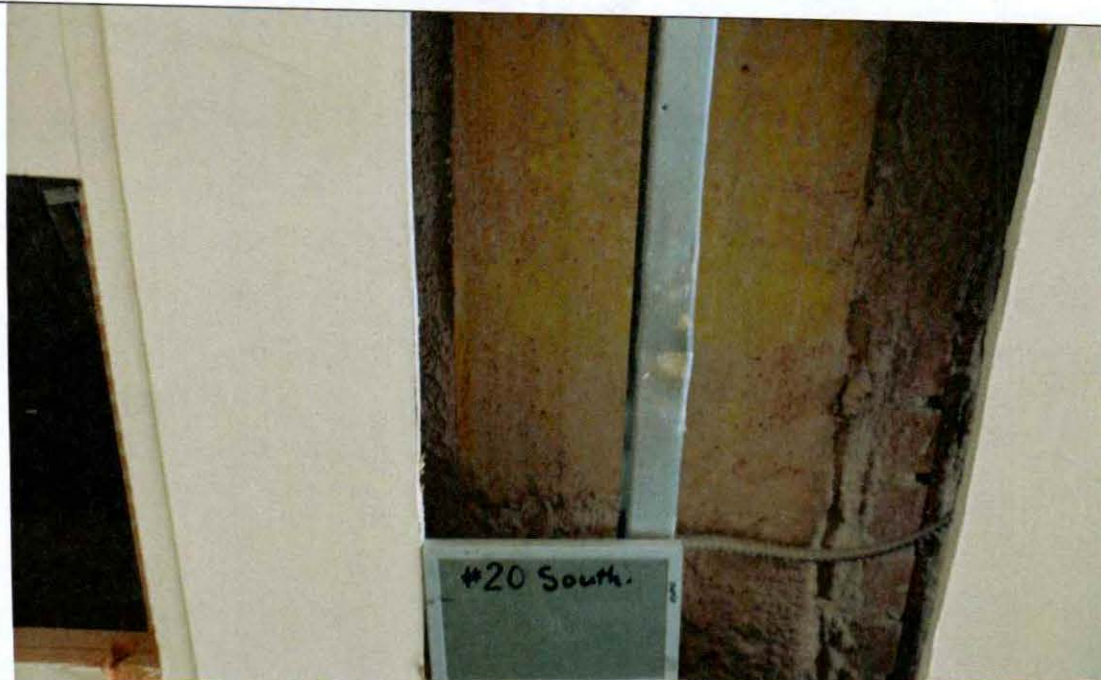
Figure 49 Investigation opening #20 Detail. Fireproofing was removed- and the paint coating is in good condition on the column.
