505 University Avenue, Toronto- Site investigation report

Prepared by:	Donovan Pauly, MSc, CAHP, APTi (Architectural Materials Conservator)
Prepared for:	Sam Trigilia
Location:	505 University Avenue, Toronto, Ontario
Date of site visit:	September 16-25

Objective

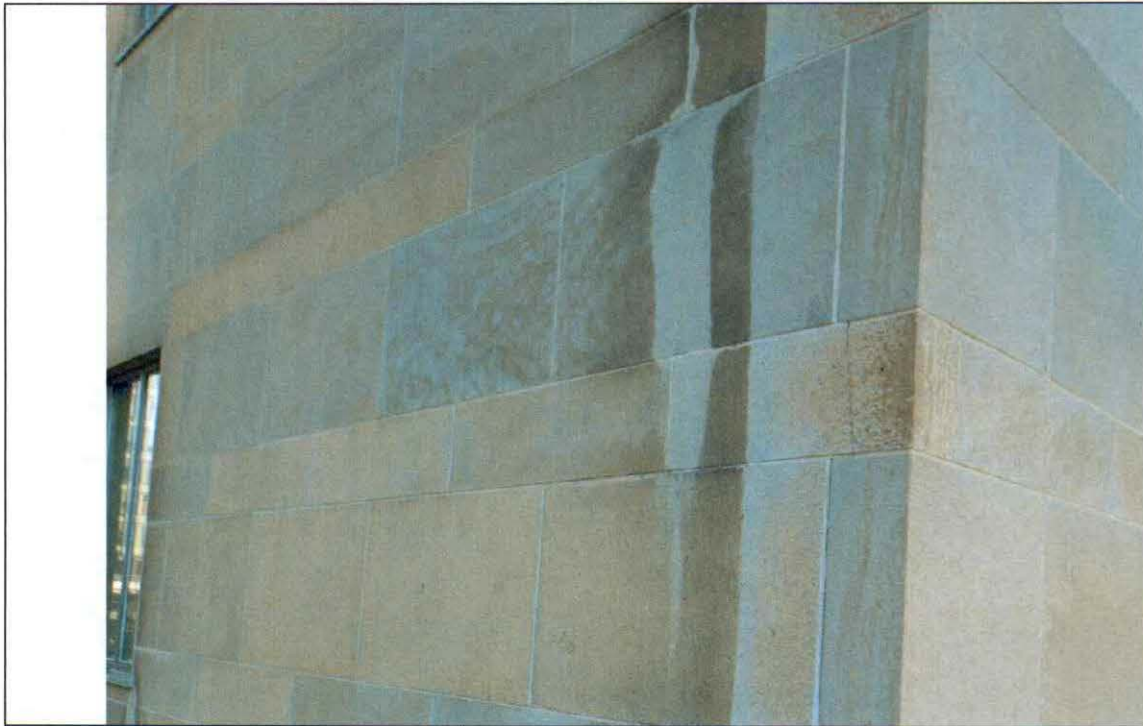
There is also a slightly less concerning crack at the southeast corner on the south elevation mirroring the cracking on the north. This crack also seems to start near grade, passing through mortar joints and eventually through some stones at the 3rd and 4th floors, and terminating at the 5th floor. This cracking/movement does not display any significant displacement in the veneer. This is a very similar pattern to the movement crack on the north and it is equally difficult to pinpoint the cause. This cracking also should be addressed soon and some additional investigation to determine and remediate the cause(s) would be prudent. The other corners of the building (southwest and northwest) were also visually examined to determine if cracking is occurring there, and one cracked (bonder) stone and some debonded mortar joints were noted at the southwest corner of the south elevation at the 4th floor similar to the east end but less severe.

Figure 56 Southeast corner elevation at 4th floor. Note cracked stone and debonded joints.

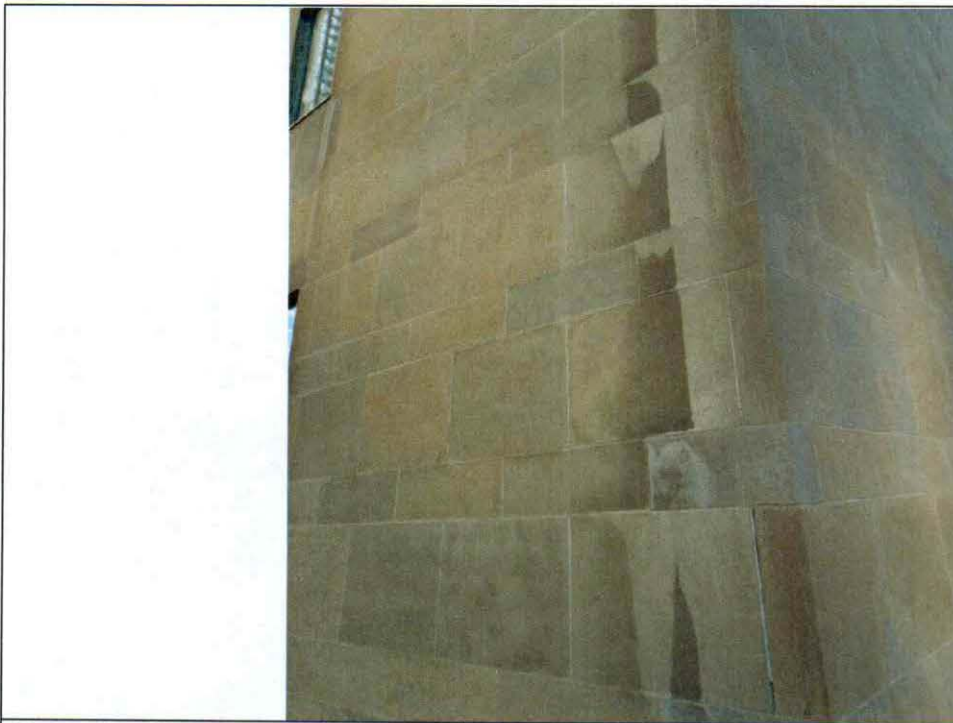
Figure 57 Southeast corner elevation at 3rd floor. Note open and debonded joints.

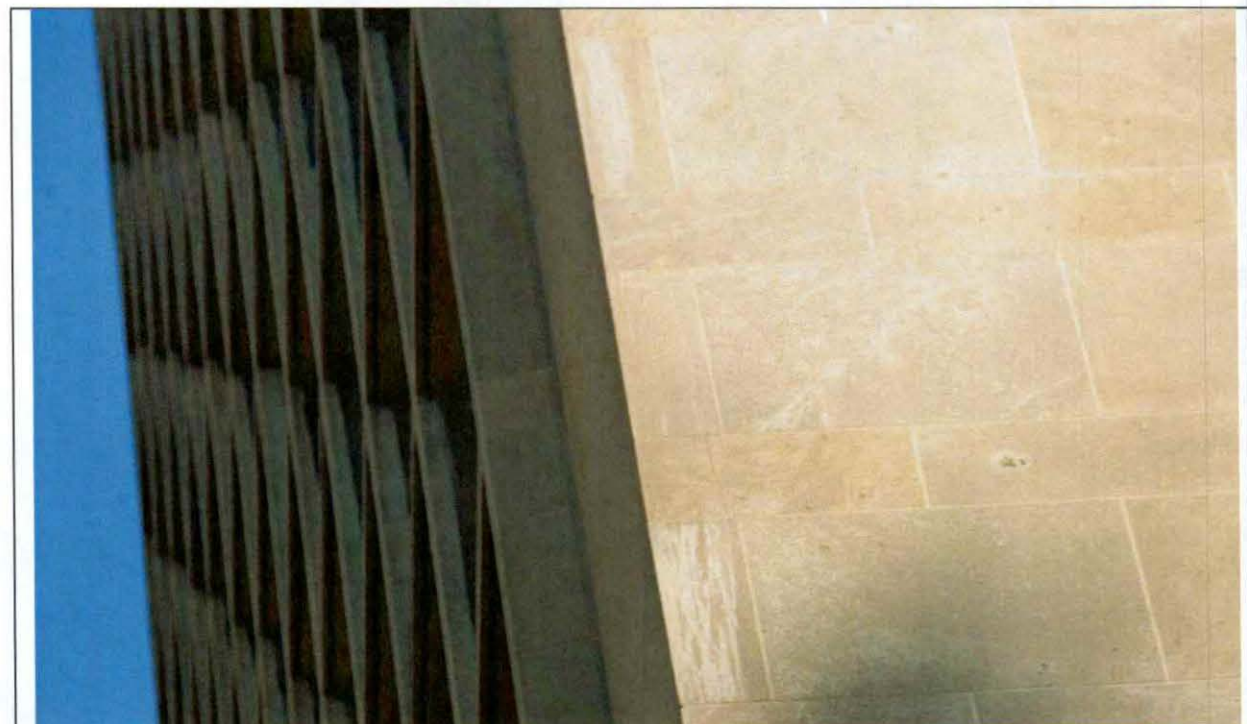
Figure 59 South elevation southwest corner cracked stone and debonded joints at 4th floor.

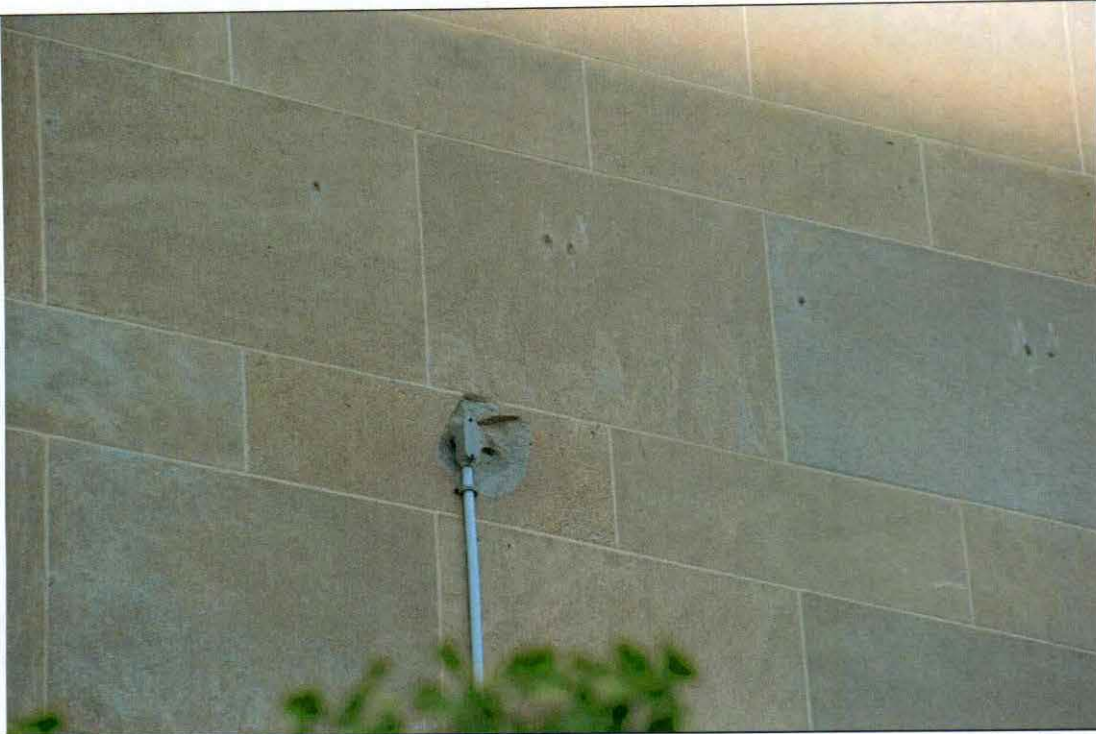
Figure 60 South elevation-west side spalled stone at electrical service penetration and holes in cladding from fixings.

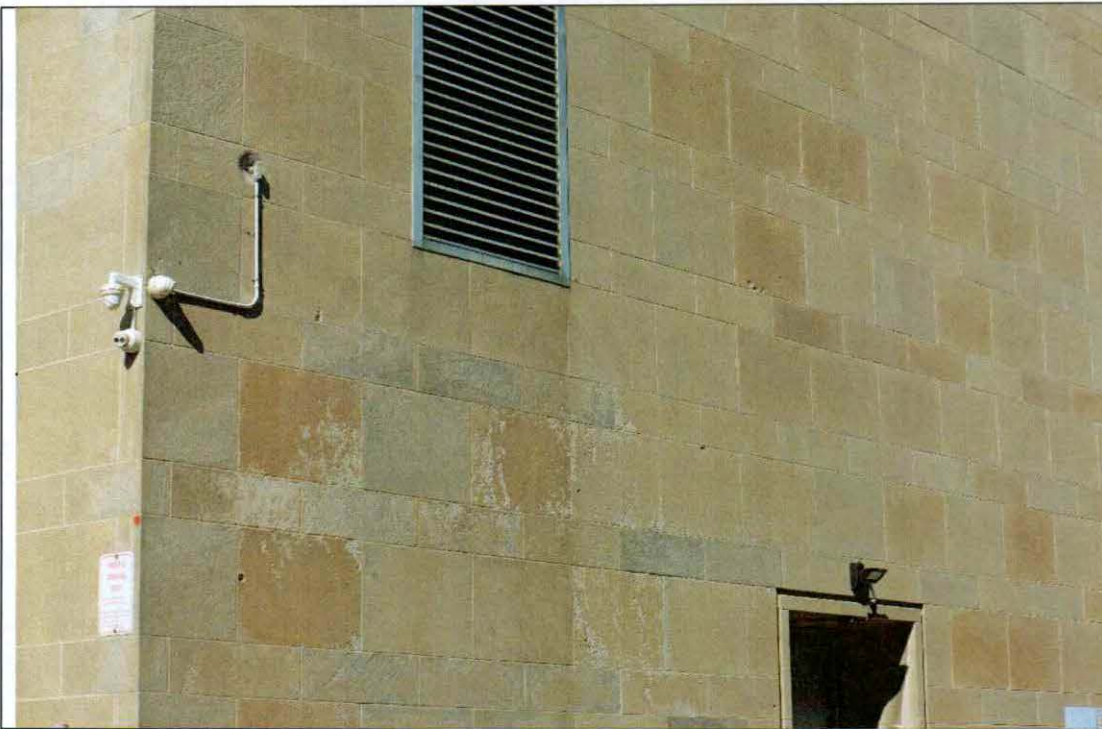
There are also areas of surface loss on the east elevation above grade around the large louvred vent. This is most likely due to moisture in the expelled air from the vent accelerating the surface decay.

Figure 65 East elevation ground to 2nd floor. Surface erosion/ exfoliation related to moisture from the vent above.

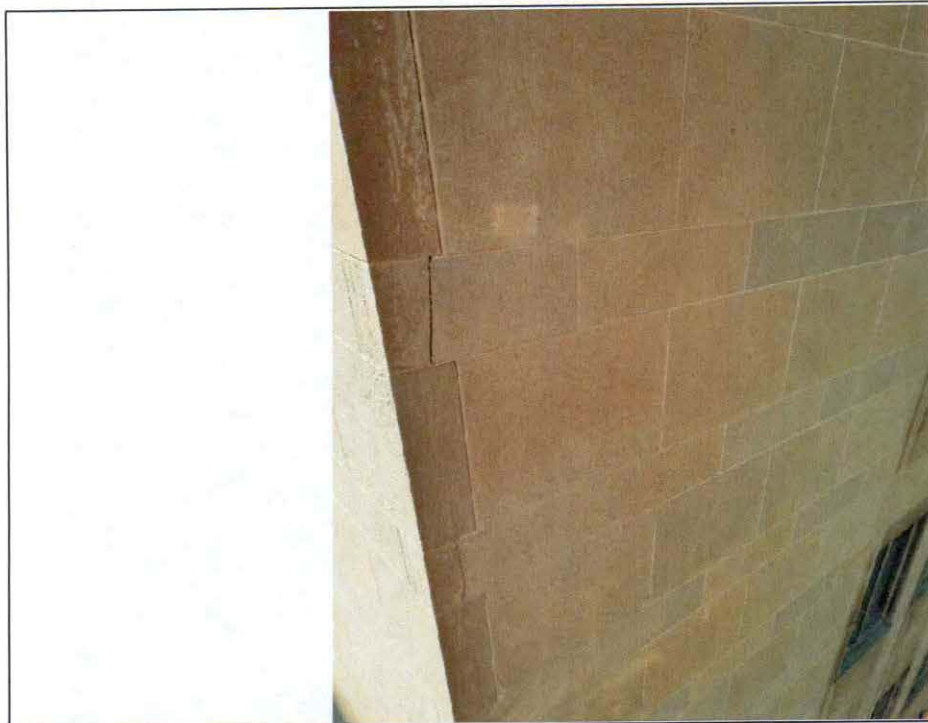
There are two areas where some significant vertical cracks have occurred. The most serious of these is at the northeast corner, primarily on the north side. There is a structural movement that appears in the cladding at grade and travels upward in a relatively straight line to the middle of the 5th floor. There is a slight displacement out-of-plane toward the north at this crack +/- 6mm at the lowest stone and to a lesser degree above. It is difficult to determine the cause of this movement and cracking as there may be several factors involved, including building settlement, thermal movement or perhaps some internal corrosion of embedded metals stressing the cladding (it was not possible to investigate this internally as there is a large boiler or incinerator flue directly behind this area).

This cracking and displacement are a concern, and some movement appears to have occurred more recently, evidenced by a spreading mortar joint that appears to have been repointed previously (not original). This crack is also open to the elements, passes directly through some bonder (12" high) stones and certainly allows water runoff to enter the wall assembly. This defect should certainly be monitored and should be repaired as soon as possible to limit additional decay and potential worsening. It would be prudent to carry out an investigation in this area and below grade to determine the cause of this and repair and remediate it to restore structural cohesion in this corner.

Figure 68 North elevation northeast corner. Crack/ displacement and debonded joints from the 5th floor to grade.

The primary recommendation currently is to carry out some additional investigation at the northeast corner where the vertical cracking is most severe. This should include some excavation to confirm the condition of the foundation and below-grade areas at this corner as the lowest ashlar block on the north is displaced down and outward here and this could be a sign of foundation settlement issues. It would also be beneficial to remove some stone units higher up on the structure (2nd-4th floor areas) to determine if there is a metal corrosion issue there stressing the cladding and forcing it outward.

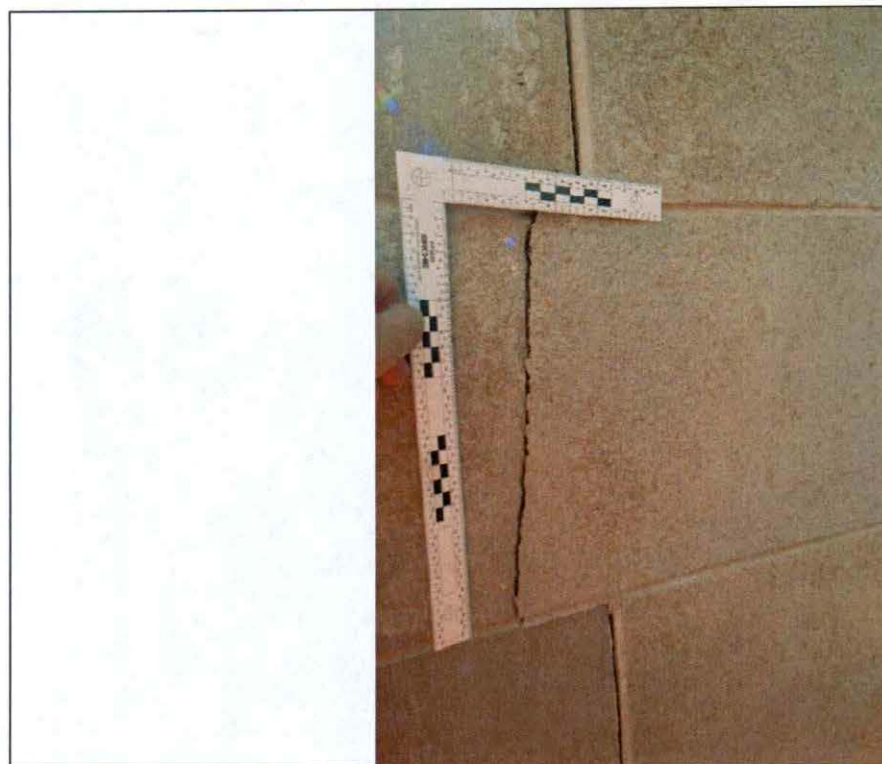
Figure 69 North elevation northeast corner. Detail of Crack/ displacement at 4th floor.

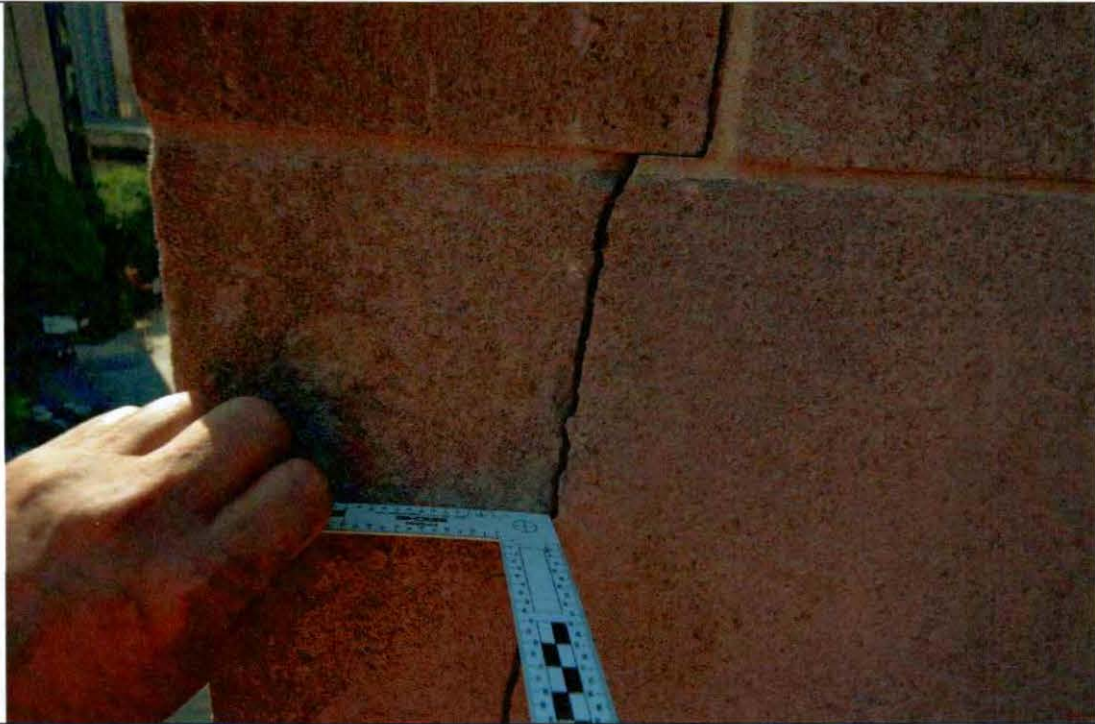
Figure 70 North elevation northeast corner. Detail of Crack/ displacement at 4th floor.

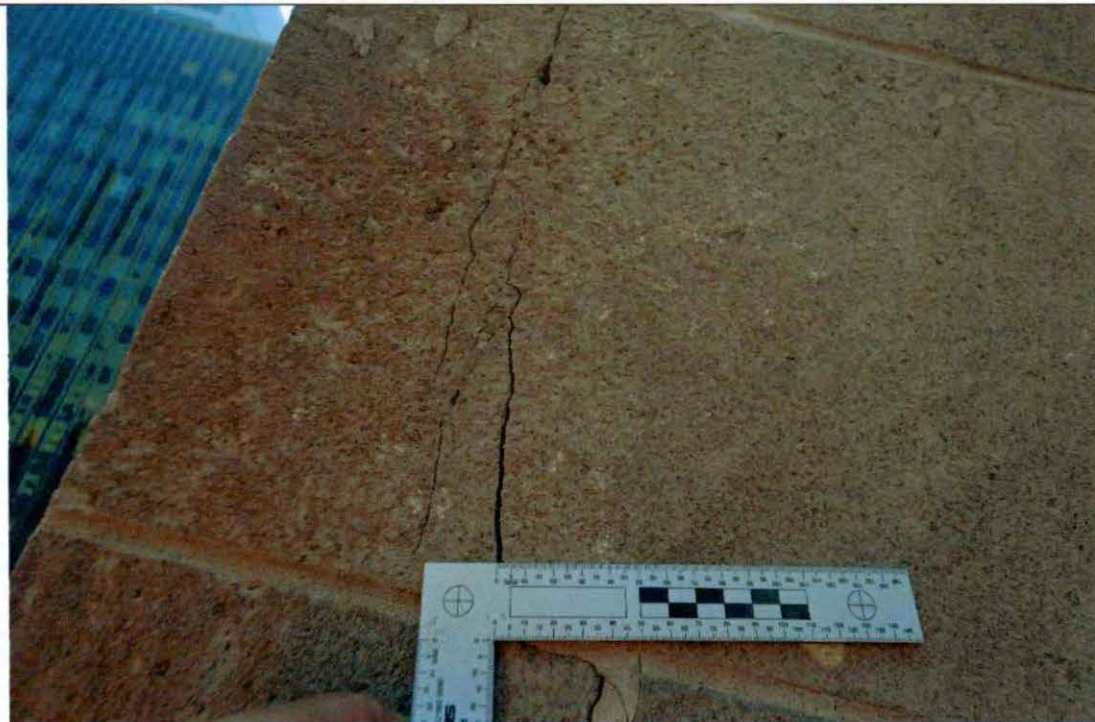
Figure 71 North elevation northeast corner. Detail of Crack/ displacement at 3rd floor.

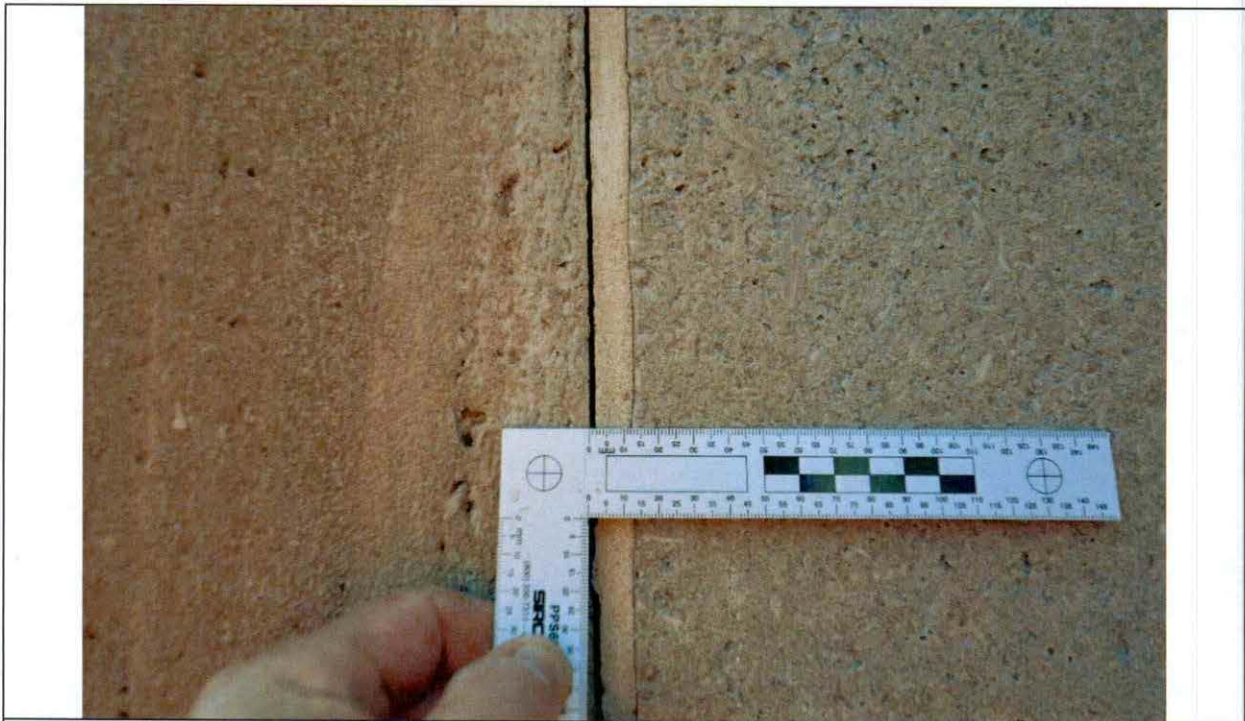
Figure 72 North elevation northeast corner. Detail of debonded joint at 2nd floor.

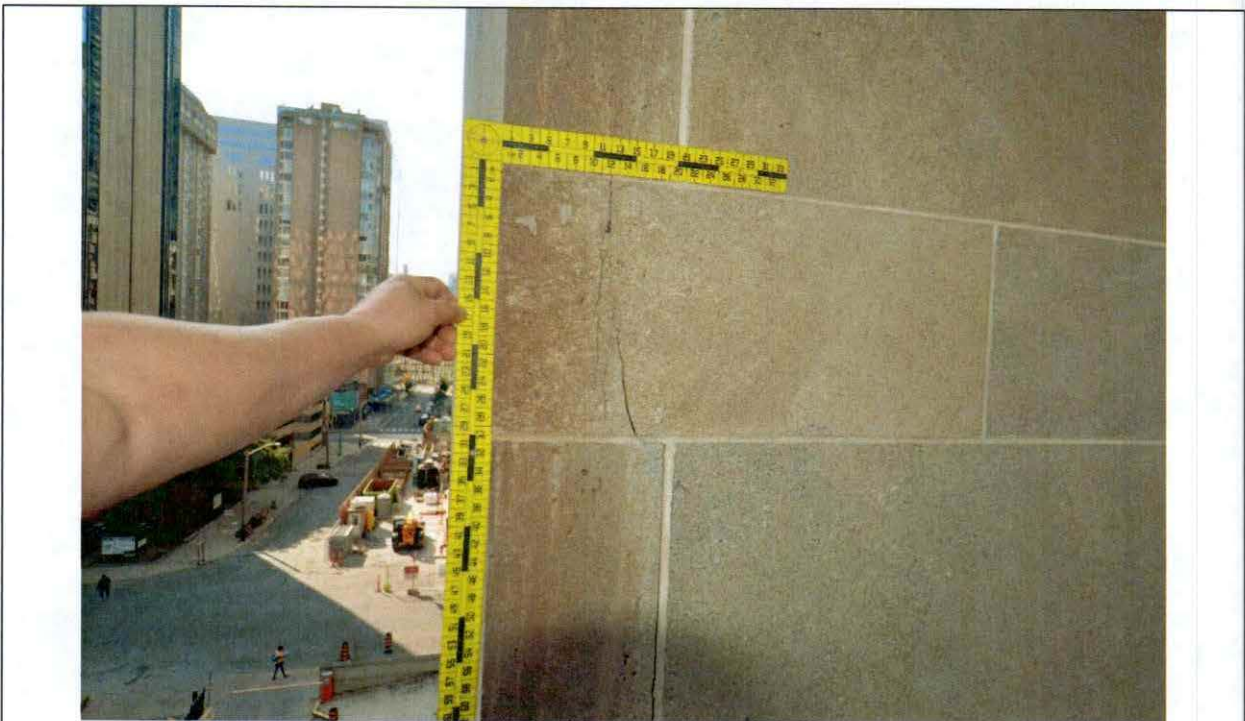
Figure 73 North elevation northeast corner. Detail of Crack/ displacement at 3rd floor.

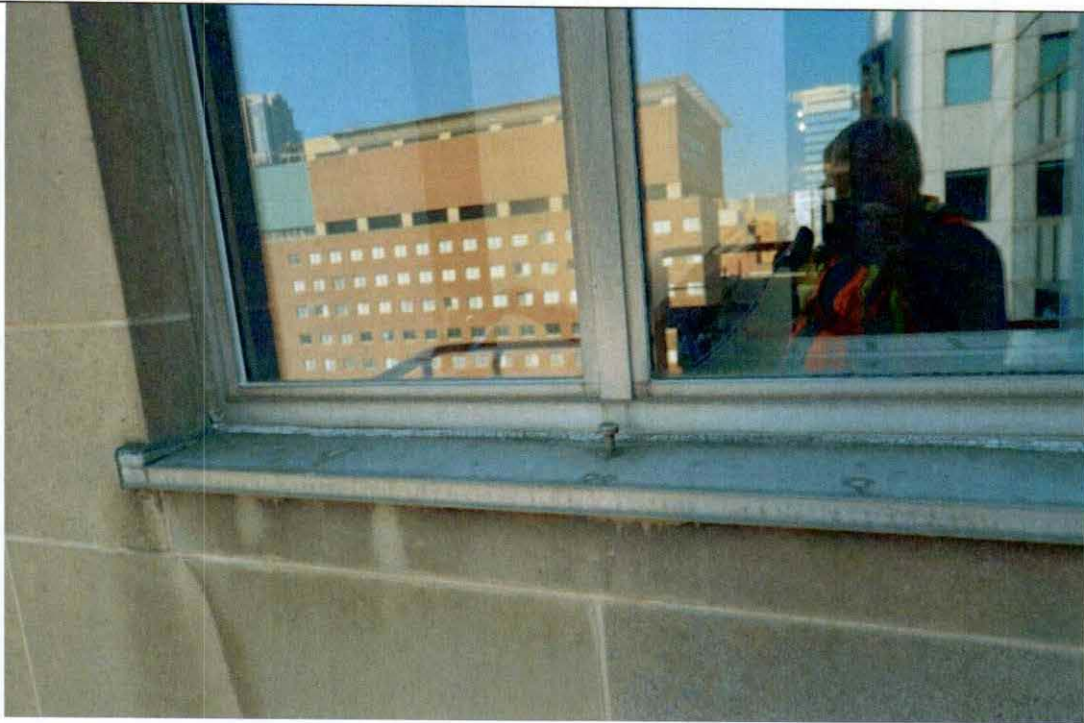
The original aluminum framed IGU windows are typically quite oxidized, have lost most of their protective surface finish and are at the end of their reasonable service life. The sealant around many of the windows observed is also at or beyond its service life. It was noted by the building maintenance staff that the replacement of failed IGU glazing is ongoing and a regular maintenance issue and some leaks around the frames have occurred.

Figure 76 North elevation typical window condition- sealants failing and window frames heavily oxidized.

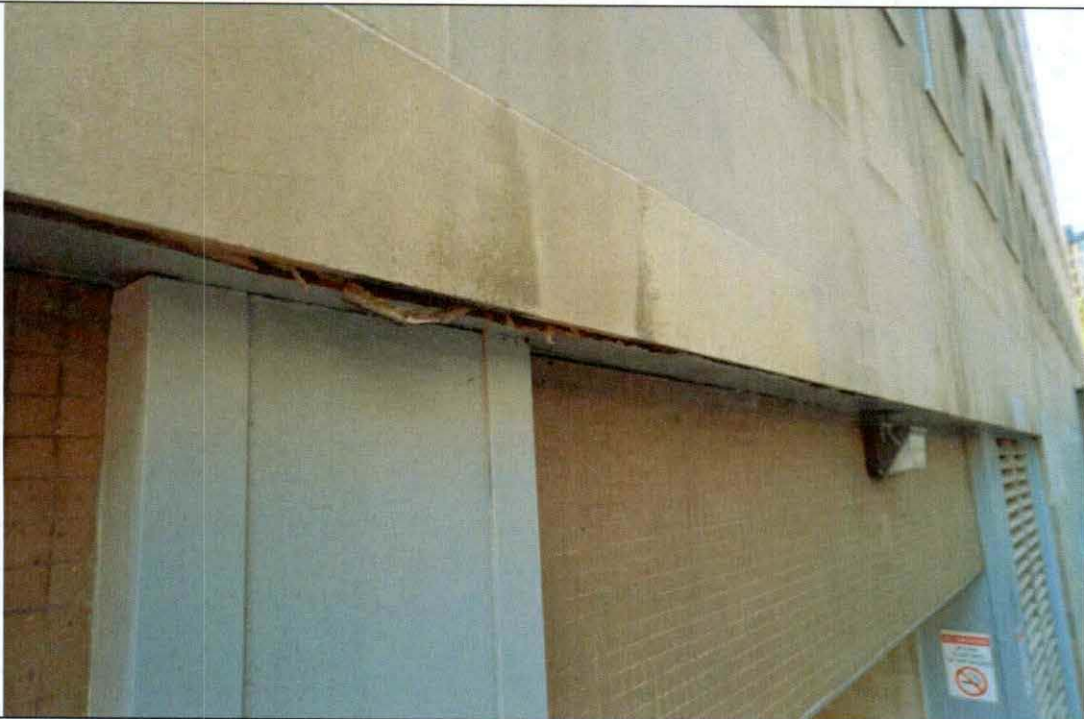
Figure 77 North elevation first-floor soffit sealant has failed and there is some evidence of internal corrosion of steel elements (rusting and some displacement at the soffit plate) along this elevation.

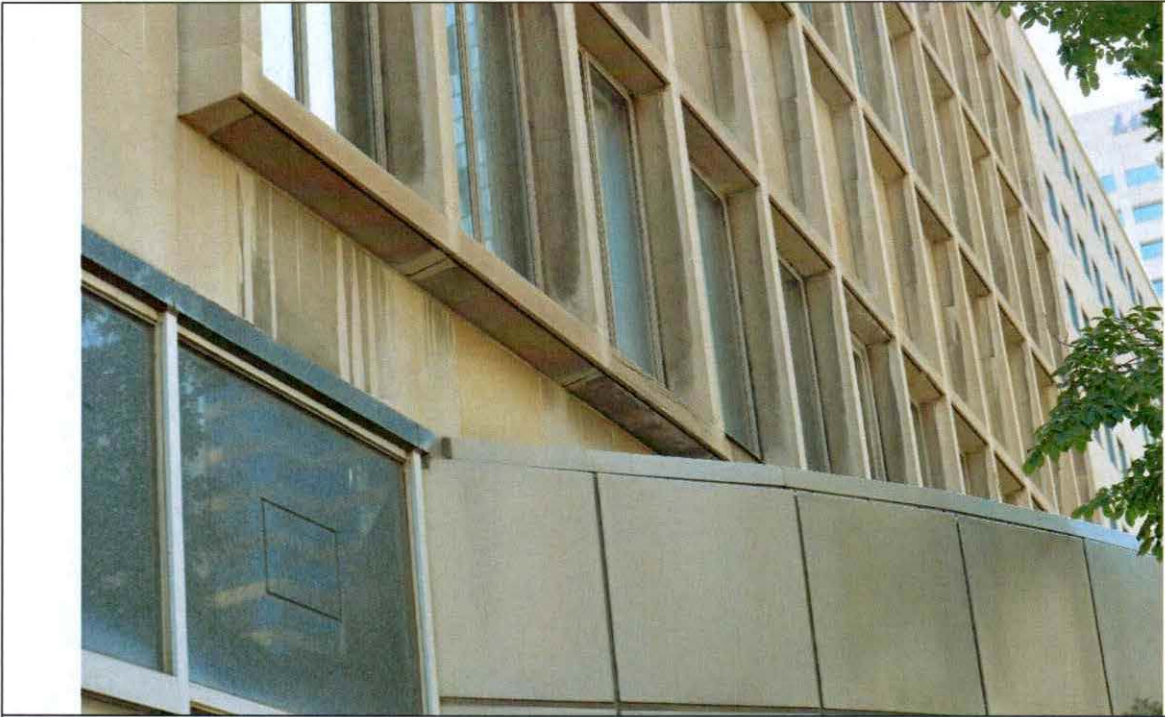
Figure 78 West elevation eroded sill at the 2nd floor window.

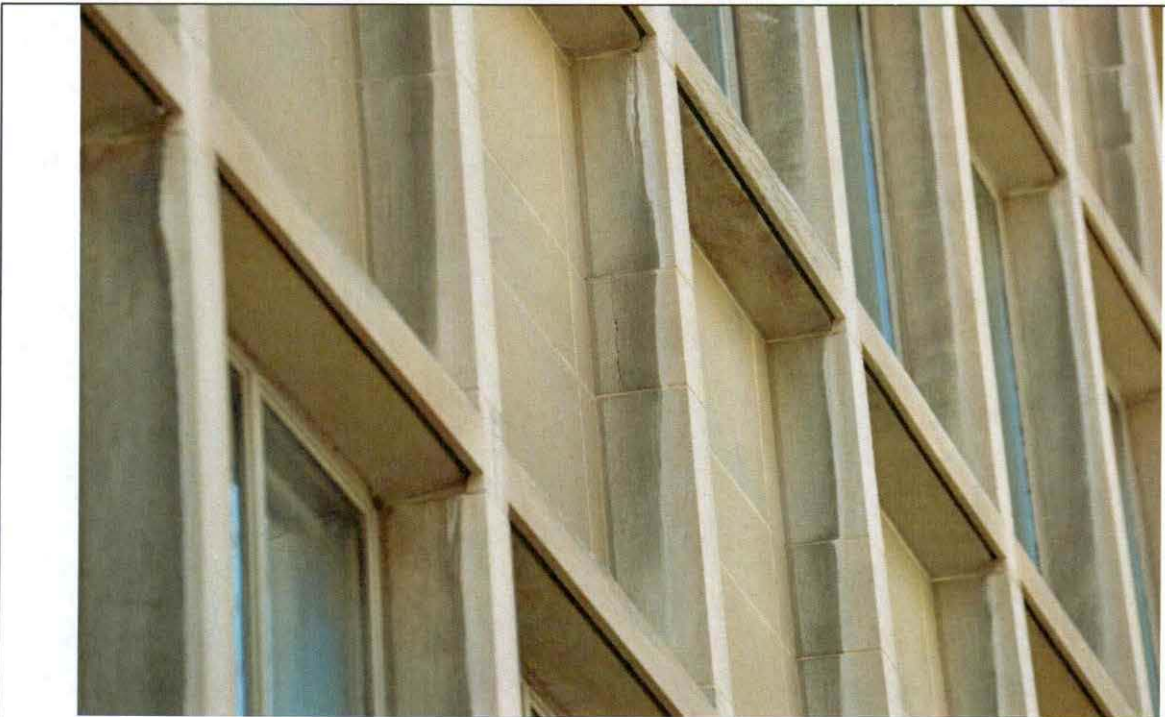
Figure 79 West elevation cracked small mullion stone in spandrel and eroded sill at the 3rd floor window.

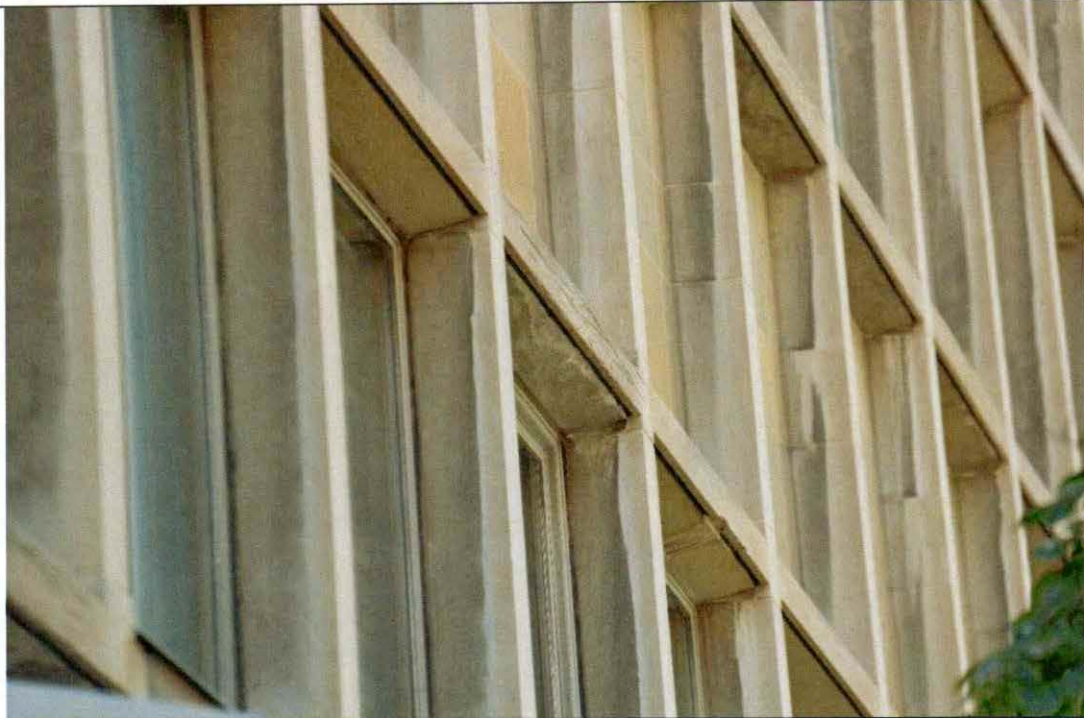
Figure 80 West elevation eroded lintel stone and area of damaged drip edge at the 5th-floor windows.

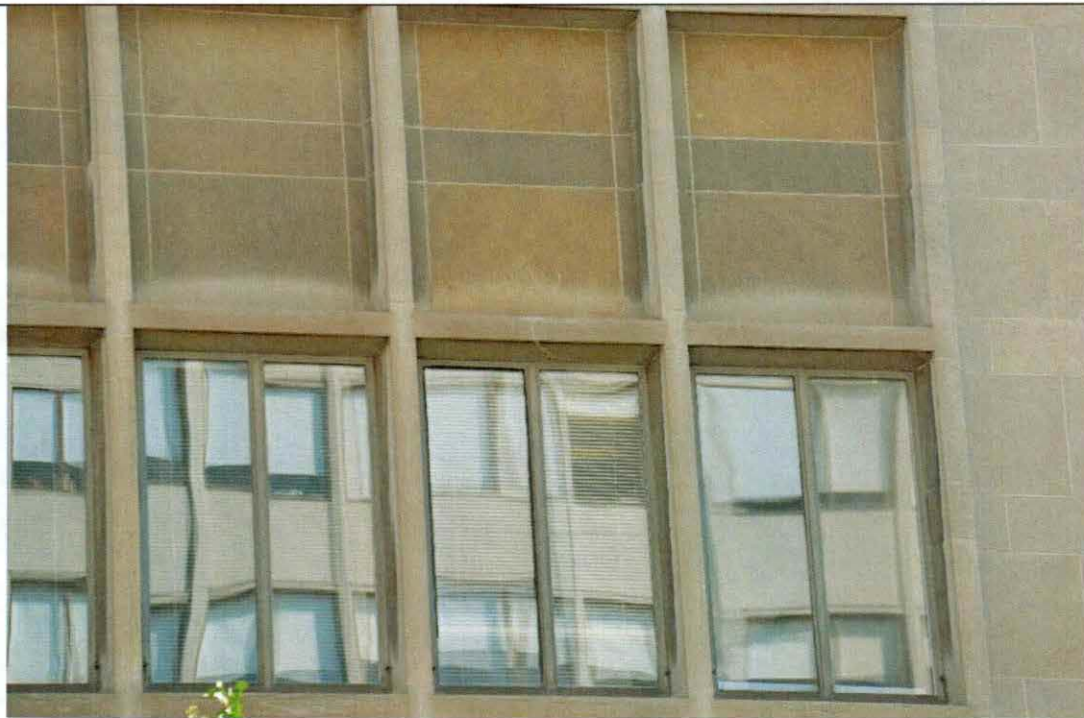
Figure 81 West elevation cracked/ repaired lintel stone in at 2nd floor window.

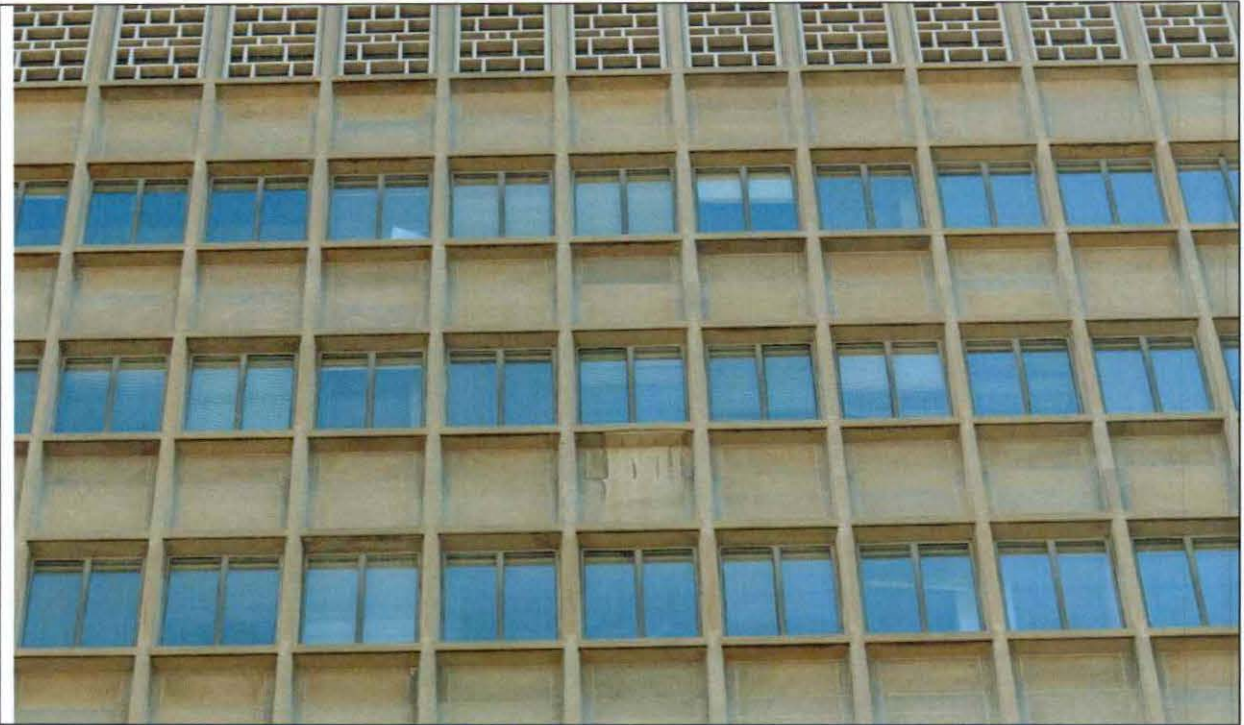
Figure 82 West elevation lost section of drip edge on the sill at the 11th floor.
