## 505 University Avenue, Toronto- Site investigation report

| Prepared by: | Donovan Pauly, MSc, CAHP, APTi (Architectural Materials Conservator) |
| Location: | 505 University Avenue, Toronto, Ontario |
| Date of site visit: | September 16-25 |

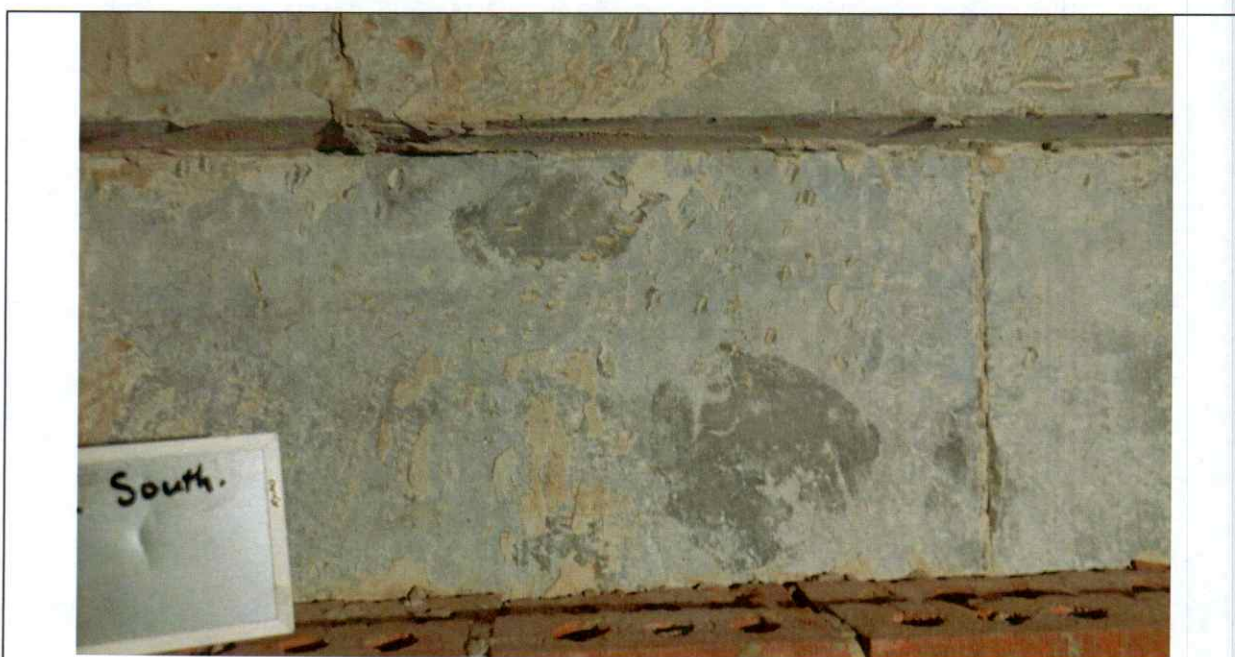
**Figure 11** Investigation opening #1 Detail. Stone veneer is block bonded with brick backup. No ties were found here.

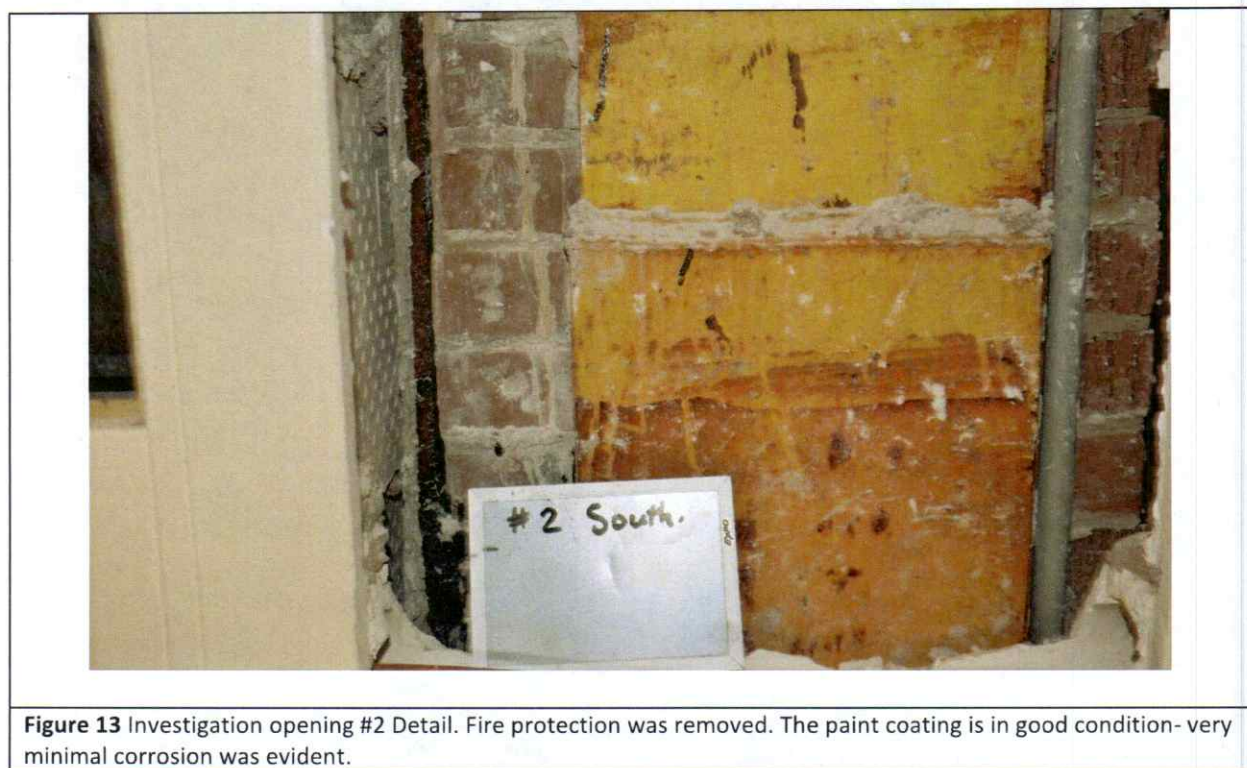
**Figure 13** Investigation opening #2 Detail. Fire protection was removed. The paint coating is in good condition- very minimal corrosion was evident.

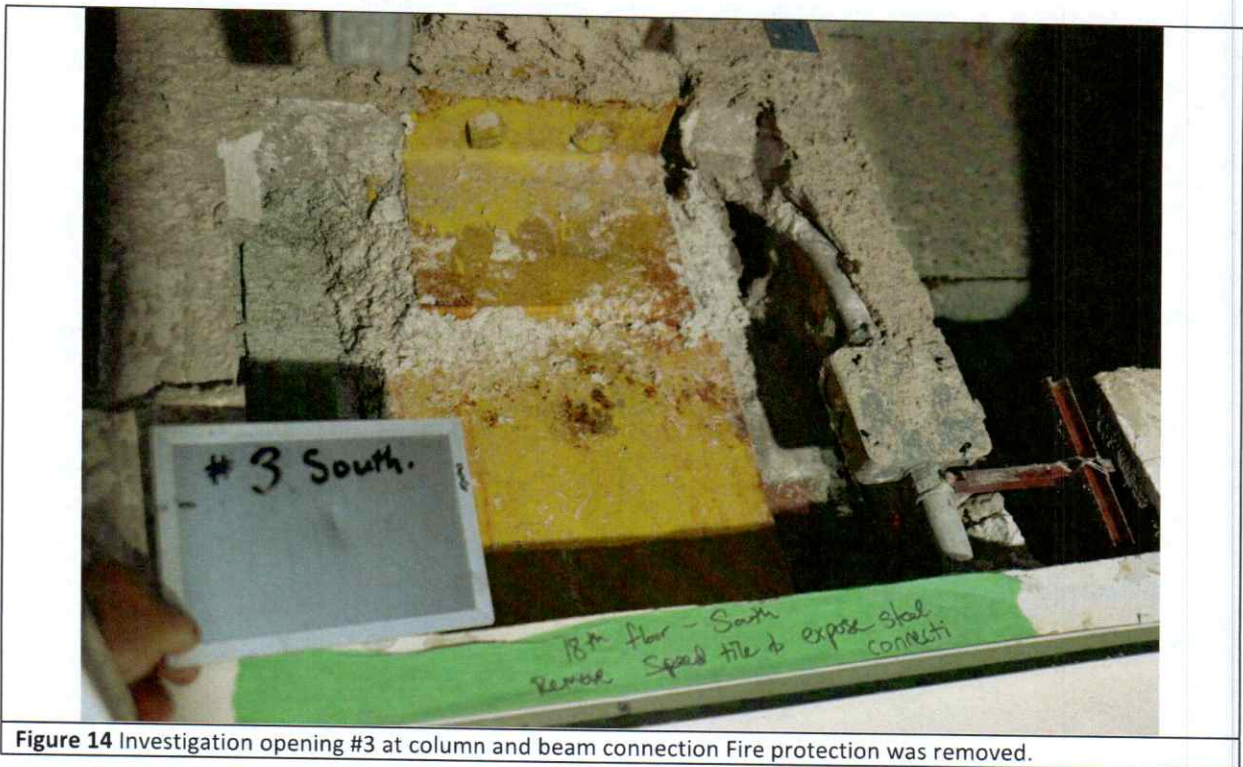
Figure 14 Investigation opening #3 at column and beam connection Fire protection was removed.

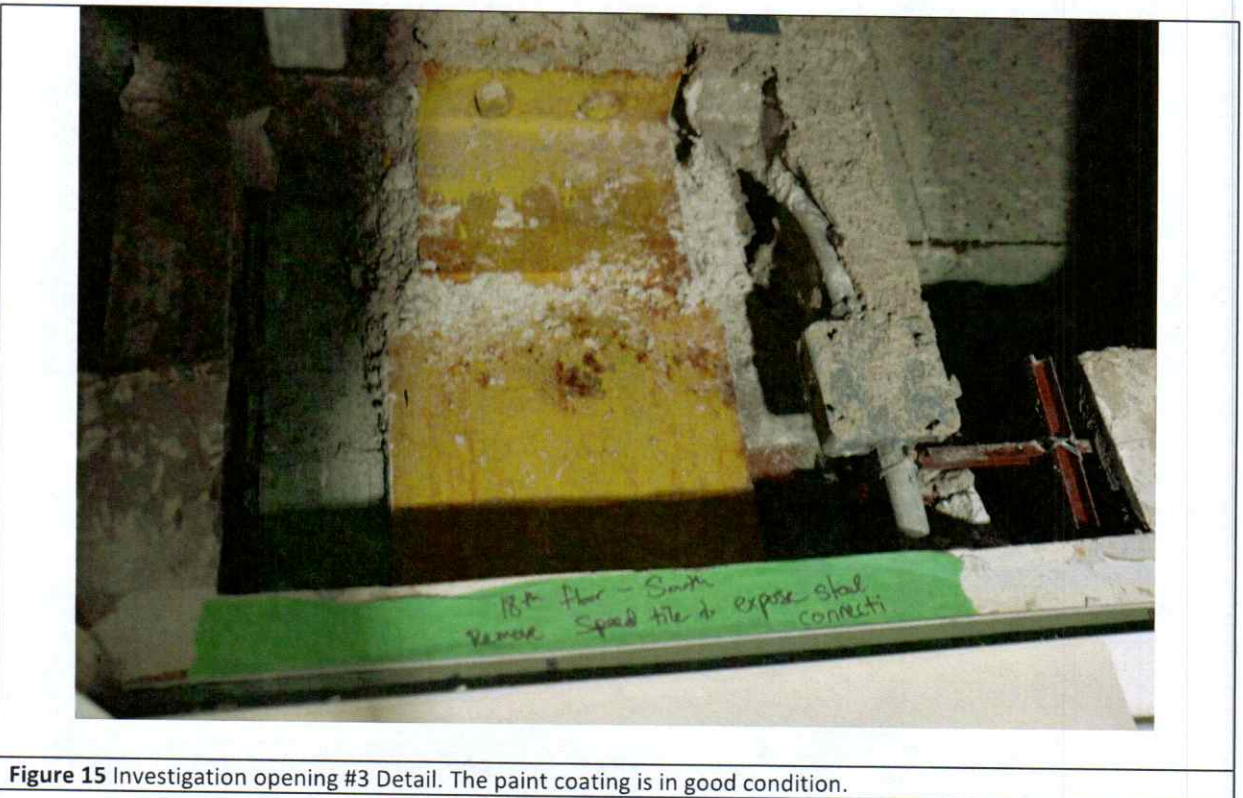
Figure 15 Investigation opening #3 Detail. The paint coating is in good condition.

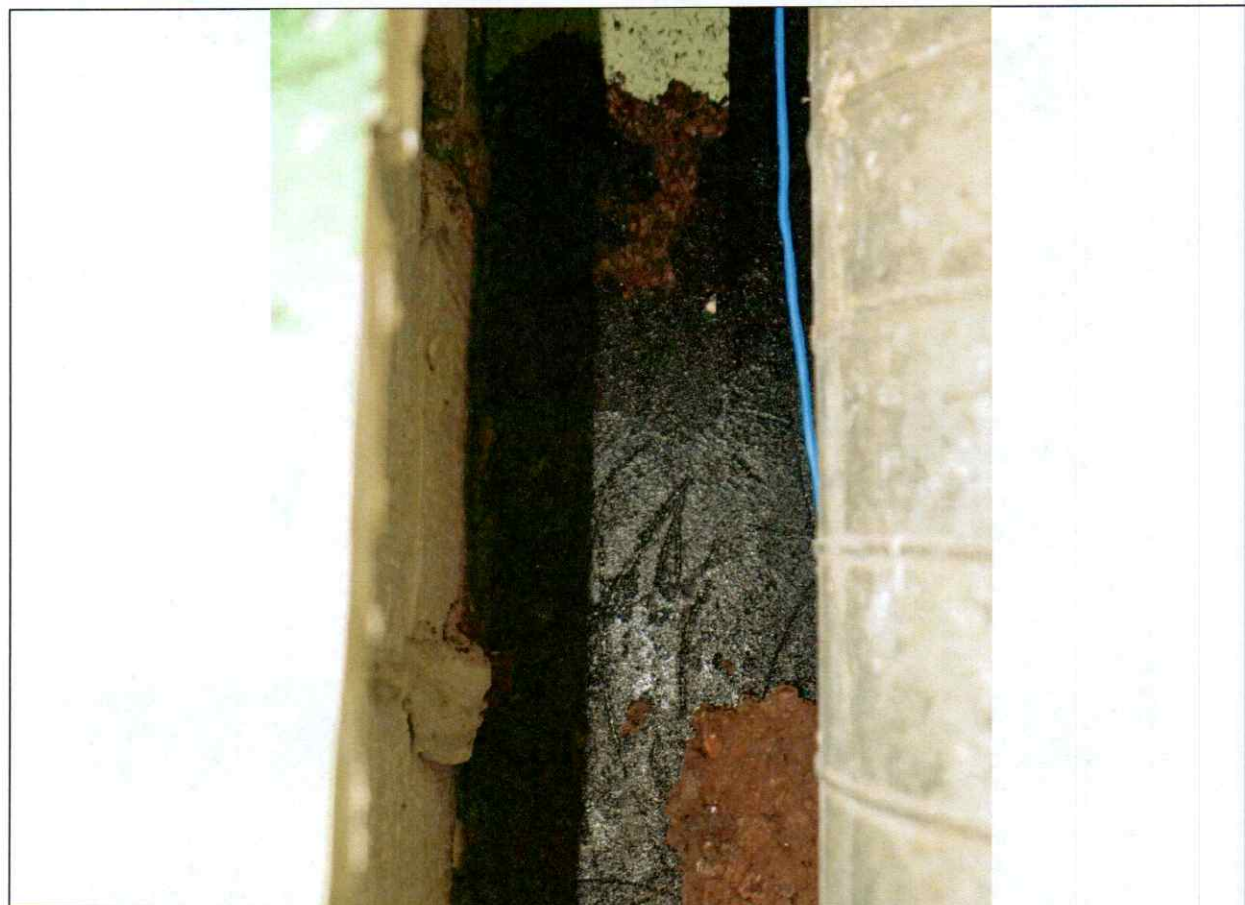
**Figure 17** Investigation opening #4 Detail. The corkboard insulation was removed. A bituminous layer over parged stone masonry was found.

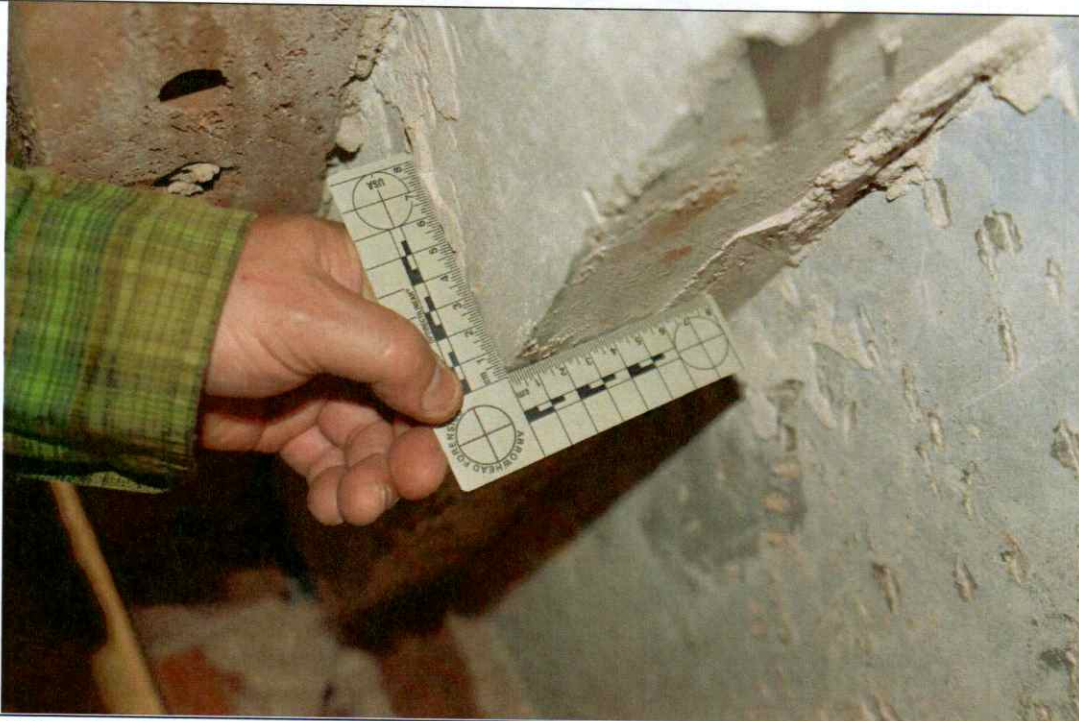
**Figure 19** Investigation opening #5 Detail. Stone veneer is block bonded with brick backup. No ties were found.

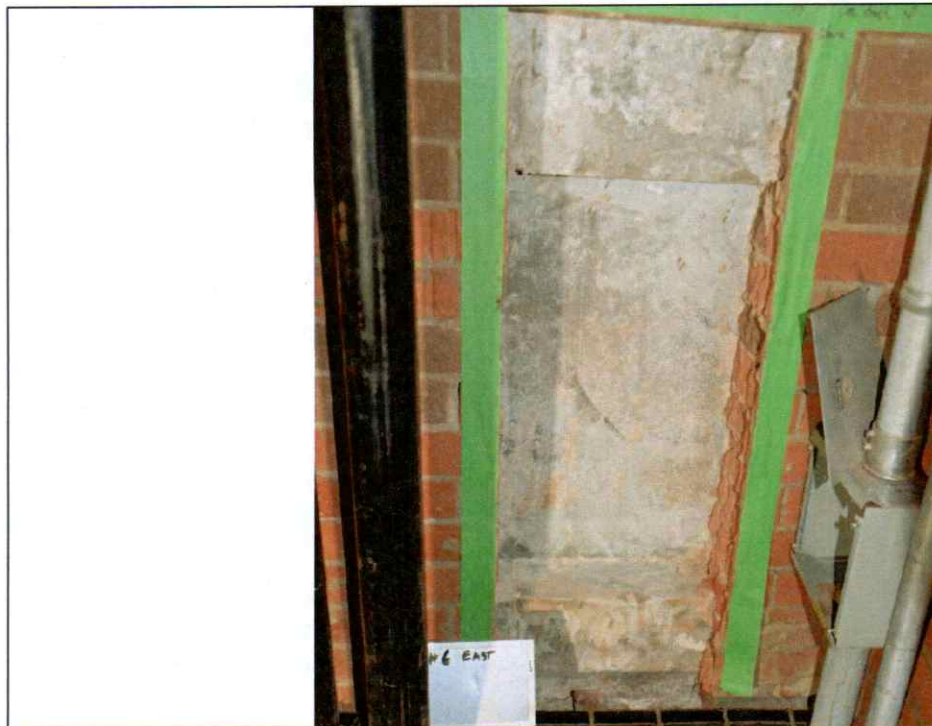
**Figure 21** Investigation opening #6 Detail. Stone veneer is block bonded with brick backup. No ties were found.

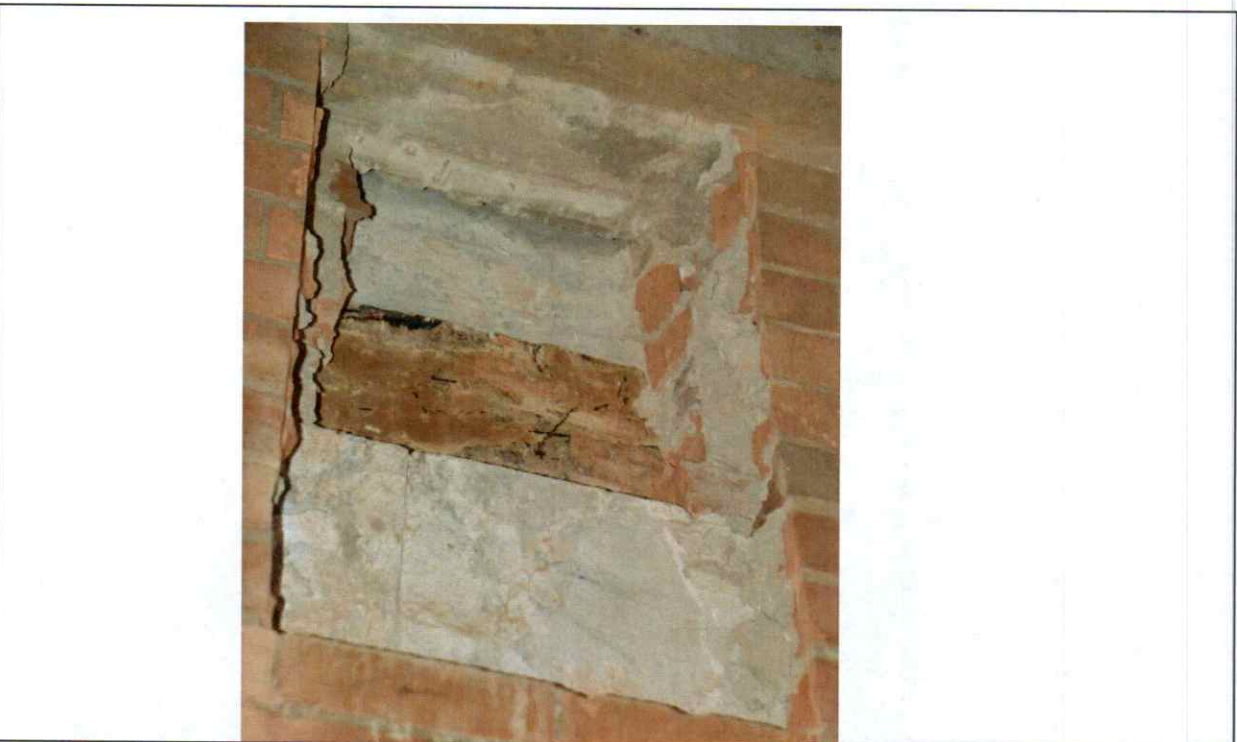
**Figure 23** Investigation opening #7 Stone veneer is block bonded with brick backup. No ties were found.

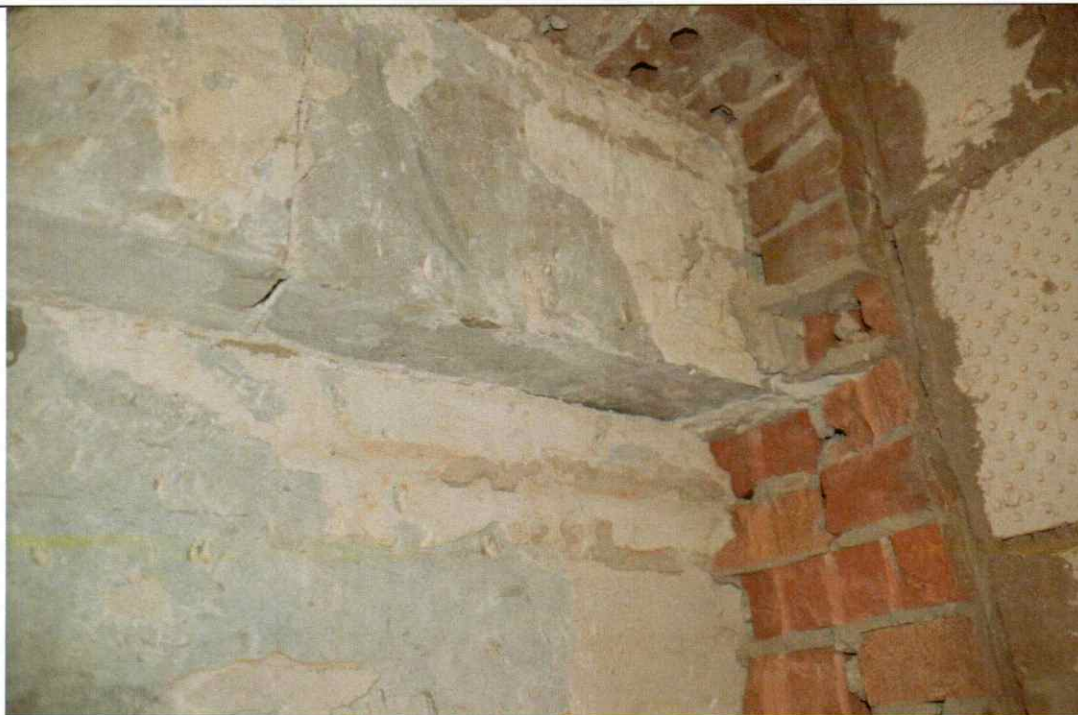
**Figure 25** Investigation opening #8 Detail. Stone veneer is block bonded with brick backup. No ties were found.

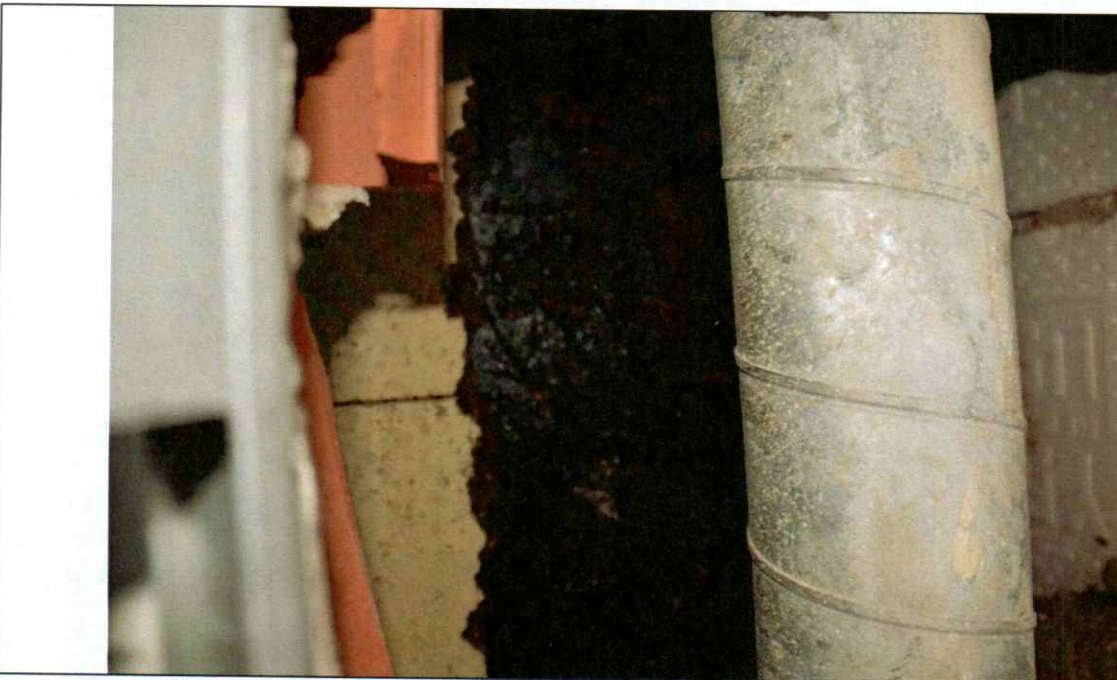
**Figure 27** Investigation opening #9 Detail. The corkboard insulation was removed. A bituminous layer over parged stone masonry was found.

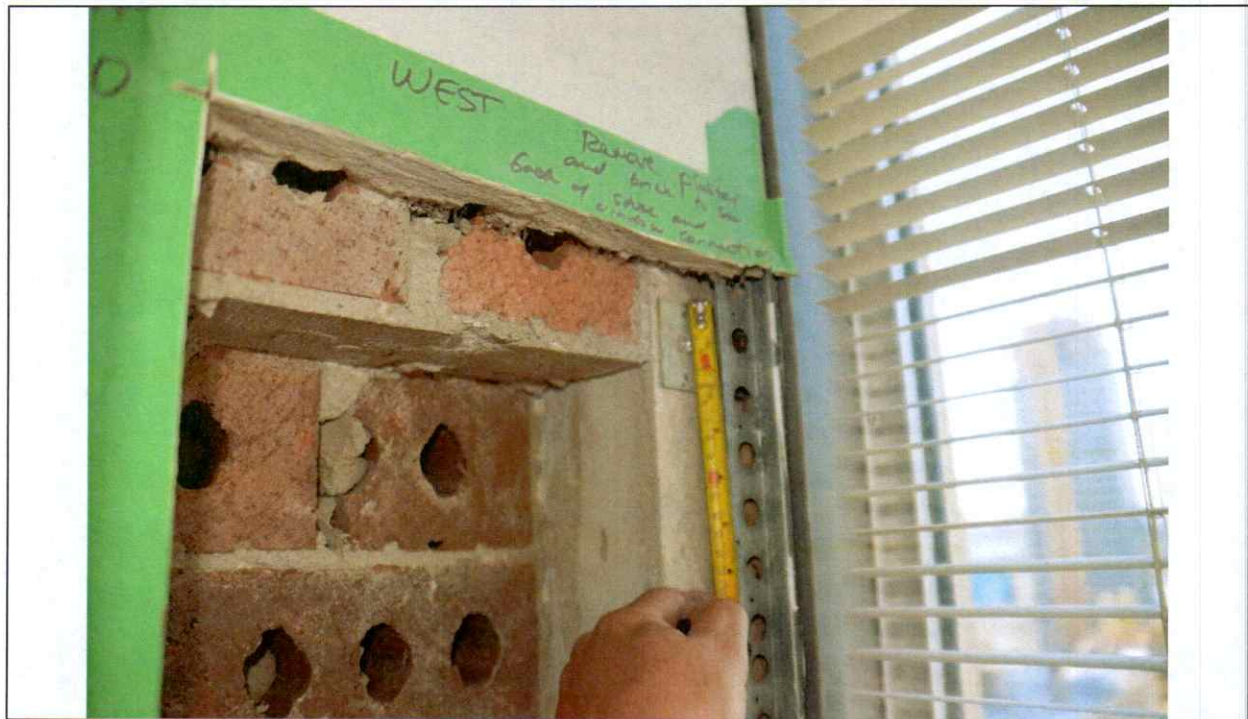
**Figure 29** Investigation opening #10 Detail. Stone window reveal mullion with brick backup. Window tie anchored with #12 Galvanized screw. No moisture barrier was found.

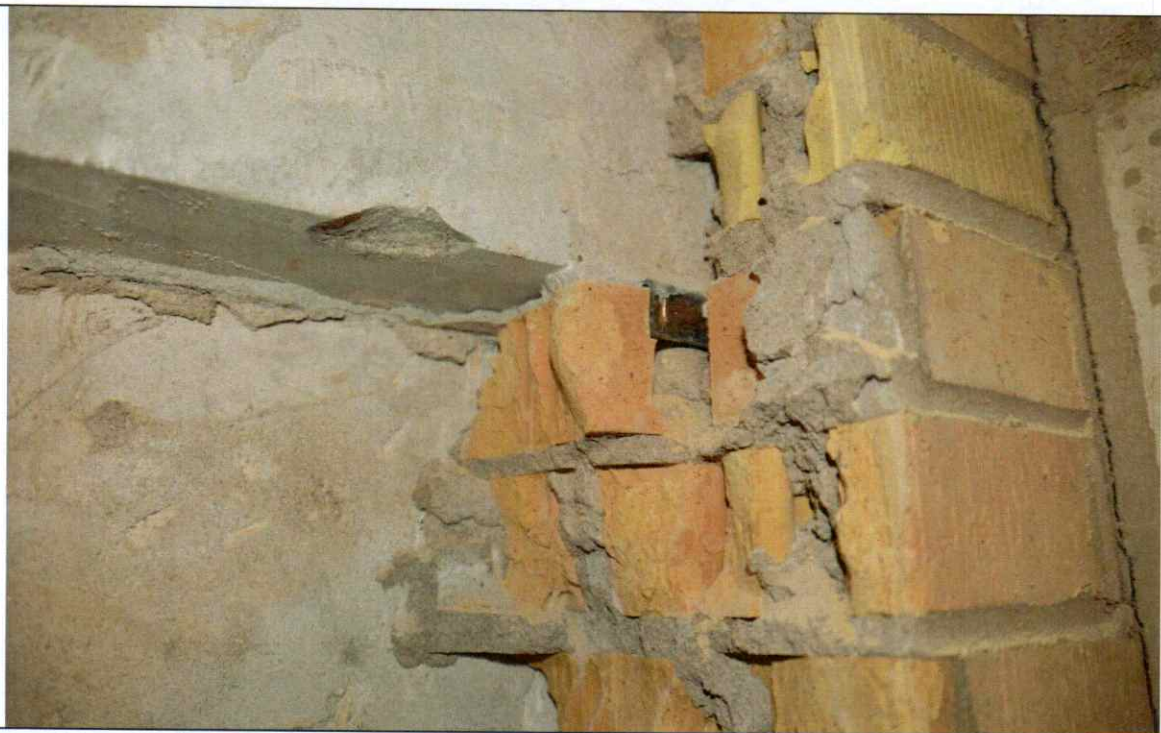
**Figure 31** Investigation opening #11 Detail. Stone veneer is block bonded with brick backup. One bronze wall tie was found (RHS).

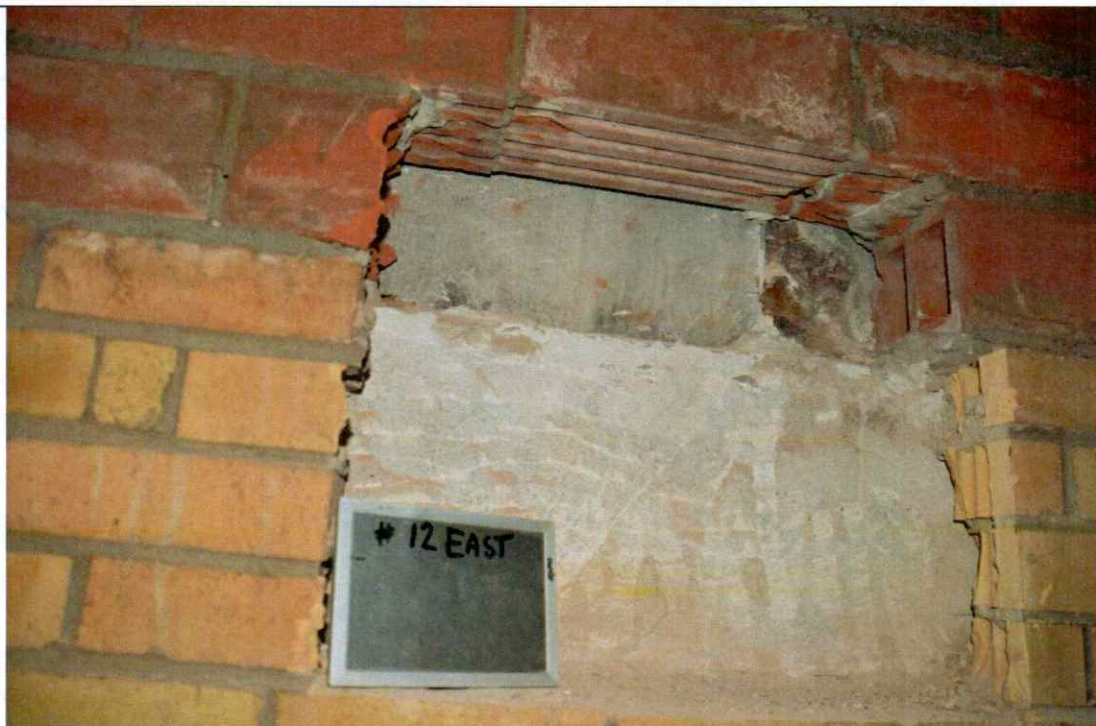
**Figure 33** Investigation opening #12 in vent shaft Detail. Stone veneer with brick backup- replaced Indiana limestone (vent infill) at upper. No ties were found.

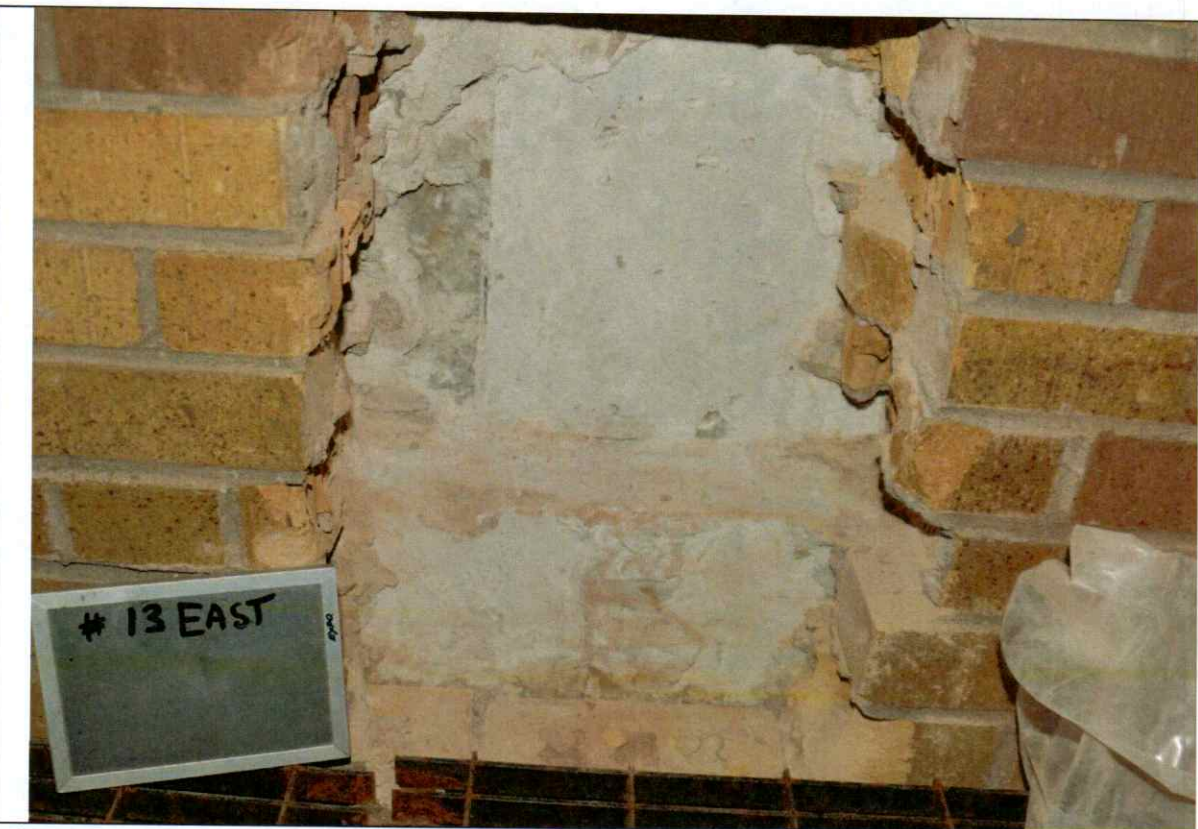
Figure 35 Investigation opening #13 in vent shaft Detail. Stone veneer is block bonded with brick backup. No ties were found.

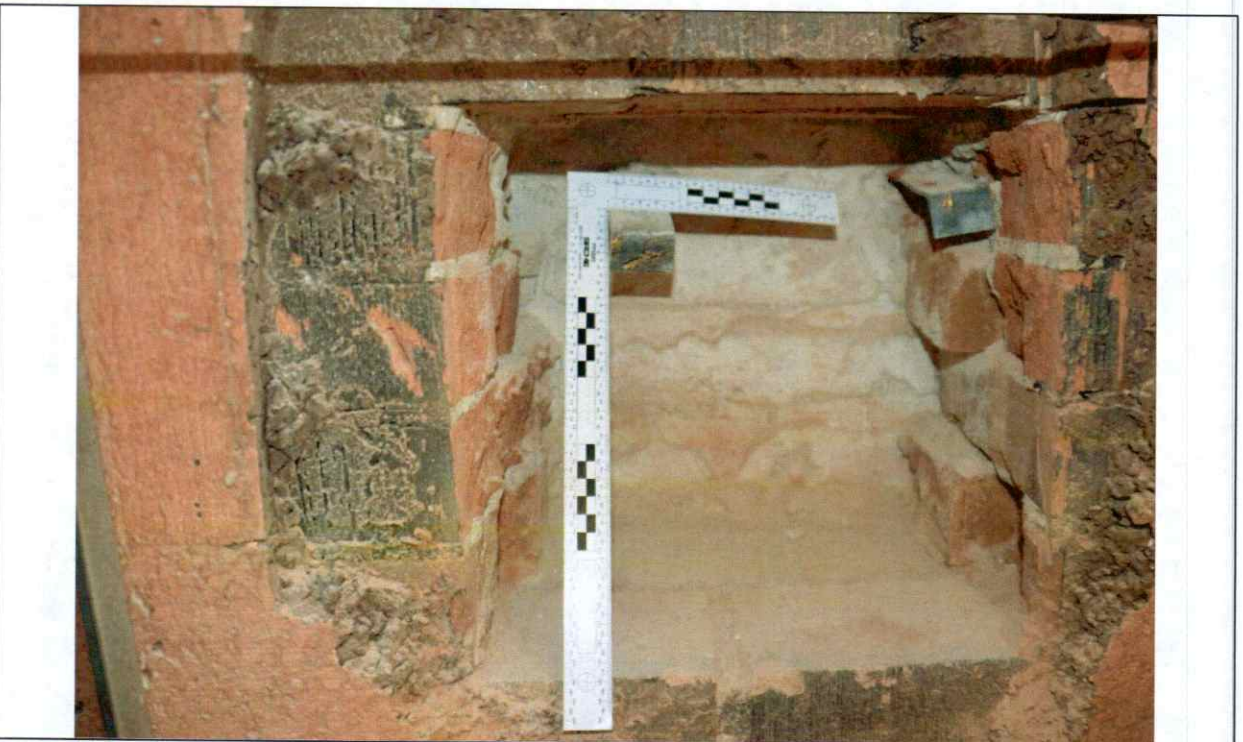
Figure 39 Investigation opening #15 Detail. Corkboard and brick masonry were removed. 2 ties were found- ties appear to be bronze (or similar copper alloy) and in good condition.

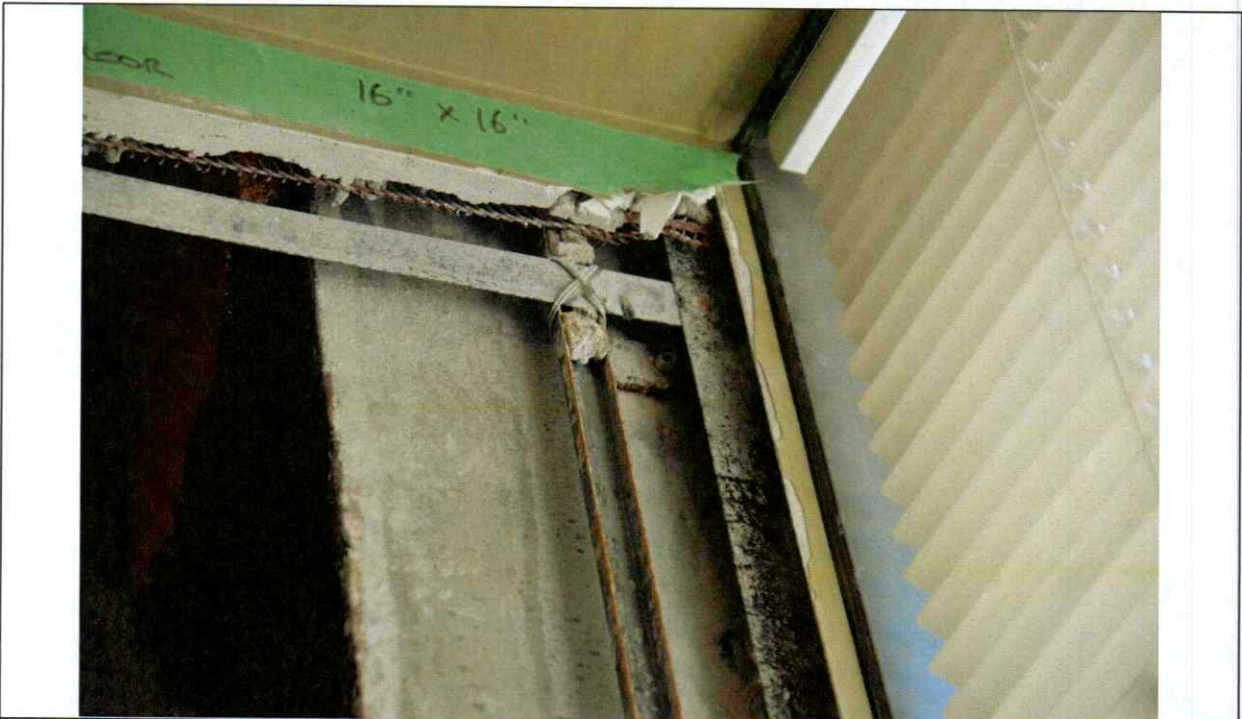
**Figure 43** Investigation opening #17 Detail. Mullion stone is full depth- no backup masonry is present. Some light corrosion is evident on plaster framing elements. Window ties are anchored with #12 Galvanized screws into stone.

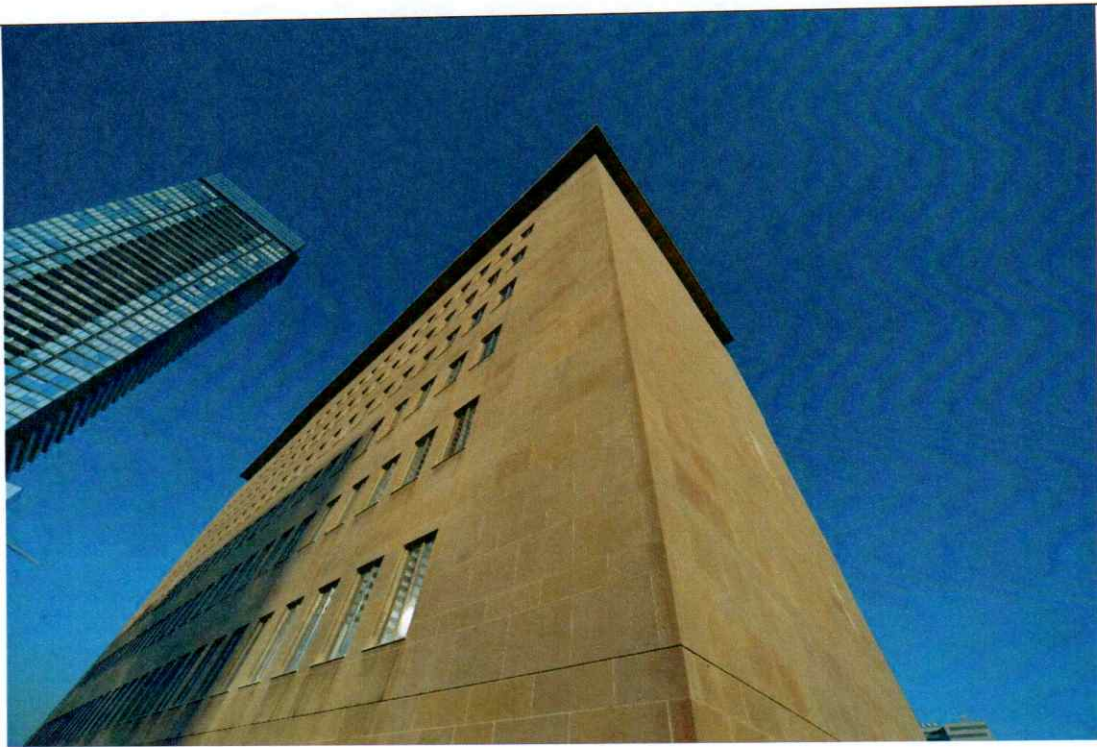
**Figure 52** South and East elevations additional 7 floors above vent screens. The masonry is in good condition.

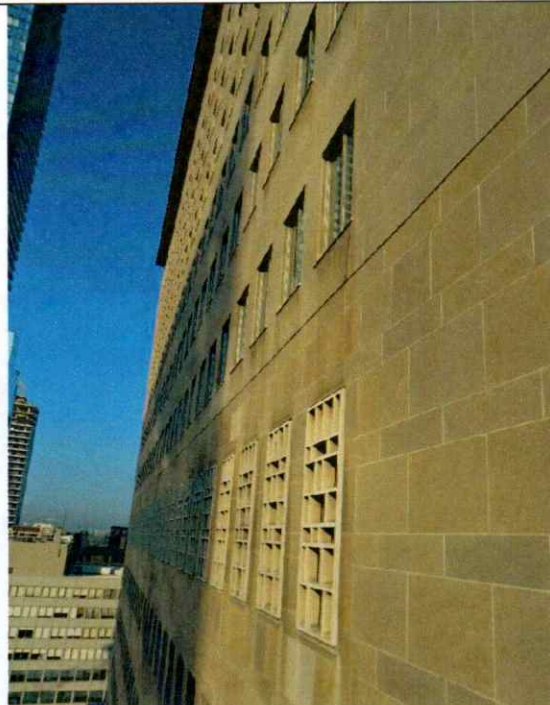
**Figure 53** South elevation at vent screens. The masonry is in good condition.

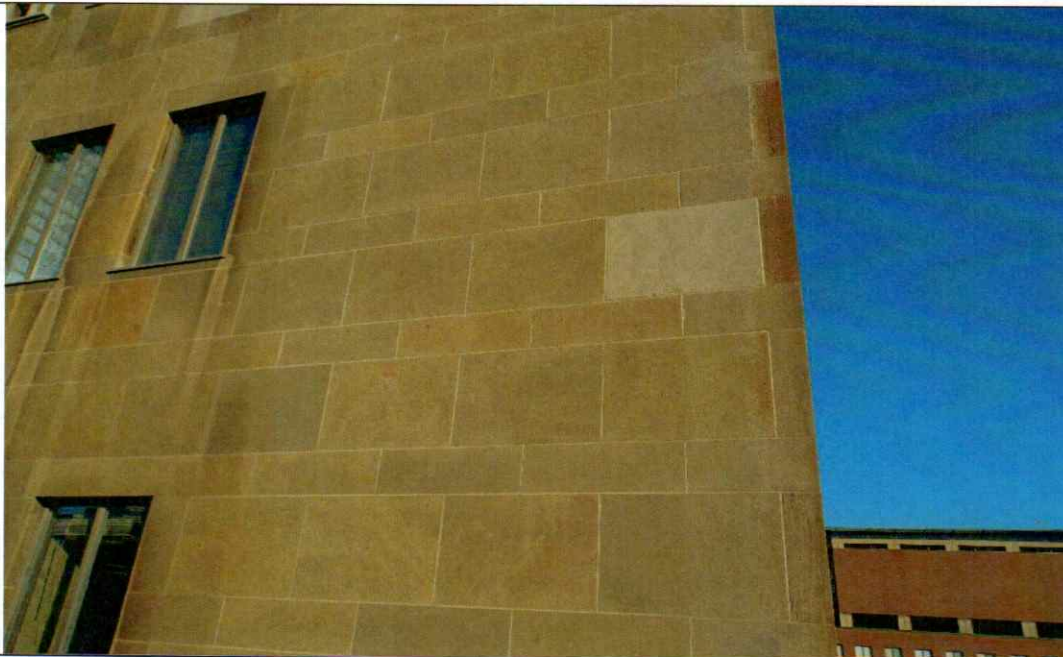
**Figure 54** South elevation at the 12<sup>th</sup> floor. The masonry is in good condition. Note replaced (lighter appearing) veneer ashlar panel- Indiana limestone.

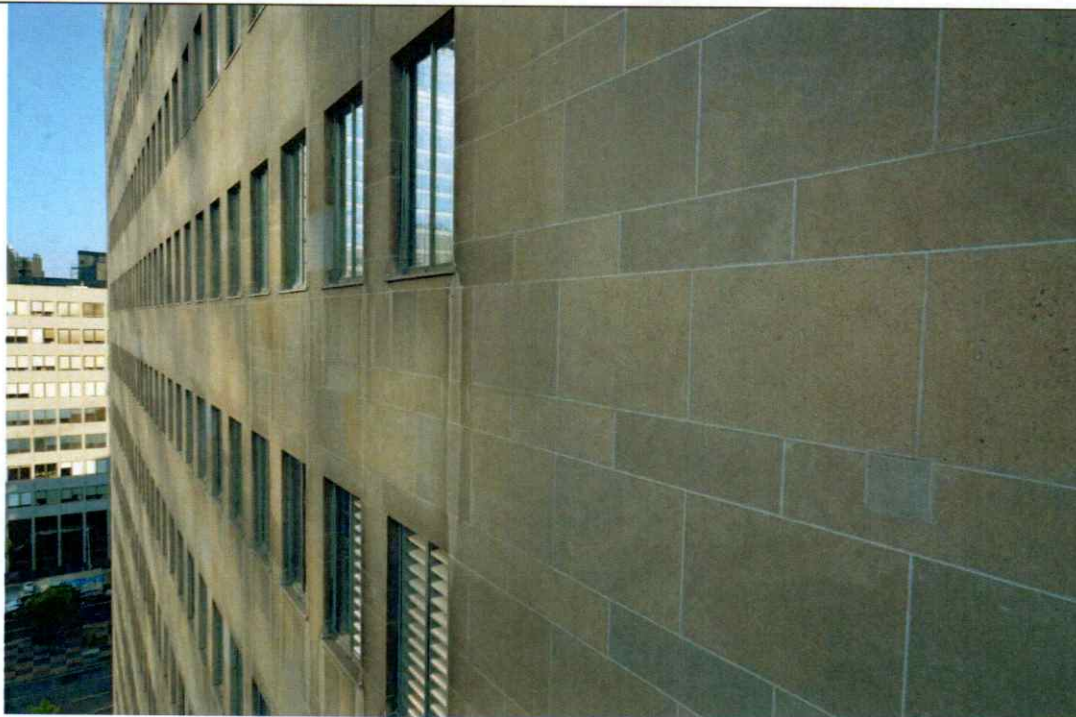
**Figure 55** South elevation at the 5<sup>th</sup> floor. The masonry is in good condition. Note replaced window mullion panel- Indiana limestone and surface mortar patch (RHS).

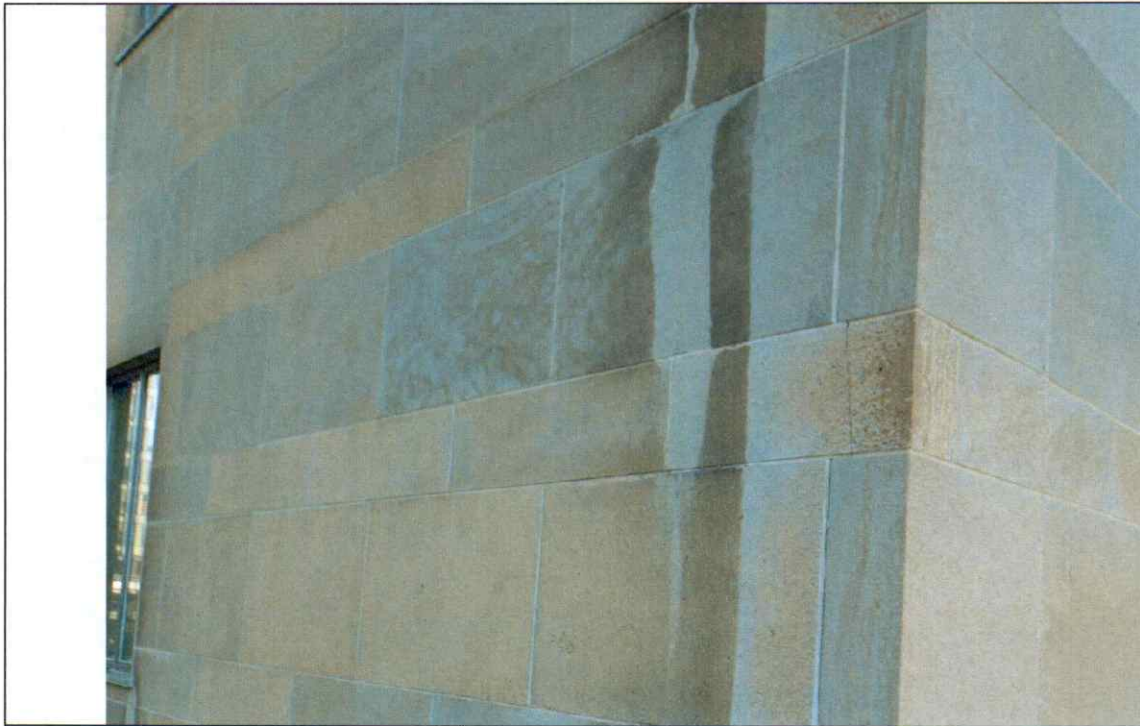
There is also a slightly less concerning crack at the southeast corner on the south elevation mirroring the cracking on the north. This crack also seems to start near grade, passing through mortar joints and eventually through some stones at the 3<sup>rd</sup> and 4<sup>th</sup> floors, and terminating at the 5<sup>th</sup> floor. This cracking/movement does not display any significant displacement in the veneer. This is a very similar pattern to the movement crack on the north and it is equally difficult to pinpoint the cause. This cracking also should be addressed soon and some additional investigation to determine and remediate the cause(s) would be prudent. The other corners of the building (southwest and northwest) were also visually examined to determine if cracking is occurring there, and one cracked (bonder) stone and some debonded mortar joints were noted at the southwest corner of the south elevation at the 4<sup>th</sup> floor similar to the east end but less severe.

**Figure 56** Southeast corner elevation at 4<sup>th</sup> floor. Note cracked stone and debonded joints.

The exterior cladding does require some repair most notably, to address the vertical cracking on the east end, to consolidate some isolated cracked stones and to repair/ replace some eroding sill and lintel units on the west. The stones that are cracked on the north and south at the east end could be structurally repaired after the cause of the cracking and movement is identified and remediated. It would be a good conservation decision to pin and stitch these cracked stones back together with stainless steel rods as these stones are sizable and thick enough to allow for this type of repair and replacement material in Queenston limestone is not available and any other available repair material would be a compromise.

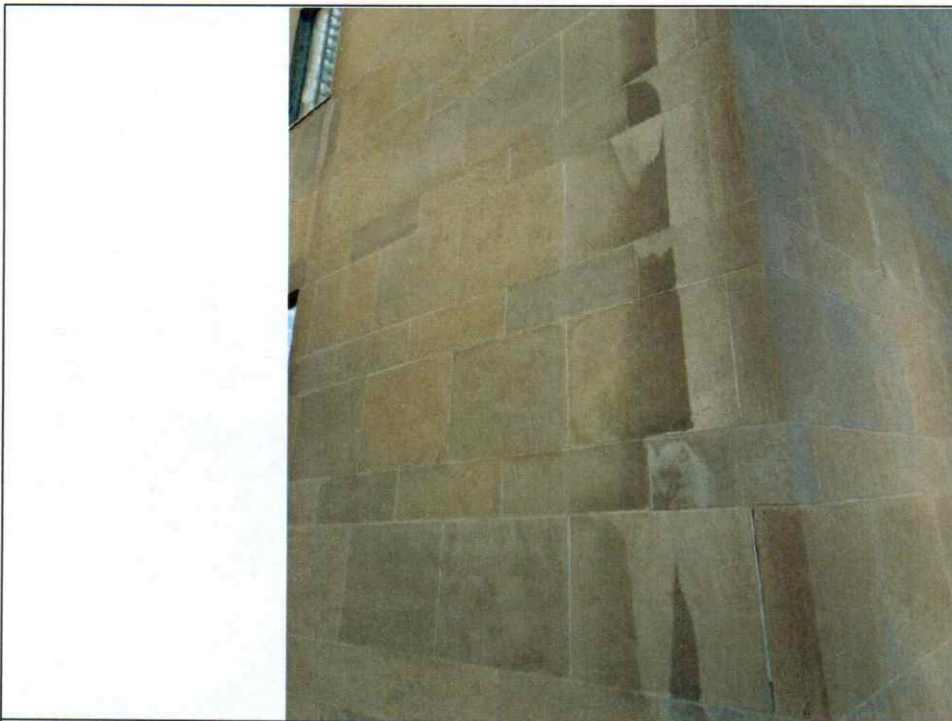
**Figure 57** Southeast corner elevation at 3<sup>rd</sup> floor. Note open and debonded joints.

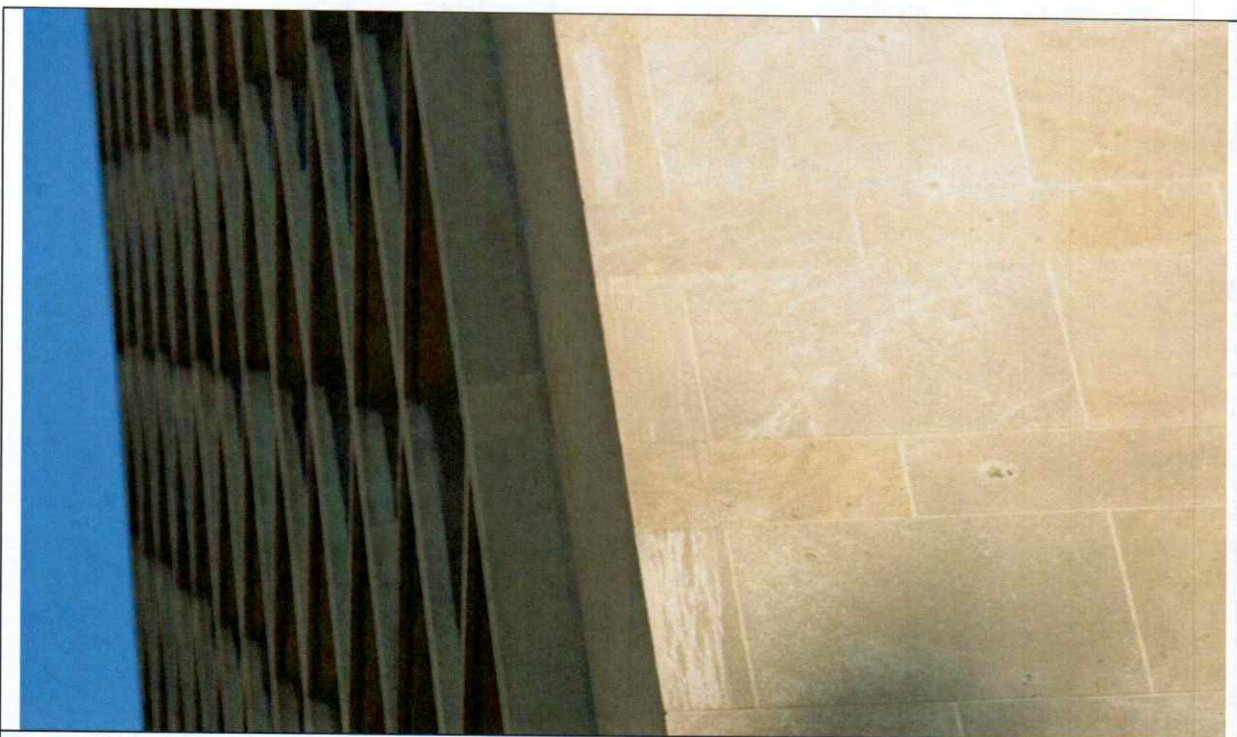
**Figure 59** South elevation southwest corner cracked stone and debonded joints at 4<sup>th</sup> floor.

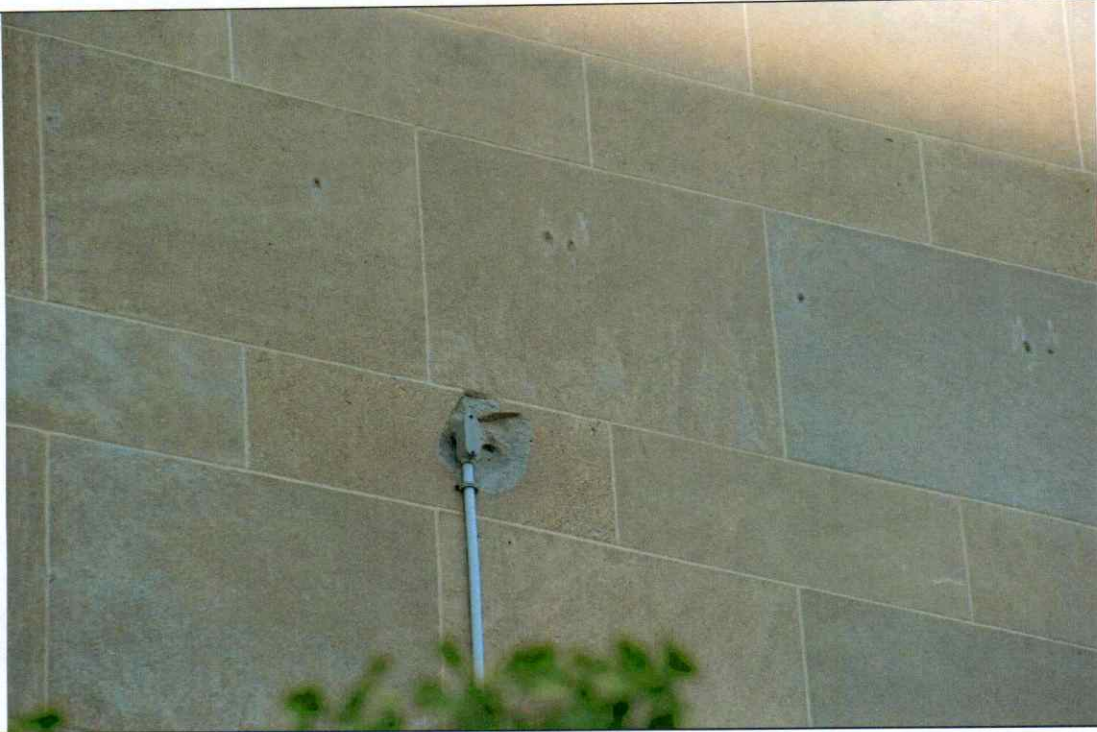
**Figure 60** South elevation-west side spalled stone at electrical service penetration and holes in cladding from fixings.

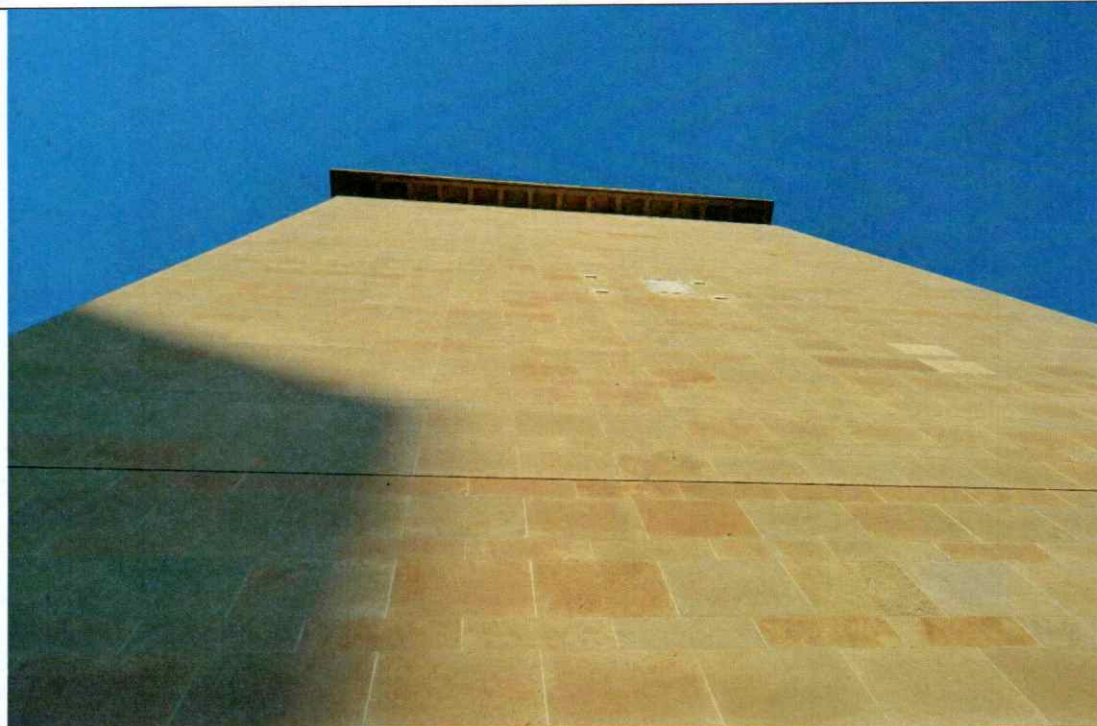
**Figure 61** East elevation floors 12-20. The masonry is in good condition.

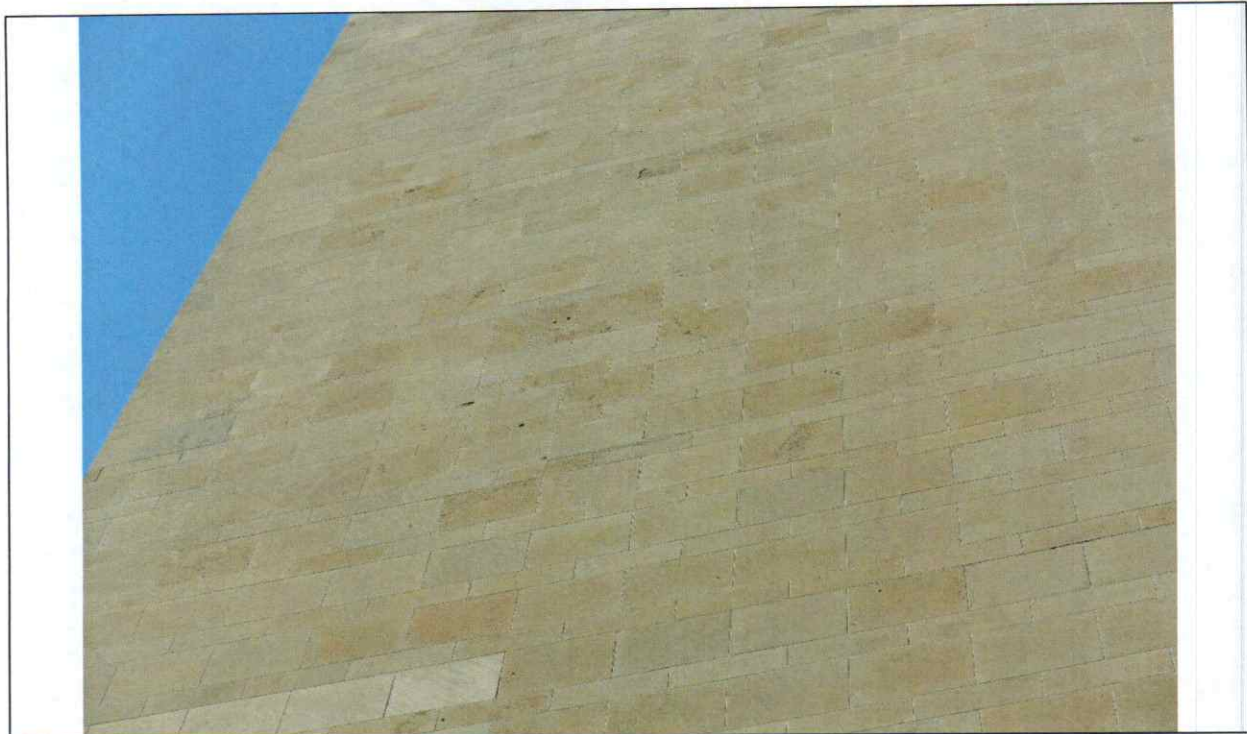
**Figure 64** East elevation floors 4-9. Some superficial erosion patches are evident.
