## 505 University Avenue, Toronto- Site investigation report

| Prepared by: | Donovan Pauly, MSc, CAHP, APTi (Architectural Materials Conservator) |
| Location: | 505 University Avenue, Toronto, Ontario |
| Date of site visit: | September 16-25 |

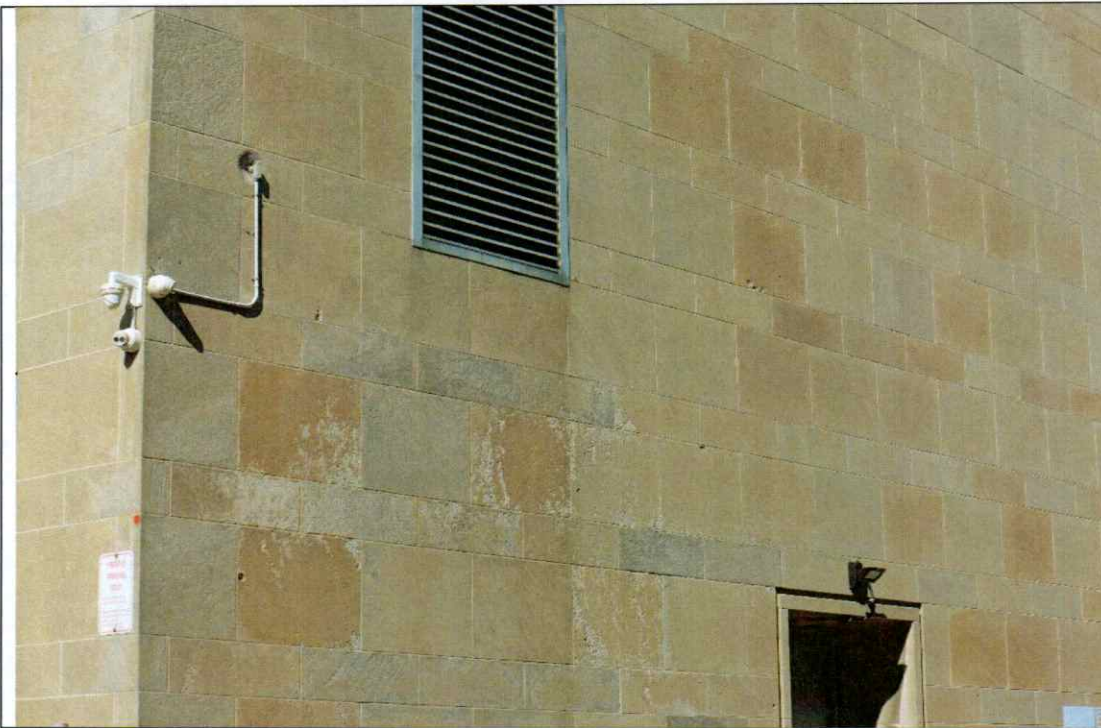
There are also areas of surface loss on the east elevation above grade around the large louvred vent. This is most likely due to moisture in the expelled air from the vent accelerating the surface decay.

**Figure 65** East elevation ground to 2<sup>nd</sup> floor. Surface erosion/ exfoliation related to moisture from the vent above.

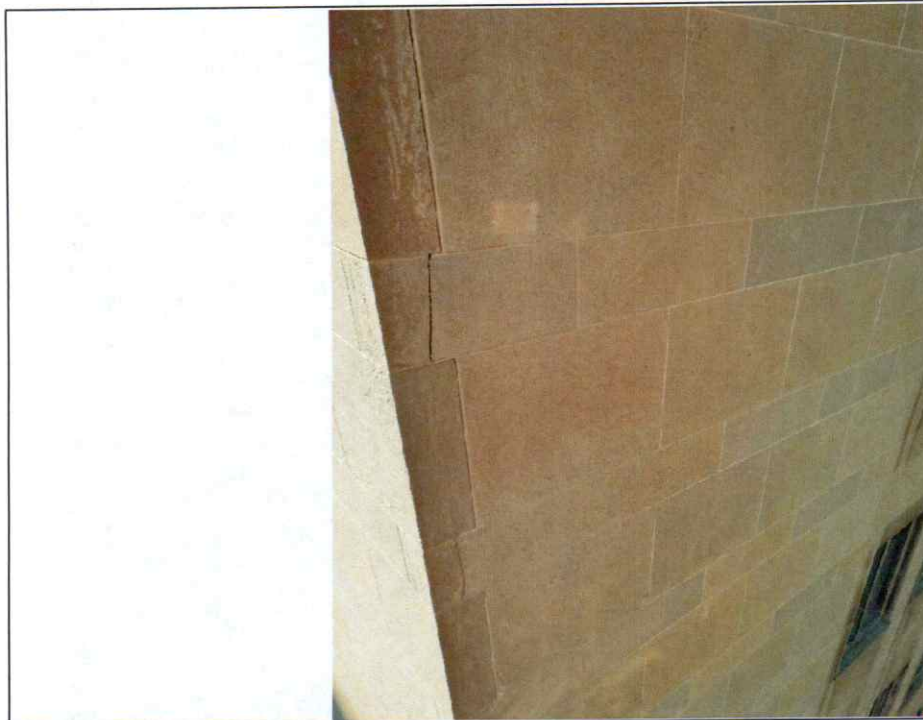
There are two areas where some significant vertical cracks have occurred. The most serious of these is at the northeast corner, primarily on the north side. There is a structural movement that appears in the cladding at grade and travels upward in a relatively straight line to the middle of the 5<sup>th</sup> floor. There is a slight displacement out-of-plane toward the north at this crack +/- 6mm at the lowest stone and to a lesser degree above. It is difficult to determine the cause of this movement and cracking as there may be several factors involved, including building settlement, thermal movement or perhaps some internal corrosion of embedded metals stressing the cladding ( it was not possible to investigate this internally as there is a large boiler or incinerator flue directly behind this area).

This cracking and displacement are a concern, and some movement appears to have occurred more recently, evidenced by a spreading mortar joint that appears to have been repointed previously (not original). This crack is also open to the elements, passes directly through some bonder (12" high) stones and certainly allows water runoff to enter the wall assembly. This defect should certainly be monitored and should be repaired as soon as possible to limit additional decay and potential worsening. It would be prudent to carry out an investigation in this area and below grade to determine the cause of this and repair and remediate it to restore structural cohesion in this corner.

**Figure 68** North elevation northeast corner. Crack/ displacement and debonded joints from the 5<sup>th</sup> floor to grade.

The primary recommendation currently is to carry out some additional investigation at the northeast corner where the vertical cracking is most severe. This should include some excavation to confirm the condition of the foundation and below-grade areas at this corner as the lowest ashlar block on the north is displaced down and outward here and this could be a sign of foundation settlement issues. It would also be beneficial to remove some stone units higher up on the structure (2<sup>nd</sup>-4<sup>th</sup> floor areas) to determine if there is a metal corrosion issue there stressing the cladding and forcing it outward.

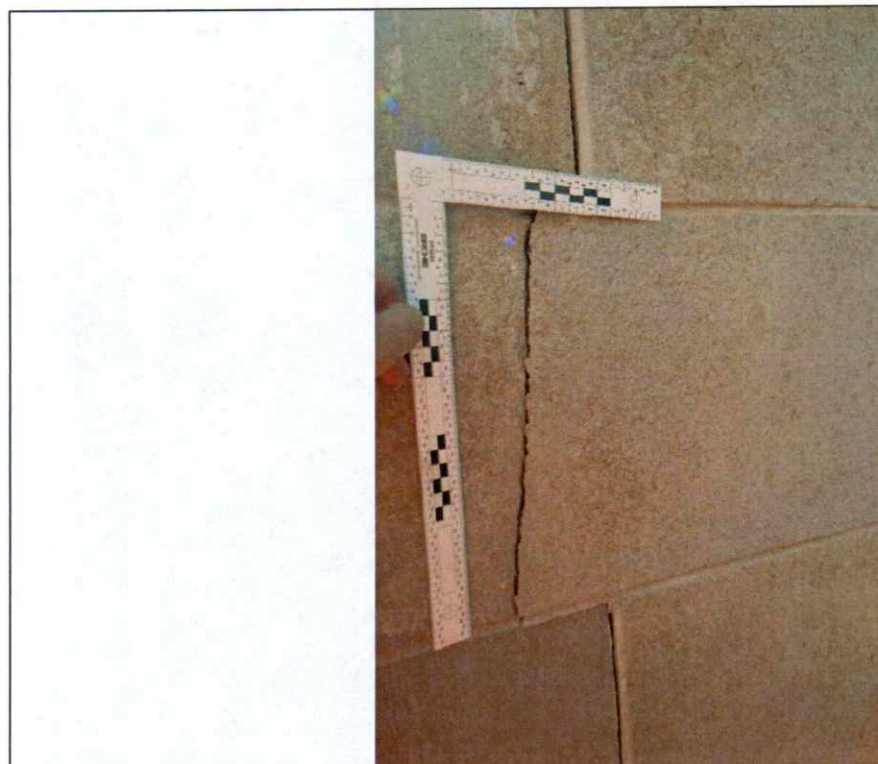
**Figure 69** North elevation northeast corner. Detail of Crack/ displacement at 4<sup>th</sup> floor.

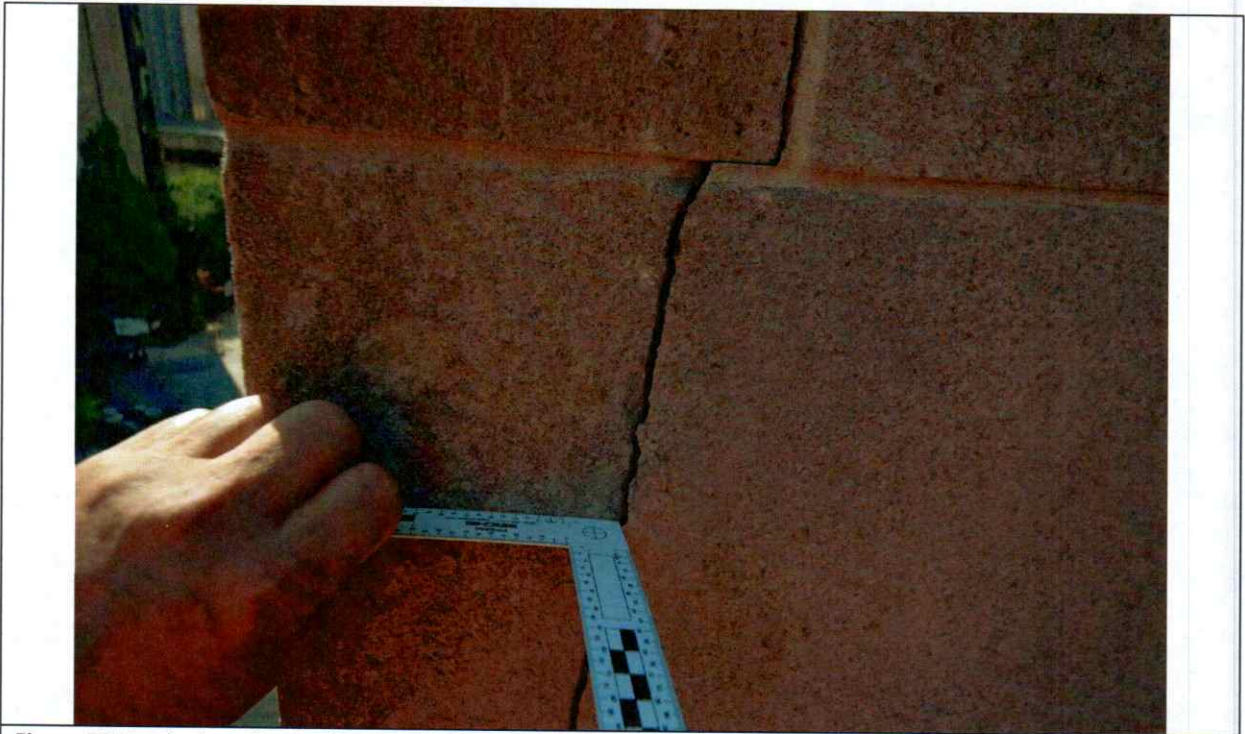
**Figure 70** North elevation northeast corner. Detail of Crack/ displacement at 4<sup>th</sup> floor.

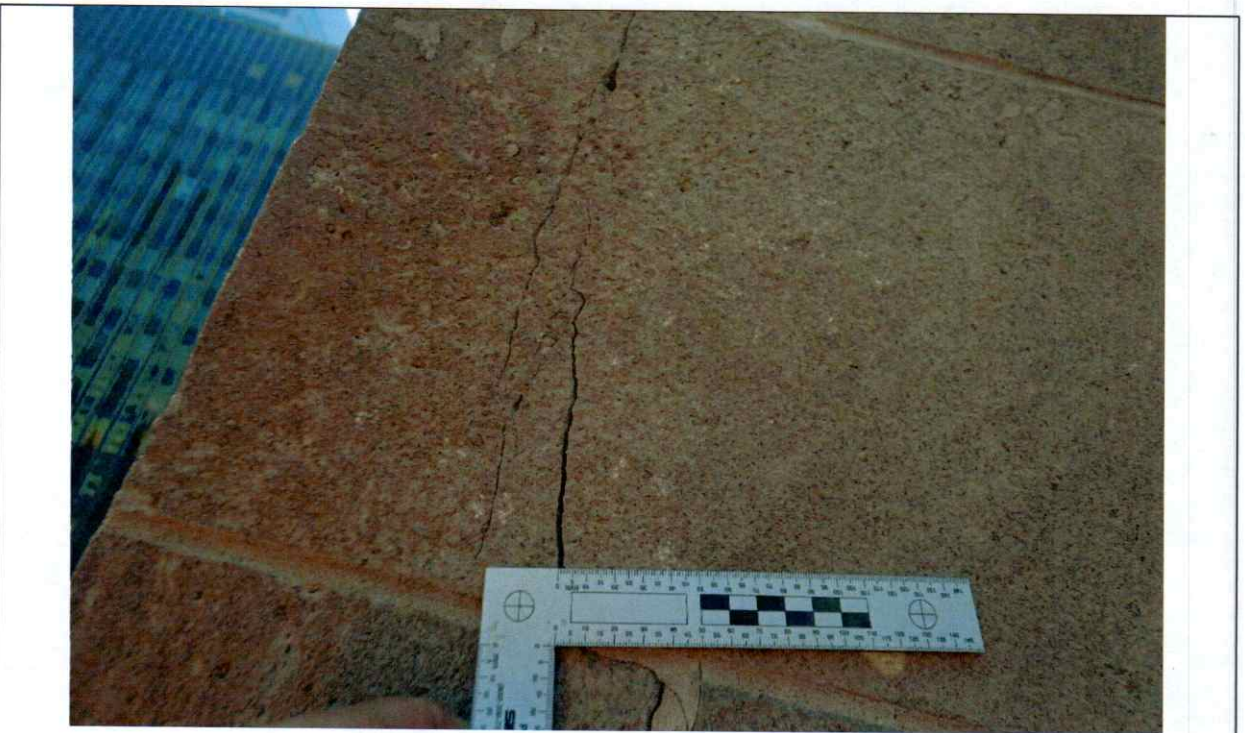
**Figure 71** North elevation northeast corner. Detail of Crack/ displacement at 3<sup>rd</sup> floor.

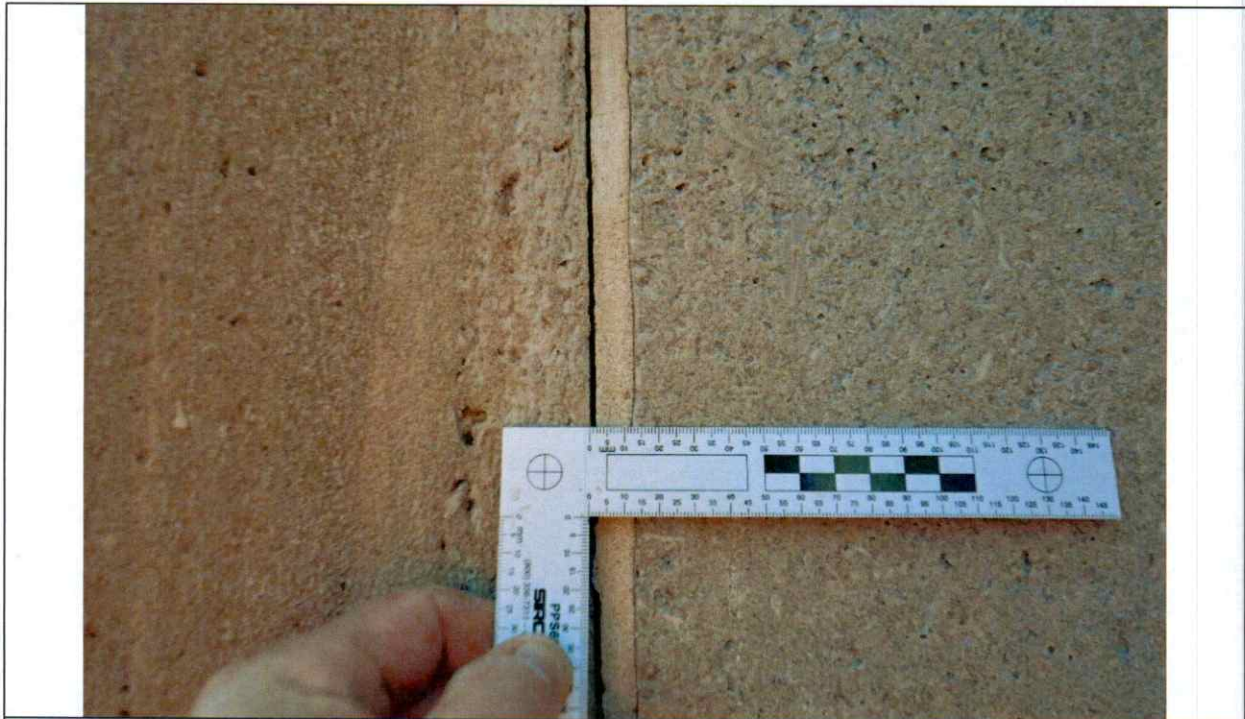
**Figure 72** North elevation northeast corner. Detail of debonded joint at 2<sup>nd</sup> floor.

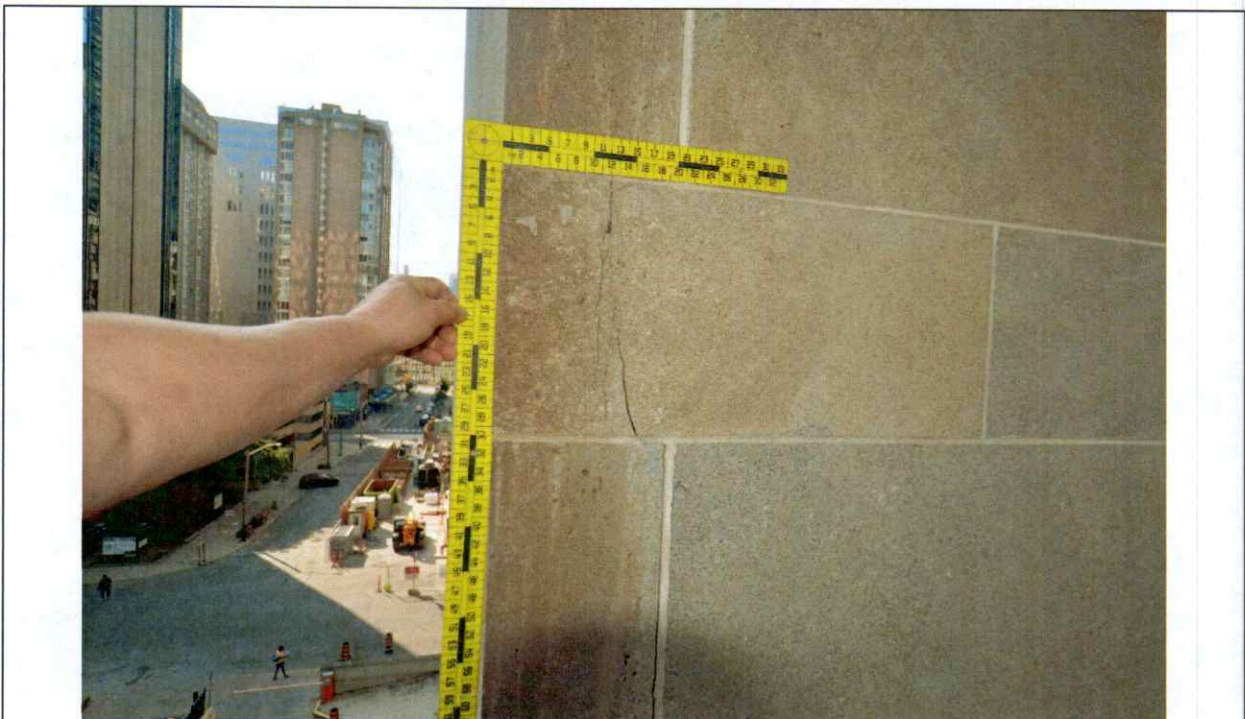
**Figure 73** North elevation northeast corner. Detail of Crack/ displacement at 3<sup>rd</sup> floor.

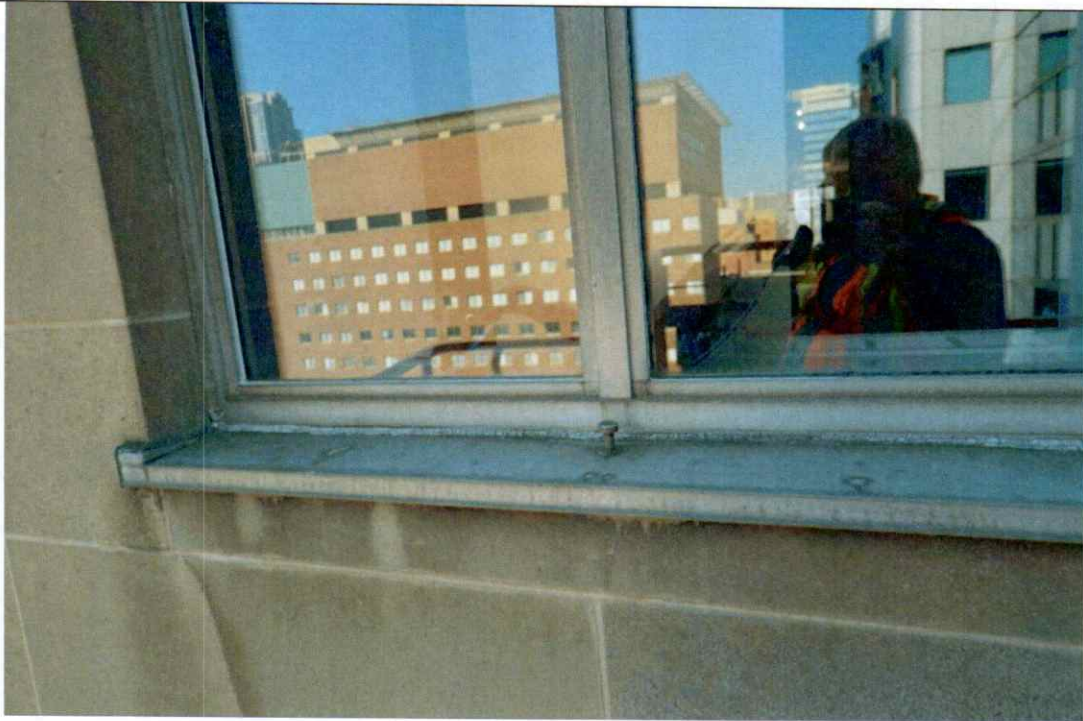
The original aluminum framed IGU windows are typically quite oxidized, have lost most of their protective surface finish and are at the end of their reasonable service life. The sealant around many of the windows observed is also at or beyond its service life. It was noted by the building maintenance staff that the replacement of failed IGU glazing is ongoing and a regular maintenance issue and some leaks around the frames have occurred.

**Figure 76** North elevation typical window condition- sealants failing and window frames heavily oxidized.

The mortar jointing will also benefit from some maintenance re-pointing. The sealants used on the windows and at some material junctions require renewal. It is also likely that there are areas at the top overhanging canopy where some maintenance of sealants would be prudent (these areas were not reviewed for this report).

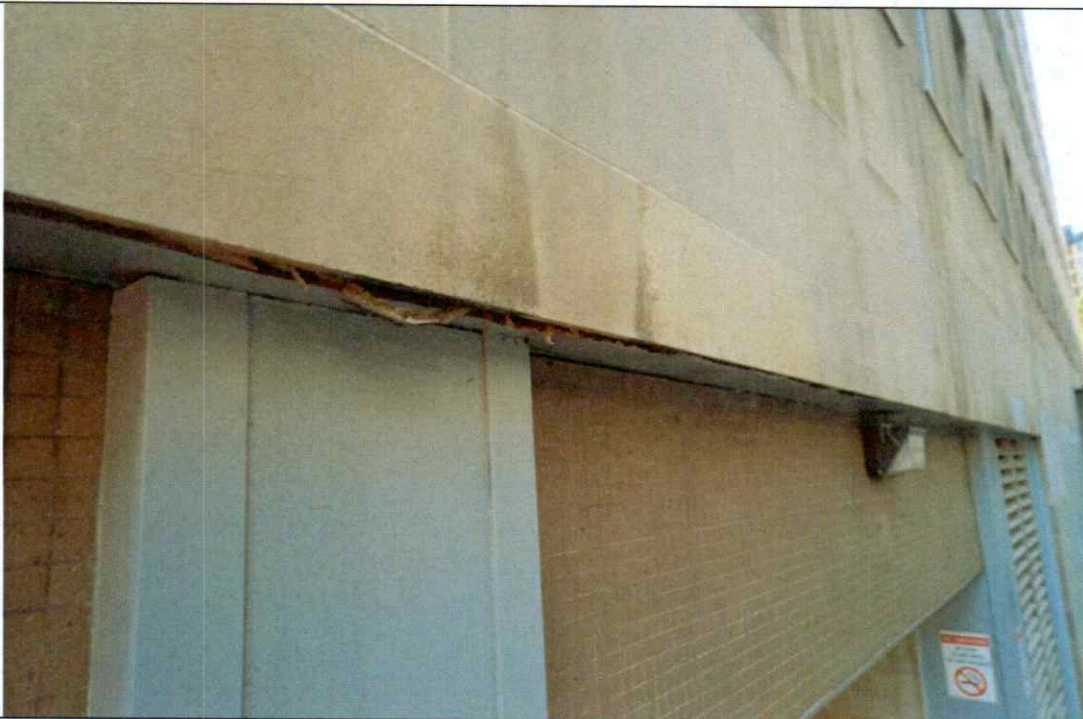
**Figure 77** North elevation first-floor soffit sealant has failed and there is some evidence of internal corrosion of steel elements (rusting and some displacement at the soffit plate) along this elevation.

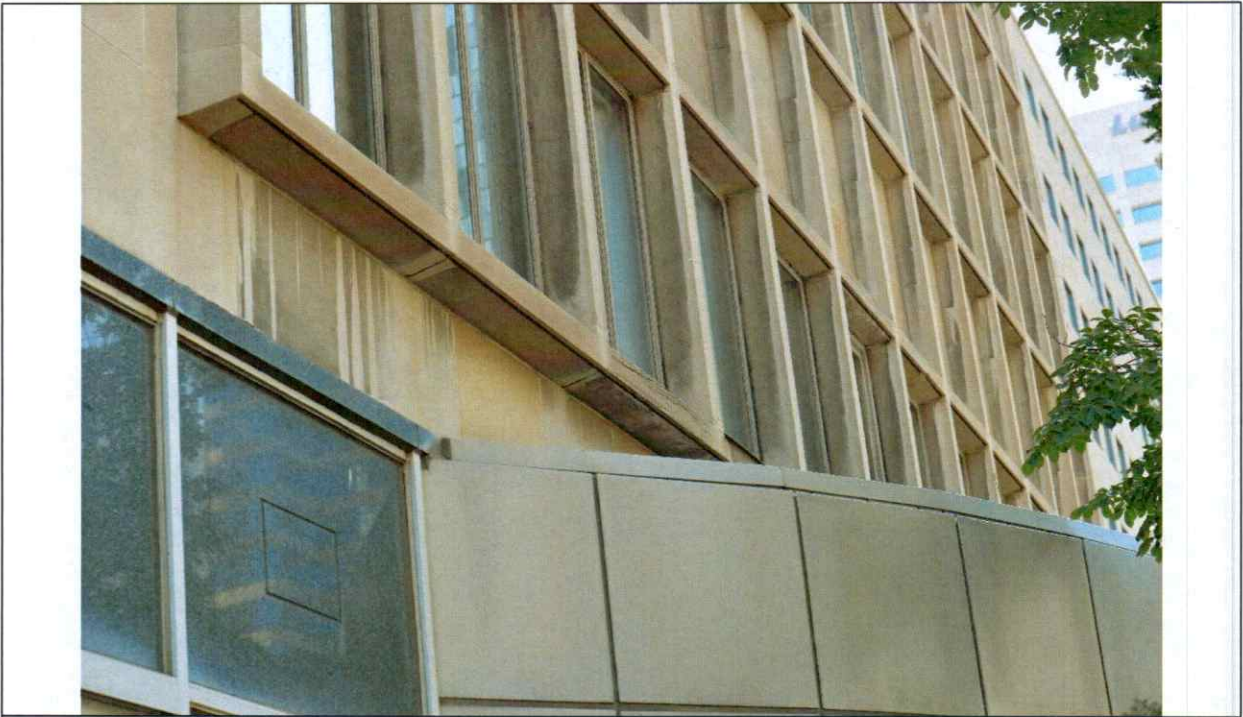
**Figure 78** West elevation eroded sill at the 2<sup>nd</sup> floor window.

The exterior cladding does require some repair most notably, to address the vertical cracking on the east end, to consolidate some isolated cracked stones and to repair/ replace some eroding sill and lintel units on the west. The stones that are cracked on the north and south at the east end could be structurally repaired after the cause of the cracking and movement is identified and remediated. It would be a good conservation decision to pin and stitch these cracked stones back together with stainless steel rods as these stones are sizable and thick enough to allow for this type of repair and replacement material in Queenston limestone is not available and any other available repair material would be a compromise.

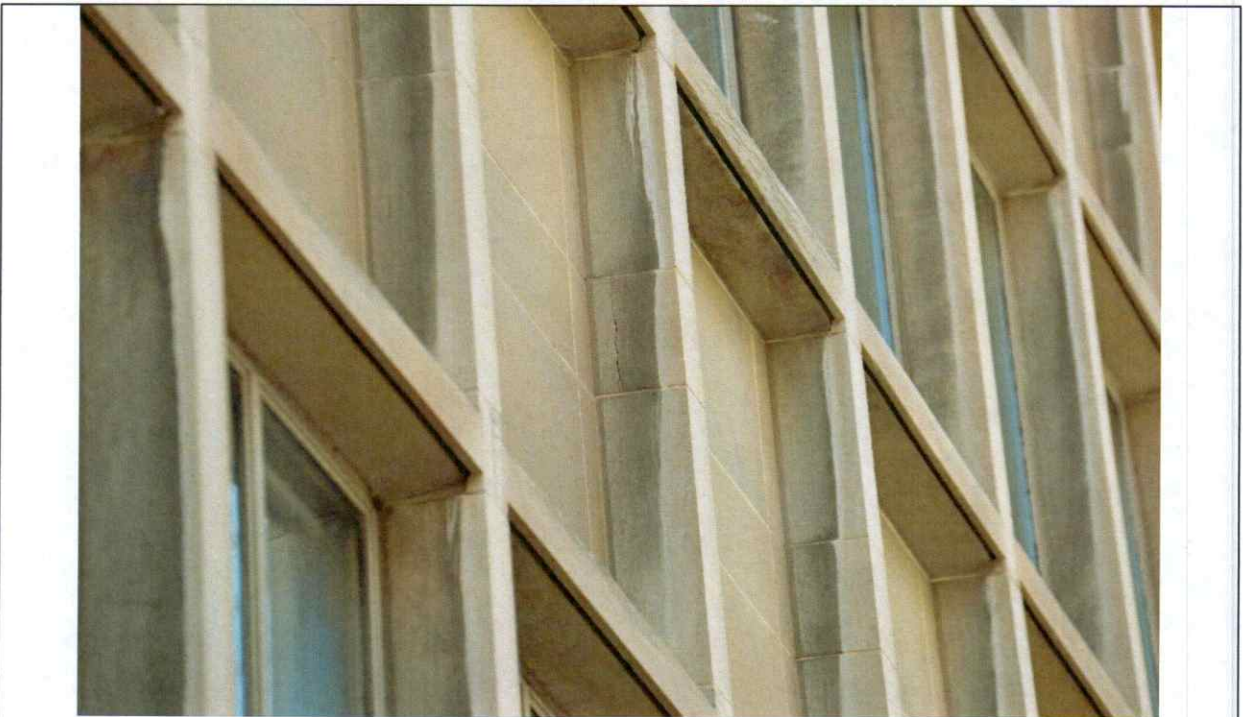
There are also a few stones that are cracked in isolated locations on the west elevation One is a small vertical spandrel mullion section, and one is a window lintel which appears to have been previously repaired. Neither of these cracked stones are any reason for concern at this point but, they should be monitored and repaired to ensure that they remain stable.

**Figure 79** West elevation cracked small mullion stone in spandrel and eroded sill at the 3<sup>rd</sup> floor window.

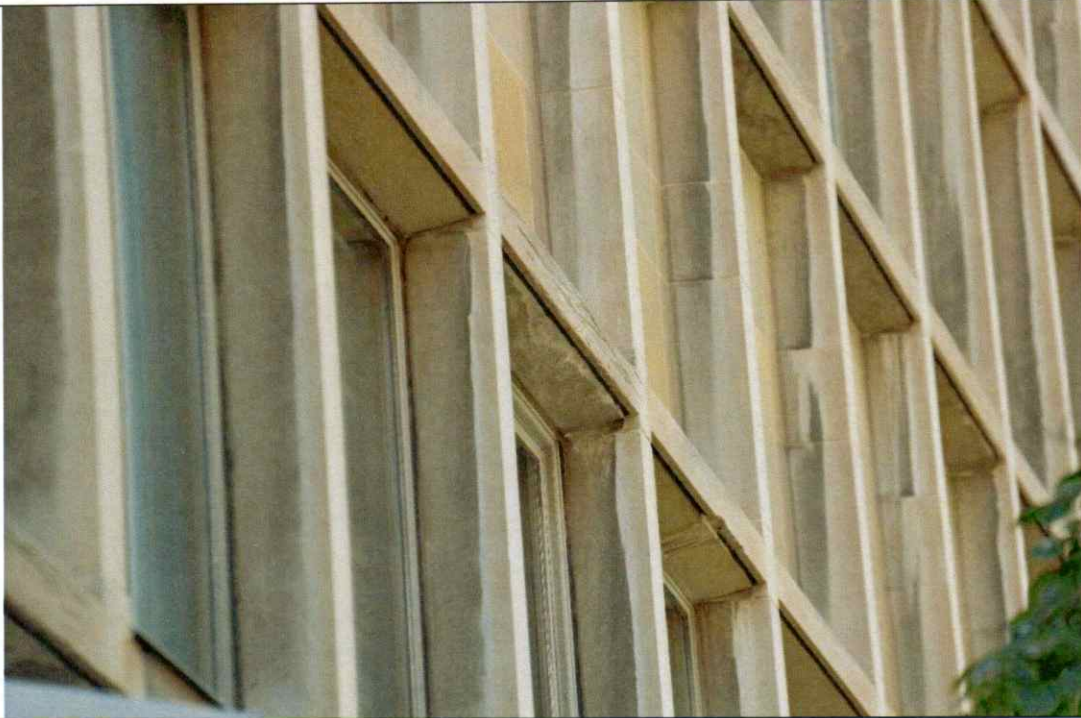
**Figure 80** West elevation eroded lintel stone and area of damaged drip edge at the 5<sup>th</sup>-floor windows.

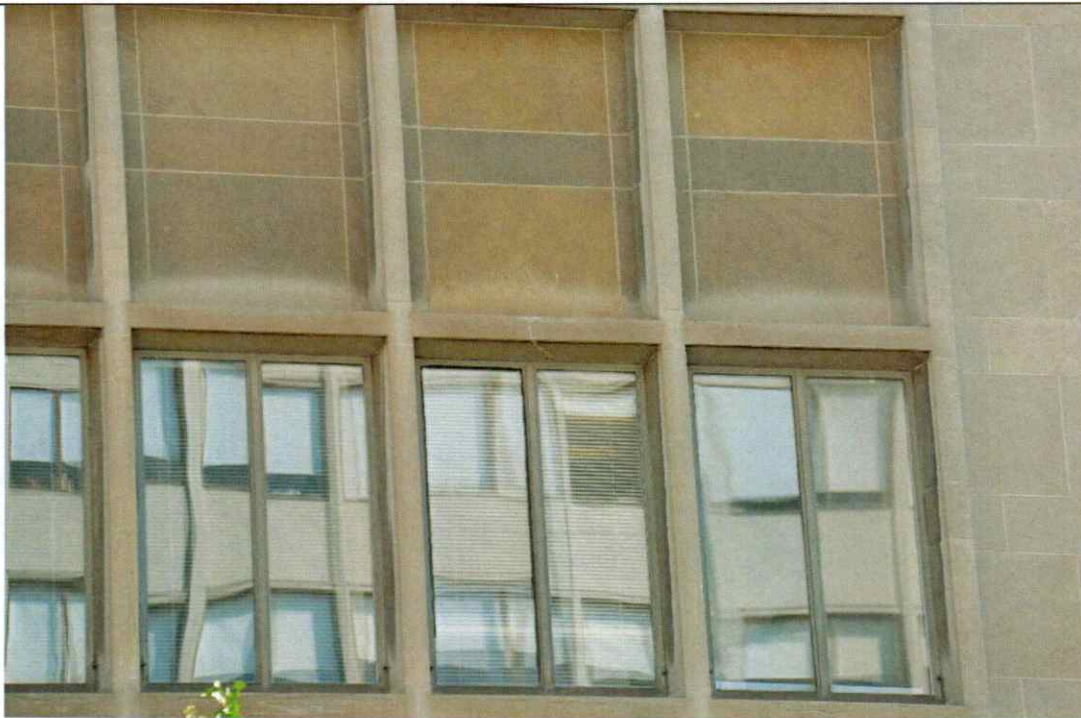
**Figure 81** West elevation cracked/ repaired lintel stone in at 2<sup>nd</sup> floor window.

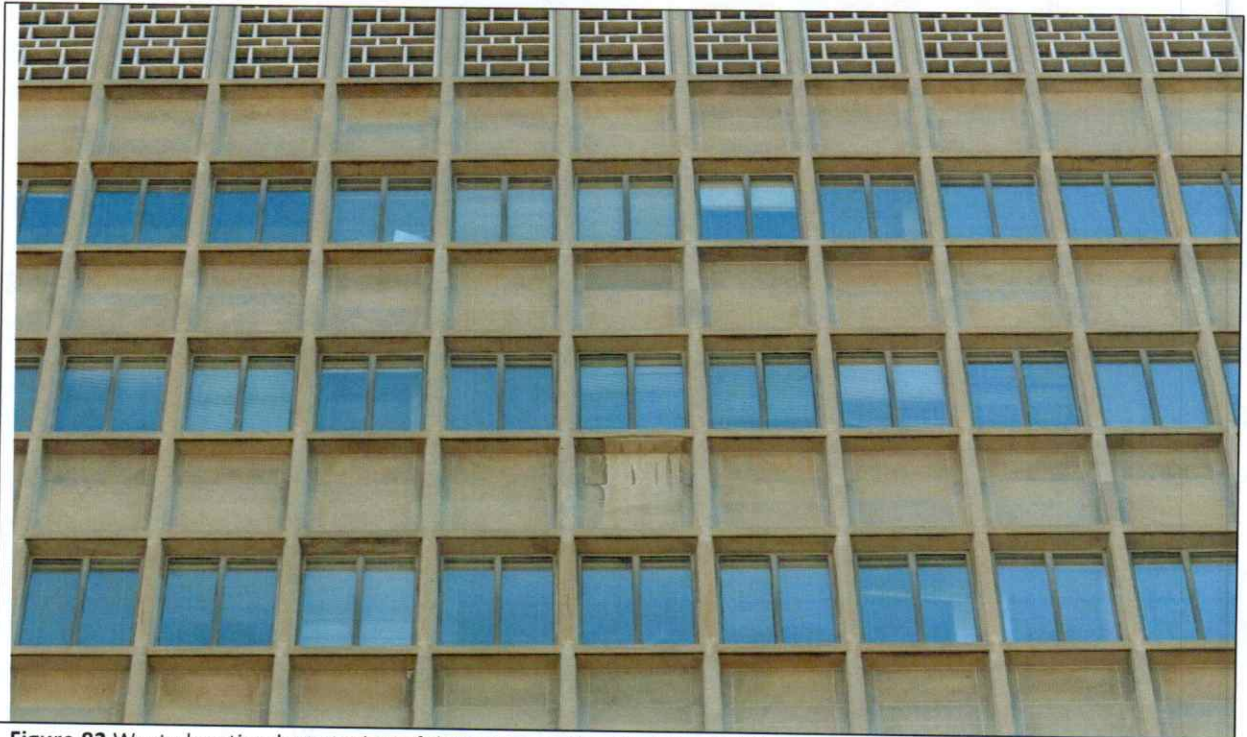
**Figure 82** West elevation lost section of drip edge on the sill at the 11<sup>th</sup> floor.
