# HERITAGE IMPACT ASSESSMENT

## 505 University Avenue

Toronto, ON

Date of Issue: 22 August 2025

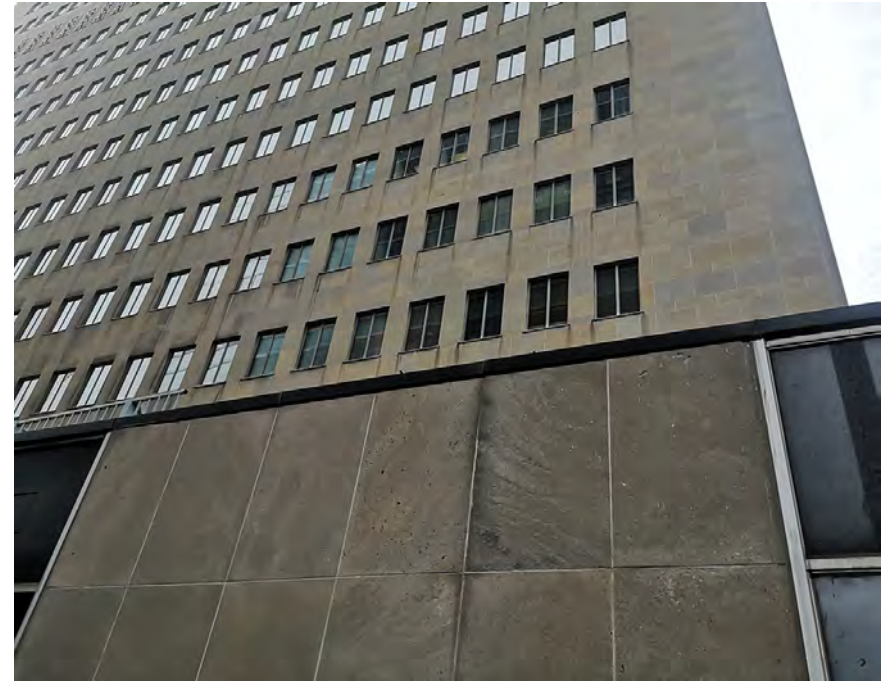
North elevation view, showing (at the bottom of the image) a portion of the one-storey volume with stone and granite cladding. Note the stone is in fair condition. Soiling is notable near the joints. Of note are some porous panels, which appears to be a natural imperfection of the stone and has not caused deterioration. On the north elevation of the tower, soiling below the window sills is noticeable at the corners, due to a lack of proper edge detailing.

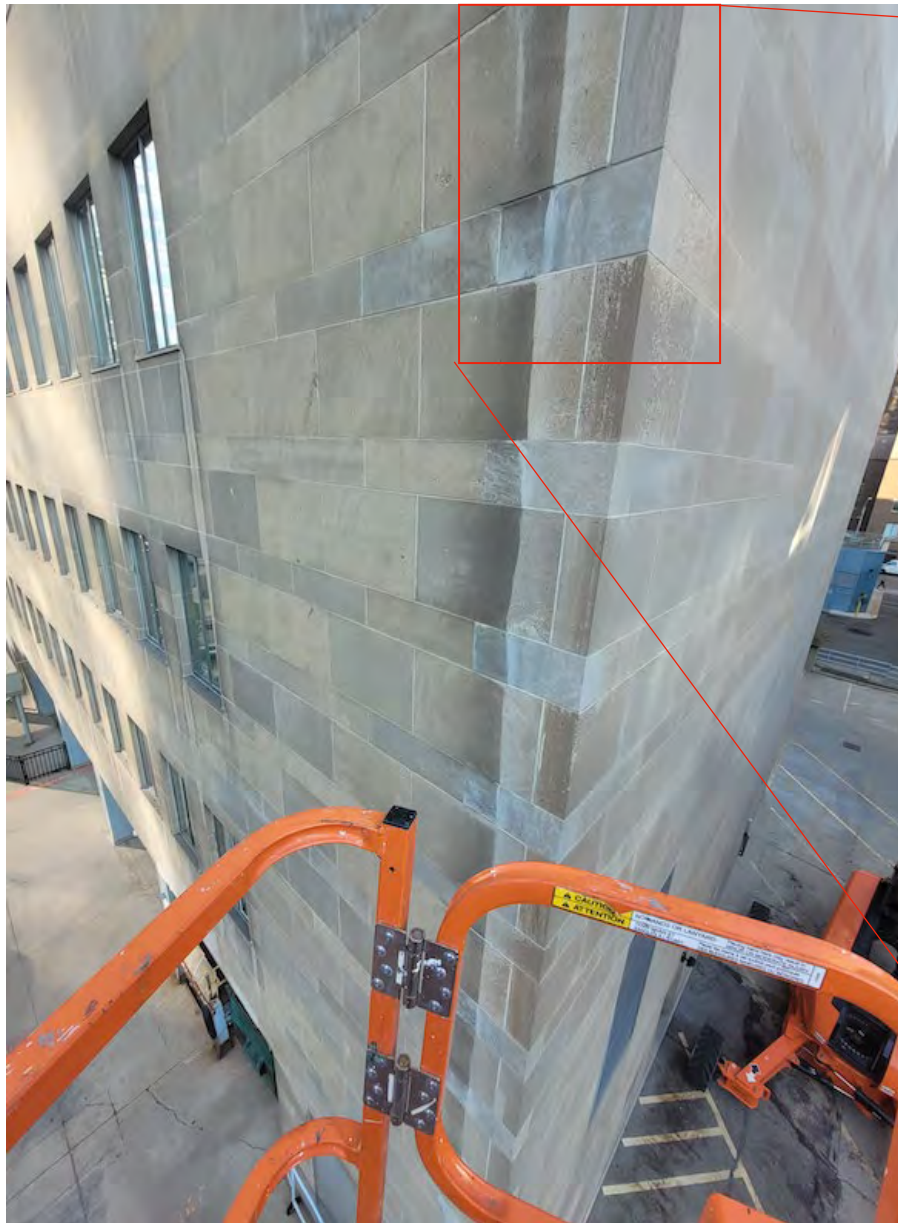
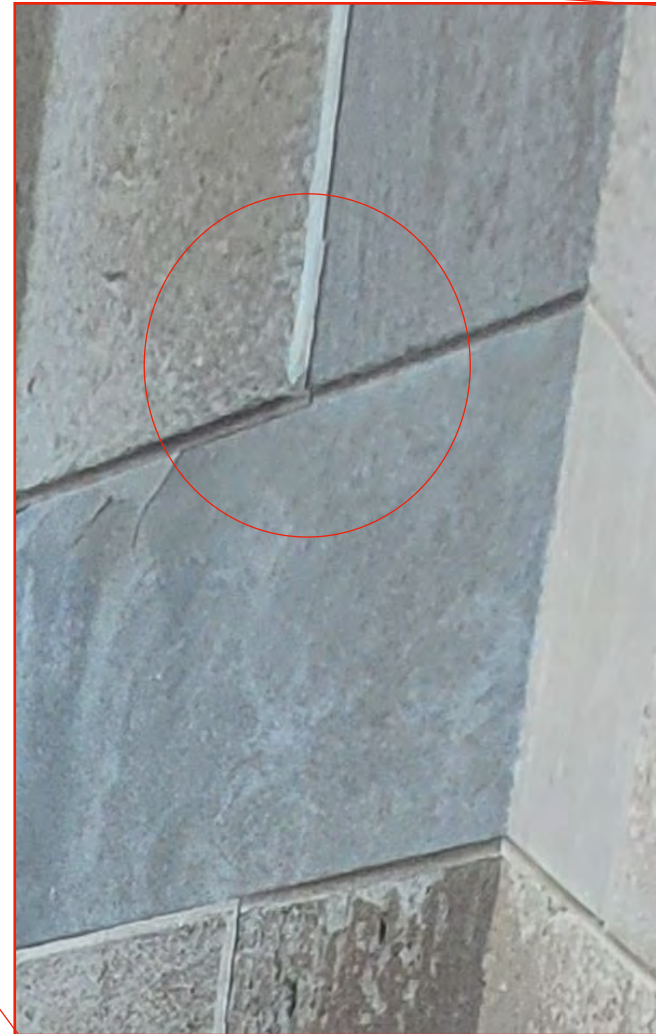
*Cracking at southeast corner (4<sup>th</sup> Floor extending to grade). Joint repairs within the past 20 years are again opening up (circle in the magnified detail. Similar conditions occur at other corners (particularly the northeast and southwest although the base of the building at the west is partially constrained by the podium causing less damage at the west corners).*

A review by GBCA and Clifford Restoration Limited revealed cracking for over five storeys at the northeast, southeast and southwest corners of the facades as noted above. It has been determined that the masonry facade is very stiff and contributes to the lateral stiffness of the building. This was not considered in the original design. Seismic<sup>10</sup> loads and heavy wind loads on the long walls put pressure on the structure<sup>11</sup> and are resisted by the masonry rather than the structural moment frame system, the latter of which is not fully engaged before the loads are absorbed by the masonry. While Toronto is in a low-level seismic zone, minimal provisions for seismic movement were made in the original design. As the building is thin in the north to south direction, there is less stiffness in the end walls than the long walls. The result is that the building is subject to torsional, or twisting, loads with the bending most severe at the corners at the lower portion of the tower. Movement induced by these loads results in observed cracking, typical for masonry in these conditions, which has already been repeatedly repaired.

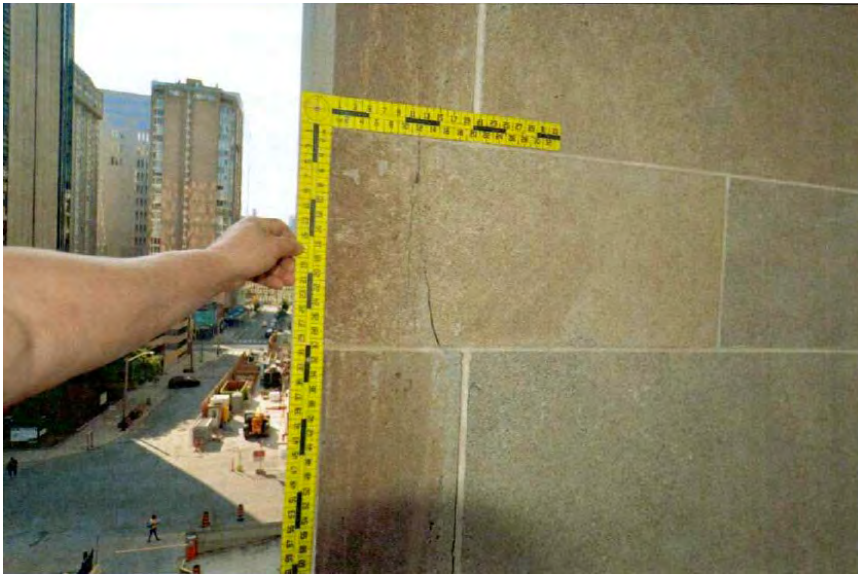
*Above - Through-stone cracking at northeast corner (3<sup>rd</sup> floor)*

*At right - Through stone crack and joint de-bonding (4<sup>th</sup> Floor).*

*This cracking, repaired previously, extends from the 5<sup>th</sup> floor to grade and includes outward displacement of stone by as much as 8mm.*

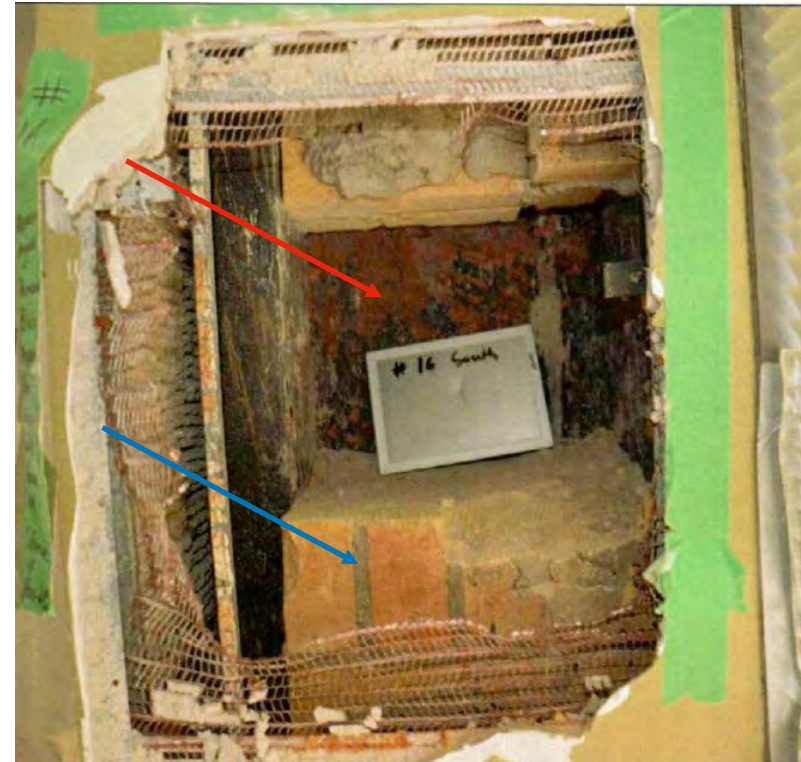
*Illustration from the Clifford Restoration report. The red arrow points to the web of a steel H column into which masonry (blue arrow) has been built. The masonry is built tight to the flanges and web of the column. The steel is corroding at this middle level floor – lower floors will see greater levels of corrosion due to ponding of water.*
