Residential Demolition Application – 554 and 556 Dupont Street

August 05, 2025

Project Address: 554-556 Dupont St. Toronto, ON, M6G 1Y9

Subject: Structural Integrity Assessment and Recommendation for Building Demolition

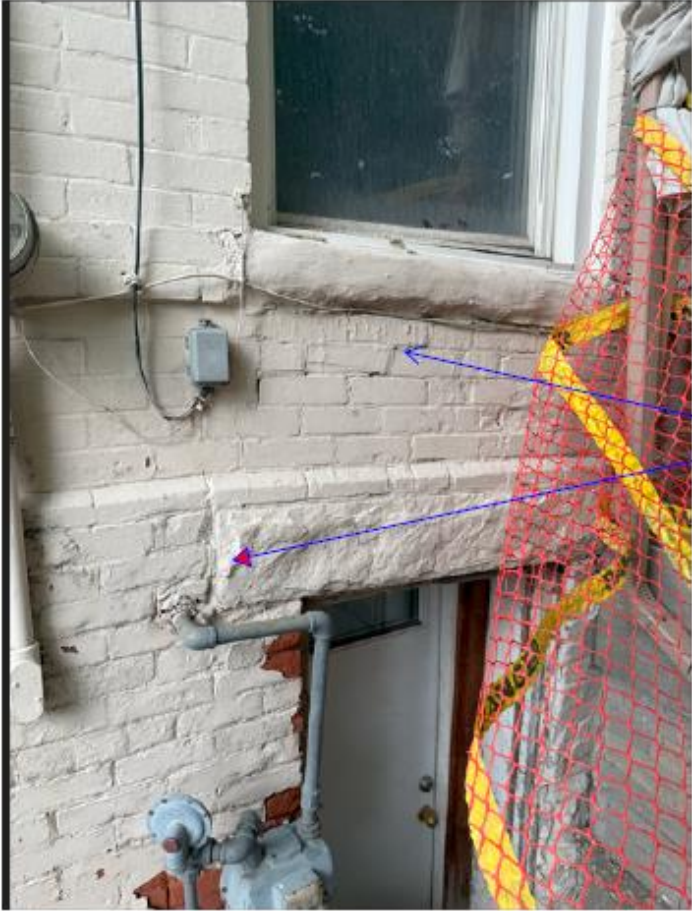
- **Cracks in Brick Below First Floor Window and Above Basement Door Entrance:** Visible cracks in the brickwork below the first-floor window and above the basement door are signs of settlement and shifting of the building structure. These cracks suggest that the foundation is compromised.

Crack and shifted
Brick Veneer

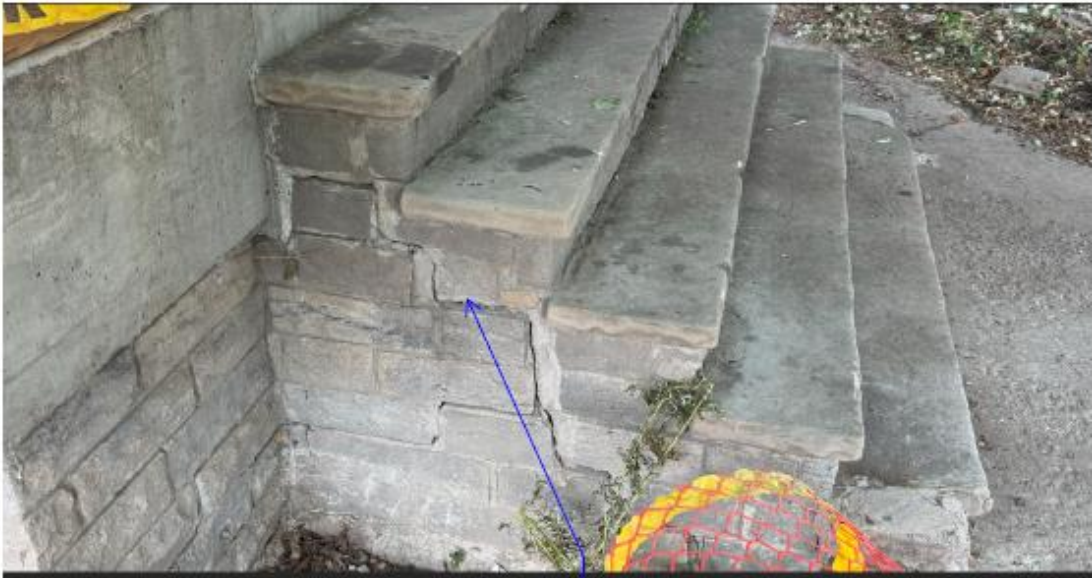
- **Cracking Front Concrete Stairs:** The front concrete stairs exhibit significant cracking, indicative of structural movement and potential instability. This could lead to further deterioration if left unaddressed.

Crack Front Entrance
stairs

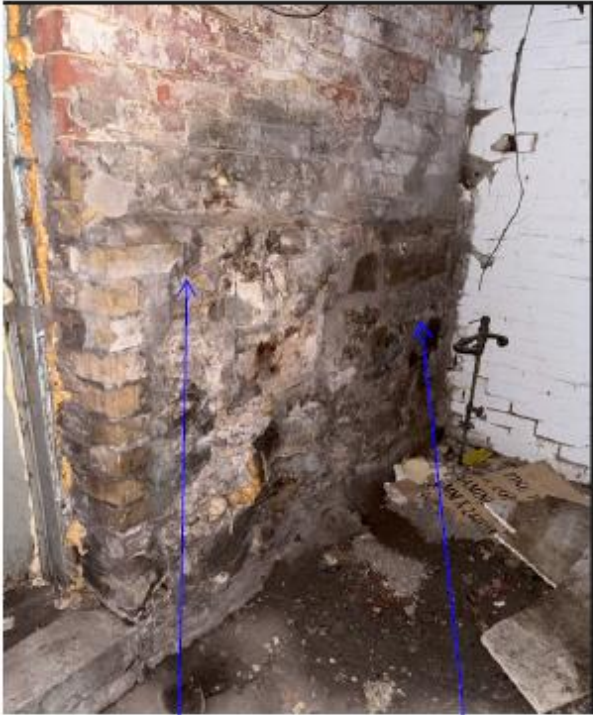
- **Disintegration of Mixed Stone and Brick Foundation Wall:** The foundation wall composed of mixed stone and brick is disintegrating, compromising the load-bearing capacity of the structure.

Foundation wall made of stone and brick .
Visual Moisture

Mold on foundation wall

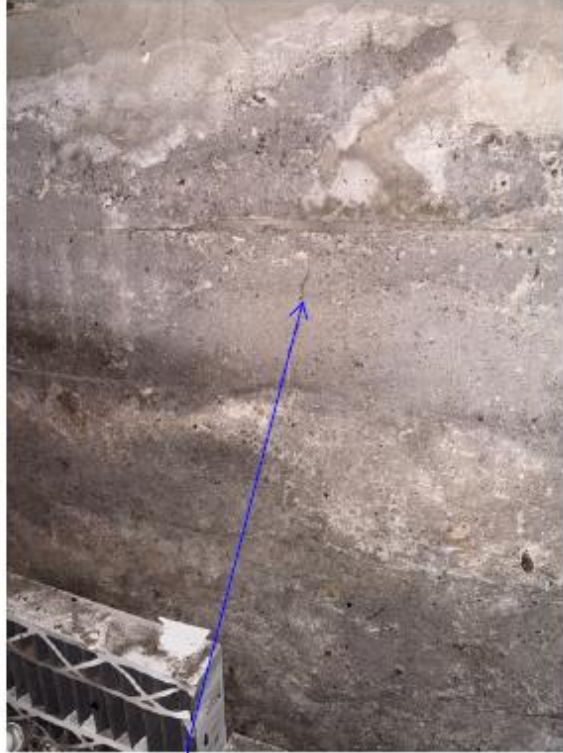
- **Crack in Concrete Foundation Wall:** A large crack in the concrete foundation wall is observed, which compromises the structural integrity of the foundation and could lead to further foundation failure if not properly addressed.

Concrete Wall cracke

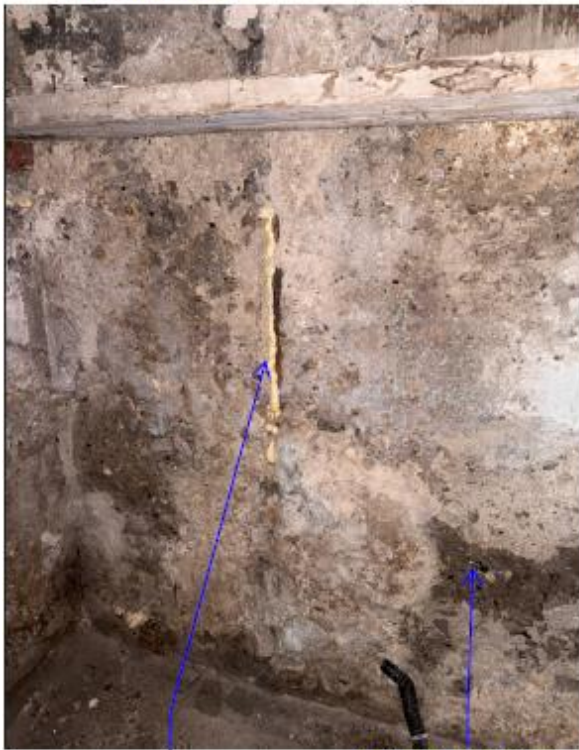
Foundation wall crack filled with foam

Mold on foundation wall

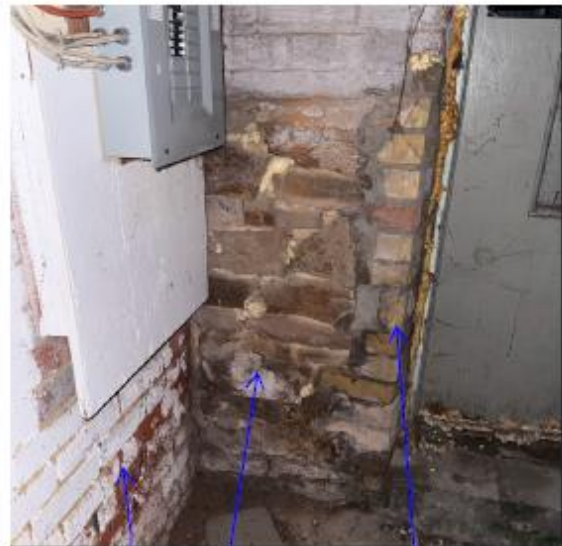
Multiple material in foundation walls

Stone Wall repaired with brick

Mold on foundation wall

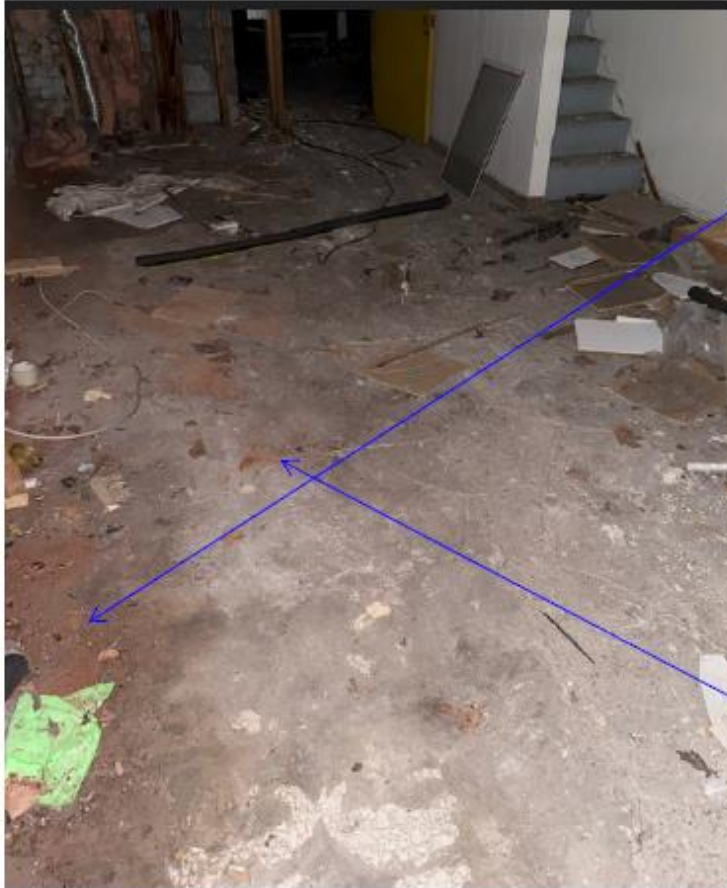
- **Water Leaks and Dampness in the Foundation:** Dampness is present throughout the foundation floor, and there is evidence of water infiltration into the basement through the old fieldstone foundation wall. The ongoing water penetration exacerbates the foundation's deterioration.

Basement Concrete Floor moisture

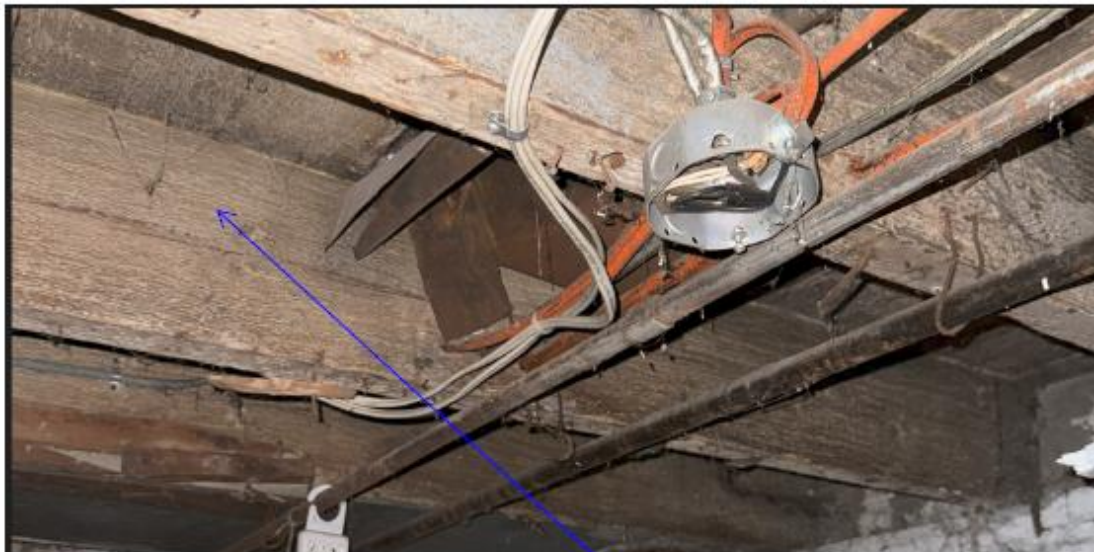
Mold on foundation Joist system

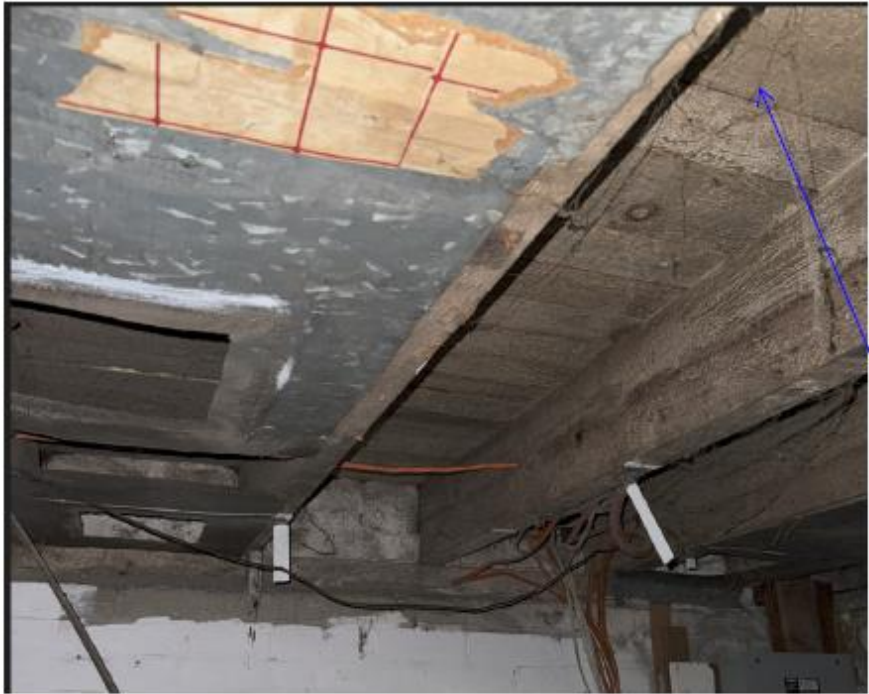
Mold on foundation
Joist system

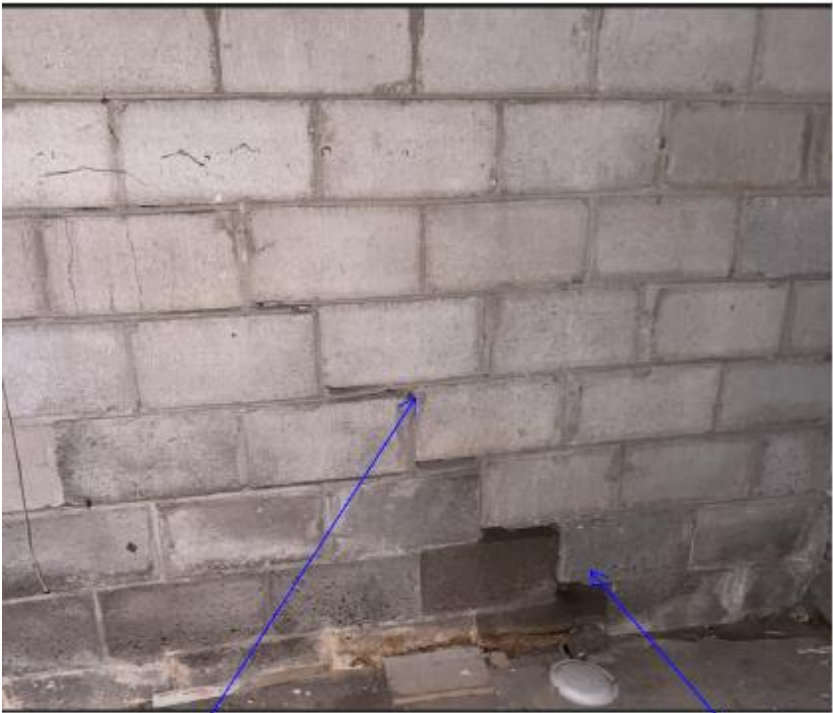
- **Shifting of Block Foundation Wall:** Both horizontal and vertical shifting of the block foundation walls has been noted. This indicates severe movement in the foundation that affects the overall structural stability of the house.

Concrete Block
Foundation wall
Shifted crack

Foundation wall Mold

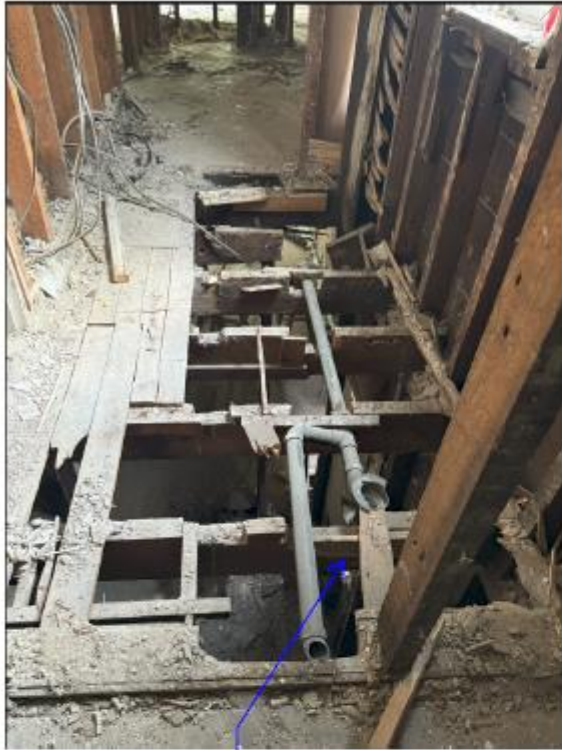
Joist floor Damage

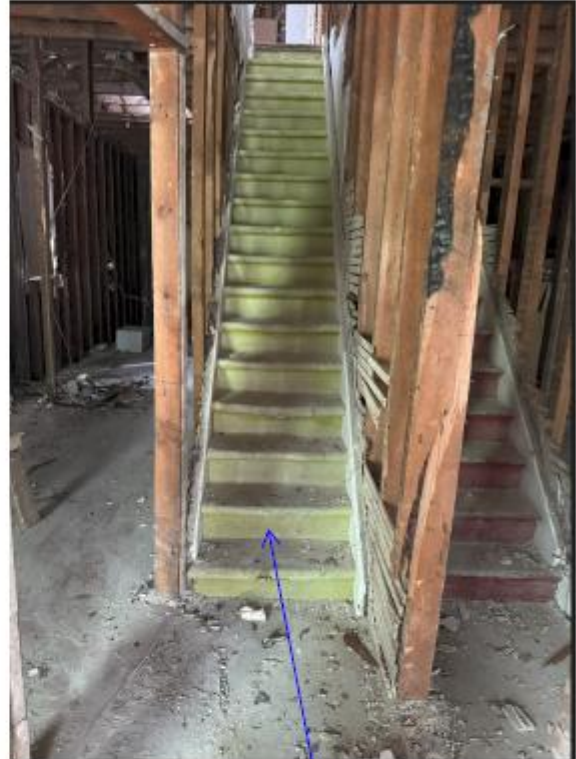
All stairs 2' 3" wide
not comply with OBC requirements

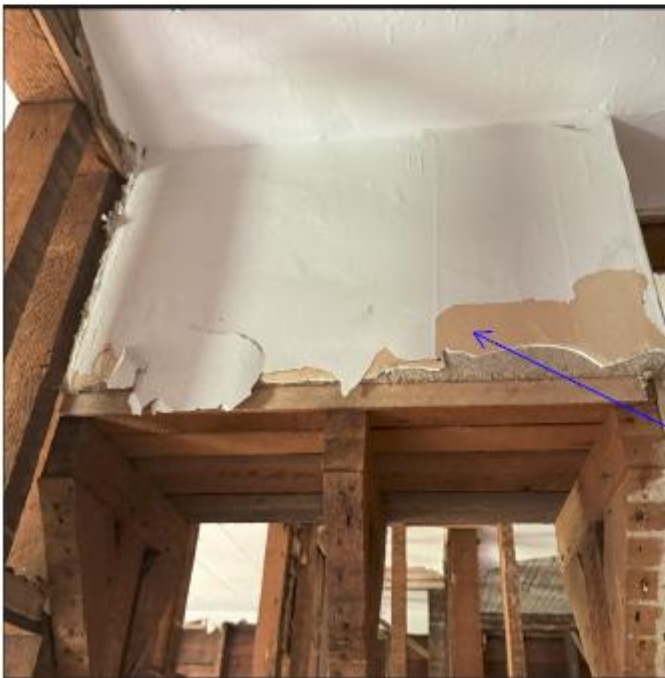
- **Chimney Masonry Issues:** The chimney masonry on the first floor has been removed and is unsupported by masonry on the second floor, creating a collapse risk. This condition could lead to a serious structural failure in the chimney system.
- **Missing Wall Studs on the First and Second Floors:** Numerous interior walls on both the first and second floors are missing studs in multiple locations, which compromises the building's load-bearing structure and overall safety.

Brick Chimney
supported by wood
frame at the ceiling of
second floor . no
proper support at the
ground floor

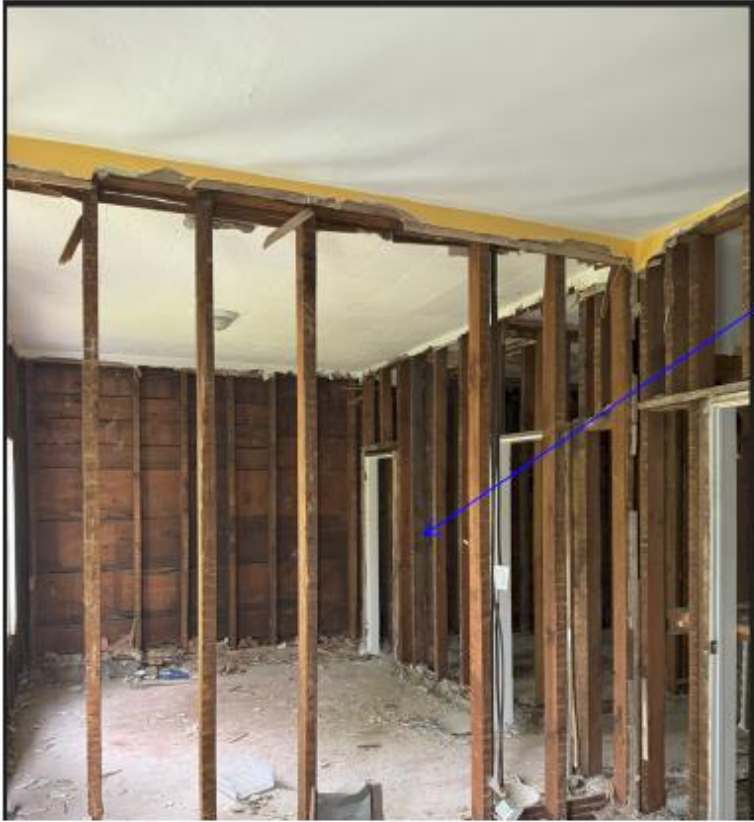
Missing wall frameStud
in many locations

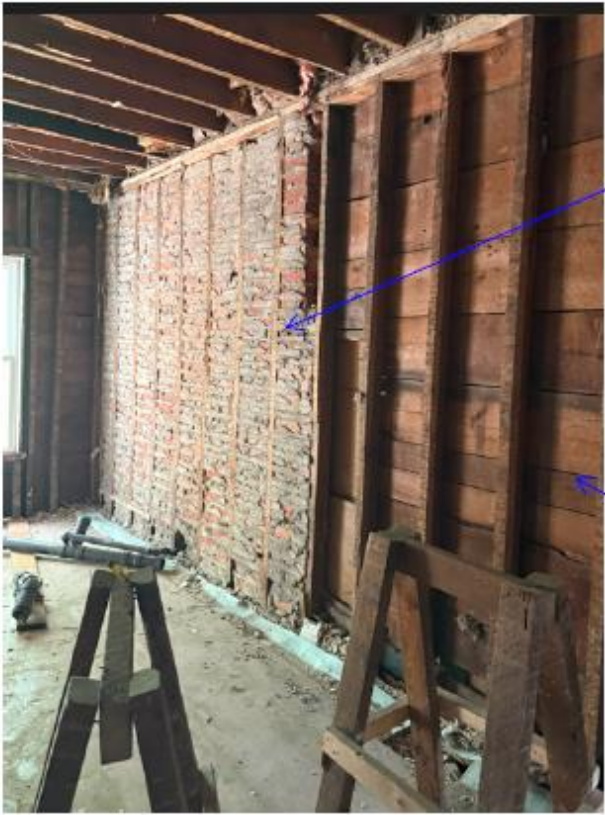
- **Improper Insulation:** The exterior walls were constructed with bricks in place of standard insulation materials, leading to improper insulation and poor thermal performance. The entire house is uninsulated, which results in energy inefficiency and thermal discomfort.

Brick was used as
insulation material on
exterior wall

All building missing
insulation

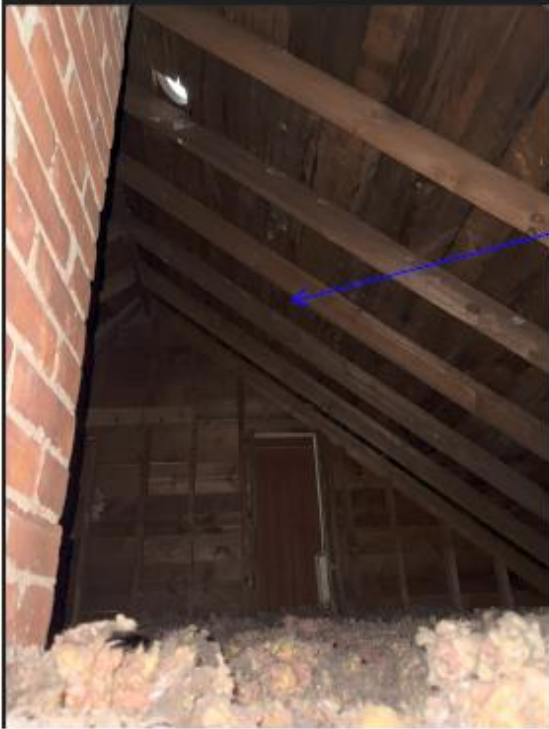
- **Roof Structure Deficiencies:** The roof is missing collar ties, which are critical for maintaining the roof's stability. Without these structural components, the roof is susceptible to shifting, which could cause significant damage to the entire building.

- **Mold on the Roof:** The presence of black-colored wood on the roof indicates extensive mold growth, which is detrimental to the structural integrity of the roof and poses serious health risks. The roof insulation is also moldy and requires complete replacement.

No collar ties at the roof location

Roof insulation moldy and required replacement

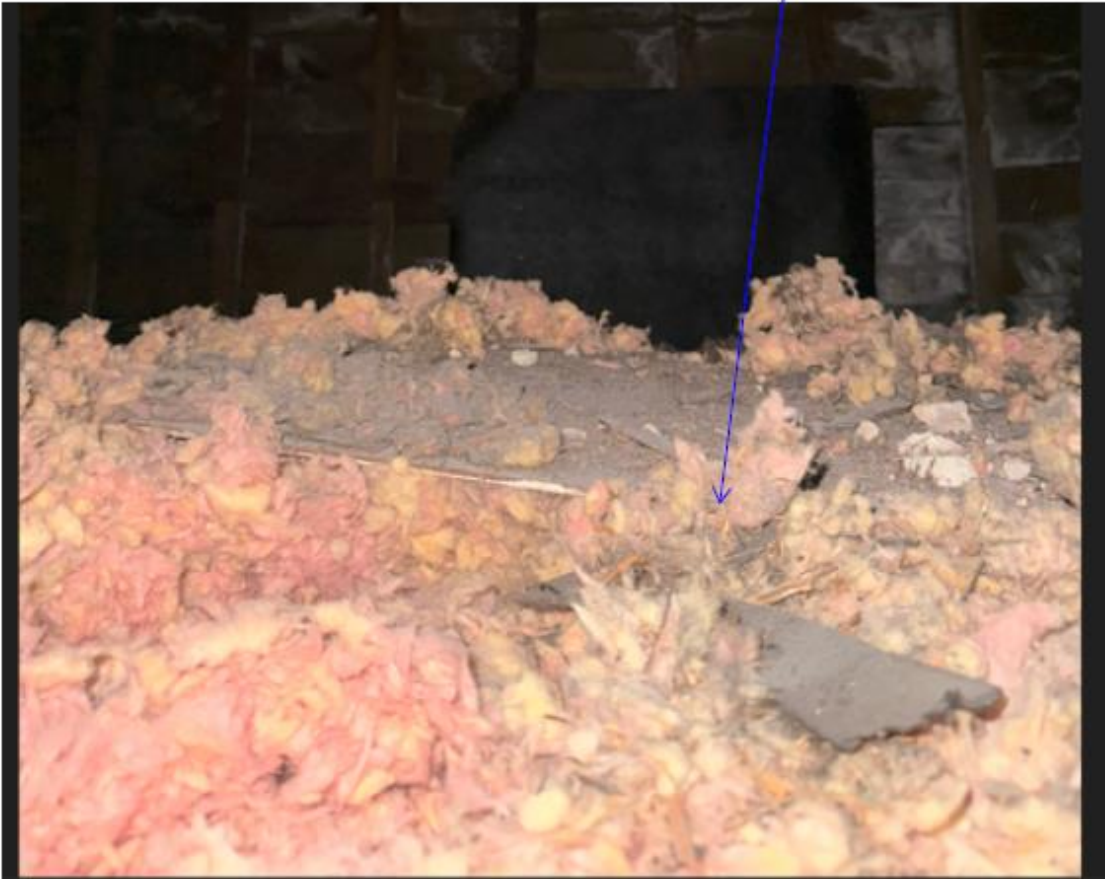
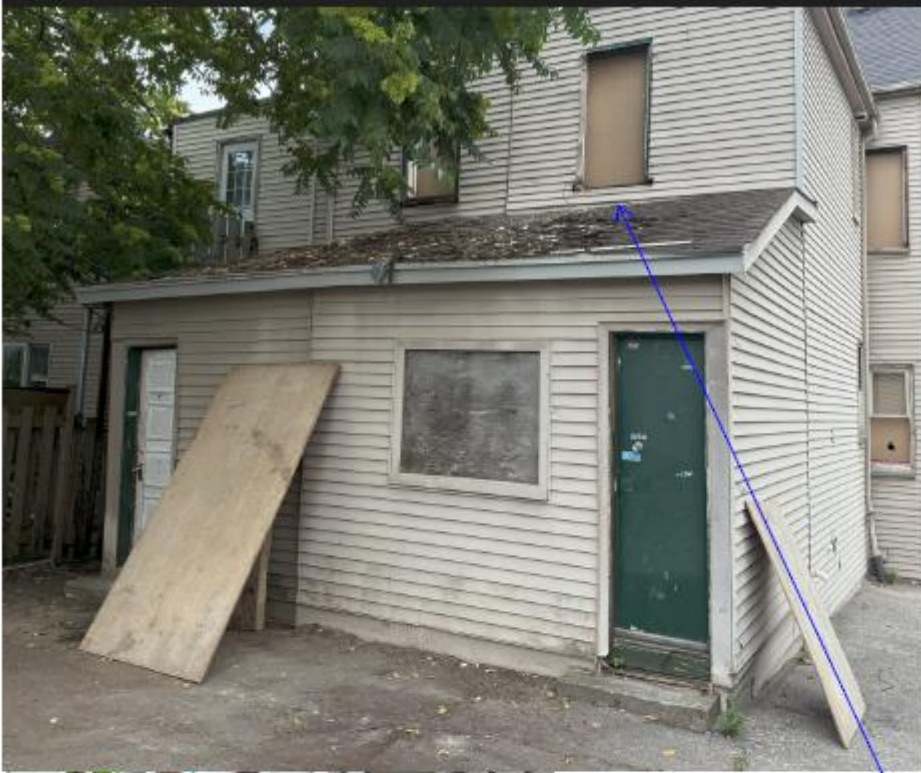
- **Rotten Roof Shingles:** The shingles on the roof of the back addition are significantly rotted, leading to water penetration and further structural degradation.

Roof replacement
required

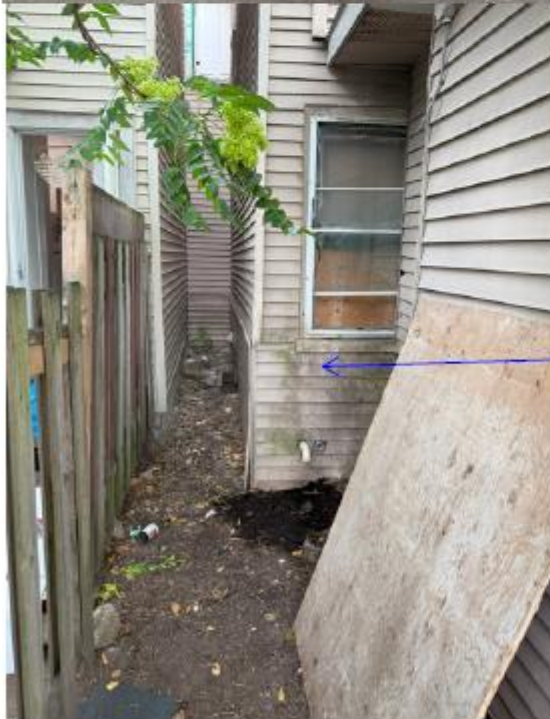
- **Exterior Siding Mold:** Mold is also present on the exterior siding, which further contributes to the building's decay and deteriorating appearance.

Mold on the wall
sidings
