## 54 Fraser Avenue

### General Description

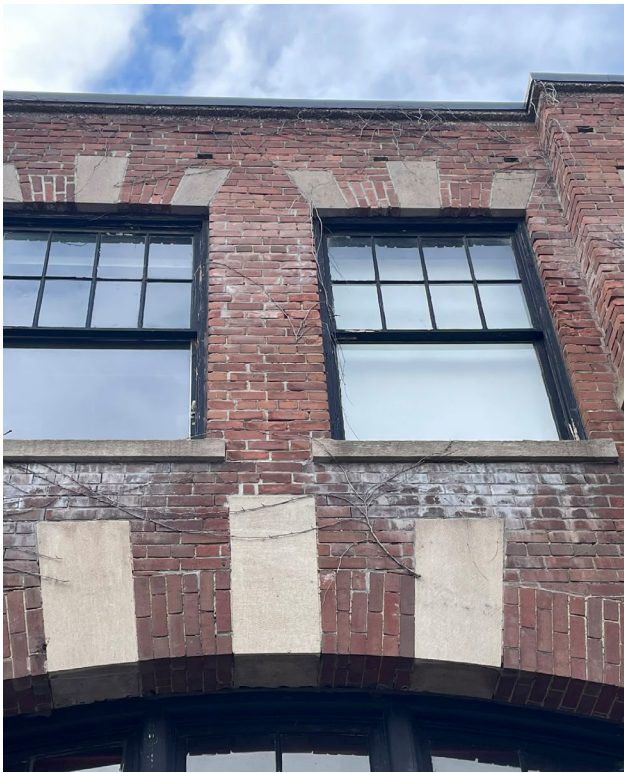
Fig. 5.23. East facade at the second storey addition: example of efflorescence.

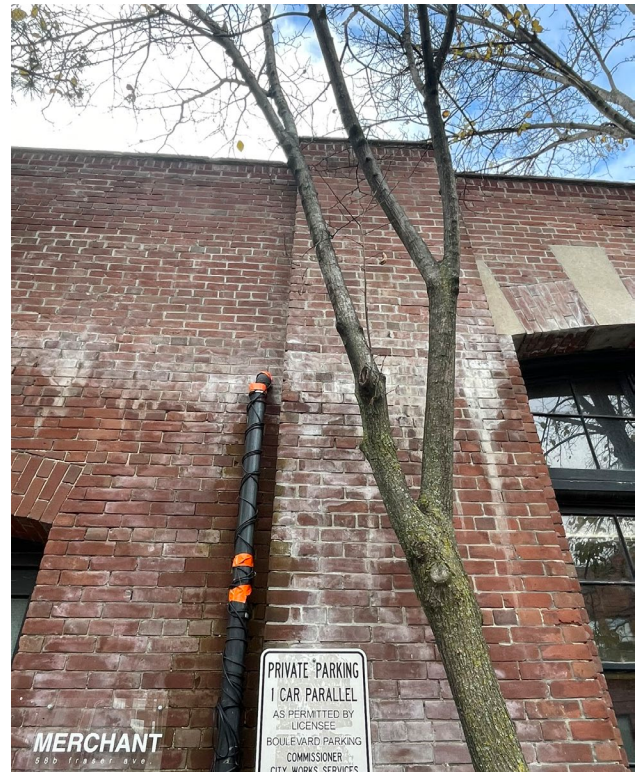
Fig. 5.24. East facade at the second storey addition: example of efflorescence.

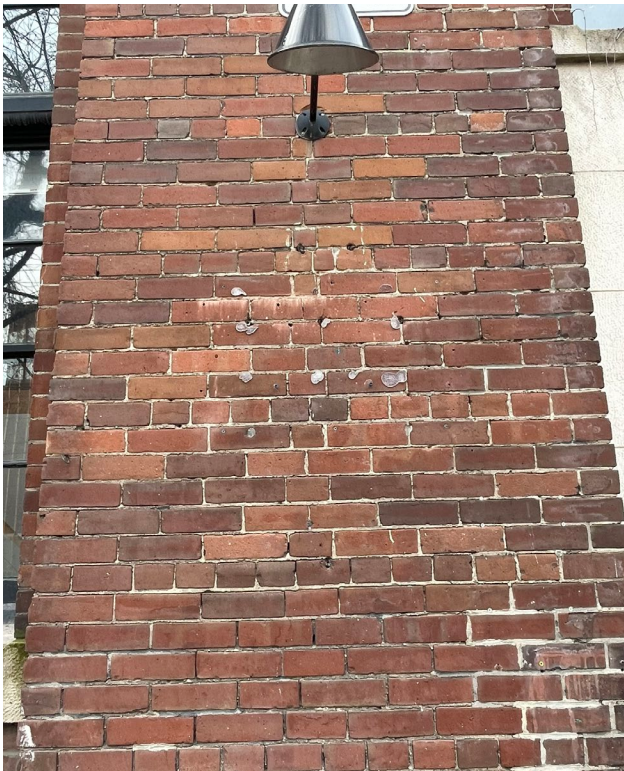
Fig. 5.25. East facade: example of mortar repairs at the southern bays.

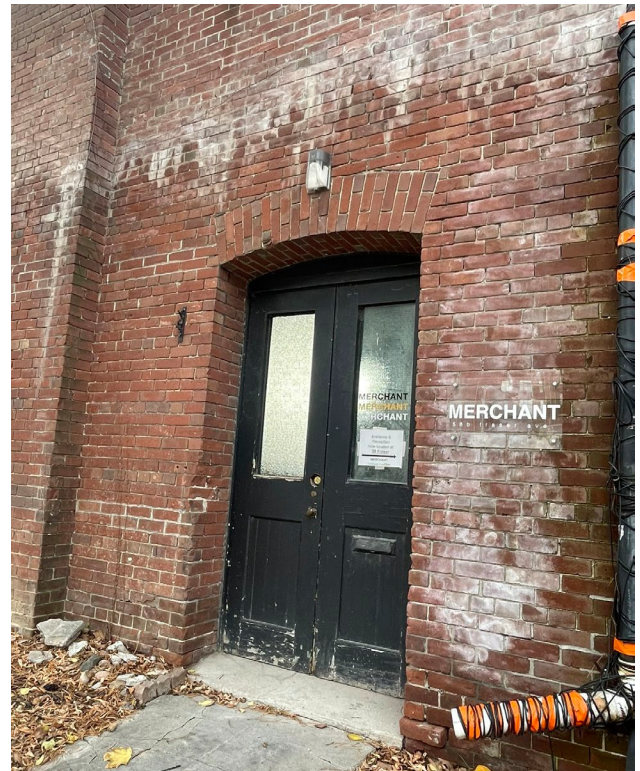
Fig. 5.26. East facade: example of efflorescence at the south wing addition.

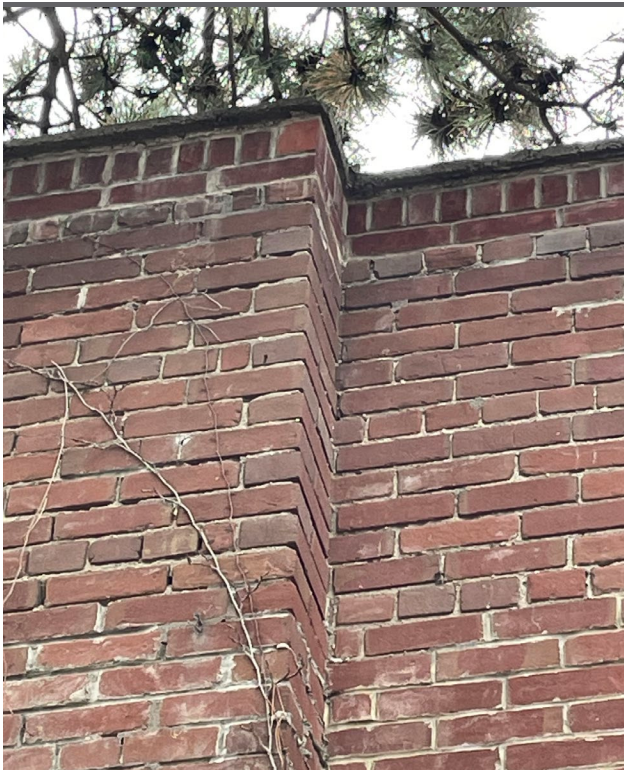
Fig. 5.27. East facade: brick condition at the roof line of the south wing addition.

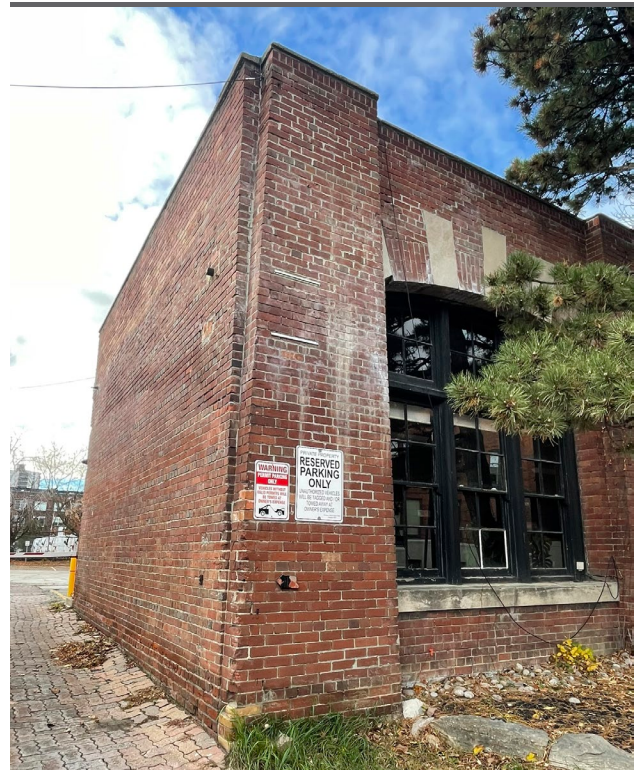
Fig. 5.28. South end of the south wing addition showing florescence, soiling and mortar repairs.

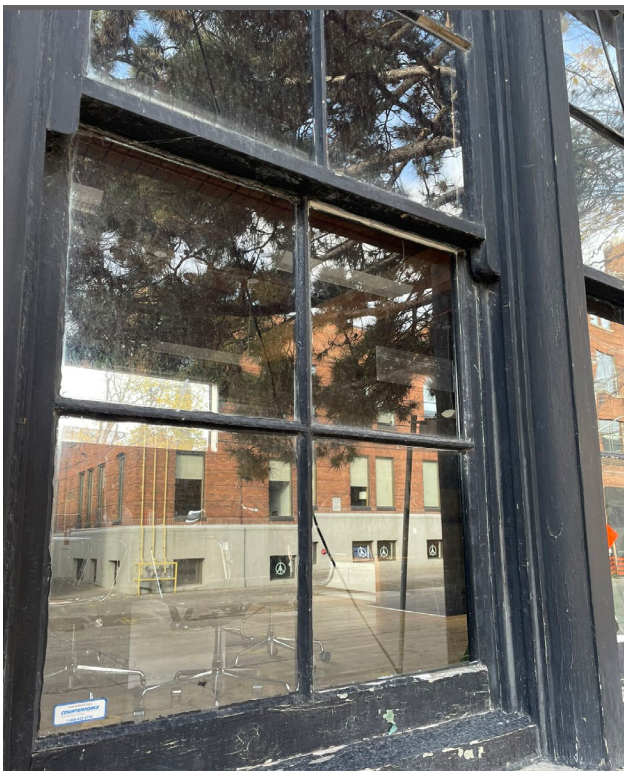
Fig. 5.29. Original wood windows in fair condition.

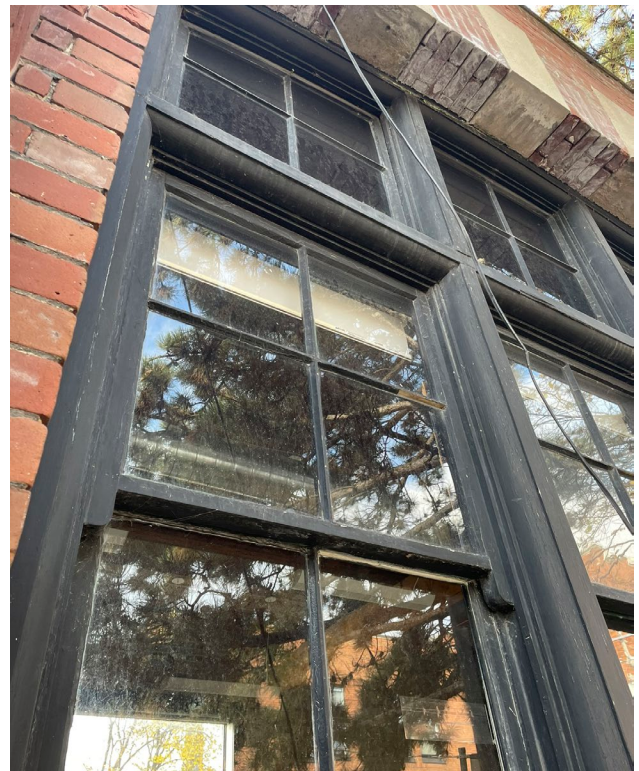
Fig. 5.30. Original wood windows in fair condition.

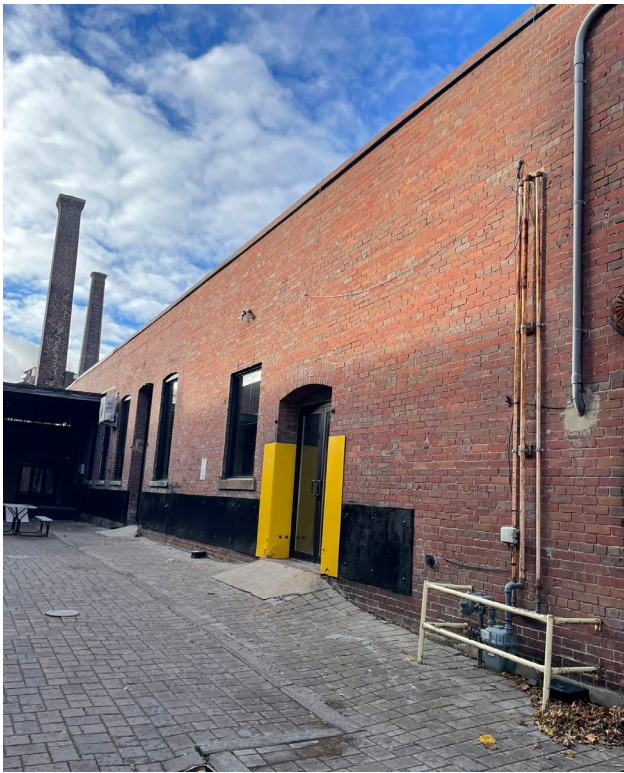
Fig. 5.31. Courtyard: masonry in fair condition.

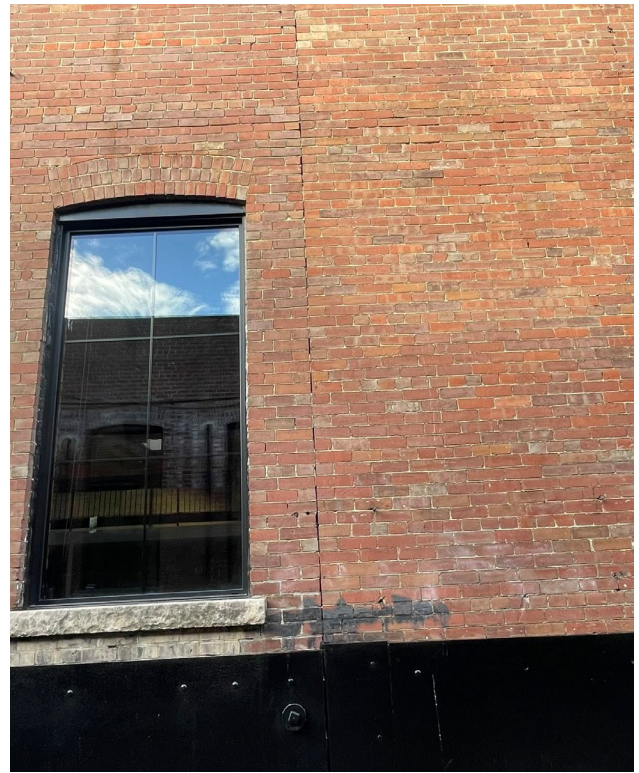
Fig. 5.32. Courtyard: line of one storey addition, and contemporaneity window replacements.

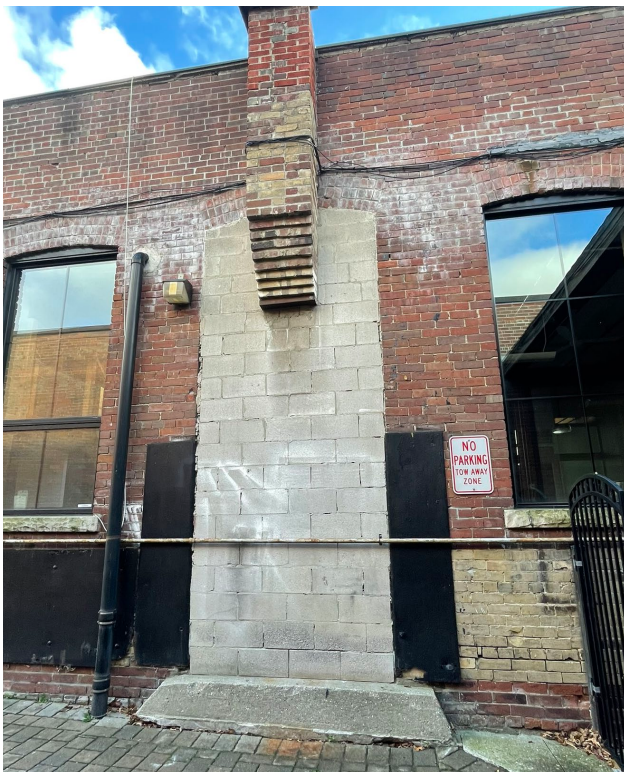
Fig. 5.33. Courtyard: masonry replacements and poor condition in some areas.

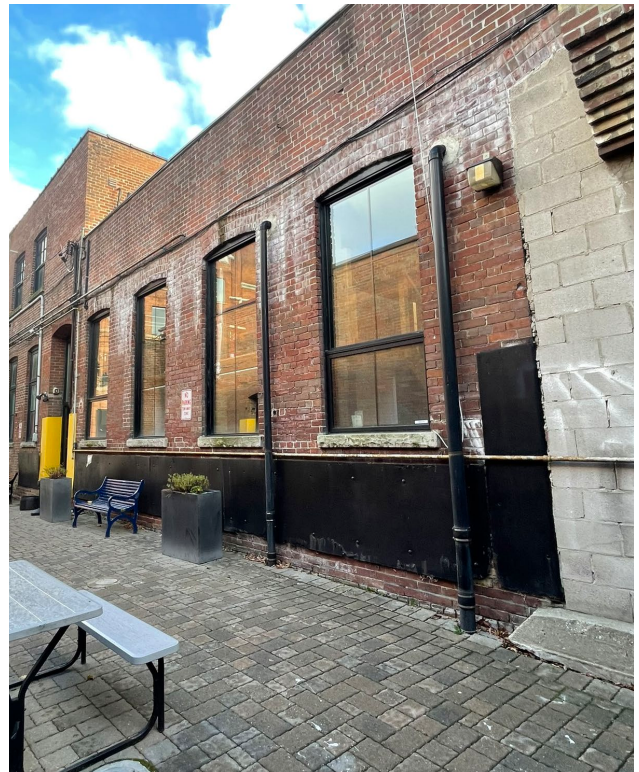
Fig. 5.34. Courtyard: masonry if fair to poor condition, and contemporary window replacements.

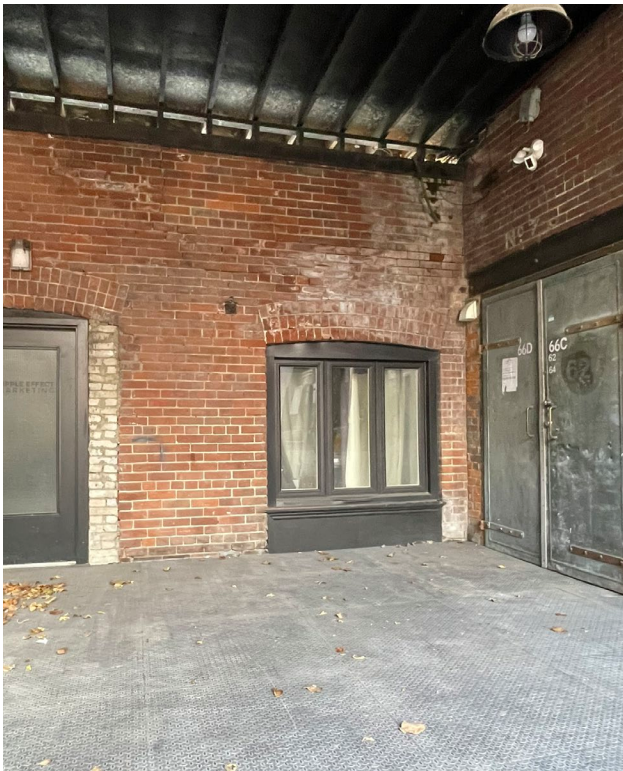
Fig. 5.35. Courtyard: masonry in fair to poor condition.

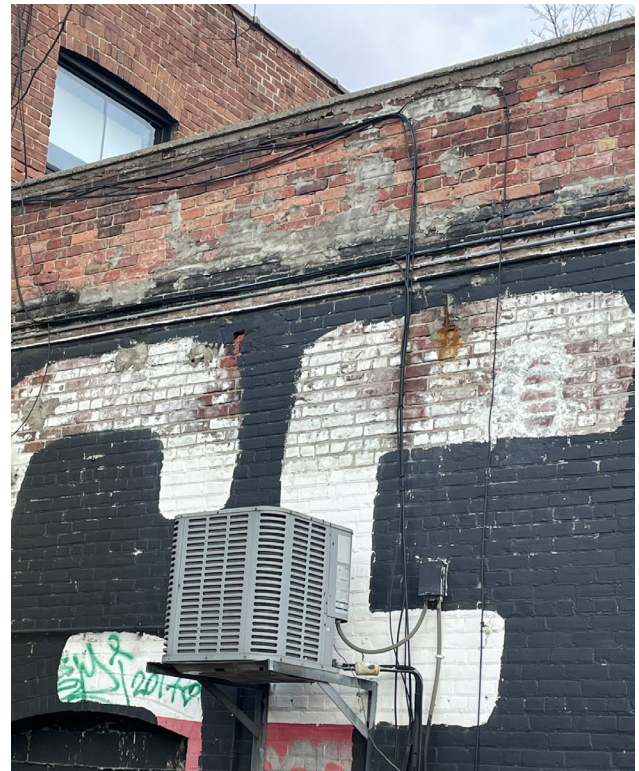
Fig. 5.36. West facade facing the parking lot: masonry in poor condition.

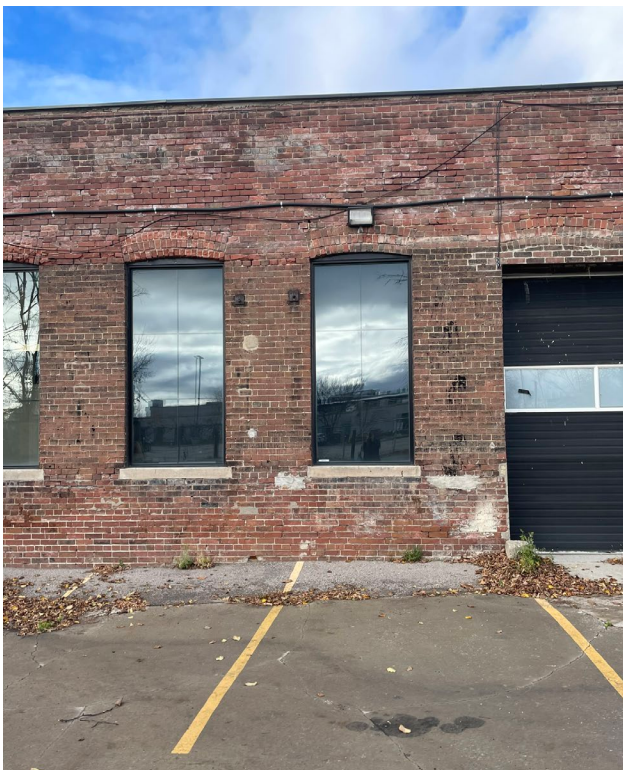
Fig. 5.37. South facade facing the parking lot: masonry in poor condition.

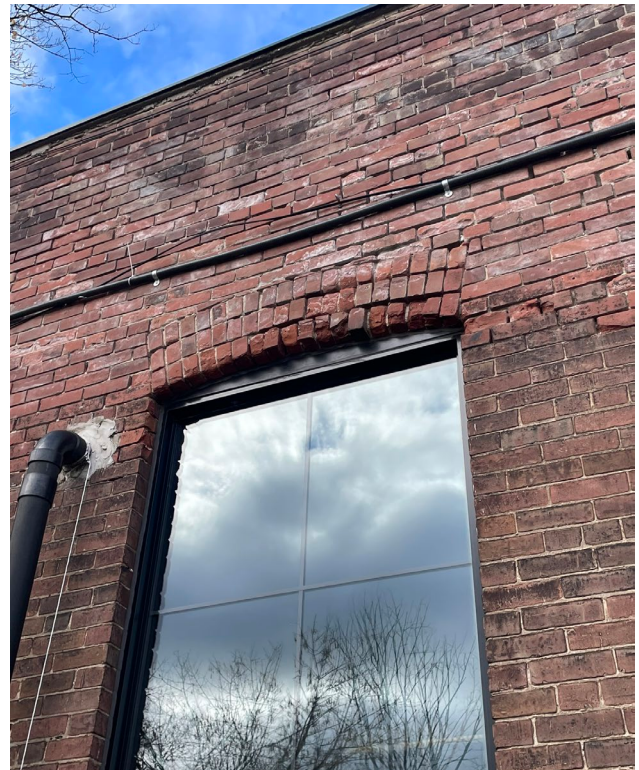
Fig. 5.38. South facade facing the parking lot: masonry in poor condition.

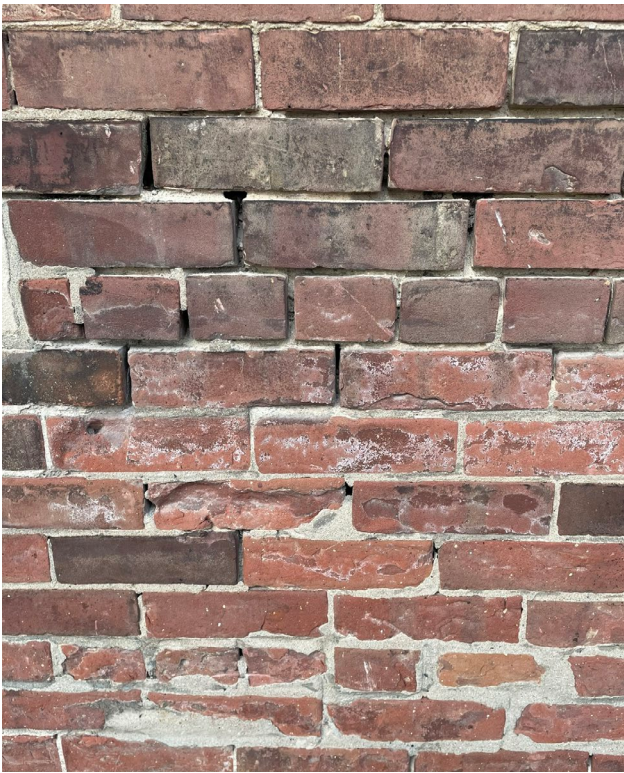
Fig. 5.39. South facade facing the parking lot: example of open joints and mortar repairs.

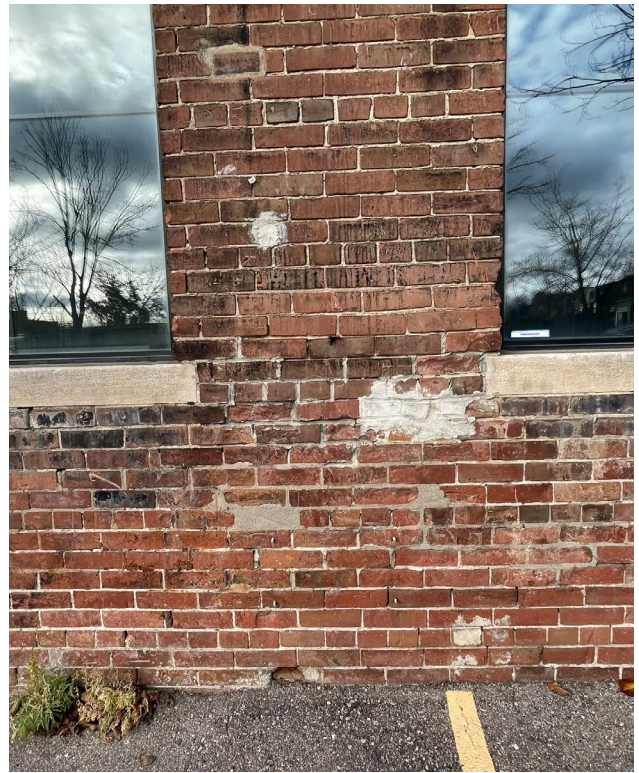
Fig. 5.40. South facade facing the parking lot: example of open joints and mortar repairs.

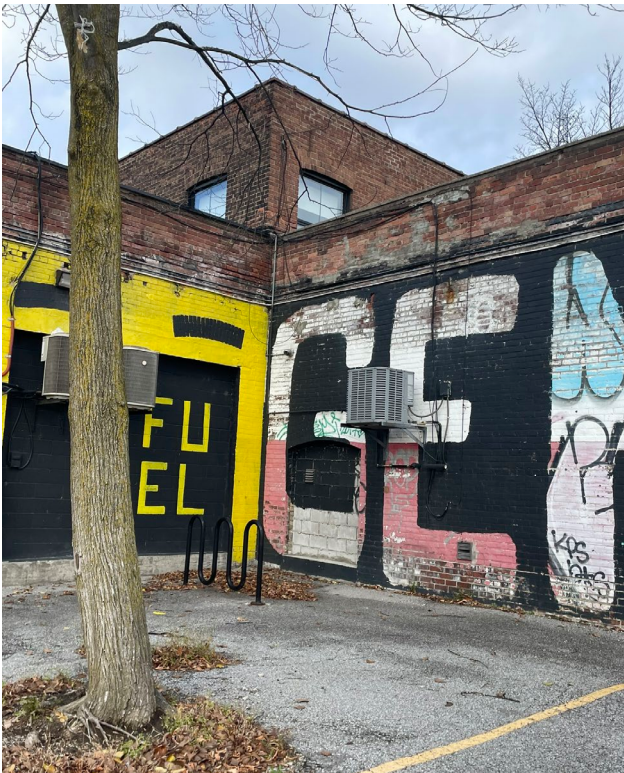
Fig. 5.41. South west corner facing the parking lot: masonry painted and in poor condition in some areas.

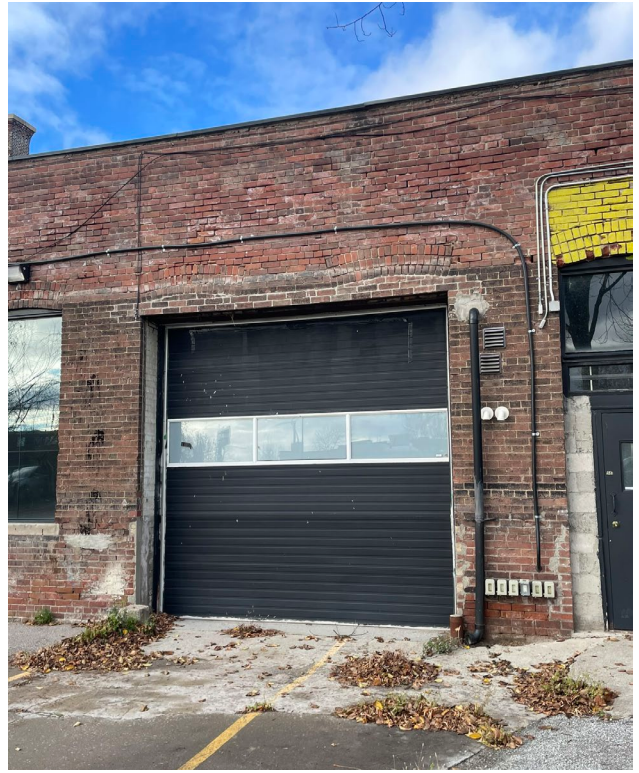
Fig. 5.42. West facade facing the parking lot: masonry in poor condition.

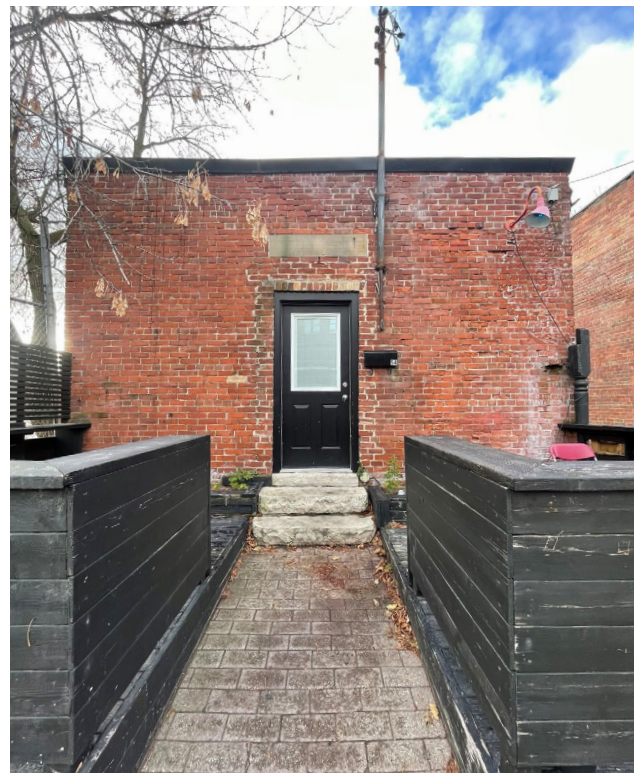
The overall condition of 54 Fraser Avenue is generally fair to poor, with significant brick deterioration in several areas. The masonry is in fair to poor condition, with significant spalling and eroding bricks throughout, particularly at the corners and lower sections close to grade. The mortar joints are generally in poor condition, with open joints throughout and incompatible repairs. At the front door surrounds, large areas have been repaired with incompatible mortar.

Fig. 5.44. East (principal) facade, masonry in fair to poor condition.

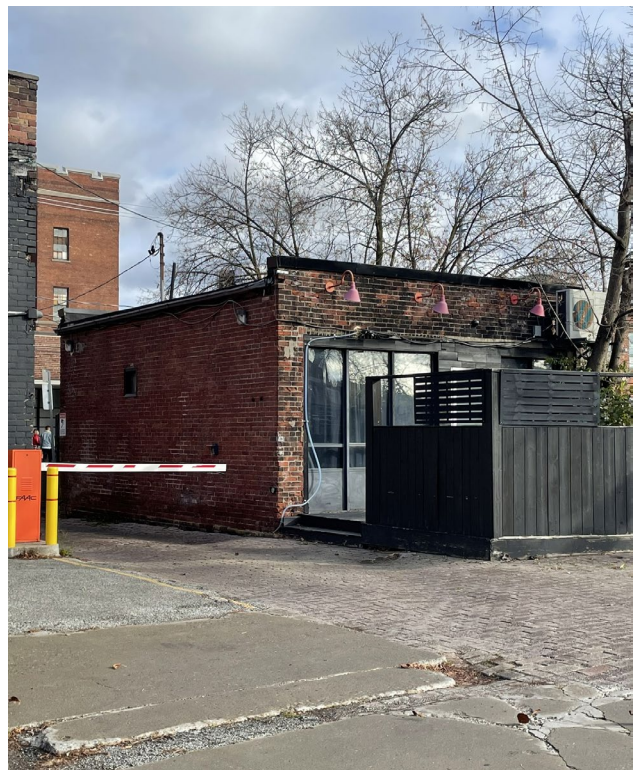
Fig. 5.43. West facade facing the parking lot: masonry in poor condition.

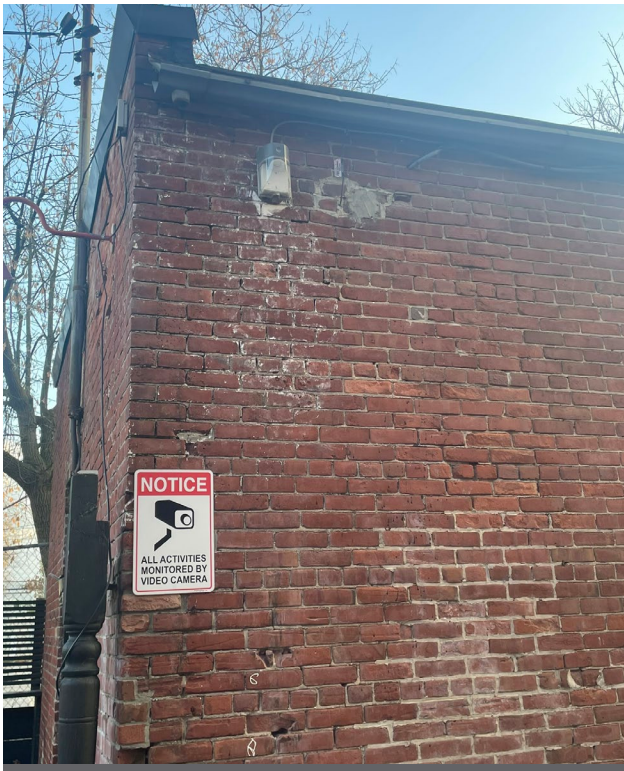
Fig. 5.45. North facade showing significant brick deterioration.

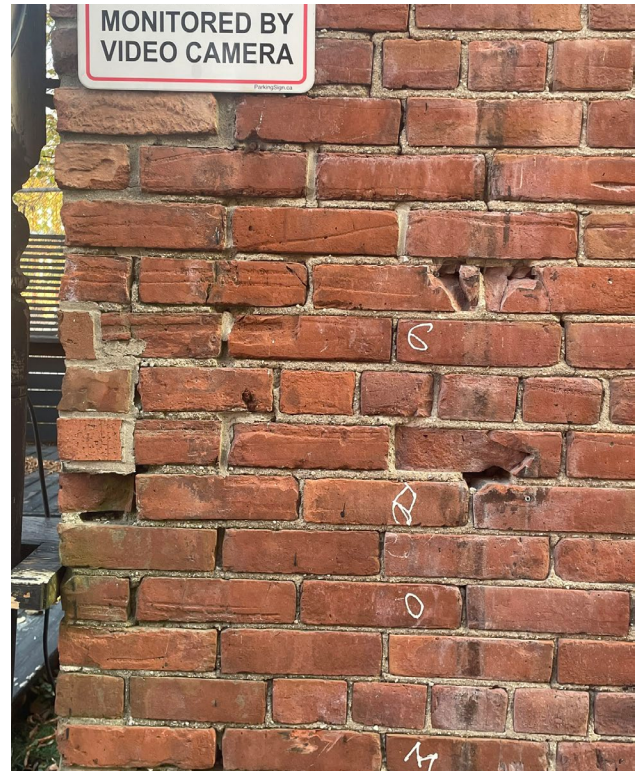
Fig. 5.47. Example of eroding bricks, open joints and incompatible repairs.

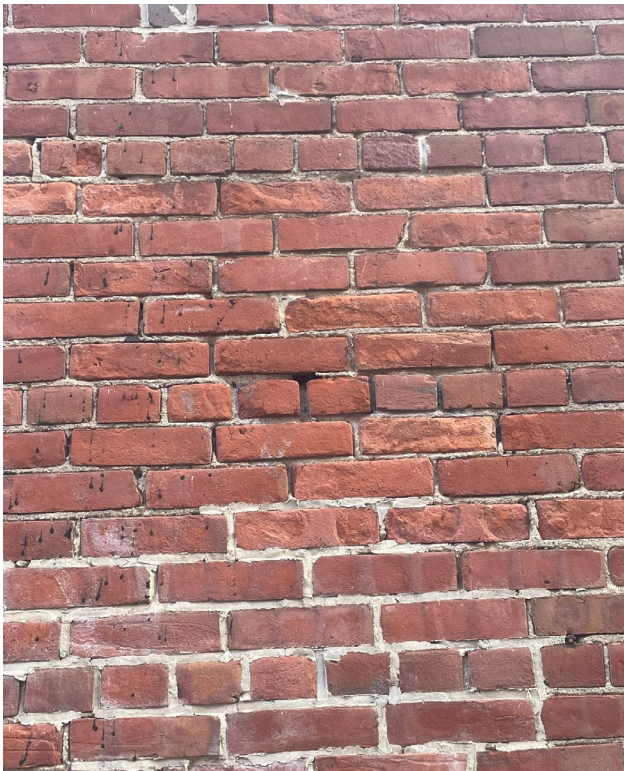
Fig. 5.46. North facade: Example of brick spalling, open joints and incompatible mortar repairs.

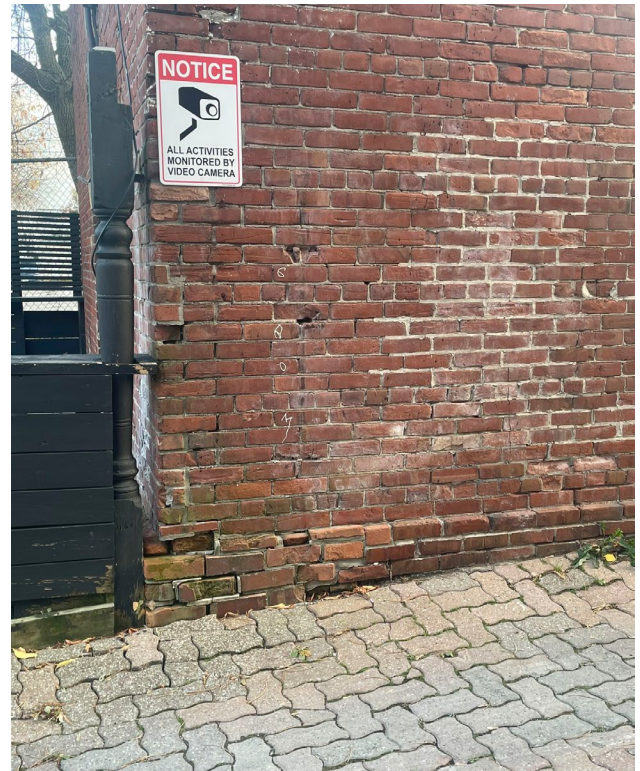
Fig. 5.48. North facade: significant brick deterioration at the corners and lower areas.
