## **Residential Demolition Application - 793 Adelaide Street West**

**Date:** June 16, 2026

## **793 ADELAIDE STREET WEST**

### Site Investigation Report #02

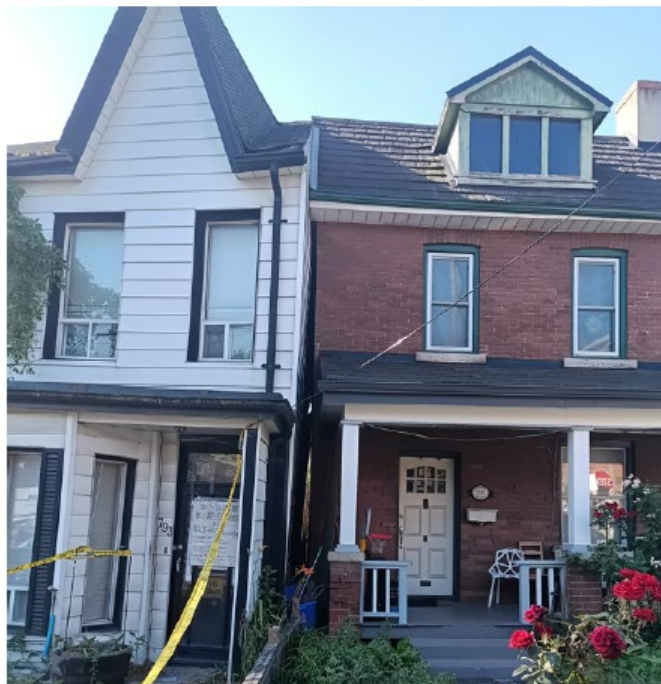
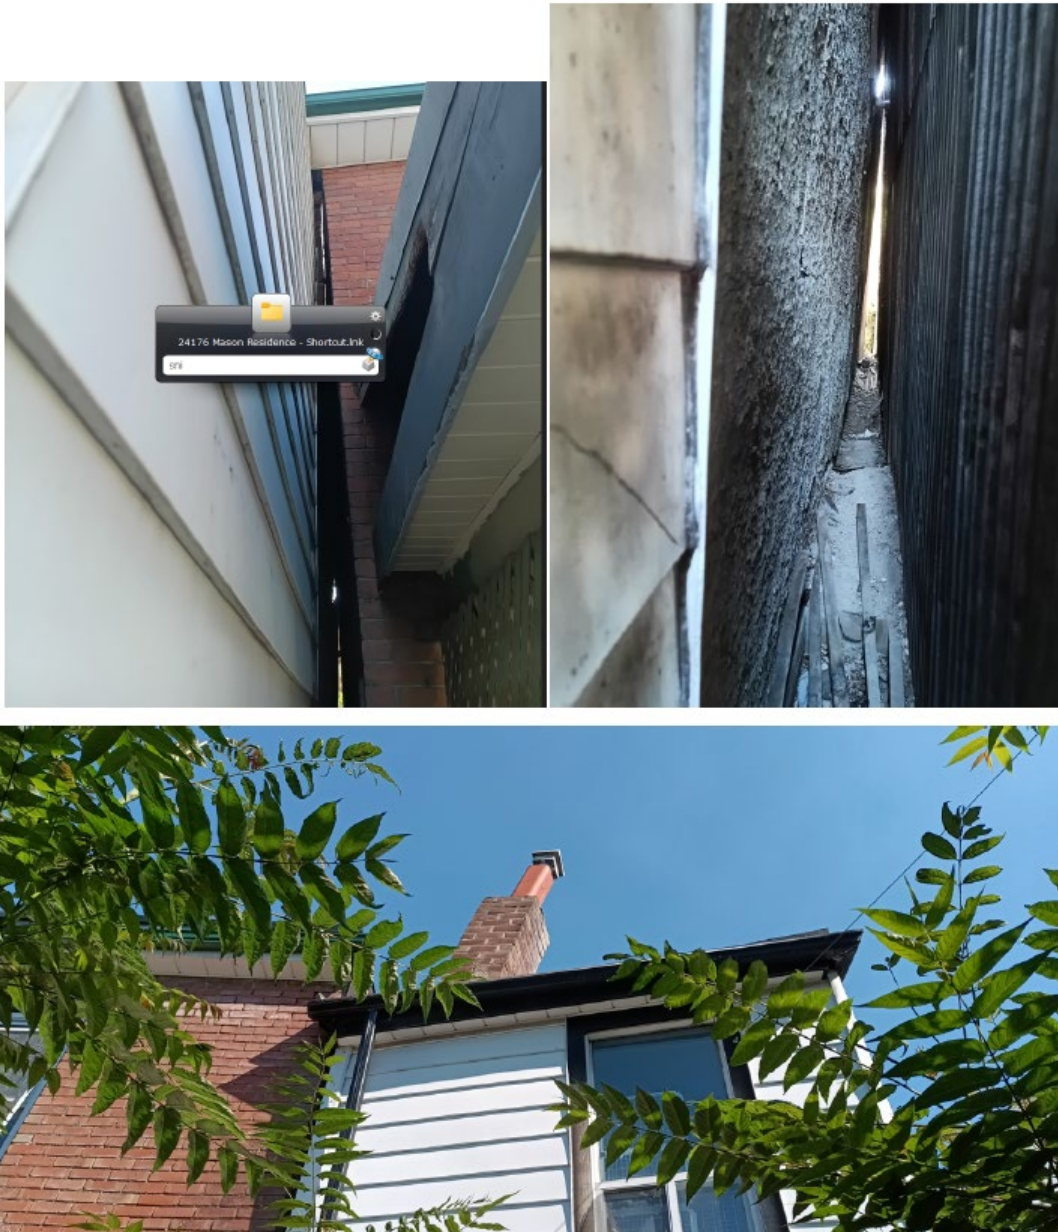
Lateral Building Movement Images

- 1.07 Based on our hand measurements with a tape measurement the buildings of 789/791/793 were leaning to the west by approximately 12", over the distance from the ground floor to second floor ceiling. 793 is in contact with the fully detached swelling of 795.

Based on our engineering experience and review of the of the reference documents, the lateral movement to the three buildings is caused by a combination of foundation settlement, structural work done in 791, insufficient lateral system, and settlement from moisture damage to wood at or below grade. Without detailed documentation of the movement of the building over time and work done, we cannot accurately determine the percentage each deficiency would account for in the overall building movement.

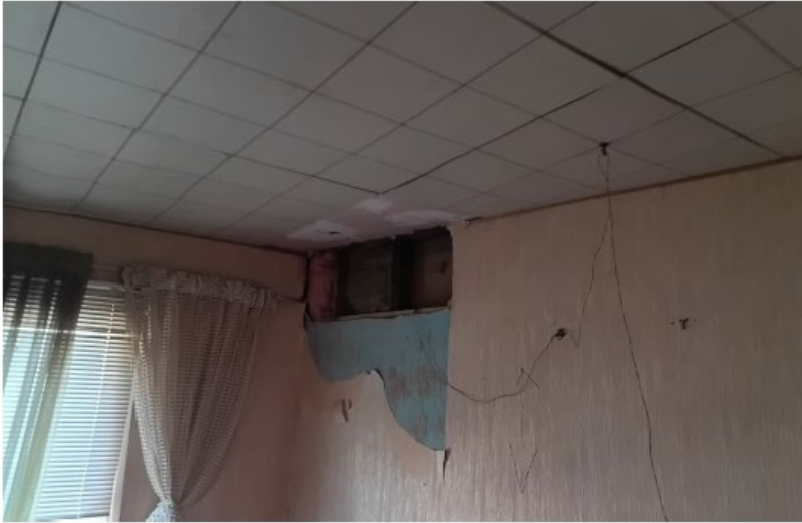
Party Wall Framing

- 1.04 Exterior walls consisted of 2X4 rough@16"OC studs with deck boarding.
- 1.05 Party wall construction consisted of a single 2X4 rough@16"OC stud wall between 791 / 793.

**RD-7:** The party wall of 791 / 793 Adelaide Street is leaning to the west and encroaching the property of 793 Adelaide Street West by 0.28m to 0.44m.

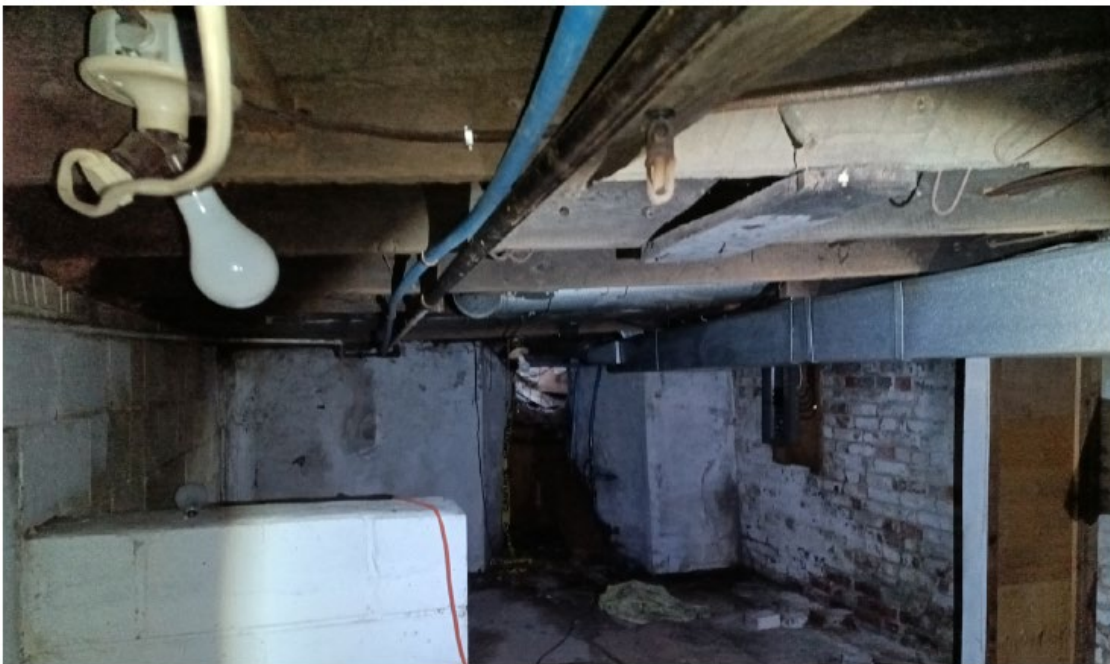
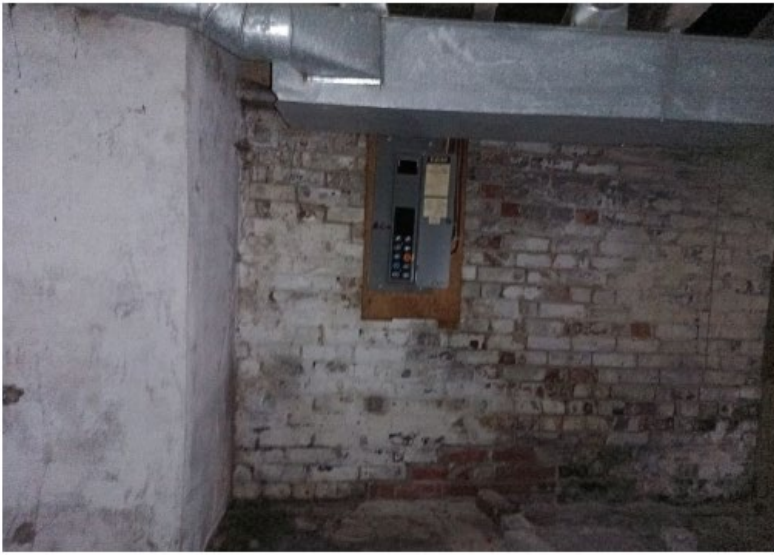
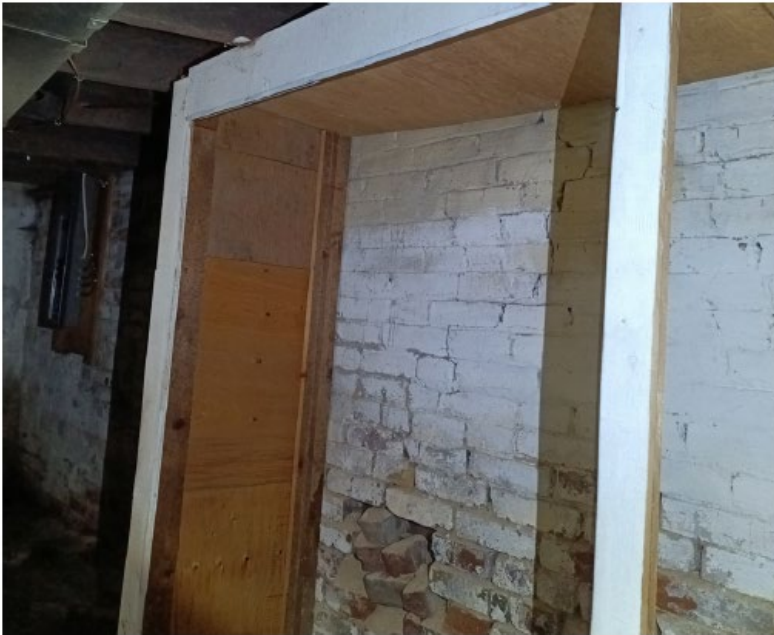
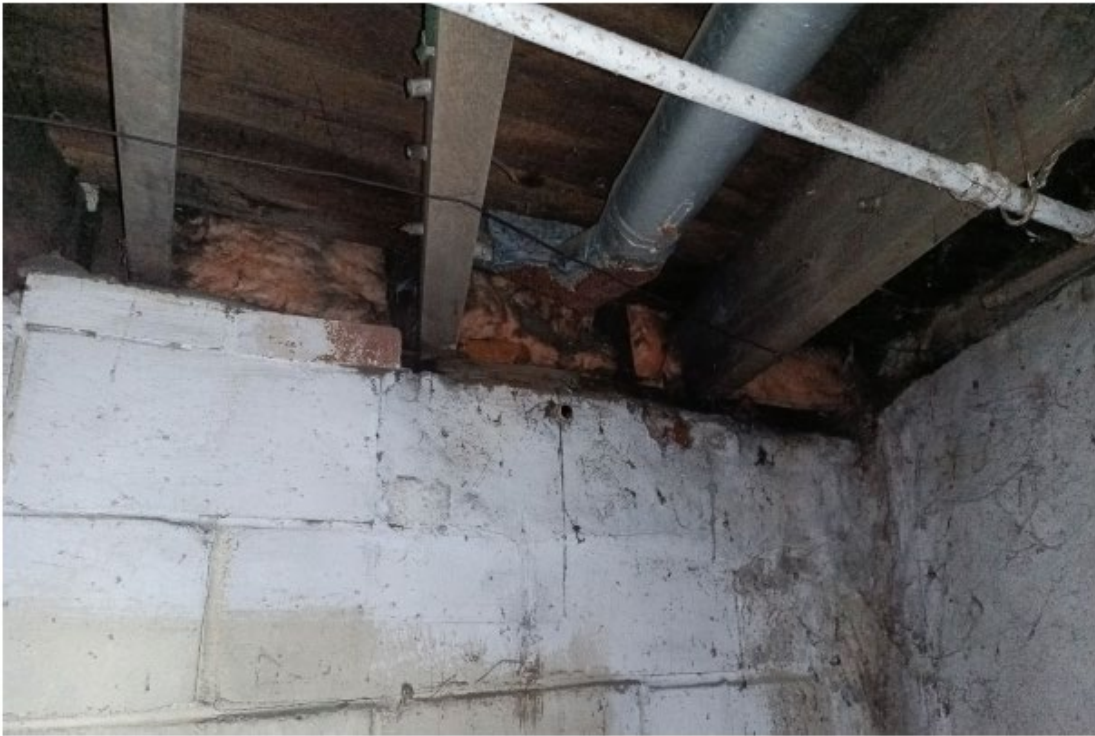
Foundation Walls and Ground Floor Framing

- 1.06 Foundations consisted of a mixture of double wythe brick and 8" concrete block foundations. There was a single shared foundation between 791 / 793 supporting the party wall.

- 1.08 The chimney to the south of the building was leaning by at least 12", visual estimate.
- 1.09 Wood framing of the ground floor was located below grade and was undergoing damage from moisture.

- 1.10 Foundations have localized damage and wetting throughout the basement and waterproof.
- 1.11 All rooms appeared out of square and level.
- 1.12 The east wall of 795 was wood framed with steel cladding.

"Footings were NOT found beneath the existing block and brick foundation walls. The reported building distress (exterior wall leaning) was likely associated with lack of footings, insufficient subgrade support and settlement."
