# **Subway Work Car RT6 and RT17 Hydraulic Fluid Leak Investigation Preliminary Findings Report From HATCH**

April 15, 2026

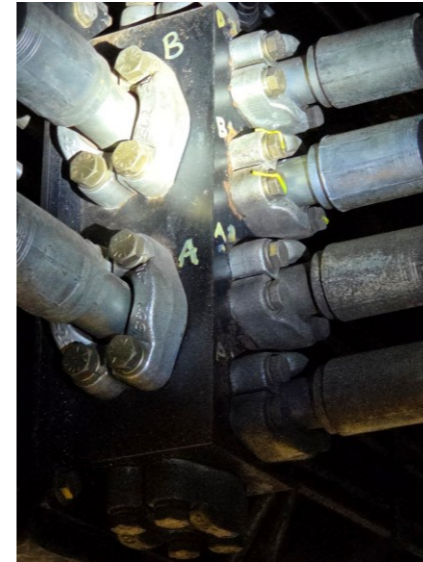
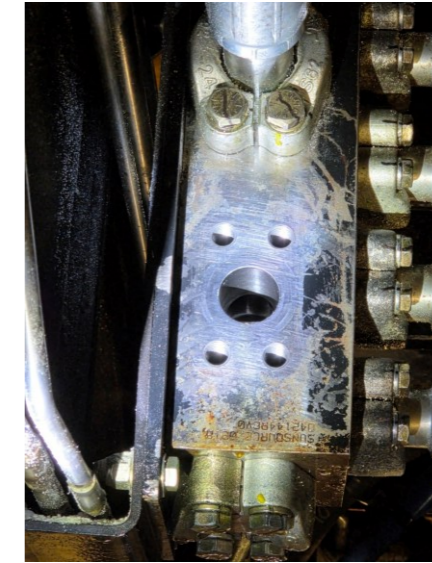
View on car

High pressure hydrostatic fitting incorrectly assembled with the mounting bolts torqued below specification.

- Review the installation process for areas of potential incorrect assembly and develop improvement steps and protocols.
- Inspect other work cars with similar fittings repaired over the last 3 to 4 weeks and recertify work performed as a containment measure.
- Send the failed O-ring for analyses to confirm failure mode, chemical composition and mechanical properties

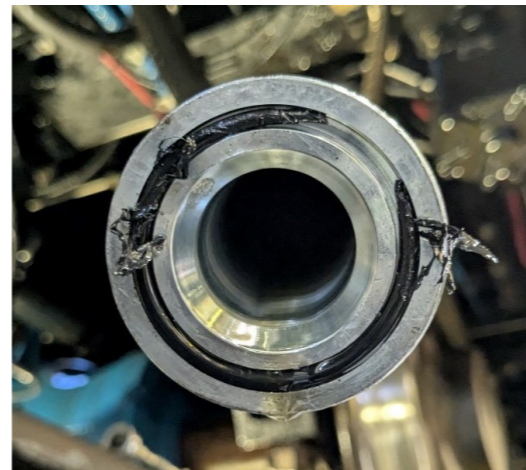
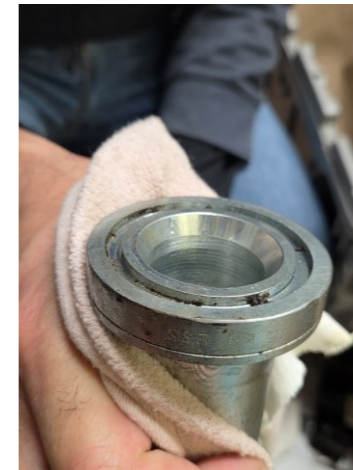
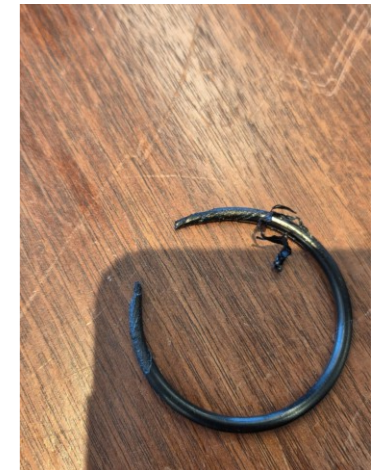
Resulted in O-ring wear causing catastrophic failure

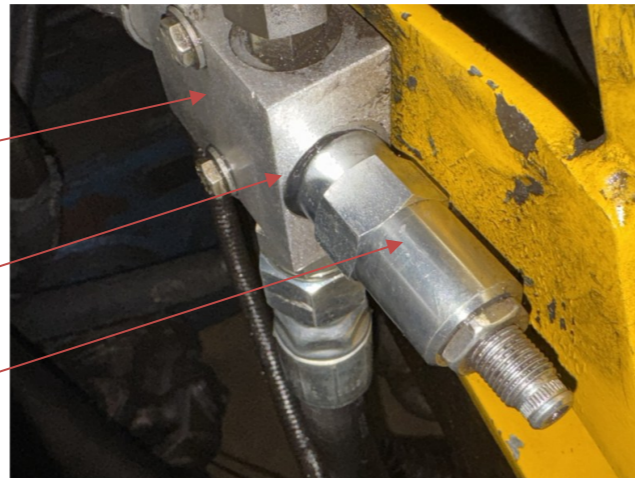
Supplier assembled Flow Control Valve found with exposed O-ring at leak location, a result of under torque during assembly

Exposed O-ring

- Immediately identify and quarantine all similar manifold assemblies, including on-car and in-stock inventory.
- Supplier to perform failure analyses on RT17 manifold assembly including inspection of the FCV mounting geometry and analyse of the O-ring (material, mechanical properties)
- Supplier to develop and implement a quality control policy that assures specification compliant assembly of the units and a pre-ship inspection process
- Review TTC's incoming inspection process for vendor supplied hydraulic components where there is a concern and ensure they are compliant to the manufacturing specifications before they are assembled into work cars.
