Project: SP3977C

June 30, 2006

**Cover Integrity Inspection – June 2006
Lakeshore Boulevard East Reconstruction at Leslie Street
Toronto, Ontario**

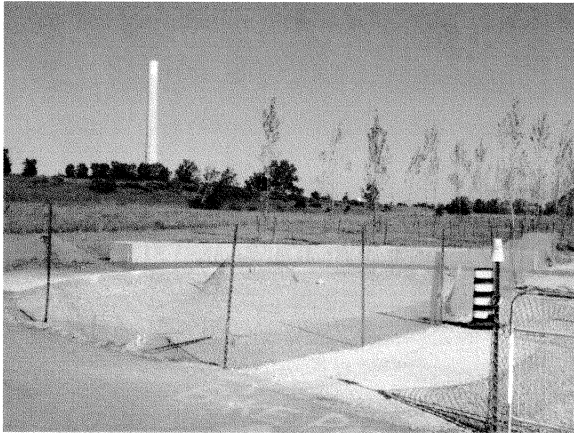
3. No evidence was observed of the presence of burrowing animals in Area A or Area B.
4. Construction activities were in progress within the western portion of Area B. This included the construction of a new sidewalk and a plaza with a diameter of about 18 m on the southeast corner of Leslie Street and Lakeshore Boulevard, the installation of new light standards on the east side of the new sidewalk parallel to Leslie Street, the construction of concrete forms (possibly for use as benches), the construction of a gravel

1 – View of new plaza area located on the southeast corner of Lakeshore and Leslie.

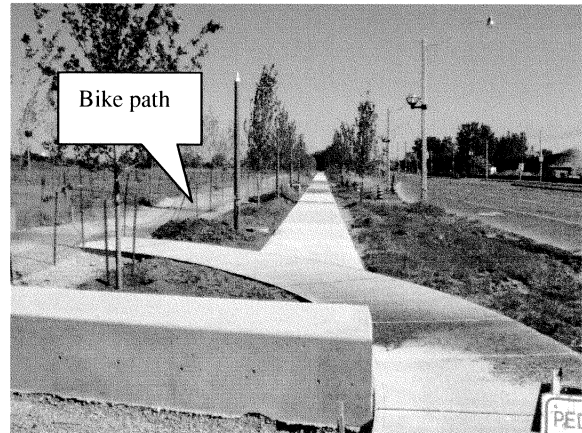
2 – Looking south parallel Leslie Street with new sidewalk and gravel covered bike path.

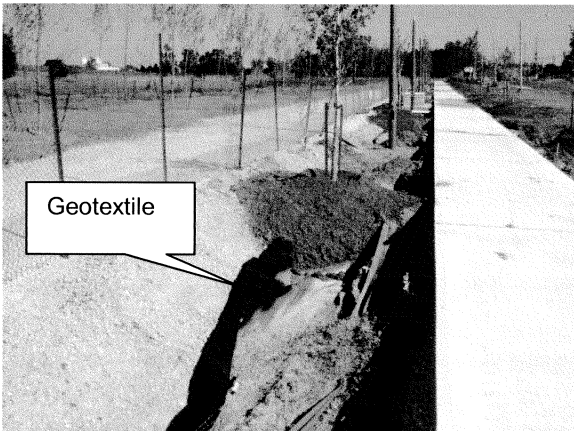
5. S&P observed that in some cases new plastic pipe appeared to have been installed beneath the geotextile indicating that the clean soil cover within selected areas in the vicinity of the new sidewalk had been breached.
6. Some of the excavations for the installations adjacent to the east side of the sidewalk parallel to Leslie Street were approximately 0.7 m deep and thus extended below the 300 mm clean cover. In one of these excavations, S&P observed soil with decayed wood, wire, glass, brick and peat indicating that this material likely originated from below the clean cover.
7. Excavations had also occurred to the west of the recently installed sidewalk parallel to Leslie Street and a geotextile placed in the shallow excavation.

3-Excavation on east side of new sidewalk for trees, light standards and cables.

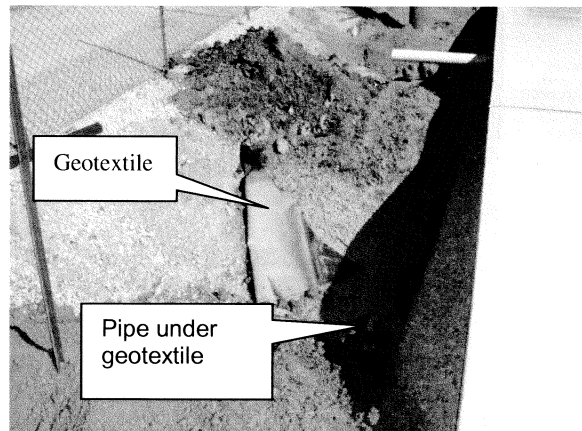
4- Geotextile folded over and pipe under geotextile on east side of new sidewalk.

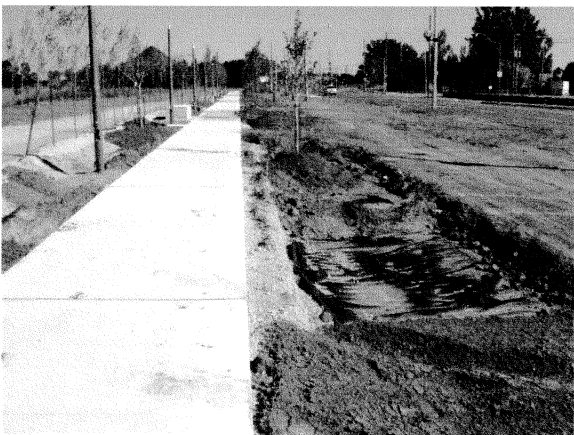
5- Geotextile in shallow excavations on the west side of the new sidewalk parallel to Leslie Street.

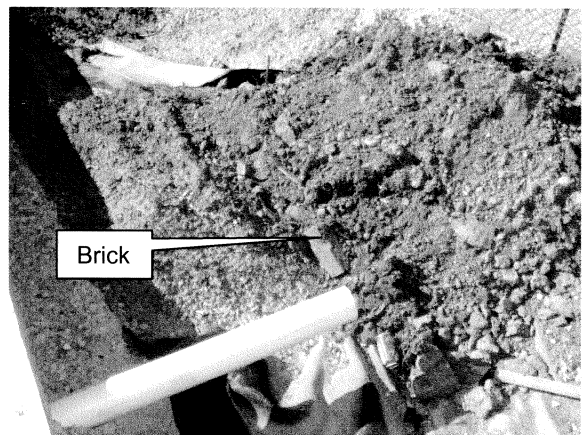
6. In one location to the east of the sidewalk recently constructed within Area B, S&P observed soil with brick, metal and glass had been placed on top of the geotextile. The presence of such material on top of the geotextile is not permitted within the terms of the SSRA. While such material may have been removed prior to backfilling the area, no documentation is available. In future, S&P recommends that all third party construction monitoring activities within the area covered by the SSRA should be undertaken by S&P (either under contract to Work & Emergency Services or to other City divisions) to ensure that the work is conducted in accordance with the terms of the Risk Management Plan of the SSRA and that the proper documentation is prepared and on file should certification of the Risk Management Plan be required.

6- Brick, metal, glass in soil adjacent to east side of new sidewalk.
