Project: SP3977C

December 31, 2006

**Cover Integrity Inspection – November 2006
Lakeshore Boulevard East Reconstruction at Leslie Street
Toronto, Ontario**

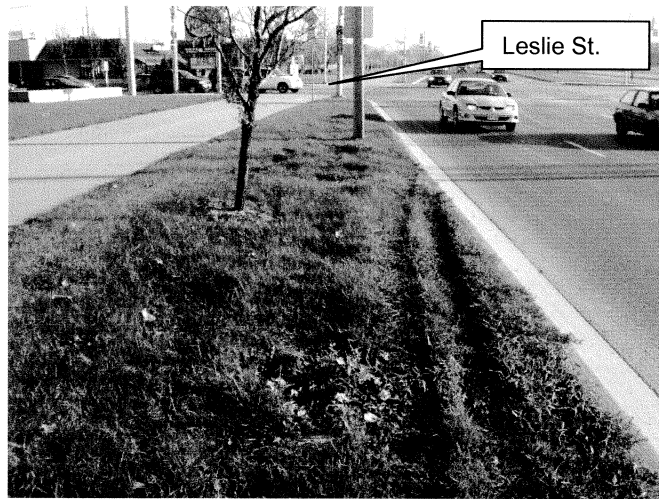
- arterial roads in the City of Toronto. In addition, within Area B, one plastic pail with a capacity of about 15 litres and a short section of plastic drainage pipe were observed.
3. Several depressions as the result of tire ruts were observed within Area A between the north curb of Lakeshore Boulevard and the bicycle path but no breaches in the clean cover as a result of the tire ruts was observed.
 4. One small hole, possibly created by a small rodent was observed in the grass cover of Area A approximately 1.5 m north of the north curb of Lakeshore Boulevard and 12 m west of the second light standard west of Leslie Street. No evidence was observed of the presence of burrowing animals in Area B.
 5. Replacement of the damaged well covers as recommended in S&P's cover integrity inspection report dated June 30, 2006 had not occurred.

Tire ruts adjacent to north curb of Lakeshore Boulevard.

1. The City of Toronto should ensure that measures are in place to abide by the terms of the SSRA.
2. The covers for the monitoring wells at BH700 and BH702 should be replaced as required by Ontario Regulation 903 and as recommended in S&P's June 2006 cover integrity inspection letter.
3. The tire ruts should be monitored for possible breaches in the cover integrity.
4. The area in the vicinity of the possible rodent hole observed in Area A should be monitored for possible rodent activity.
5. The next regularly scheduled cover integrity inspection is the spring of 2007.

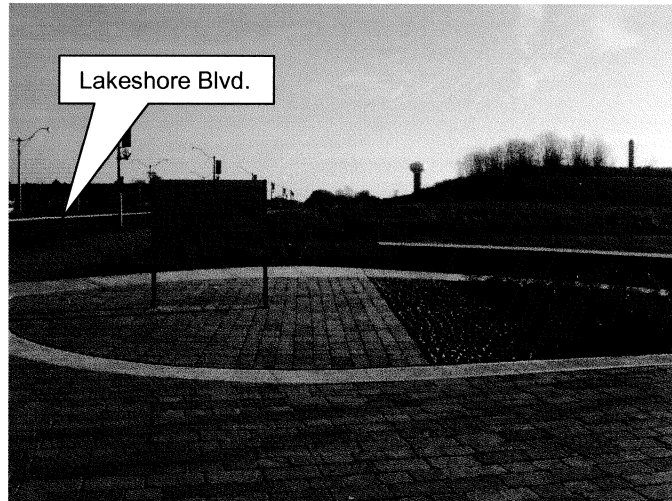
New plaza at the southeast corner of Leslie Street and Lakeshore Boulevard.

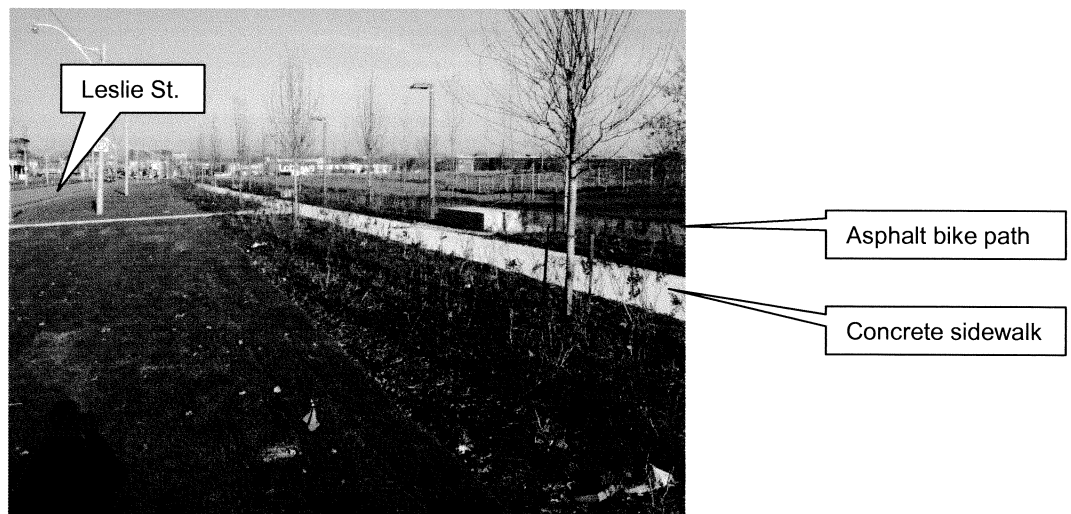
In summary, construction activities associated with the installation of underground wiring and irrigation systems for new plantings and the construction of a new sidewalk and bicycle path within the western portion of Area B have been completed. Six concrete benches as well as a longer concrete wall to serve as a bench have been constructed within the western portion of Area B. The presence of park benches within Area B was not part of the proposed land use on which the Risk Management Plan was based.

New sod, shrubs, sidewalk, lighting, concrete structures and bicycle path within Area B.
