BCA Report

Sample House High FCI

Portfolio	TCHC - All Op Units
Development	Scattered Units (CHU 20)
Size	1,005 Sq.Ft.
Construction Year	1925
Floor Above Grade	2
Divisional Units	1

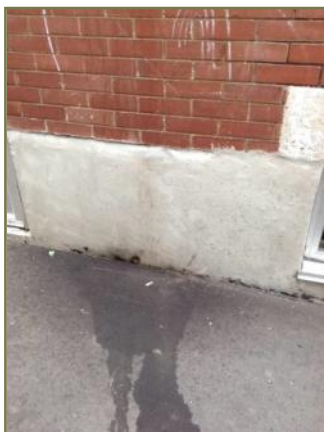
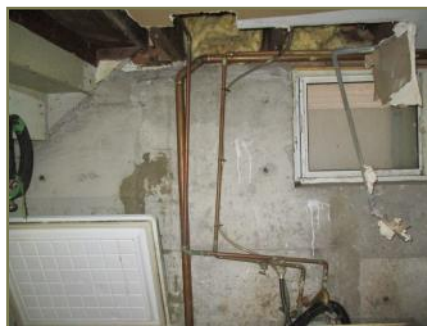
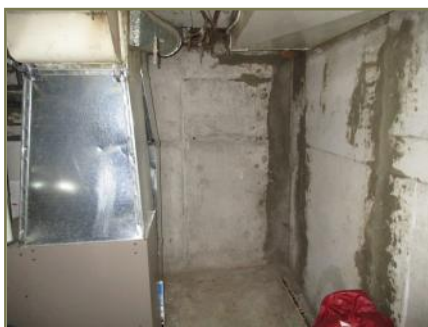
A10 - Foundations [1]

Discipline	Substructure
Category	A10 - Foundations
Element Number	1
Replacement Cost	\$10,200
Last Major Action	1925
Location/Name	Entire building
Brief Description	Where observed above grade and in the basement, the foundation walls are poured concrete.
Commentary	No major deficiencies were observed or reported.
Overall Condition	<div style="display: flex; align-items: center;"> <div style="width: 10px; height: 10px; background-color: yellow; margin-right: 5px;"></div> Fair </div>
Validated	Yes

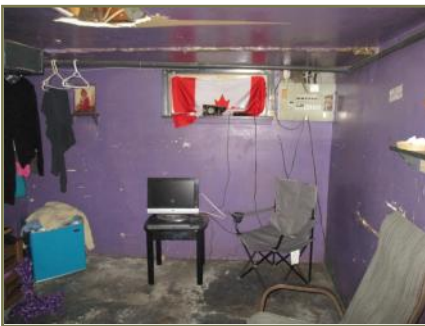
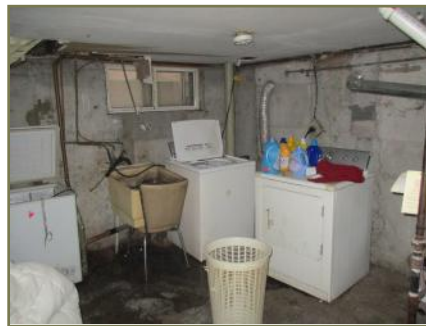
A20 - Basement Construction [1]

Discipline	Substructure
Category	A20 - Basement Construction
Element Number	1
Replacement Cost	\$15,300
Last Major Action	1925
Location/Name	Basement
Brief Description	The basement is finished with drywall ceilings and drywall partitions. The basement concrete floor is unfinished.
Commentary	The finishes in the basement have deteriorated.
Overall Condition	■ Fair
Validated	Yes

Action Summary:	Refurbish basement
Action: Commentary	Refurbishment is recommended.
Action Type	Repair
Cost	\$10,200
Year	2017
Priority	Low
Life Safety?	Not Applicable
Code Related?	Not applicable
If	No
Consequential Damage	N/A
Urgency of Action	Low
Energy & Efficiency	Not applicable or not apparent
Are there signs of Mould?	No

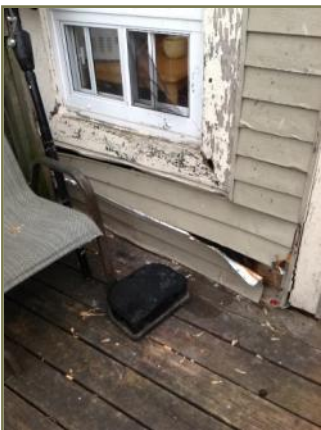
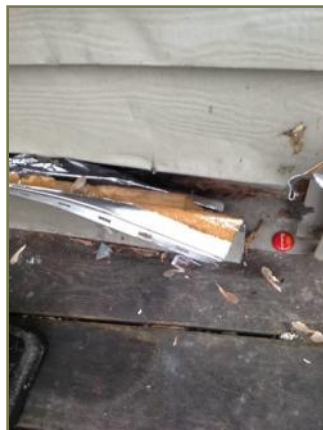
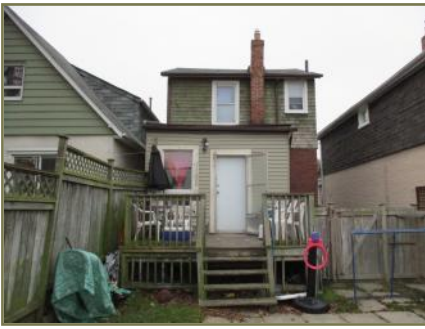
Discipline	Shell
Category	B2010 - Exterior Walls
Element Number	1
Replacement Cost	\$8,160
Last Major Action	1925
Location/Name	Exteriors of kitchen
Brief Description	The exterior walls of the kitchen are clad with metal siding.
Commentary	The metal siding at the back (east) elevation reportedly has been damaged by rats that had entered the building. The damaged siding has exposed the insulation.
Overall Condition	■ Poor
Validated	Yes

Action Summary: Repair metal siding at the back elevation

Action: Commentary Repair of the metal siding is recommended to minimize further deterioration to the exterior wall construction.

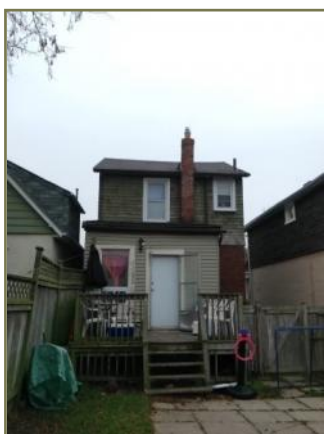
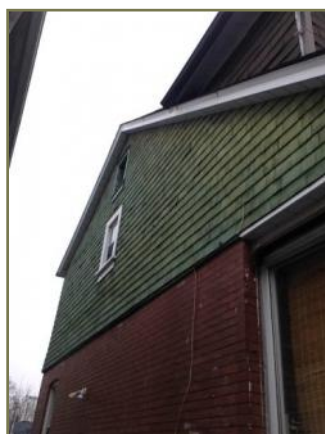
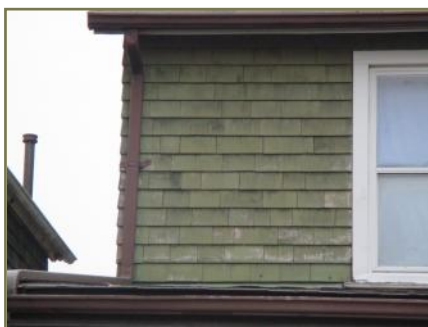
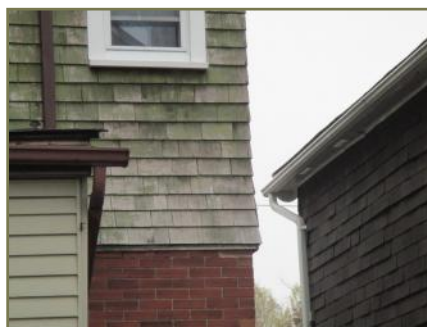
B2010 - Exterior Walls [2]

Discipline	Shell
Category	B2010 - Exterior Walls
Element Number	2
Replacement Cost	\$19,380
Last Major Action	1975
Location/Name	North, east, and south elevations - Second storey
Brief Description	Painted wood shakes are installed on the north, south, and east elevations of the second storey.
Commentary	The paint covering on the wood shakes are discoloured and stained.
Overall Condition	■ Fair
Validated	Yes

Action Summary: Repaint wood shakes

Repainting the wood shakes to extend their service life is recommended.

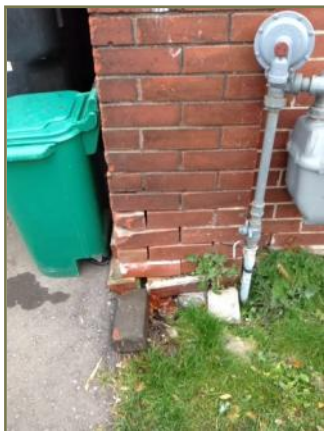
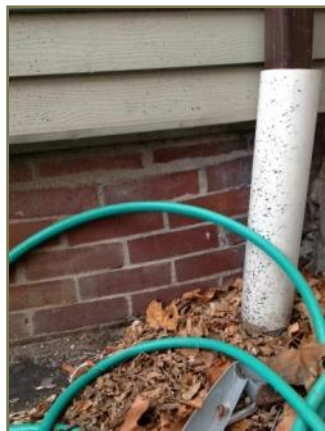
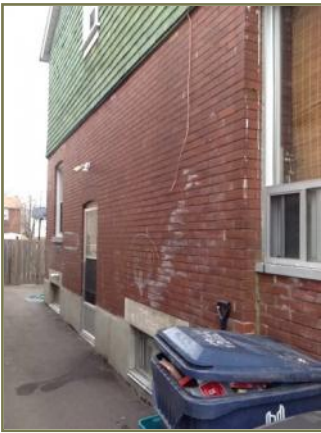
B2010 - Exterior Walls [3]

Discipline	Shell
Category	B2010 - Exterior Walls
Element Number	3
Replacement Cost	\$29,855
Last Major Action	1925
Location/Name	All elevations
Brief Description	The majority of the exterior walls are solid brick masonry walls.
Commentary	Brick mortar joints and dislodged bricks at northwest corner were noted. Bowing bricks were at the northeast corner, near the downspout, were observed.
Overall Condition	■ Fair
Validated	Yes

Action Summary: Repair bricks

Action: Commentary	A cost allowance for general brick repairs (individual brick replacement and mortar repointing, etc.) is provided.
Action Type	Repair
Cost	\$4,080
Year	2017
Priority	Medium
Life Safety?	Not Applicable
Code Related?	Not applicable
If	No
Consequential Damage	N/A
Urgency of Action	■ Medium
Energy & Efficiency	Not applicable or not apparent
Are there signs of Mould?	No

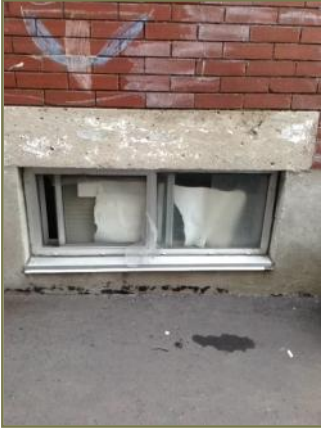
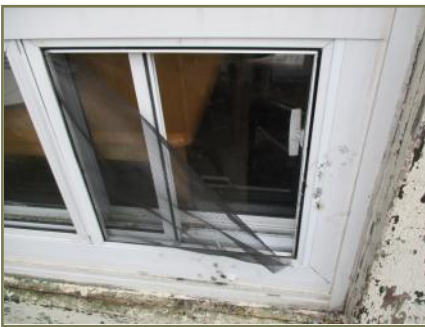
B2020 - Exterior Windows [1]

Discipline	Shell
Category	B2020 - Exterior Windows
Element Number	1
Replacement Cost	\$7,140
Last Major Action	1985
Location/Name	Entire building
Brief Description	The majority of the windows are metal-framed, single-glazed units. An insulated glass (IGU) window with horizontal sliders is provided for the kitchen. The windows above grade are typically metal-framed, vertical hung, single-glazed units.
Commentary	Damaged window screen were observed. The windows also have aged.
Overall Condition	■ Fair
Validated	Yes

Replace windows

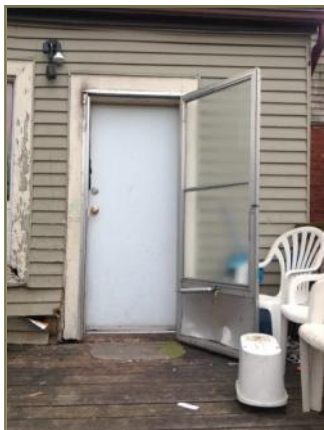
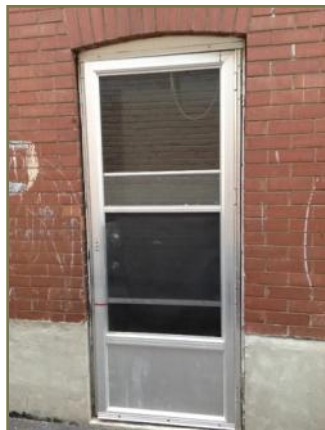
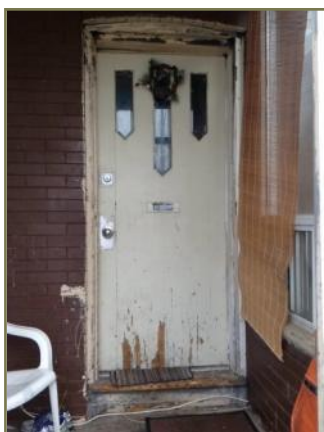
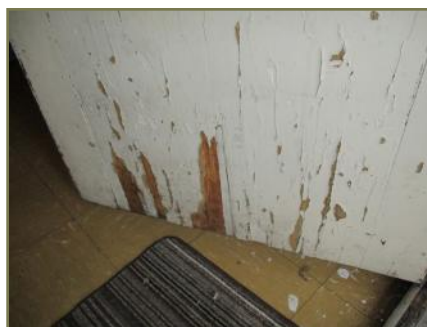
Discipline	Shell
Category	B2030 - Exterior Doors
Element Number	1
Replacement Cost	\$5,100
Last Major Action	1975
Location/Name	South, west, and east elevations
Brief Description	A wood door is provided for the main entrance. Access to the backyard is provided by a metal door that is complete with a metal storm door. The side entrance to the basement stairs, which is located on the south elevation, has a wood door that is complete with a metal storm door.
Commentary	The main entrance door exhibits damaged wood. It appears that a metal storm door is missing for the access into the mud room. The backyard metal storm door is dented.
Overall Condition	■ Fair
Validated	Yes

Replace exterior doors

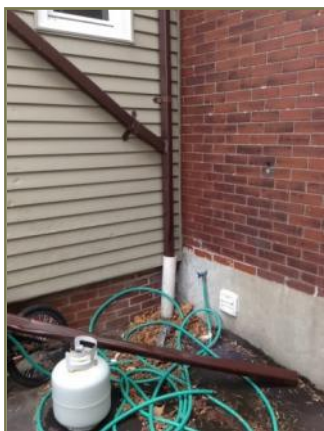
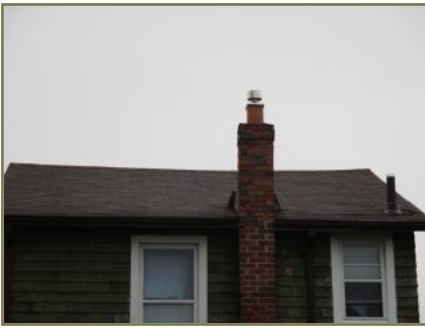
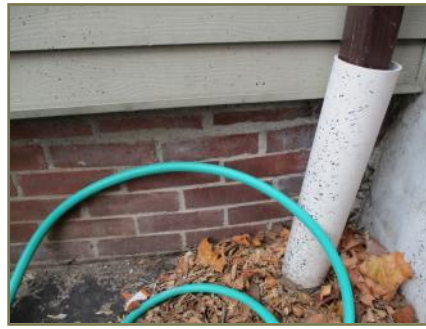
The asphalt shingles appear to be in good condition overall.

Disconnecting the downspouts in accordance to municipal requirements is recommended.

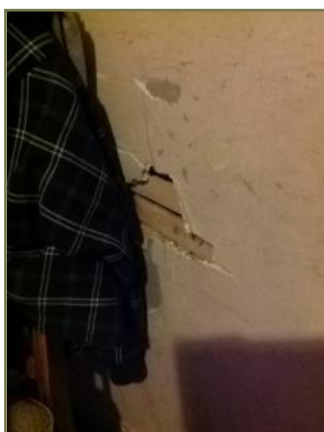
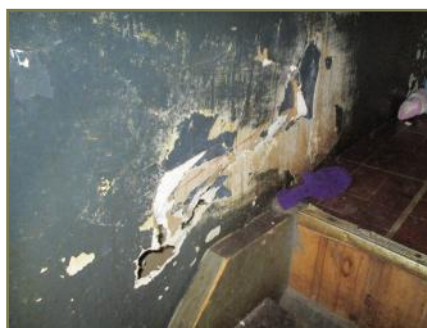
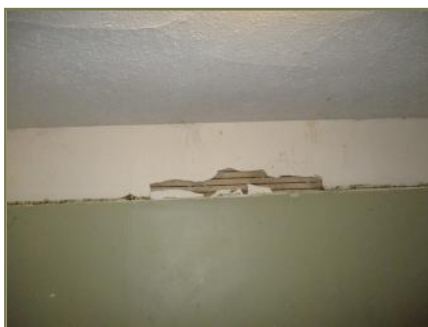
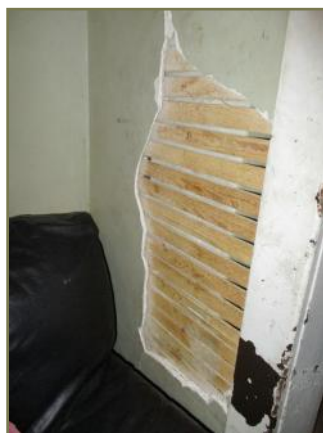
Discipline	Interiors
Category	C1010 - Partitions
Element Number	1
Replacement Cost	\$11,028
Last Major Action	1925
Location/Name	Entire building
Brief Description	The interior walls are likely wood-framed construction with plaster.
Commentary	Perforations in the plaster were observed at various locations. The tenant reported that the partitions require frequent maintenance or repairs.
Overall Condition	■ Poor
Validated	Yes

Actions**Action Summary:** Repair partitions

Action: Commentary	Partition repair is recommended to minimize further deterioration.
Action Type	Repair
Cost	\$6,120
Year	2017
Priority	High
Life Safety?	Not Applicable
Code Related?	Not applicable
If	No
Consequential Damage	N/A
Urgency of Action	<input type="checkbox"/> Medium
Energy & Efficiency	Not applicable or not apparent
Are there signs of Mould?	No

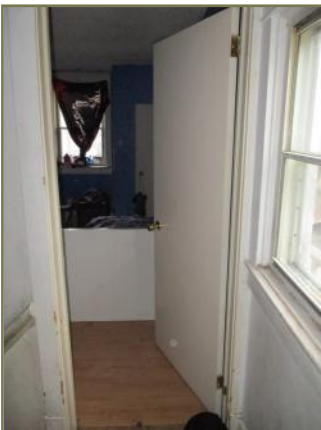
Discipline	Interiors
Category	C1040 - Interior Doors - Units
Element Number	1
Replacement Cost	\$5,100
Last Major Action	1970
Location/Name	Entire building
Brief Description	The interior doors are wood units in wood frames.
Commentary	The interior doors are in serviceable condition.
Overall Condition	<input type="checkbox"/> Fair
Validated	Yes

Action Summary:	Replace interior doors
Action: Commentary	Lifecycle renewal estimate
Action Type	Replacement
Cost	\$5,100
Year	2019
Priority	Low
Life Safety?	Not Applicable
Code Related?	Not applicable
If	No
Consequential Damage	N/A
Urgency of Action	Low
Energy & Efficiency	Not applicable or not apparent
Are there signs of Mould?	No

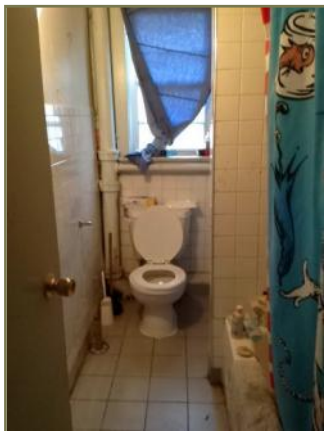
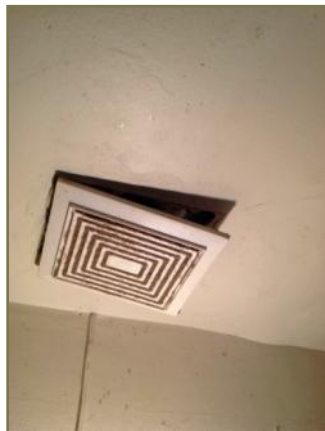
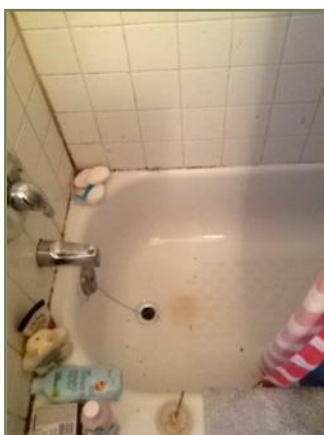
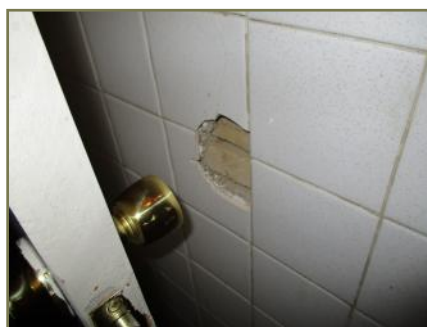
Damaged ceramic wall tiles and stains on the bathtub were observed.

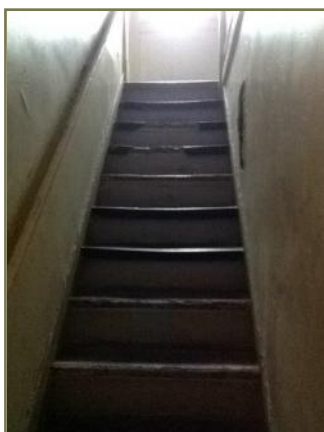
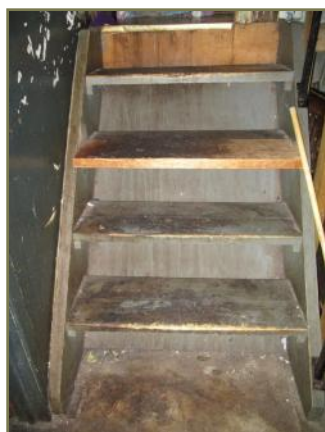
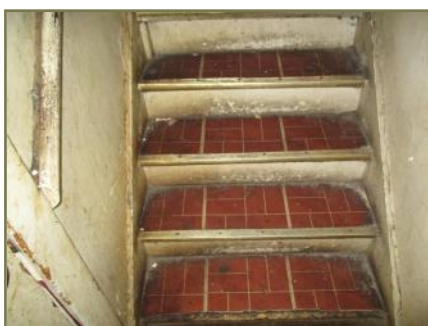
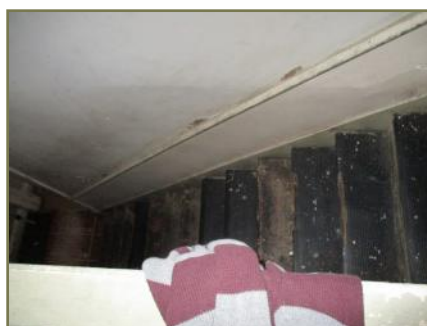
Discipline	Interiors
Category	C20 - Stairs
Element Number	1
Replacement Cost	\$4,671
Last Major Action	1925
Location/Name	Entire building
Brief Description	The interior stairs are wood framed. The basement stair treads are painted. The stairs to the second floor has tactile rubber treads.
Commentary	The treads are deteriorated. It also appears that the handrails do not meet code.
Overall Condition	■ Poor
Validated	Yes

A cost allowance for general maintenance (e.g. tread replacement, repainting, handrail installation, etc.) is provided.

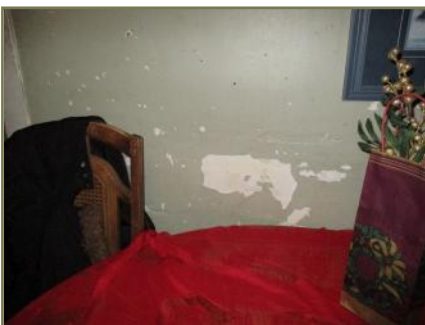
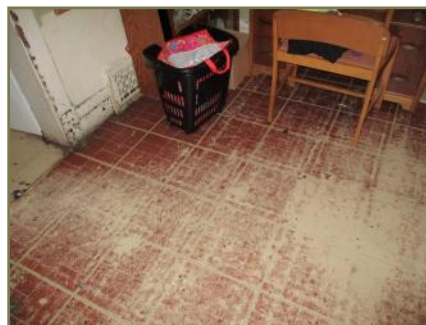
Discipline	Interiors
Category	C3200 - Interior Renovations - Units*
Element Number	1
Replacement Cost	\$14,280
Last Major Action	1980
Location/Name	Entire building
Brief Description	The interior finishes generally consist of vinyl floor tiles on the first floor, laminated wood floors on the second floor, painted plaster walls, as well as painted and textured plaster ceilings.
Commentary	The vinyl floor tiles are scuffed and cracked. The plaster ceiling in the living room is delaminating.
Overall Condition	Poor
Validated	Yes

Interior renovations is recommended.

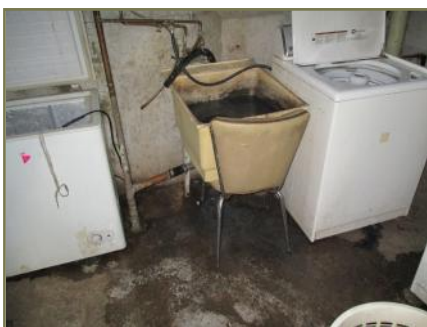
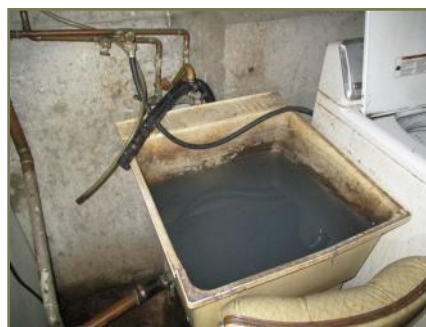
The laundry sink drainage pipe was blocked during the assessment. The tenant reportedly attempted to remove the blockage, but a leak from the laundry tub has occurred as a result.

Action Summary:	Replace laundry tub
Action: Commentary	Replacement is recommended.
Action Type	Replacement
Cost	\$510
Year	2017
Priority	High
Life Safety?	Not Applicable
Code Related?	Not applicable
If	No
Consequential Damage	N/A
Urgency of Action

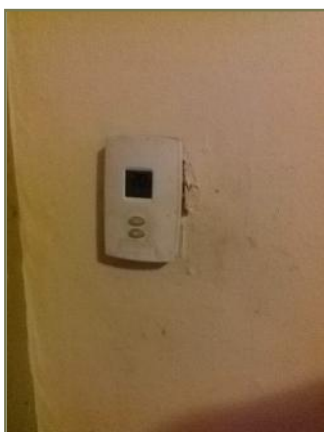
Discipline	Services
Category	D3060 - Controls And Instrumentation
Element Number	1
Replacement Cost	\$510
Last Major Action	1925
Location/Name	First floor - Dining Room
Brief Description	A thermostat to control the furnace is located on the first floor.
Commentary	The tenant reported that the thermostat requires adjustments in order to achieve adequate thermal comfort.
Overall Condition	<input type="checkbox"/> Fair
Validated	Yes

Actions**Action Summary:** Replace thermostat**Action: Commentary**

Replacement is recommended. If climate control issues persist, the thermostat may require earlier replacement.

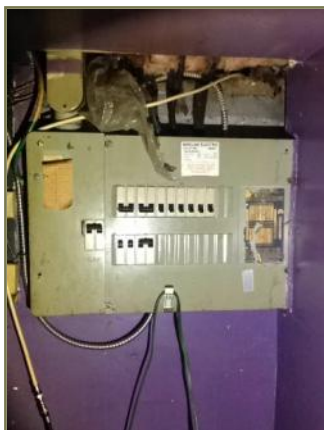
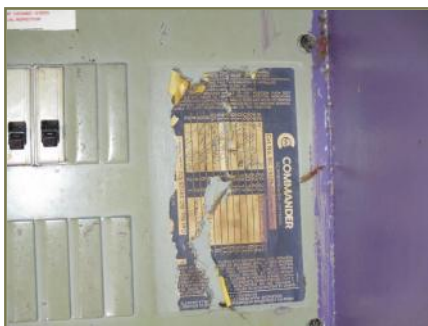
Discipline	Services
Category	D5015 - Unit Electrical Service and Distribution
Element Number	1
Replacement Cost	\$5,100
Last Major Action	1990
Location/Name	Basement
Brief Description	<p>This site component cannot be accurately assessed using visual means alone and would require invasive or specialized engineering review, however we observed a circuit breaker panel that does not appear to be original.</p> <p>The circuit breaker panel provides electrical service to mechanical units, receptacles, and lighting. The breaker panel was manufactured by Commander with ratings of 120/240V and 125A.</p> <p>Although the circuit breaker panel is not original, it appears aged.</p>
Commentary	
Overall Condition	■ Fair
Validated	Yes

Action Summary:	Replace circuit breaker panel
Action: Commentary	Replacement is recommended.
Action Type	Replacement
Cost	\$5,100
Year	2020
Priority	Low
Life Safety?	Not Applicable
Code Related?	Not applicable
If	No
Consequential Damage	N/A
Urgency of Action	Low
Energy & Efficiency	Not applicable or not apparent
Are there signs of Mould?	No

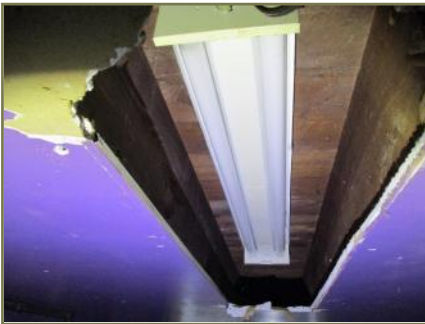
Discipline	Services
Category	D5023 - Lighting Equipment - Units
Element Number	1
Replacement Cost	\$3,060
Last Major Action	1980
Location/Name	Entire building
Brief Description	The interior lighting consists of compact fluorescent light (CFL) and incandescent fixtures.
Commentary	<p>There were no functioning lights in the basement. The tenant reported that the electrical wiring for the lighting was damaged during the installation of the furnace.</p> <p>The lamp above the basement stairs is excessively difficult for the tenant to replace. A ladder cannot be safely placed on the basement stairs to reach the light fixture.</p>
Overall Condition	■ Poor
Validated	Yes

Action Summary:	Replace interior light fixtures
Action: Commentary	Replacement is recommended.
Action Type	Replacement
Cost	\$3,060
Year	2017
Priority	High
Life Safety?	Not Applicable
Code Related?	Not applicable
If	No
Consequential Damage	N/A
Urgency of Action	■ Medium
Energy & Efficiency	Not applicable or not apparent
Are there signs of Mould?	No

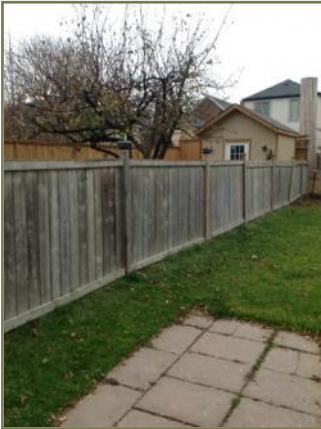
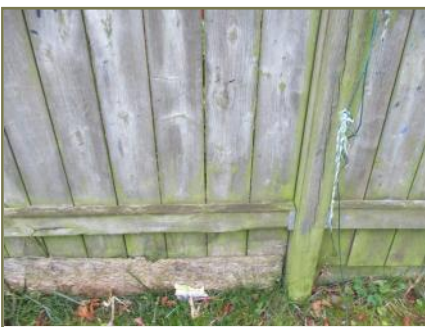
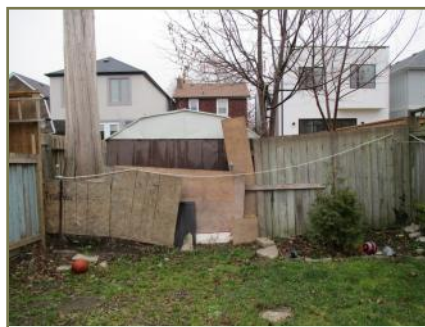
Discipline	Building Sitework
Category	G2040 - Site Development
Element Number	1
Replacement Cost	\$4,080
Last Major Action	1925
Location/Name	Backyard
Brief Description	Wood fences are constructed on the backyard perimeters.
Commentary	Mildew growth on the fences was noted, but the fences are functioning as intended. A section of the east perimeter fencing is missing.
Overall Condition	■ Fair
Validated	Yes

Action Summary: Repair fences

Replacement of the east site perimeter fence and cleaning of the fences are recommended.

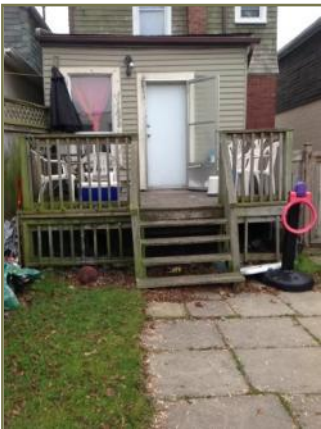
Discipline	Building Sitework
Category	G2040 - Site Development
Element Number	2
Replacement Cost	\$4,080
Last Major Action	1925
Location/Name	Backyard
Brief Description	A wood deck is constructed in the backyard, adjacent to the east elevation. A set of wood-framed stairs provide access from the wood deck to grade.
Commentary	Mildew growth was observed on the wood deck. The stairs are slanted.
Overall Condition	■ Fair
Validated	Yes

Replace wood deck

Replacement is recommended.

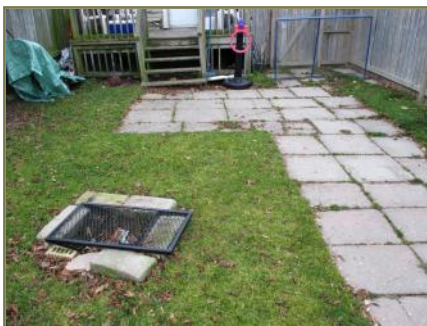
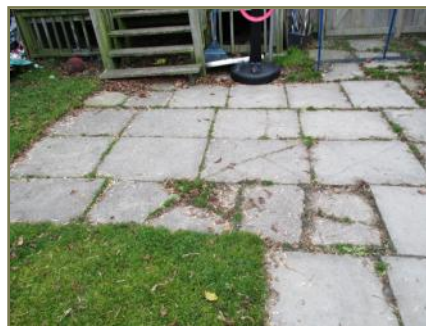
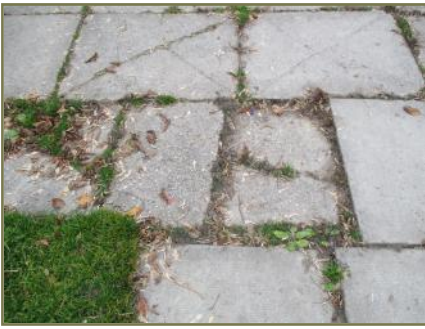
Some patio stones exhibit cracks and spalling. The deteriorated patio stones may be a tripping hazard.

Action Summary:	Replace concrete patio pavers	
Action: Commentary		Replacement is recommended.
Action Type		Replacement
Cost		\$1,020
Year		2017
Priority		Medium
Life Safety?		Not Applicable
Code Related?		Not applicable
If		No
Consequential Damage		N/A
Urgency of Action	■	Medium
Energy & Efficiency		Not applicable or not apparent
Are there signs of Mould?		No

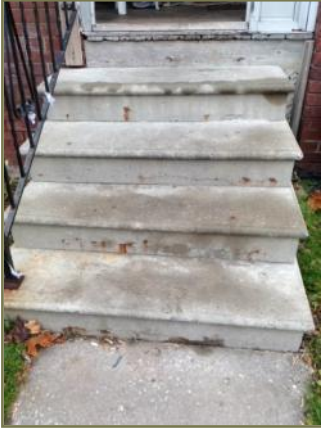
Discipline	Building Sitework
Category	G2040 - Site Development
Element Number	4
Replacement Cost	\$3,060
Last Major Action	1970
Location/Name	Adjacent to the west elevation
Brief Description	Concrete steps provide access from the concrete walkway to the mud room.
Commentary	The concrete stairs appear to be in fair condition. There are no guards on side of the steps.
Overall Condition	■ Fair
Validated	Yes

Action: Commentary	Installation of guards is recommended.
Action Type	Replacement
Cost	\$510
Year	2017
Priority	Medium
Life Safety?	Minor consequences - potential minor injuries
Code Related?	Not applicable
If	No
Consequential Damage	N/A
Urgency of Action	■ Medium
Energy & Efficiency	Not applicable or not apparent
Are there signs of Mould?	No
