BCA Report

Sample Fair FCI

Portfolio	TCHC - All Op Units
Development	Scattered Units (CHU 12)
Size	1,217 Sq.Ft.
Construction Year	1912
Floor Above Grade	2
Divisional Units	1
Description	No. of Elevators: 0; No. of UG Parking Storeys: 0 The building is a 2 storey semi-detached home made of typical wood frame construction. The building is clad in brick, siding and asphalt shingles. The windows are aluminum framed. The home is heated by forced-air furnace. Electrical service is provided to the home via overhead wires and 240 A service.

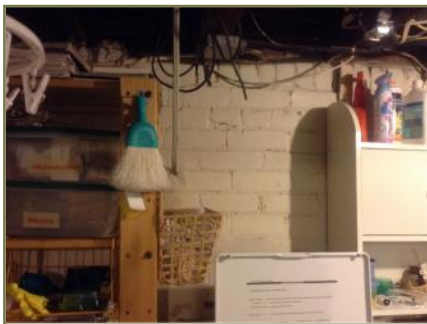
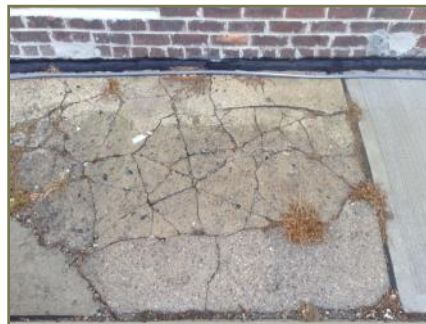
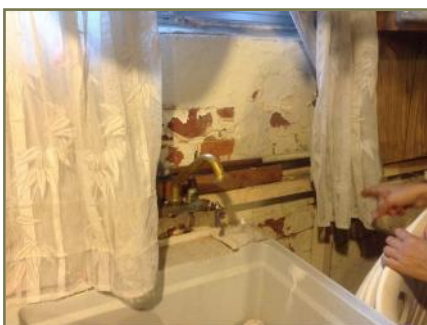
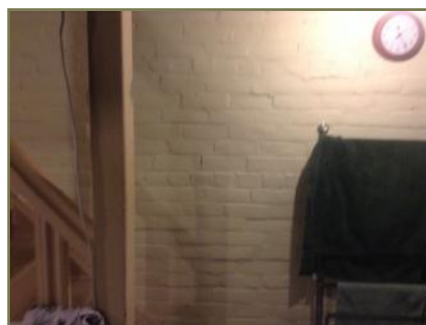
A10 - Foundations [1]

Discipline	Substructure
Category	A10 - Foundations
Element Number	1
Replacement Cost	\$15,300
Last Major Action	1912
Location/Name	
Brief Description	The foundations are constructed of concrete block.
Commentary	The tenant has reported heavy leaking, and some deterioration of the interior wall conditions.
Overall Condition	■ Fair
Validated	Yes

Action Summary:	Investigate foundation wall conditions.
Action: Commentary	The tenant has reported heavy leaking, and some deterioration of the interior wall conditions. We have budgeted to waterproof walls and install weeping tile to address leakage.
Action Type	Replacement
Cost	\$15,300
Year	2017
Priority	Low

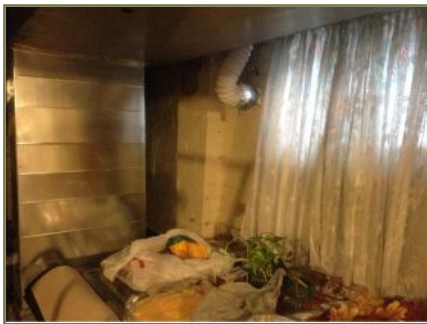
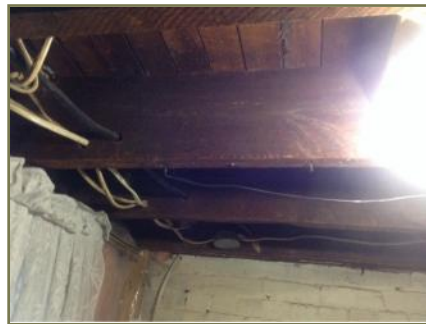
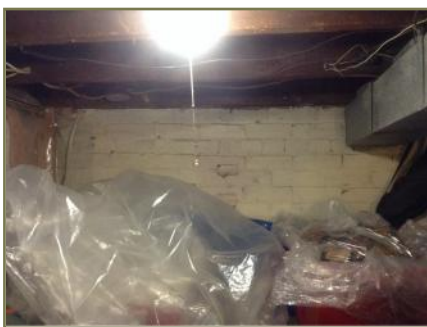
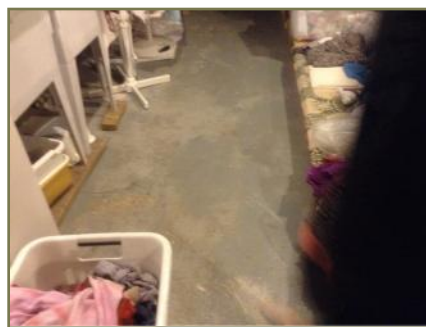
A20 - Basement Construction [1]

Discipline	Substructure
Category	A20 - Basement Construction
Element Number	1
Replacement Cost	\$23,330
Last Major Action	1912
Location/Name	
Brief Description	The basement construction consists of exterior concrete block and masonry brick walls and cast in place concrete slab on grade. The first floor joists are supported on wood beams on Concrete block columns.
Commentary	No repairs are anticipated during this report period.
Overall Condition	Good
Validated	Yes

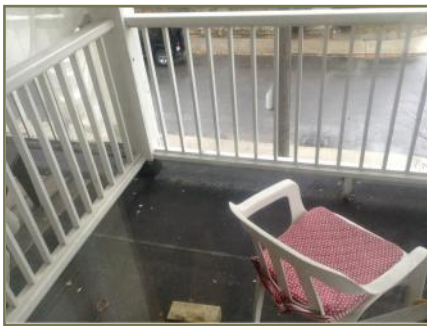
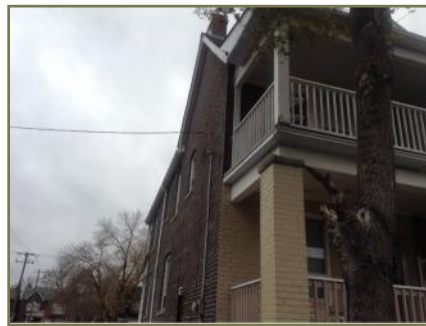
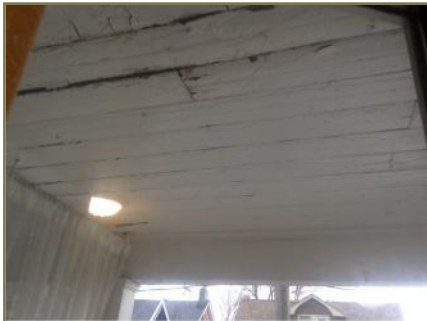
B10 - Superstructure [1]

Discipline	Shell
Category	B10 - Superstructure
Element Number	1
Replacement Cost	\$13,290
Last Major Action	1912
Location/Name	
Brief Description	The above grade structure consists of typical wood framed construction. The roof has engineered roof trusses with plywood sheathing.
Commentary	No repairs are anticipated during this report period.
Overall Condition	Good
Validated	Yes

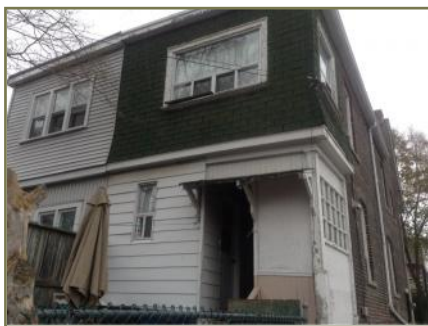
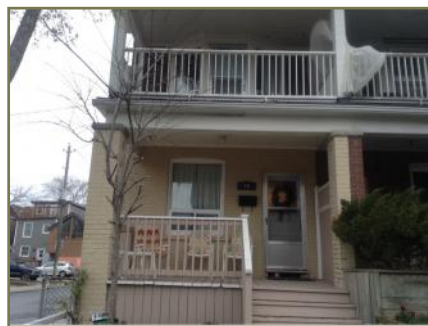
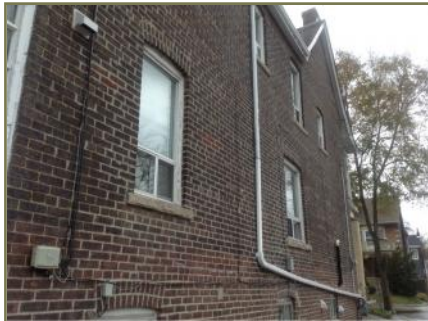
B2010 - Exterior Walls [1]

Discipline	Shell
Category	B2010 - Exterior Walls
Element Number	1
Replacement Cost	\$26,420
Last Major Action	1912
Location/Name	
Brief Description	The side elevation is brick masonry, the first floor if the front elevation is painted masonry.
Commentary	The masonry is in good condition.
Overall Condition	Good
Validated	Yes

Action Summary:	Masonry repair program.
Action: Commentary	The masonry is in good condition. Replace unsound bricks and deteriorated mortar joints.
Action Type	Replacement
Cost	\$765
Year	2020
Priority	Low
Life Safety?	Not Applicable
Code Related?	Not applicable
If	No
Consequential Damage	N/A
Urgency of Action	Low
Energy & Efficiency	Not applicable or not apparent

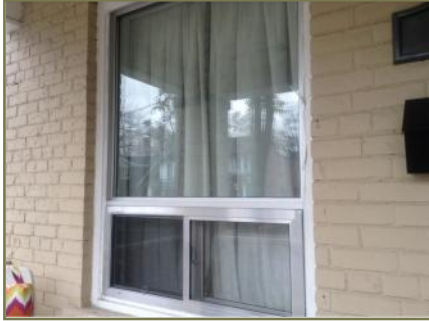
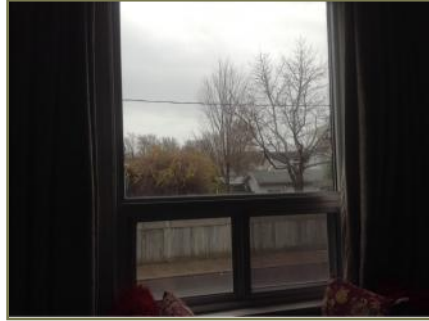
B2020 - Exterior Windows [1]

Discipline	Shell
Category	B2020 - Exterior Windows
Element Number	1
Replacement Cost	\$13,770
Last Major Action	1985
Location/Name	
Brief Description	The windows are aluminum with insulating glass units.
Commentary	The windows are in fair condition. The windows were last replaced in 1985.
Overall Condition	■ Fair
Validated	Yes

Action Summary:	Replace exterior windows.
Action: Commentary	The windows are in fair condition. The windows were last replaced in 1985. Replace all exterior windows at end of service life.
Action Type	Replacement
Cost	\$13,770
Year	2020
Priority	Low
Life Safety?	Not Applicable
Code Related?	Not applicable
If	No
Consequential Damage	N/A
Urgency of Action	Low
Energy & Efficiency	Not applicable or not apparent
Are there signs of Mould?	No

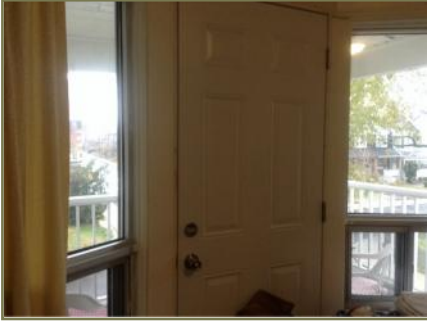
B2030 - Exterior Doors [1]

Discipline	Shell
Category	B2030 - Exterior Doors
Element Number	1
Replacement Cost	\$4,488
Last Major Action	2010
Location/Name	
Brief Description	There are 3 exterior doors, which are hollow metal, and wood and are balcony, front and rear entrances.
Commentary	The exterior doors are in good condition.
Overall Condition	Good
Validated	Yes

Action Summary:	Replace exterior doors.
Action: Commentary	The exterior doors are in good condition. Replace 3 exterior doors.
Action Type	Replacement
Cost	\$4,488
Year	2035
Priority	Low
Life Safety?	Not Applicable
Code Related?	Not applicable
If	No
Consequential Damage	N/A
Urgency of Action	Low
Energy & Efficiency	Not applicable or not apparent
Are there signs of Mould?	No

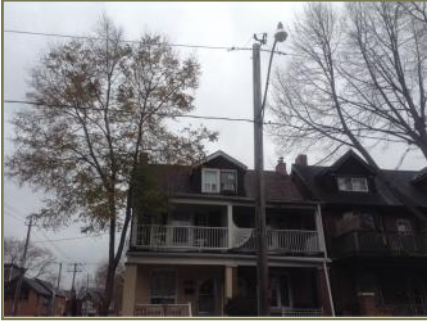
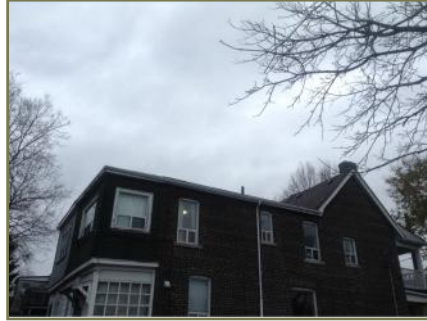
B30 - Roofing [1]

Discipline	Shell
Category	B30 - Roofing
Element Number	1
Replacement Cost	\$5,100
Last Major Action	2010
Location/Name	
Brief Description	The roof is covered in a laminated asphalt shingle. The roof drains into metal eaves troughs and downspouts.
Commentary	The roof is in good condition.
Overall Condition	Good
Validated	Yes

Action Summary:	Replace roof.	
Action: Commentary		The roof is in good condition. Replace shingles and damaged plywood sheathing at end of service life.
Action Type		Replacement
Cost		\$5,100
Year		2040
Priority		Low
Life Safety?		Not Applicable
Code Related?		Not applicable
If		No
Consequential Damage		N/A
Urgency of Action		Low
Energy & Efficiency		Not applicable or not apparent
Are there signs of Mould?		No

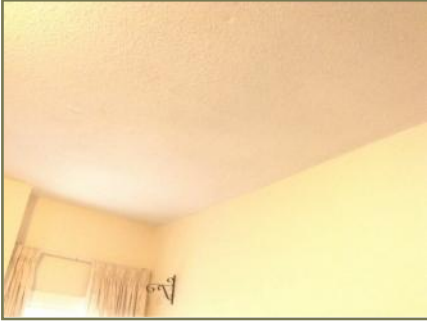
C1010 - Partitions [1]

Discipline	Interiors
Category	C1010 - Partitions
Element Number	1
Replacement Cost	\$13,735
Last Major Action	2000
Location/Name	
Brief Description	The interior walls and partitions are constructed of drywall.
Commentary	The partitions are in good condition. Wholesale replacement is not anticipated.
Overall Condition	Good
Validated	Yes

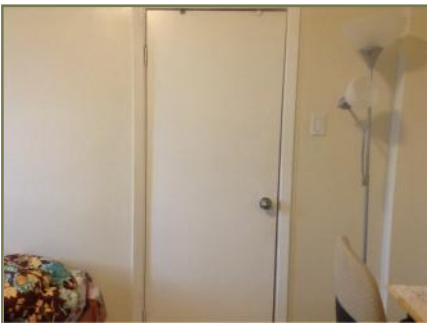
C1040 - Interior Doors - Units [1]

Discipline	Interiors
Category	C1040 - Interior Doors - Units
Element Number	1
Replacement Cost	\$3,366
Last Major Action	2005
Location/Name	
Brief Description	The interior doors are hollow wood.
Commentary	The doors are in good condition, there was no missing or damaged hardware.
Overall Condition	Good
Validated	Yes

Action Summary:	Replace interior doors.
Action: Commentary	Replace interior doors.
Action Type	Replacement
Cost	\$3,366
Year	2025
Priority	Low
Life Safety?	Not Applicable
Code Related?	Not applicable

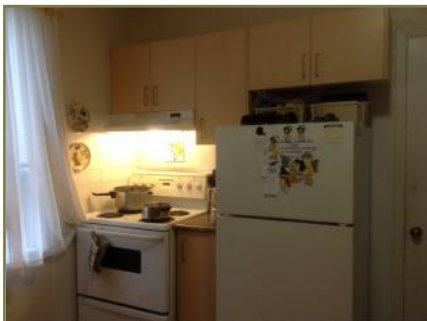
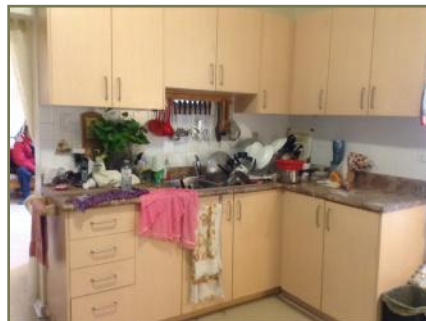
C1060 - Kitchen Refurbishment [1]

Discipline	Interiors
Category	C1060 - Kitchen Refurbishment
Element Number	1
Replacement Cost	\$7,650
Last Major Action	2010
Location/Name	
Brief Description	The kitchen floors are vinyl tile with painted walls and ceilings. The cupboards are wood and the countertops are laminate.
Commentary	The kitchen is in good condition.
Overall Condition	Good
Validated	Yes

Action Summary:	Refurbish kitchen.
Action: Commentary	The kitchen is in good condition. Refurbish kitchen at end of service life.
Action Type	Replacement
Cost	\$7,650
Year	2030
Priority	Low
Life Safety?	Not Applicable
Code Related?	Not applicable
If	No
Consequential Damage	N/A
Urgency of Action	Low
Energy & Efficiency	Not applicable or not apparent
Are there signs of Mould?	No

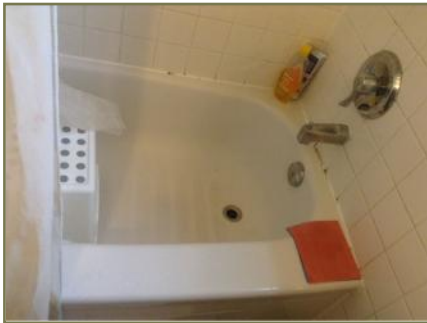
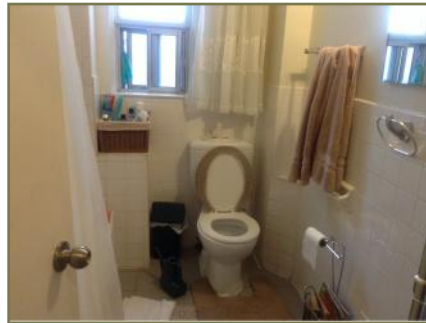
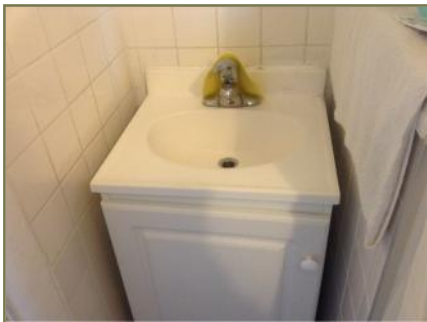
C1070 - Bathroom Refurbishment [1]

Discipline	Interiors
Category	C1070 - Bathroom Refurbishment
Element Number	1
Replacement Cost	\$5,100
Last Major Action	2010
Location/Name	
Brief Description	The bathroom floors are ceramic tile with painted walls and acrylic surrounds and painted ceilings. There is a vanity mounted sink with laminate counter.
Commentary	The bathroom is in good condition.
Overall Condition	Good
Validated	Yes

Action Summary:	Refurbish bathroom.
Action: Commentary	The bathroom is in good condition. Refurbish bathroom at end of service life.
Action Type	Replacement
Cost	\$5,100
Year	2030
Priority	Low
Life Safety?	Not Applicable
Code Related?	Not applicable
If	No
Consequential Damage	N/A
Urgency of Action	Low

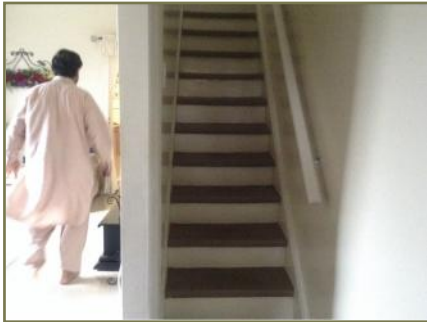
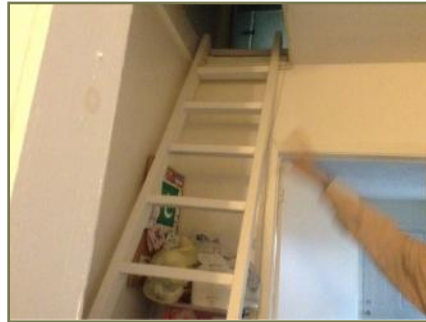
C20 - Stairs [1]

Discipline	Interiors
Category	C20 - Stairs
Element Number	1
Replacement Cost	\$5,708
Last Major Action	1912
Location/Name	
Brief Description	The interior stairs are wooden with non-slip treads. Exterior stairs are wood.
Commentary	The interior stairs are in good condition. Replacement of the stairs is not anticipated.
Overall Condition	Good
Validated	Yes

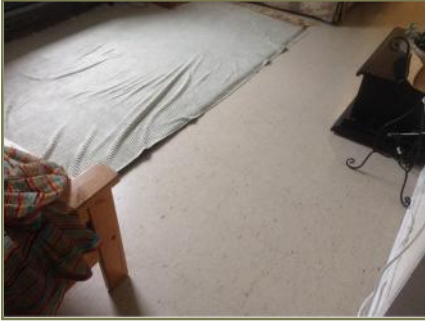
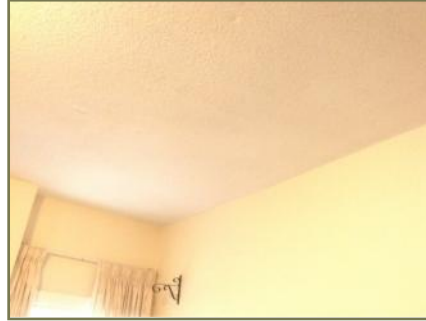
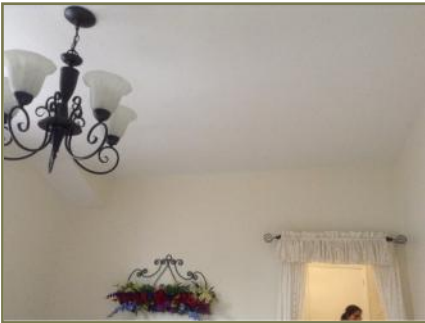
C3200 - Interior Renovations - Units* [1]

Discipline	Interiors
Category	C3200 - Interior Renovations - Units*
Element Number	1
Replacement Cost	\$6,630
Last Major Action	2010
Location/Name	
Brief Description	The ceilings and walls are painted drywall, and the flooring is vinyl.
Commentary	The interior finishes are in good condition.
Overall Condition	Good
Validated	Yes

Action: Commentary	The interior are in good condition. Renovate at end of service life or at tenant turnover.
Action Type	Replacement
Cost	\$6,630
Year	2030
Priority	Low
Life Safety?	Not Applicable
Code Related?	Not applicable
If	No
Consequential Damage	N/A
Urgency of Action	Low
Energy & Efficiency	Not applicable or not apparent
Are there signs of Mould?	No

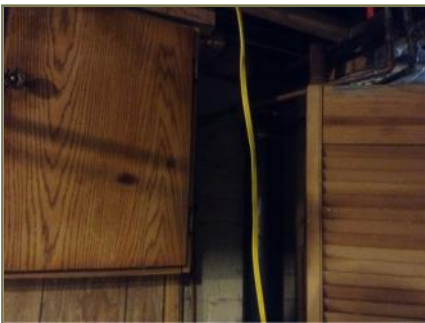
Discipline	Services
Category	D2050 - Domestic Water Distribution - Units
Element Number	1
Replacement Cost	\$2,471
Last Major Action	1912
Location/Name	
Brief Description	Domestic water distribution is provided through incoming line in the basement.
Commentary	No leakage was observed or reported by the tenants.
Overall Condition	Good
Validated	Yes

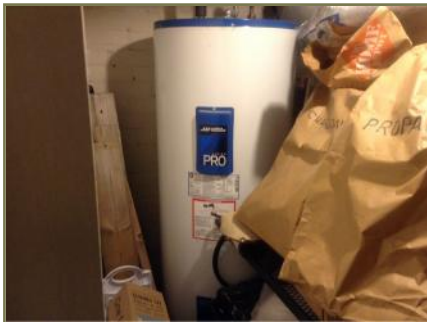
D2095 - Domestic Water Heaters [1]

Discipline	Services
Category	D2095 - Domestic Water Heaters
Element Number	1
Replacement Cost	\$1,836
Last Major Action	2011
Location/Name	
Brief Description	The domestic electric water heater has a 284 L storage capacity .
Commentary	The heater was installed in 2010 and is functioning as intended.
Overall Condition	Good
Validated	Yes

Action Summary:	Replace hot water heater.
Action: Commentary	The heater was installed in 2010 and is functioning as intended. Replace at end of service life.
Action Type	Replacement
Cost	\$1,836
Year	2030
Priority	Low
Life Safety?	Not Applicable
Code Related?	Not applicable
If	No
Consequential Damage	N/A
Urgency of Action	Low
Energy & Efficiency	Not applicable or not apparent
Are there signs of Mould?	No

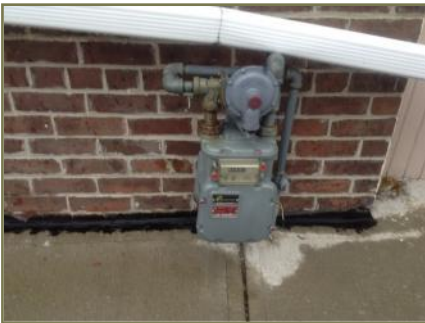
D3012 - Gas Supply System [1]

Discipline	Services
Category	D3012 - Gas Supply System
Element Number	1
Replacement Cost	\$510
Last Major Action	1912
Location/Name	
Brief Description	Natural gas is supplied by Enbridge, the gas meter and supply is located at the side of the house.
Commentary	The meter is maintained by Enbridge and no capital costs are anticipated for TCHC.
Overall Condition	Good
Validated	Yes

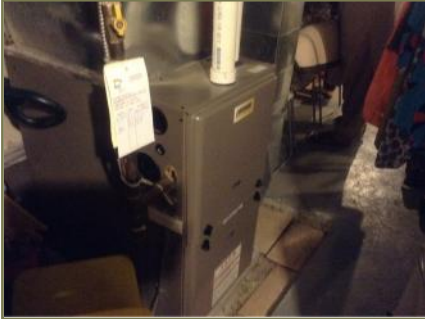
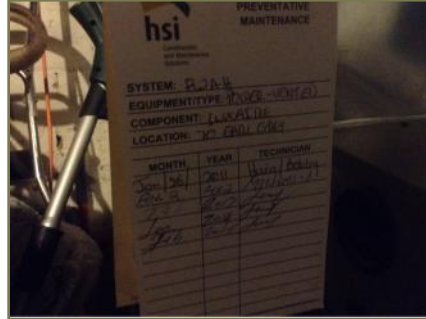
Discipline	Services
Category	D3023 - Furnaces
Element Number	1
Replacement Cost	\$3,570
Last Major Action	2011
Location/Name	
Brief Description	The furnaces are natural gas power by Luxaire.
Commentary	The furnace was installed in 2011 and is functioning as intended.
Overall Condition	Good
Validated	Yes

Action Summary:	Replace furnace.
Action: Commentary	The furnace was installed in 2011 and is functioning as intended. Replace at end of service life.
Action Type	Replacement
Cost	\$3,570
Year	2041
Priority	Low
Life Safety?	Not Applicable
Code Related?	Not applicable
If	No
Consequential Damage	N/A
Urgency of Action	Low
Energy & Efficiency	Not applicable or not apparent
Are there signs of Mould?	No

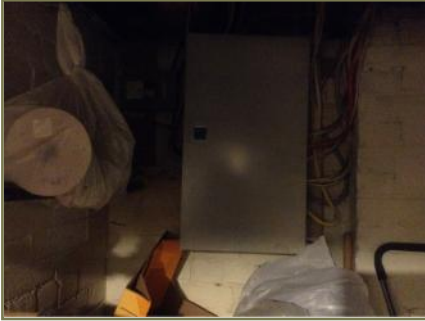
D5015 - Unit Electrical Service and Distribution [1]

Discipline	Services
Category	D5015 - Unit Electrical Service and Distribution
Element Number	1
Replacement Cost	\$1,914
Last Major Action	1975
Location/Name	
Brief Description	The electrical service enters the home via overhead wires. The feed enters the breaker panel located in the basement. The panel is rated at 120/240 V manufactured by Commander.
Commentary	No anticipated capital costs.
Overall Condition	Good
Validated	Yes

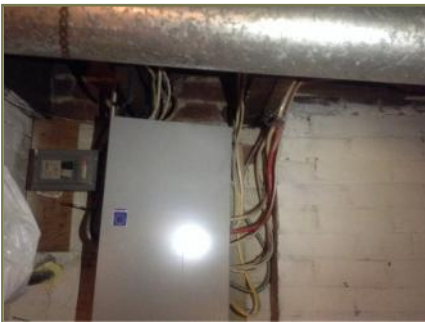
D5021 - Branch Wiring [1]

Discipline	Services
Category	D5021 - Branch Wiring
Element Number	1
Replacement Cost	\$5,929
Last Major Action	1912
Location/Name	
Brief Description	The branch wiring is copper by Aslan.
Commentary	No capital costs are anticipated.
Overall Condition	Good
Validated	Yes

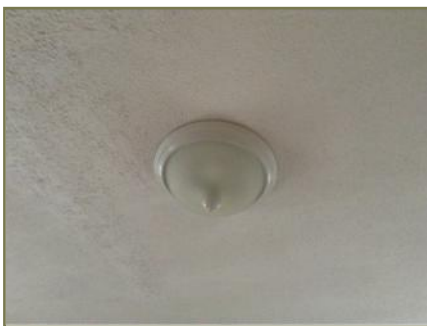
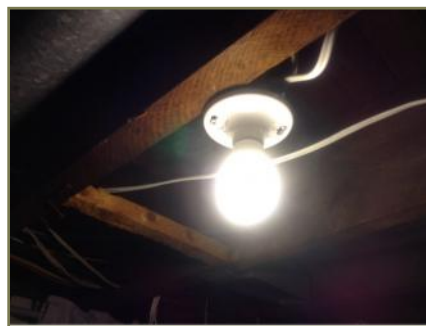
D5023 - Lighting Equipment - Units [1]

Discipline	Services
Category	D5023 - Lighting Equipment - Units
Element Number	1
Replacement Cost	\$1,224
Last Major Action	2000
Location/Name	
Brief Description	Lighting systems include the following: Suites: Ceiling-mounted fixtures with CFL.
Commentary	The lighting is in fair condition.
Overall Condition	Good
Validated	Yes

Action Summary:	Replace interior lighting fixtures.
Action: Commentary	The lighting is in fair condition. Replace fixtures at end of service life.
Action Type	Replacement
Cost	\$1,224
Year	2025
Priority	Low
Life Safety?	Not Applicable
Code Related?	Not applicable
If	No
Consequential Damage	N/A
Urgency of Action	Low
Energy & Efficiency	Not applicable or not apparent
Are there signs of Mould?	No

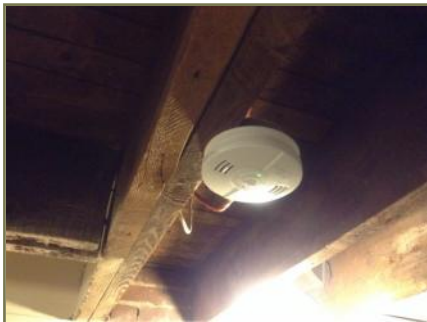
D5037 - Fire Alarm System [1]

Discipline	Services
Category	D5037 - Fire Alarm System
Element Number	1
Replacement Cost	\$510
Last Major Action	2010
Location/Name	
Brief Description	There is typically one smoke detectors per floor.
Commentary	No issues reported.
Overall Condition	Good
Validated	Yes

Action Summary:	Replace smoke detectors.
Action: Commentary	Replace smoke detectors on regular 10 year cycle.
Action Type	Replacement
Cost	\$510
Year	2020
Priority	Low
Life Safety?	Not Applicable
Code Related?	Not applicable
If	No
Consequential Damage	N/A
Urgency of Action	Low
Energy & Efficiency	Not applicable or not apparent
Are there signs of Mould?	No

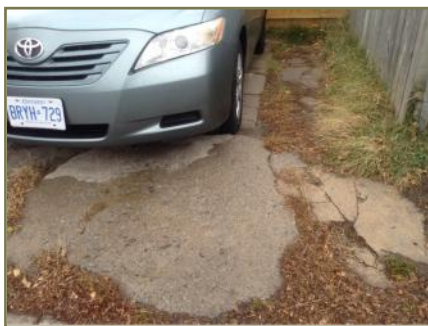
G2020 - Parking Lots [1]

Discipline	Building Sitework
Category	G2020 - Parking Lots
Element Number	1
Replacement Cost	\$3,060
Last Major Action	1995
Location/Name	
Brief Description	There is one concrete parking space.
Commentary	The driveway is in poor condition. The concrete, is cracked and present potential tripping hazards.
Overall Condition	■ Poor
Validated	Yes

Action Summary:	Replace driveway.
Action: Commentary	The driveway is in poor condition. The concrete, is cracked and present potential tripping hazards. Remove and replace driveway.
Action Type	Replacement
Cost	\$3,060
Year	2017
Priority	Medium
Life Safety?	Not Applicable
Code Related?	Not applicable
If	No
Consequential Damage	N/A
Urgency of Action	Low
Energy & Efficiency	Not applicable or not apparent
Are there signs of Mould?	No

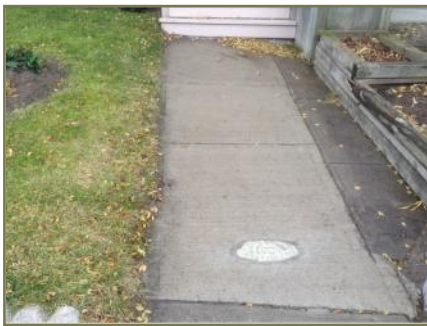
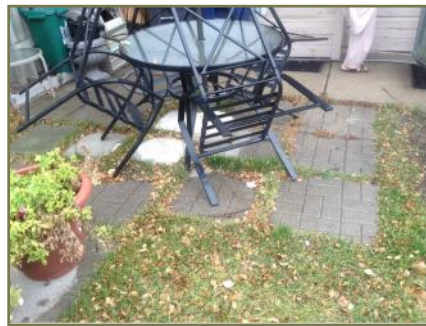
G2030 - Pedestrian Paving [1]

Discipline	Building Sitework
Category	G2030 - Pedestrian Paving
Element Number	1
Replacement Cost	\$1,530
Last Major Action	2005
Location/Name	
Brief Description	The pedestrian paving consists of cast in place concrete sidewalks, and unit pavers.
Commentary	The paving is in good condition.
Overall Condition	Good
Validated	Yes

<u>Action Summary:</u>	Replace pedestrian paving.
Action: Commentary	Replace concrete sidewalks and relevel unit pavers.
Action Type	Replacement
Cost	\$1,530
Year	2025
Priority	Low
Life Safety?	Not Applicable
Code Related?	Not applicable
If	No
Consequential Damage	N/A
Urgency of Action	Low
Energy & Efficiency	Not applicable or not apparent
Are there signs of Mould?	No

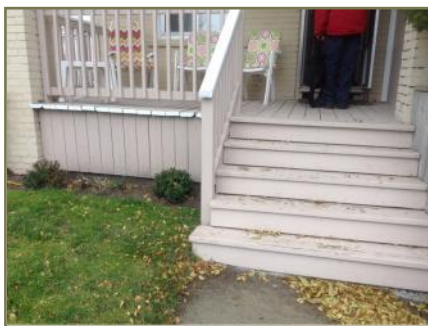
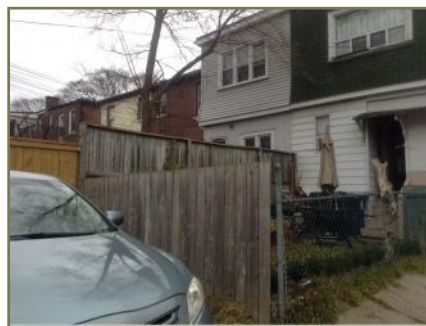
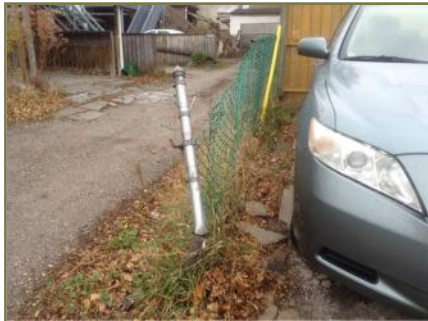
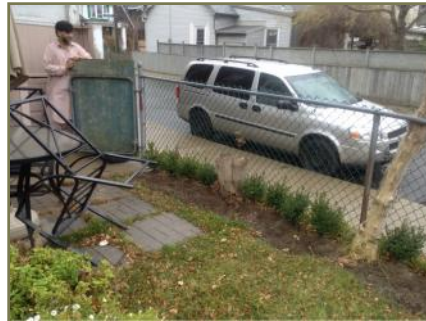
G2040 - Site Development [1]

Discipline	Building Sitework
Category	G2040 - Site Development
Element Number	1
Replacement Cost	\$2,176
Last Major Action	1912
Location/Name	
Brief Description	There is a front wood porch, and chain link and wood fencing.
Commentary	The wood fence and porch is in good condition. The chain link fence is damaged.
Overall Condition	■ Poor
Validated	Yes

Action Summary: Replace chain link fence.

Action: Commentary	Replace damaged chain link fence adjacent to parking spot.
Action Type	Replacement
Cost	\$765
Year	2017
Priority	Medium
Life Safety?	Not Applicable
Code Related?	Not applicable
If	No
Consequential Damage	N/A
Urgency of Action	Low
Energy & Efficiency	Not applicable or not apparent

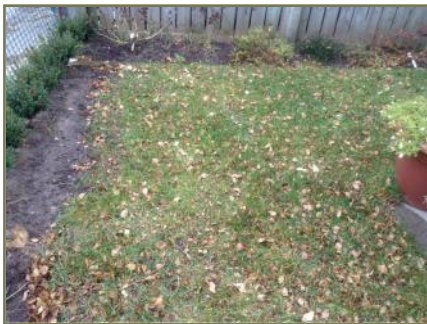
G2050 - Landscaping [1]

Discipline Building Sitework
Category G2050 - Landscaping
Element Number 1
Replacement Cost \$510
Last Major Action 1912
Location/Name
Brief Description Soft landscaping consists of sod.
Commentary Wholesale sod replacement is not anticipated.
Overall Condition Good
Validated Yes
