BCA Report

Sample Low FCI

Portfolio	TCHC - All Op Units
Development	Scattered Units (CHU 01)
Size	1,488 Sq.Ft.
Construction Year	1958
Floor Above Grade	1
Divisional Units	1
Description	The building consist of semi detached duplex house with 3 bedrooms. The 2 story building is constructed slab on grade brick frame superstructure, and brick exterior walls. Heating is provided by a natural gas fired furnace. Domestic hot water heater is provided by a gas water heater and distributed by copper piping.

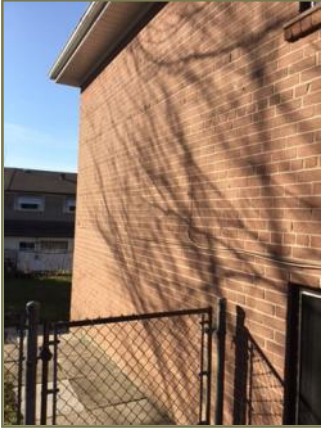
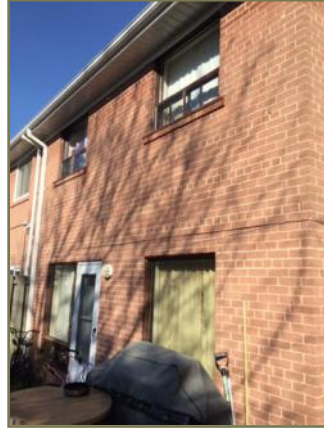
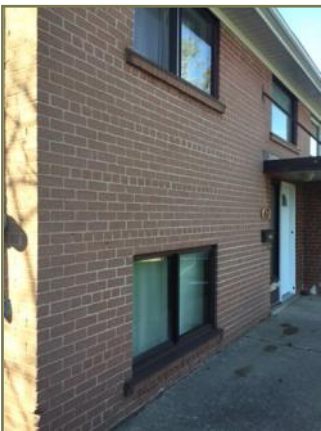
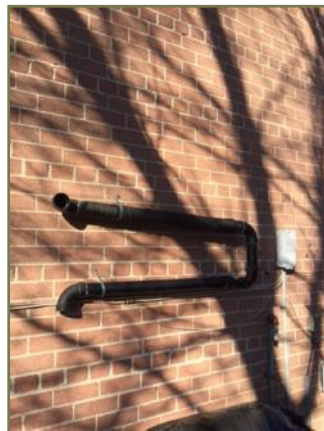
B2010 - Exterior Walls [1]

Discipline	Shell
Category	B2010 - Exterior Walls
Element Number	1
Replacement Cost	\$29,522
Last Major Action	1958
Location/Name	
Brief Description	Brick walls throughout.
Commentary	No issues reported or observed.
Overall Condition	Good
Validated	Yes

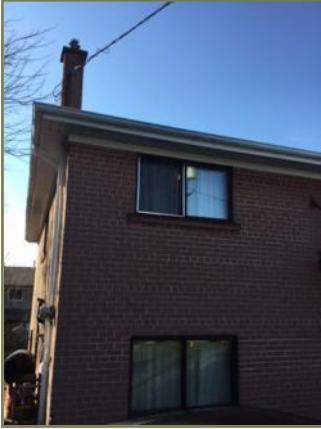
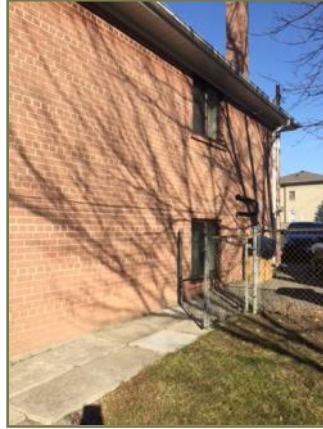
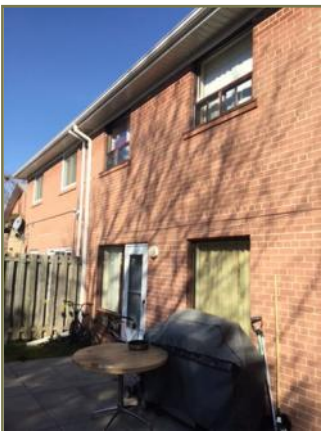
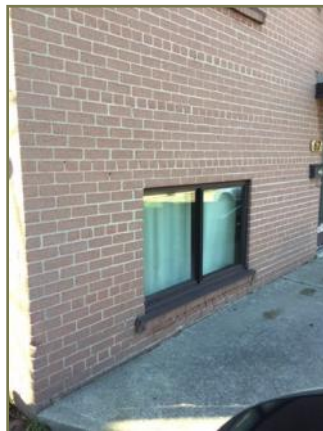
B2020 - Exterior Windows [1]

Discipline	Shell
Category	B2020 - Exterior Windows
Element Number	1
Replacement Cost	\$6,630
Last Major Action	1988
Location/Name	
Brief Description	Insulated glass units in metal frames.
Commentary	Window units have 1988 date stamp. No issues reported or observed.
Overall Condition	Good
Validated	Yes

Action Summary: Replace exterior windows.

Action: Commentary	Replace components by the end of designed service life.
Action Type	Replacement
Cost	\$6,630
Year	2020
Priority	Low
Life Safety?	Not Applicable
Code Related?	Not applicable
If	No
Consequential Damage	N/A
Urgency of Action	Low
Energy & Efficiency	Not applicable or not apparent
Are there signs of Mould?	No

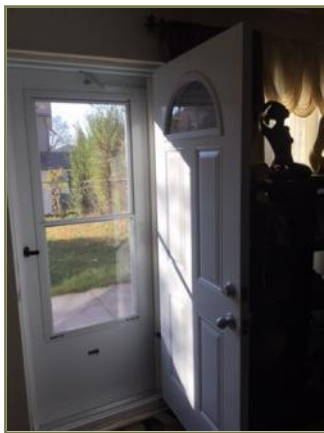
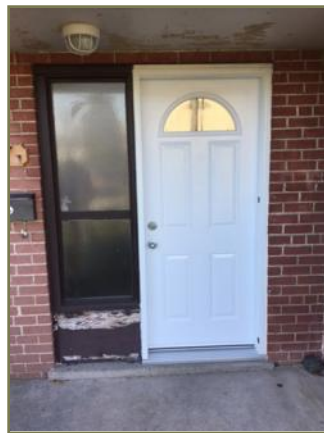
B2030 - Exterior Doors [1]

Discipline	Shell
Category	B2030 - Exterior Doors
Element Number	1
Replacement Cost	\$3,060
Last Major Action	2015
Location/Name	Main entrance, backyard
Brief Description	2 insulated metal doors. One metal storm door.
Commentary	No issues reported or observed.
Overall Condition	Good
Validated	Yes

Action Summary:	Replace exterior doors.
Action: Commentary	
Action Type	Replacement
Cost	\$3,060
Year	2045
Priority	Low
Life Safety?	Not Applicable
Code Related?	Not applicable
If	No
Consequential Damage	N/A
Urgency of Action	Low
Energy & Efficiency	Not applicable or not apparent
Are there signs of Mould?	No

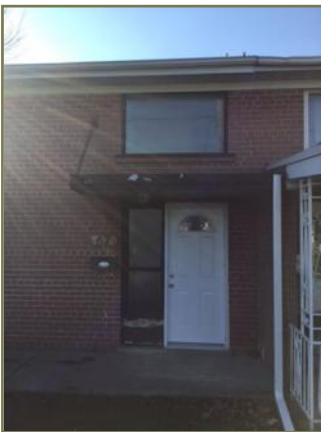
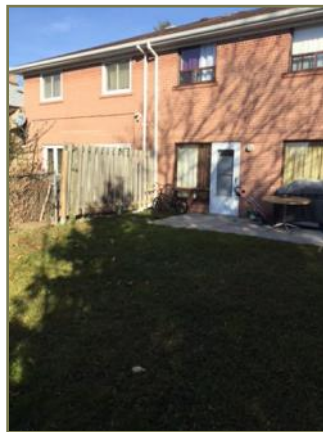
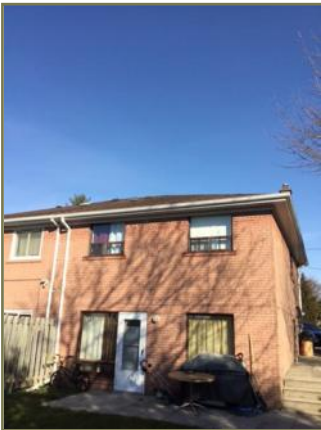
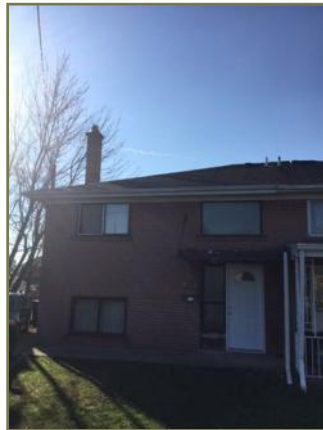
B30 - Roofing [1]

Discipline	Shell
Category	B30 - Roofing
Element Number	1
Replacement Cost	\$8,670
Last Major Action	2005
Location/Name	
Brief Description	Asphalt shingle roof. Assumed flat built up canopy roof
Commentary	Reported leak from the canopy roof. Shingle roof installed approximately in 2005. No issues reported or observed.
Overall Condition	■ Fair
Validated	Yes

Action Summary: Replace asphalt shingle roof.

Action Summary: Replace flat built up canopy roof.

Action: Commentary Deferral of replacement may cause further damage to the structure of the canopy.

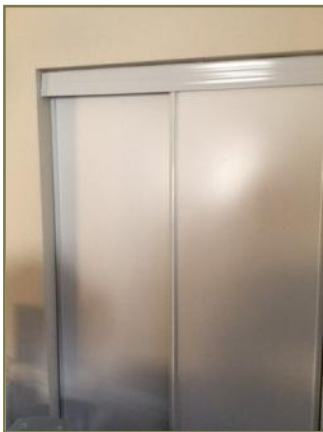
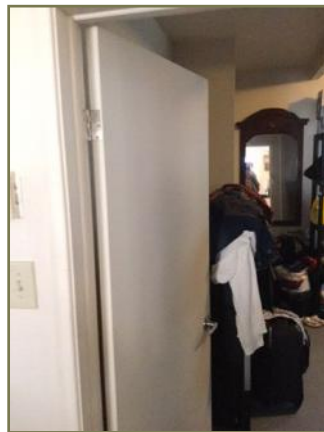
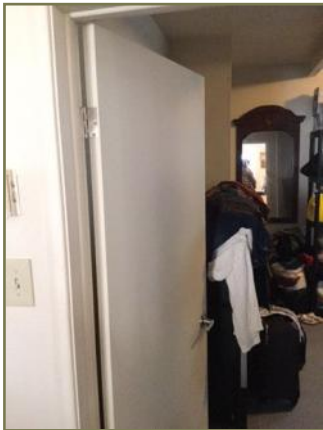
C1040 - Interior Doors - Units [1]

Discipline	Interiors
Category	C1040 - Interior Doors - Units
Element Number	1
Replacement Cost	\$6,120
Last Major Action	2014
Location/Name	Throughout
Brief Description	Hollow wood doors, sliding closet doors
Commentary	5 in total hollow wood doors and 5 in total closet sliding doors. No issues reported or observed.
Overall Condition	Good
Validated	Yes

Action Summary:	Replace interior doors and closet doors.
Action: Commentary	
Action Type	Replacement
Cost	\$6,120
Year	2039
Priority	Low
Life Safety?	Not Applicable
Code Related?	Not applicable
If	No
Consequential Damage	N/A
Urgency of Action	Low
Energy & Efficiency	Not applicable or not apparent
Are there signs of Mould?	No

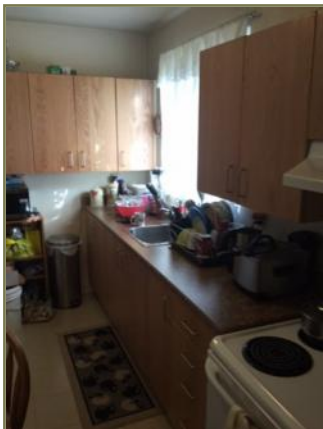
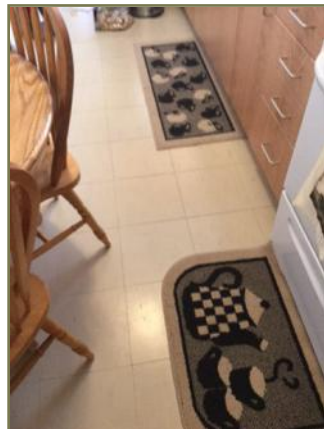
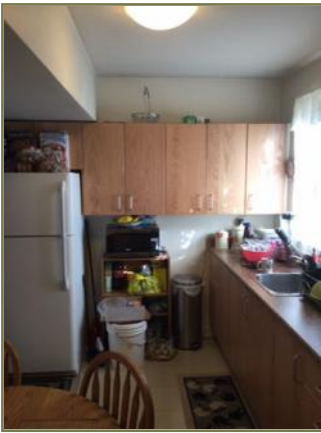
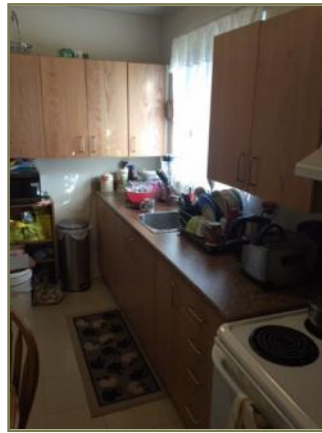
C1060 - Kitchen Refurbishment [1]

Discipline	Interiors
Category	C1060 - Kitchen Refurbishment
Element Number	1
Replacement Cost	\$9,180
Last Major Action	2014
Location/Name	Main floor
Brief Description	Cabinetry, laminate countertop, vinyl tile flooring, and kitchen sink with faucet.
Commentary	No issues reported or observed.
Overall Condition	Good
Validated	Yes

Action Summary: Replace the cabinetry, plumbing fixtures, and finishes within the kitchen.

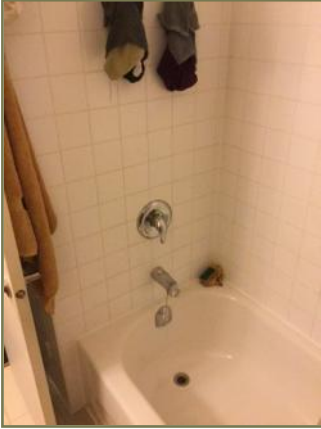
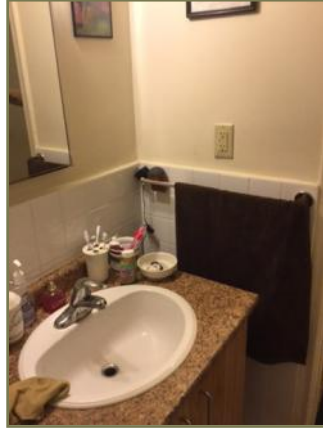
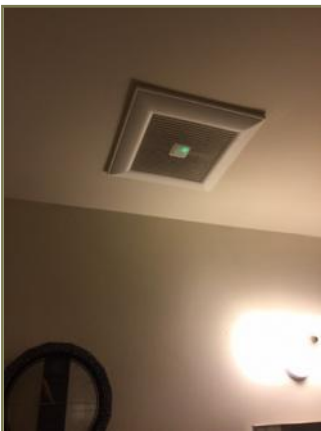
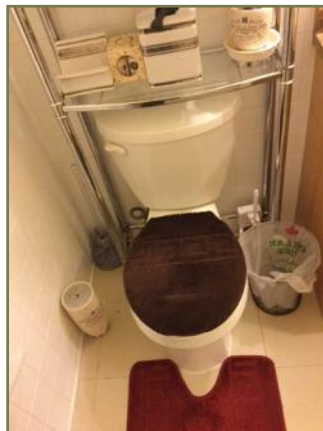
C1070 - Bathroom Refurbishment [1]

Discipline	Interiors
Category	C1070 - Bathroom Refurbishment
Element Number	1
Replacement Cost	\$6,120
Last Major Action	2015
Location/Name	2nd floor
Brief Description	3 piece bathroom, ceramic tile flooring
Commentary	No issues reported or observed.
Overall Condition	Good
Validated	Yes

Action Summary: Replace the bathroom finishes and plumbing fixtures.

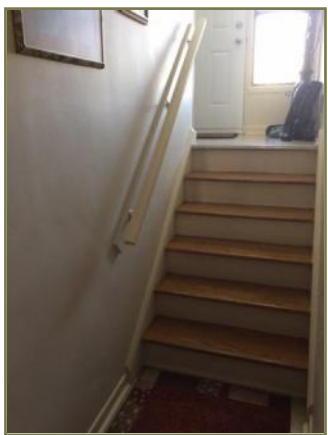
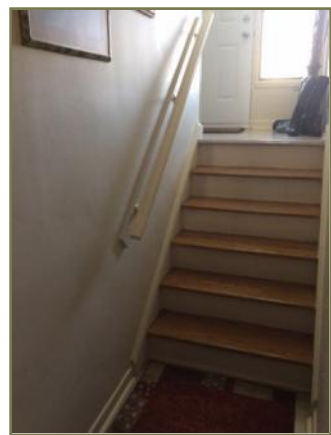
C20 - Stairs [1]

Discipline	Interiors
Category	C20 - Stairs
Element Number	1
Replacement Cost	\$2,687
Last Major Action	2014
Location/Name	
Brief Description	Hardwood stairs with hand rails.
Commentary	No issues reported or observed.
Overall Condition	Good
Validated	Yes

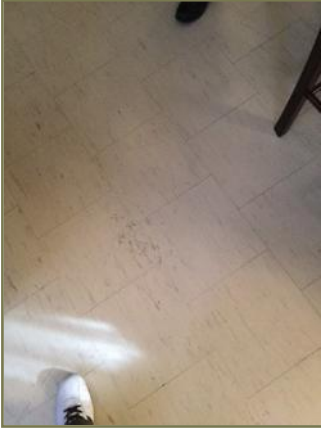
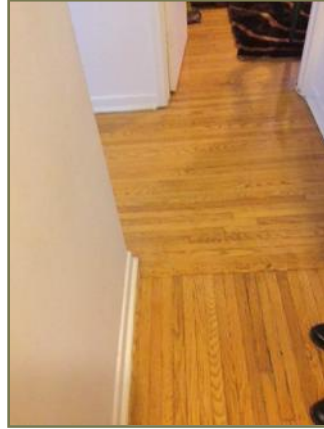
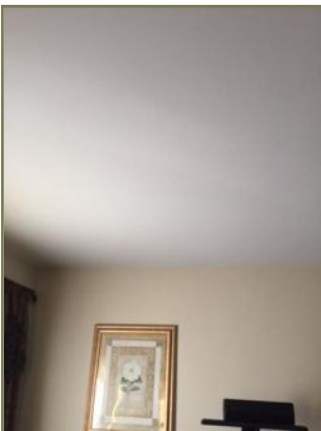
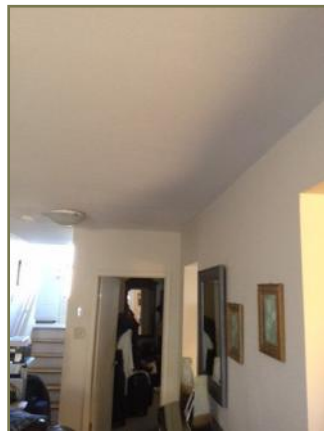
C3200 - Interior Renovations - Units* [1]

Discipline	Interiors
Category	C3200 - Interior Renovations - Units*
Element Number	1
Replacement Cost	\$12,240
Last Major Action	2014
Location/Name	
Brief Description	Vinyl tile floor, hardwood floor, painted walls.
Commentary	Vinyl tile floors on the main floor. Hardwood flooring on the 2nd floor. No issues reported or observed. Painted walls and ceilings throughout.
Overall Condition	Good
Validated	Yes

Action Summary: Replace interior finishes.

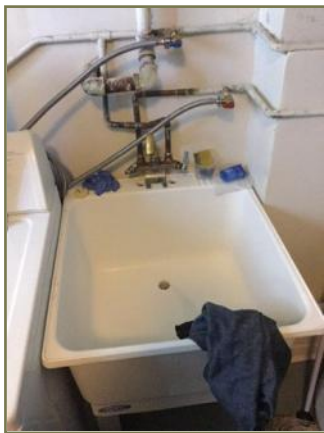
D2010 - Plumbing Fixtures [1]

Discipline	Services
Category	D2010 - Plumbing Fixtures
Element Number	1
Replacement Cost	\$1,530
Last Major Action	2014
Location/Name	
Brief Description	Laundry sink, and hose bib.
Commentary	No issues reported or observed.
Overall Condition	Good
Validated	Yes

Action Summary:	Replace laundry sink and hose bib.
Action: Commentary	
Action Type	Replacement
Cost	\$1,530
Year	2045
Priority	Low
Life Safety?	Not Applicable
Code Related?	Not applicable
If	No
Consequential Damage	N/A
Urgency of Action	Low
Energy & Efficiency	Not applicable or not apparent
Are there signs of Mould?	No

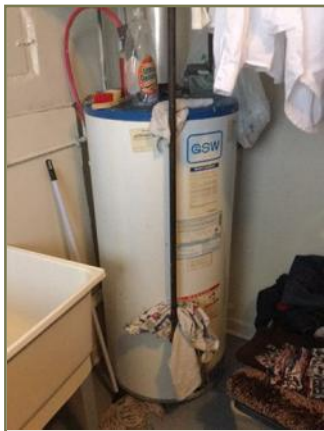
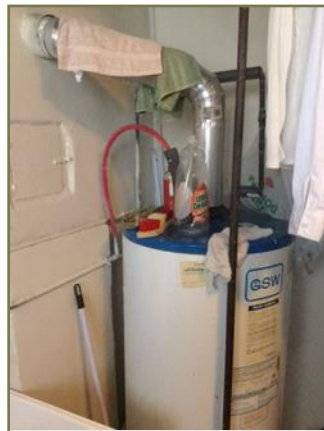
D2095 - Domestic Water Heaters [1]

Discipline	Services
Category	D2095 - Domestic Water Heaters
Element Number	1
Replacement Cost	\$1,530
Last Major Action	2008
Location/Name	Main floor
Brief Description	Gas fired domestic hot water heater.
Commentary	No issues reported or observed.
Overall Condition	Good
Validated	Yes

Action Summary:	Replace domestic hot water heater.
Action: Commentary	Plan to replace component at the end of its assumed service life.
Action Type	Replacement
Cost	\$1,530
Year	2018
Priority	Low
Life Safety?	Not Applicable
Code Related?	Not applicable
If	No
Consequential Damage	N/A
Urgency of Action	Low
Energy & Efficiency	Not applicable or not apparent
Are there signs of Mould?	No

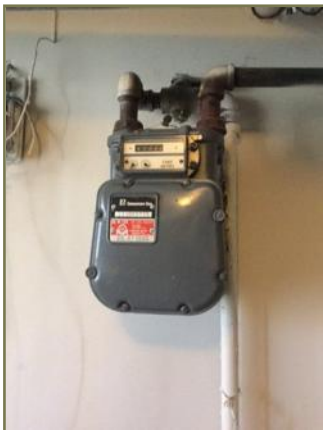
D3012 - Gas Supply System [1]

Discipline	Services
Category	D3012 - Gas Supply System
Element Number	1
Replacement Cost	\$510
Last Major Action	1958
Location/Name	Main floor
Brief Description	Gas meter and piping
Commentary	No issues reported or observed.
Overall Condition	Good
Validated	Yes

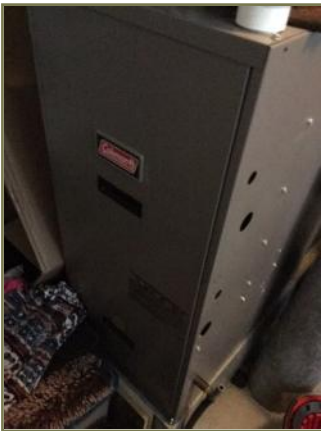
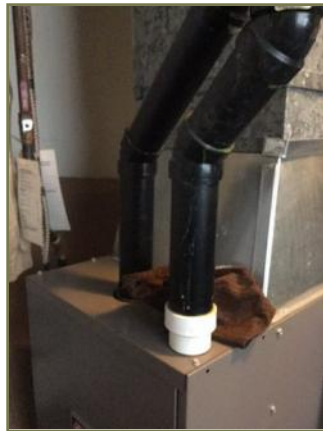
D3023 - Furnaces [1]

Discipline	Services
Category	D3023 - Furnaces
Element Number	1
Replacement Cost	\$5,100
Last Major Action	2010
Location/Name	Main floor
Brief Description	Natural gas fired high efficient furnace.
Commentary	No issues reported or observed.
Overall Condition	Good
Validated	Yes

Action Summary:	Replace furnace.
Action: Commentary	
Action Type	Replacement
Cost	\$5,100
Year	2030
Priority	Low
Life Safety?	Not Applicable
Code Related?	Not applicable
If	No
Consequential Damage	N/A
Urgency of Action	Low
Energy & Efficiency	Not applicable or not apparent
Are there signs of Mould?	No

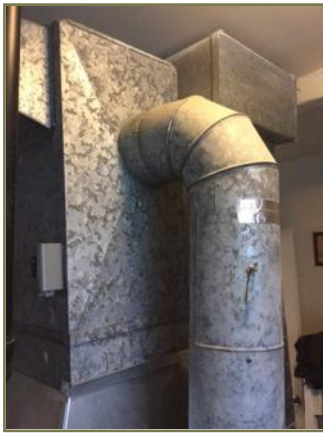
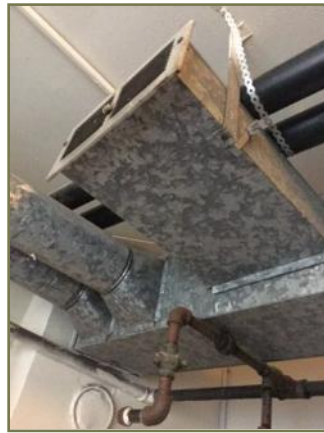
D3041 - Air Distribution Systems [1]

Discipline	Services
Category	D3041 - Air Distribution Systems
Element Number	1
Replacement Cost	\$5,100
Last Major Action	1958
Location/Name	Throughout
Brief Description	Metal ductwork.
Commentary	No issues reported.
Overall Condition	Good
Validated	Yes

<u>Action Summary:</u>	Replace metal ductwork
Action: Commentary	
Action Type	Replacement
Cost	\$5,100
Year	2030
Priority	Low
Life Safety?	Not Applicable
Code Related?	Not applicable
If	No
Consequential Damage	N/A
Urgency of Action	Low
Energy & Efficiency	Not applicable or not apparent
Are there signs of Mould?	No

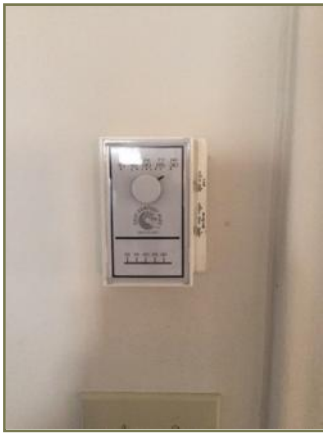
D3060 - Controls And Instrumentation [1]

Discipline	Services
Category	D3060 - Controls And Instrumentation
Element Number	1
Replacement Cost	\$510
Last Major Action	2010
Location/Name	Main floor
Brief Description	Thermostat
Commentary	No issues reported or observed.
Overall Condition	Good
Validated	Yes

Action Summary:	Replace thermostat
Action: Commentary	
Action Type	Replacement
Cost	\$510
Year	2035
Priority	Low
Life Safety?	Not Applicable
Code Related?	Not applicable
If	No
Consequential Damage	N/A
Urgency of Action	Low
Energy & Efficiency	Not applicable or not apparent
Are there signs of Mould?	No

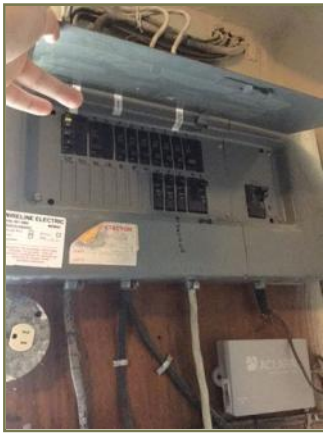
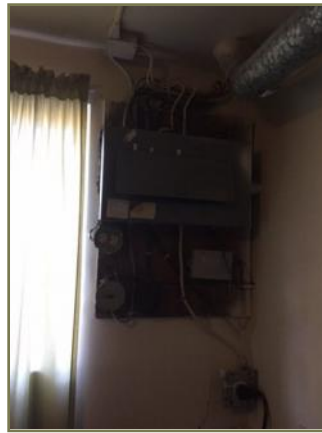
D5015 - Unit Electrical Service and Distribution [1]

Discipline	Services
Category	D5015 - Unit Electrical Service and Distribution
Element Number	1
Replacement Cost	\$3,060
Last Major Action	1995
Location/Name	Main floor
Brief Description	Circuit breaker panel.
Commentary	No issues reported or observed.
Overall Condition	Good
Validated	Yes

Action Summary:	Replace circuit breaker panel.
Action: Commentary	
Action Type	Replacement
Cost	\$3,060
Year	2025
Priority	Low
Life Safety?	Not Applicable
Code Related?	Not applicable
If	No
Consequential Damage	N/A
Urgency of Action	Low
Energy & Efficiency	Not applicable or not apparent
Are there signs of Mould?	No

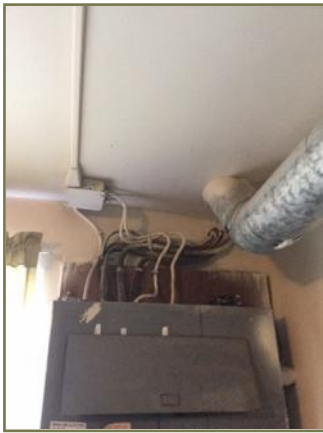
D5021 - Branch Wiring [1]

Discipline	Services
Category	D5021 - Branch Wiring
Element Number	1
Replacement Cost	\$6,120
Last Major Action	1958
Location/Name	Throughout
Brief Description	Branch wiring serving all electrical devices.
Commentary	No issues reported or observed.
Overall Condition	Good
Validated	Yes

Action Summary:	Replace branch wiring.
Action: Commentary	
Action Type	Repair
Cost	\$6,120
Year	2030
Priority	Low
Life Safety?	Not Applicable
Code Related?	Not applicable
If	No
Consequential Damage	N/A
Urgency of Action	Low
Energy & Efficiency	Not applicable or not apparent
Are there signs of Mould?	No

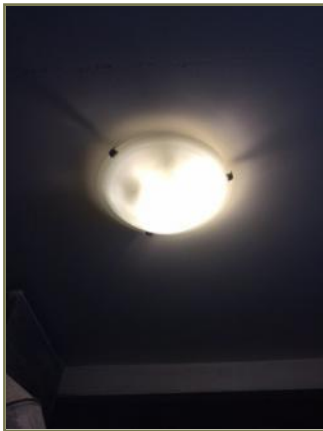
D5023 - Lighting Equipment - Units [1]

Discipline	Services
Category	D5023 - Lighting Equipment - Units
Element Number	1
Replacement Cost	\$1,530
Last Major Action	2015
Location/Name	Throughout
Brief Description	Ceiling mounted light fixtures.
Commentary	No issues reported or observed.
Overall Condition	Good
Validated	Yes

Action Summary:	Replace light fixtures.
Action: Commentary	
Action Type	Replacement
Cost	\$1,530
Year	2040
Priority	Low
Life Safety?	Not Applicable
Code Related?	Not applicable
If	No
Consequential Damage	N/A
Urgency of Action	Low
Energy & Efficiency	Not applicable or not apparent
Are there signs of Mould?	No

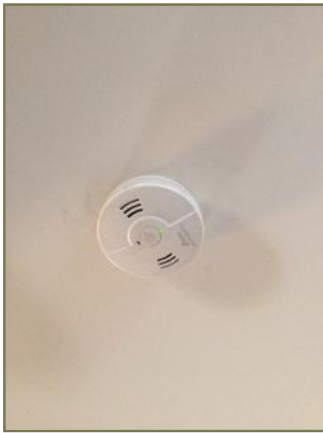
D5037 - Fire Alarm System [1]

Discipline	Services
Category	D5037 - Fire Alarm System
Element Number	1
Replacement Cost	\$1,020
Last Major Action	2014
Location/Name	
Brief Description	Combined smoke and carbon monoxide detector on each floor.
Commentary	No issues reported or observed.
Overall Condition	Good
Validated	Yes

Action Summary:	Replace some and carbon monoxide detectors
Action: Commentary	
Action Type	Replacement
Cost	\$1,020
Year	2025
Priority	Low
Life Safety?	Not Applicable
Code Related?	Not applicable
If	No
Consequential Damage	N/A
Urgency of Action	Low
Energy & Efficiency	Not applicable or not apparent
Are there signs of Mould?	No

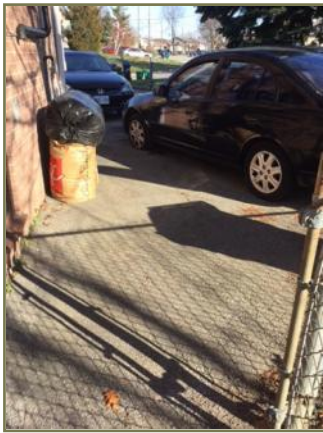
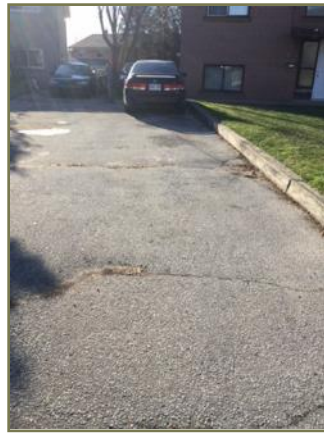
G2020 - Parking Lots [1]

Discipline	Building Sitework
Category	G2020 - Parking Lots
Element Number	1
Replacement Cost	\$3,060
Last Major Action	1990
Location/Name	
Brief Description	Asphalt pavement driveway.
Commentary	4 car driveway. Some cracking observed.
Overall Condition	Good
Validated	Yes

Action Summary:	Replace the asphalt driveway.
Action: Commentary	
Action Type	Replacement
Cost	\$3,060
Year	2027
Priority	Low
Life Safety?	Not Applicable
Code Related?	Not applicable
If	No
Consequential Damage	N/A
Urgency of Action	Low
Energy & Efficiency	Not applicable or not apparent
Are there signs of Mould?	No

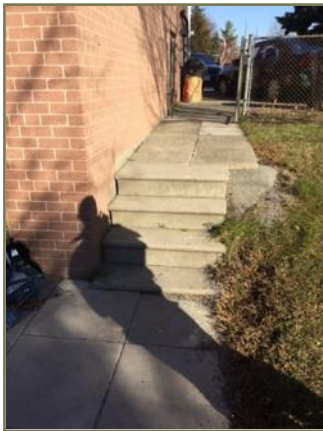
G2030 - Pedestrian Paving [1]

Discipline	Building Sitework
Category	G2030 - Pedestrian Paving
Element Number	1
Replacement Cost	\$1,530
Last Major Action	1958
Location/Name	East side
Brief Description	Concrete patio stone walkway and concrete steps.
Commentary	No issues reported or observed.
Overall Condition	Good
Validated	Yes

Action Summary:	Replace concrete patio stones and steps
Action: Commentary	
Action Type	Replacement
Cost	\$1,530
Year	2031
Priority	Low
Life Safety?	Not Applicable
Code Related?	Not applicable
If	No
Consequential Damage	N/A
Urgency of Action	Low
Energy & Efficiency	Not applicable or not apparent
Are there signs of Mould?	No

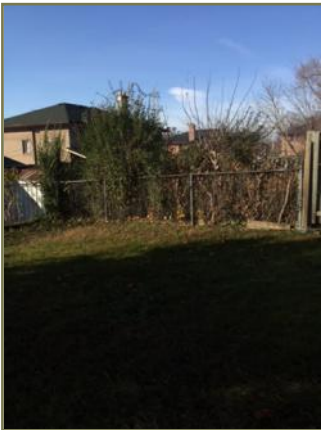
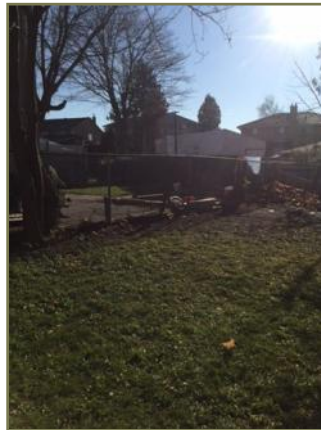
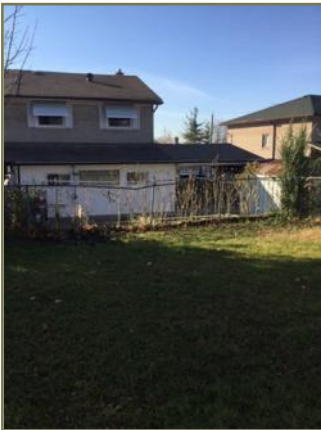
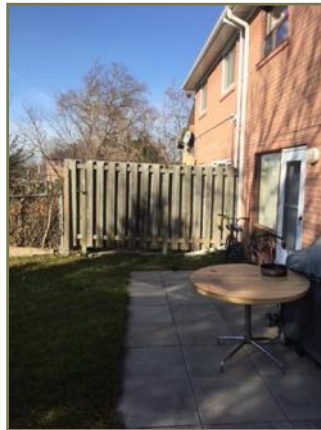
G2040 - Site Development [1]

Discipline	Building Sitework
Category	G2040 - Site Development
Element Number	1
Replacement Cost	\$7,140
Last Major Action	1980
Location/Name	Backyard
Brief Description	Metal post with linked chain fence along backyard property line. 3 meter long wood fence.
Commentary	No issues reported or observed.
Overall Condition	Good
Validated	Yes

Action Summary: Replace metal post with linked chain fence.

Action Summary: Replace wood fence

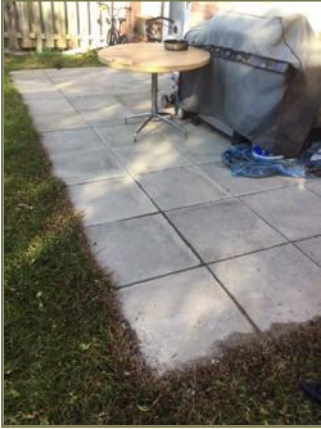
G2040 - Site Development [2]

Discipline	Building Sitework
Category	G2040 - Site Development
Element Number	2
Replacement Cost	\$1,530
Last Major Action	2015
Location/Name	Backyard
Brief Description	Concrete patio stones.
Commentary	No issues reported or observed.
Overall Condition	Good
Validated	Yes

Action Summary:	Replace concrete patio stones.
Action: Commentary	
Action Type	Replacement
Cost	\$1,530
Year	2045
Priority	Low
Life Safety?	Not Applicable
Code Related?	Not applicable
If	No
Consequential Damage	N/A
Urgency of Action	Low
Energy & Efficiency	Not applicable or not apparent
Are there signs of Mould?	No

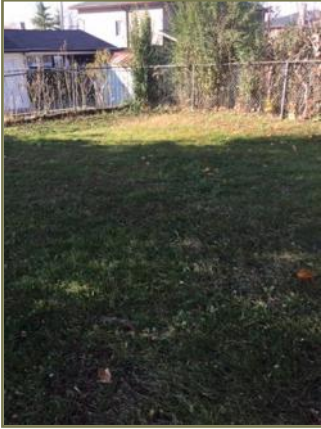
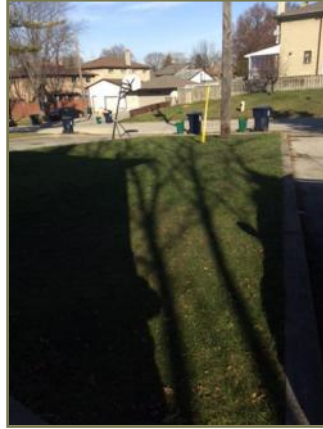
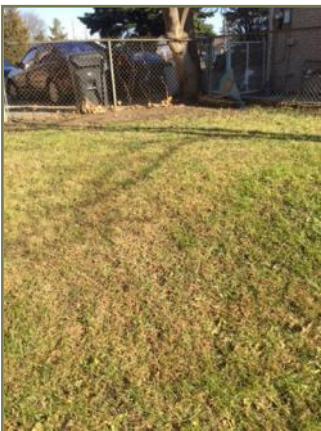
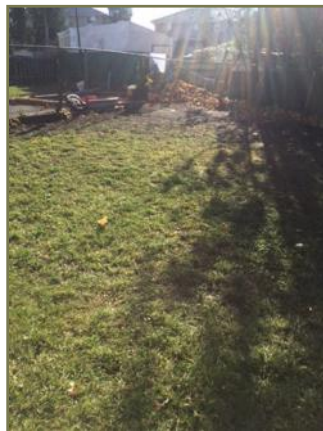
G2050 - Landscaping [1]

Discipline	Building Sitework
Category	G2050 - Landscaping
Element Number	1
Replacement Cost	\$510
Last Major Action	1958
Location/Name	Front and backyard
Brief Description	Sod and trees.
Commentary	No issues reported or observed. Assumed to be maintained by the tenant.
Overall Condition	Good
Validated	Yes

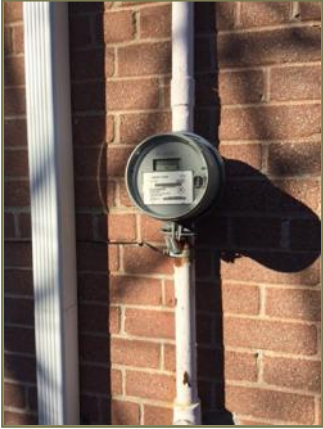
Discipline	Building Sitework
Category	G4010 - Electrical Distribution
Element Number	1
Replacement Cost	\$2,550
Last Major Action	1958
Location/Name	East wall
Brief Description	Hydro meter supplied by overhead cable
Commentary	No issues reported or observed.
Overall Condition	Good
Validated	Yes
