**REPORT ON
SLOPE STABILITY INVESTIGATION
DON MILLS ROAD AND EGLINTON AVENUE EAST
TORONTO, ONTARIO**

**Prepared for:
TORONTO AND REGION CONSERVATION AUTHORITY**

**Prepared By:
SIRATI & PARTNERS CONSULTANTS LIMITED**

Project: SP16-146-10
November 8, 2016

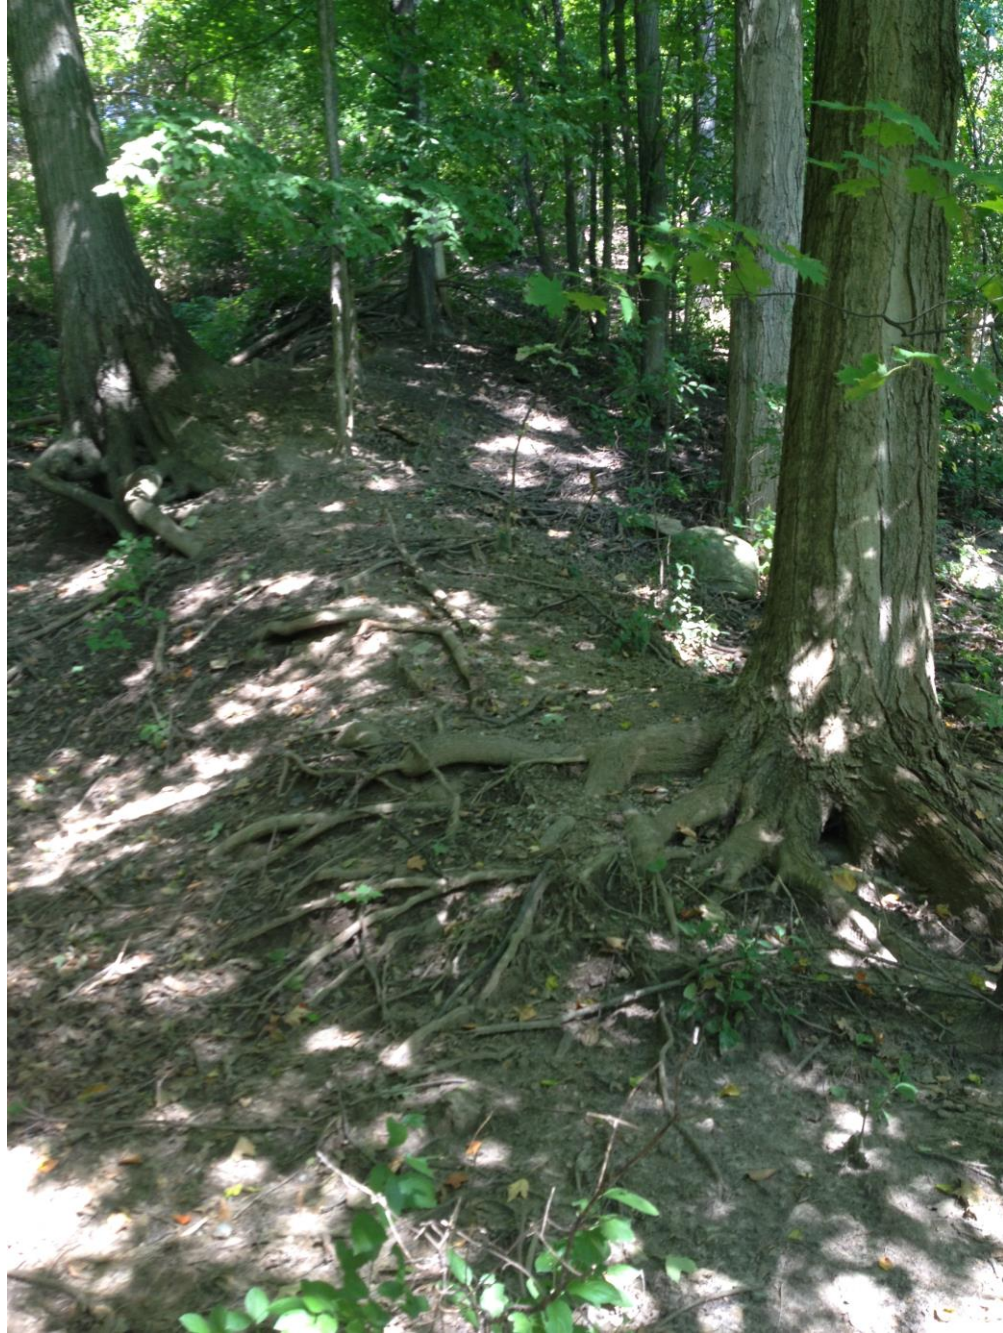
Photo 5: Exposed Tree Roots, Bending Trees in area of Section C-C (Looking North)

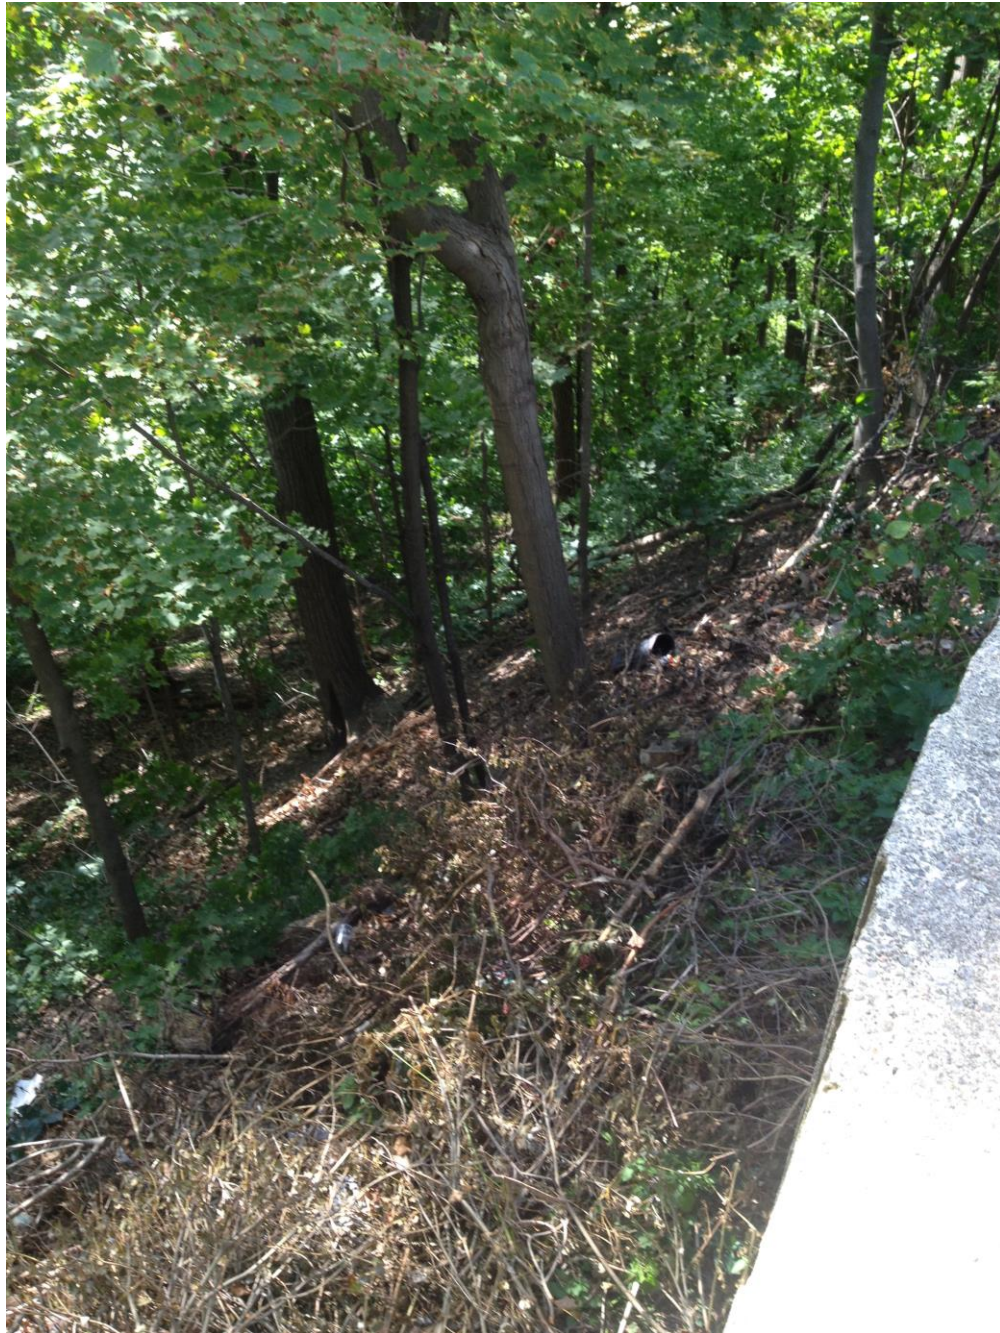
Photo 10: Slope Conditions behind Retaining Wall between Section G-G & F-F (looking southwest)

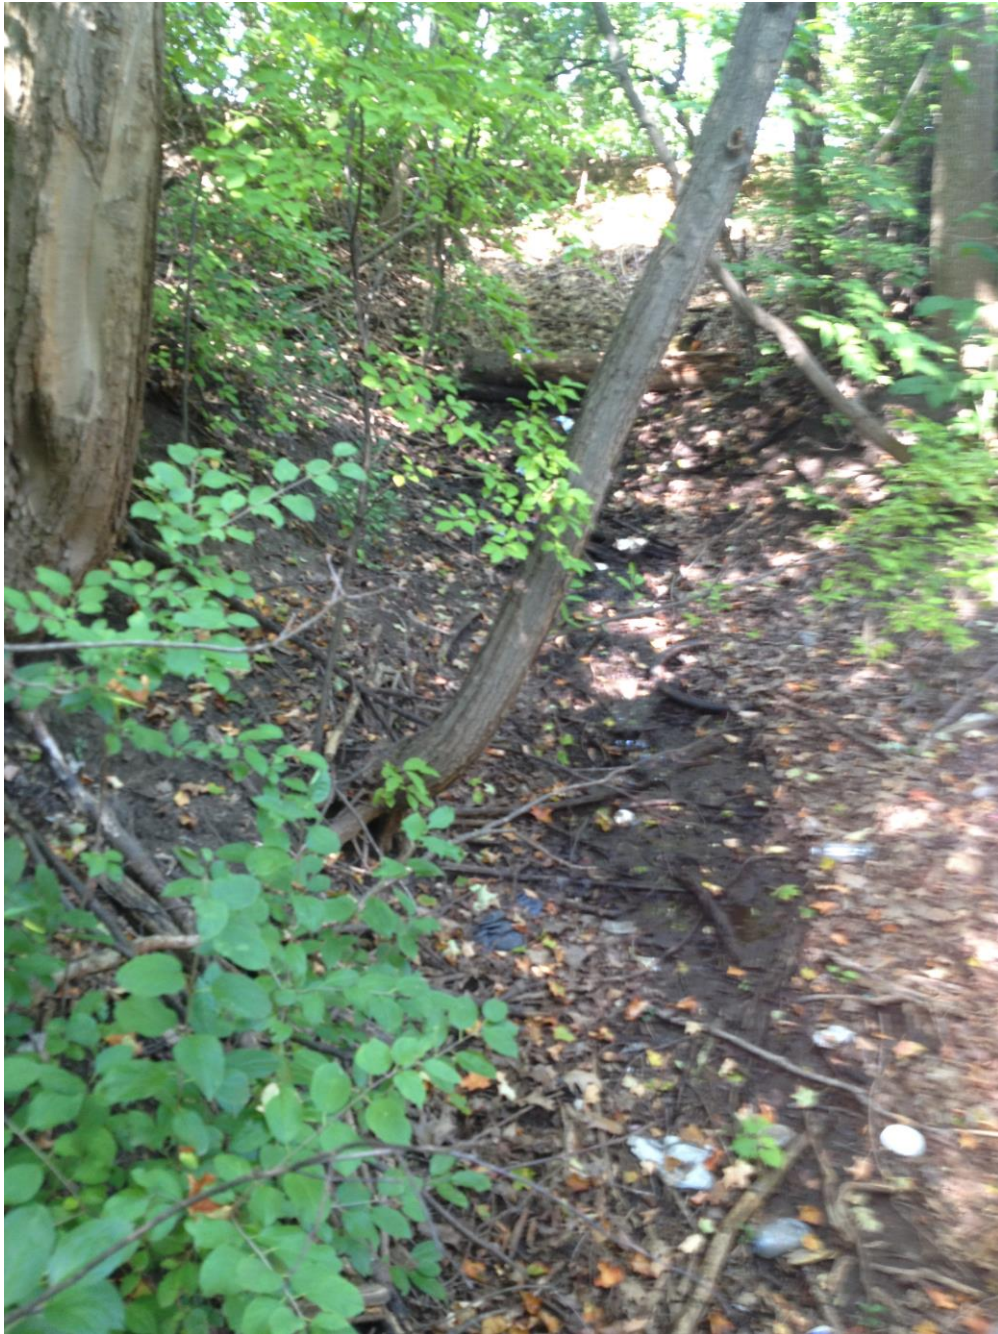
Photo 11: Drainage Gully between Section G-G & H-H (looking North)

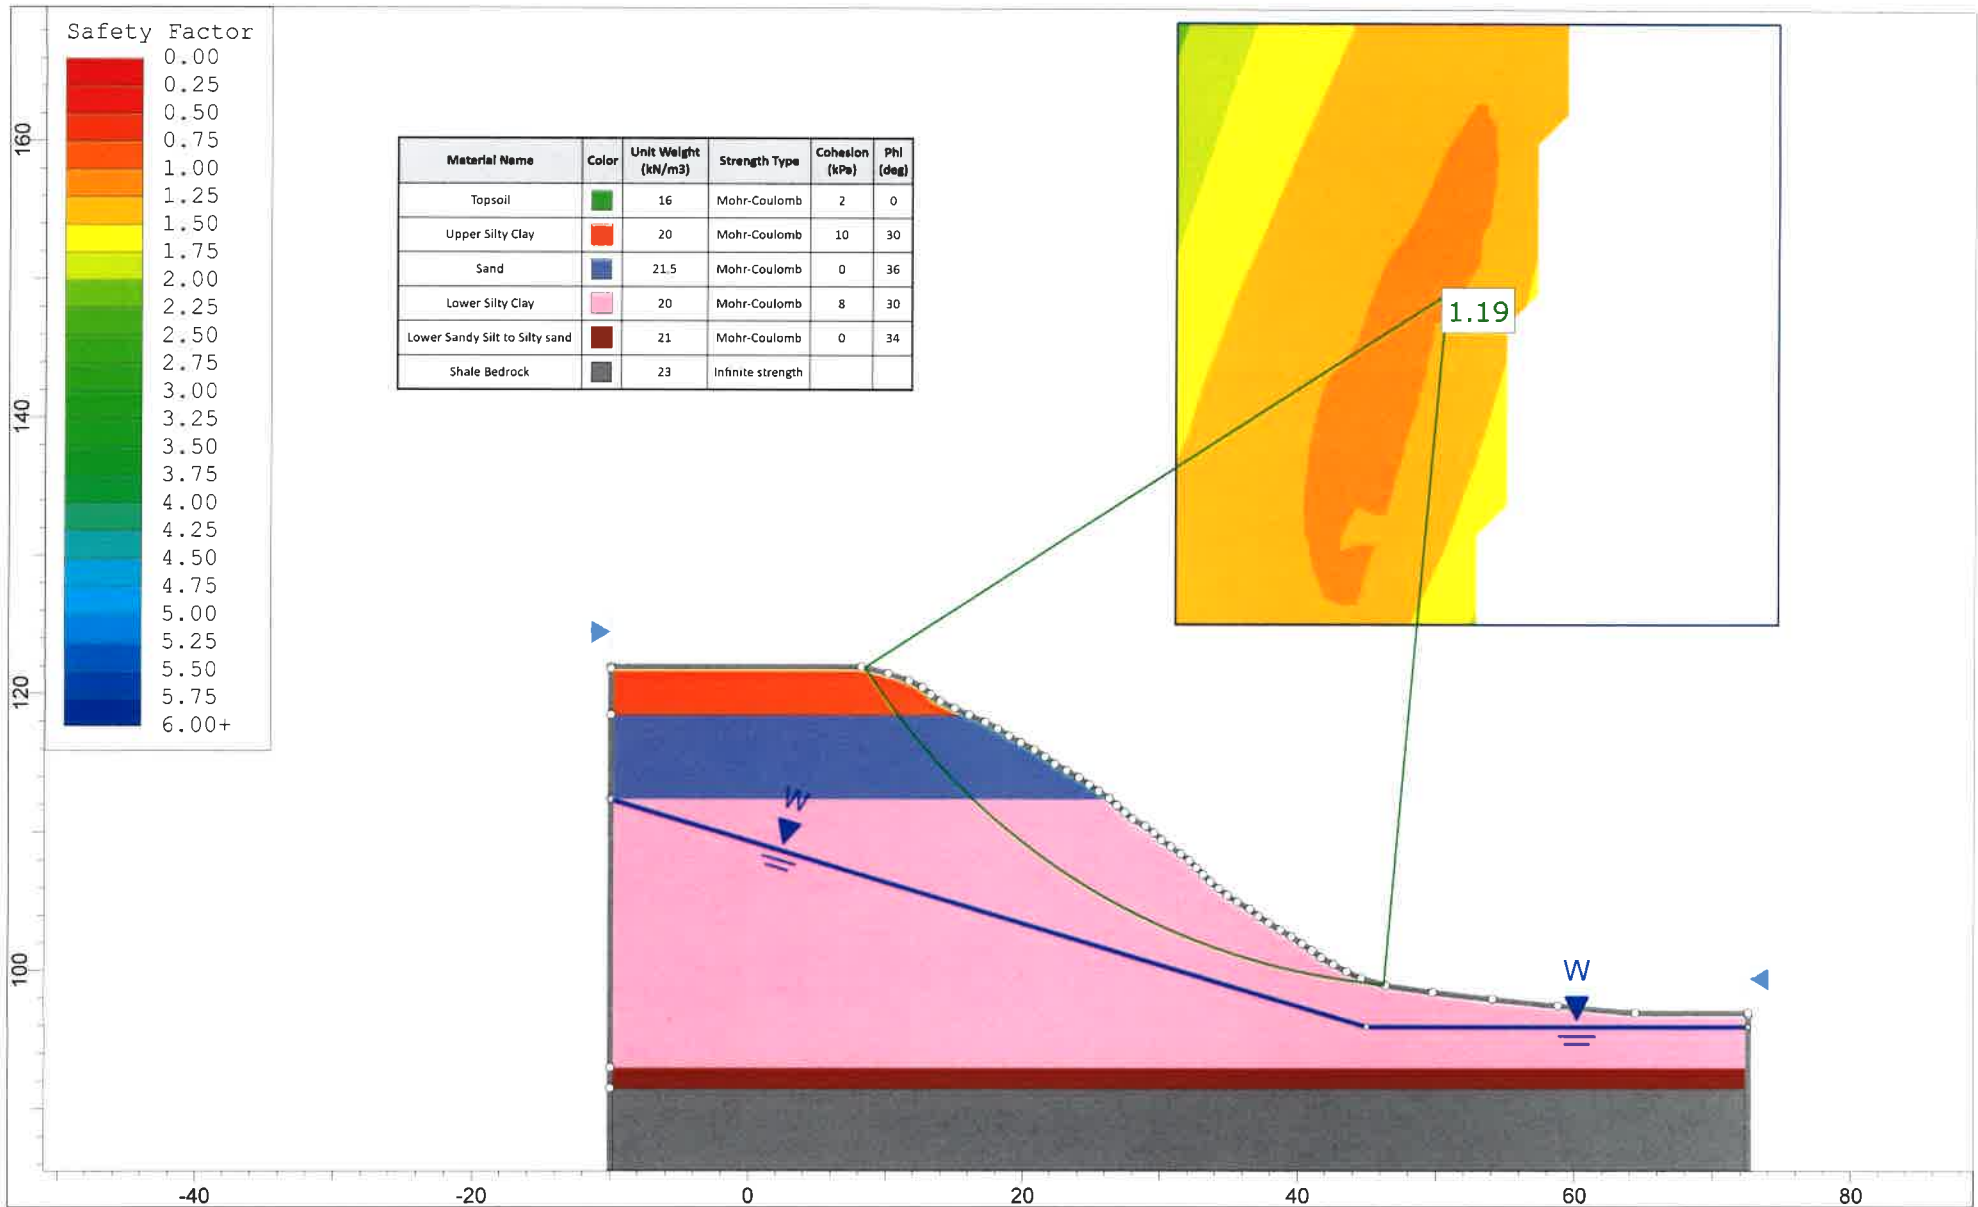
Project			
SP16-146-10 Slope Stability Investigation-Eglinton Avenue & Don Mills Road, Toronto, ON			
Analysis Description			
Existing Slope at Section B-B			
Drawn By	AS	Scale	1:550
Company	SPCL		
Date	2016-09-23	File Name	Drawing C1.slim

Stability analyses of the existing slopes at Section B-B, Section D-D and Section G-G have been carried out and the results are presented on Drawings C1 to C3, using the soil parameters listed in Table 1 and considering the soil profiles in the nearby boreholes.

The calculated factor of safety (FS) of the existing slopes at Section B-B, Section D-D and Section G-G range from 1.19 to 1.31, which are less than the generally acceptable value of 1.5 for long-term stability of slopes. The existing slopes at Section B-B, Section D-D and Section G-G are considered unstable in terms of their long-term stability.

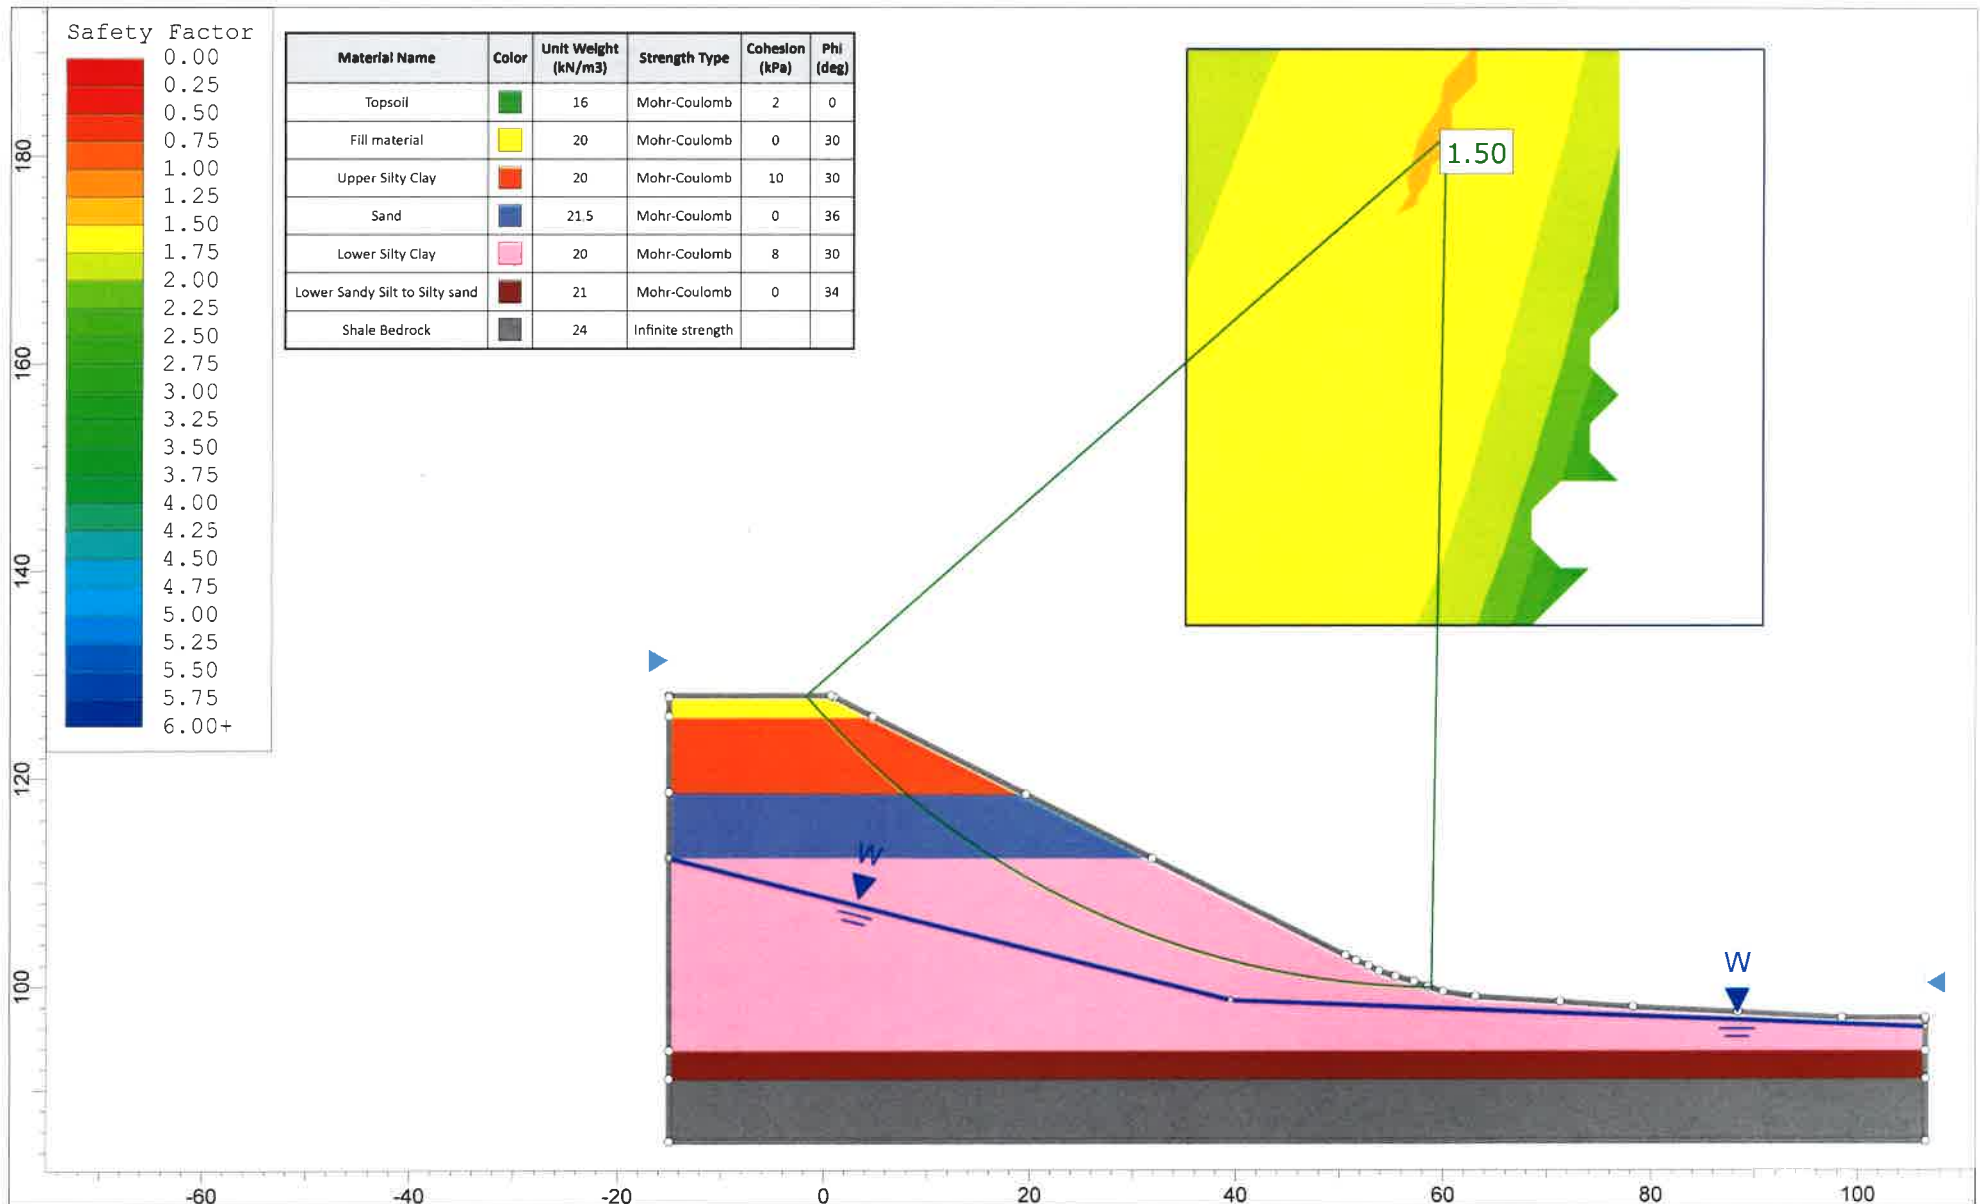
Project					
SP16-146-10 Slope Stability Investigation-Eglinton Avenue & Don Mills Road, Toronto, ON					
Analysis Description					
2H:1V Slope at Section D-D					
Drawn By	AS	Scale	1:733	Company	SPCL
Date	2016-09-23			File Name	Drawing C4.slim

In order to determine the steepness of the long-term stable slope, analyses of imaginary flatter slopes of 2H:1V have been carried out at Section B-B, Section D-D and Section G-G, as shown on Drawings C4 to C6 in Appendix C. The calculated factors of safety (FS) of the imaginary 2.0H: 1V slope on Drawings C4 to C6 are 1.50 to 1.53, which are equal or greater than the minimum acceptable value of 1.5. The 2.0H: 1V slope shown on Drawings C4 to C6 are considered stable in terms of long-term stability.

Based on the slope stability analyses results, the slopes of 2H: 1V or flatter inclination are considered to be the stable in terms of long-term stability of slopes.
