Page 1 MEMO

To:	City of Toronto	Date:	January 23 th , 2017
From:	MMM Group Limited	Job No.:	3216026
Subject:	Glen Road Pedestrian Tunnel - Field Investigation Memorandum

MMM Group Limited (MMM), on behalf of the City of Toronto (City), is undertaking a Class Environmental Assessment (EA) on the Glen Road Pedestrian Bridge. Included in this EA is a pedestrian tunnel adjacent to the bridge. This memo presents the findings of the field investigation for the pedestrian tunnel.

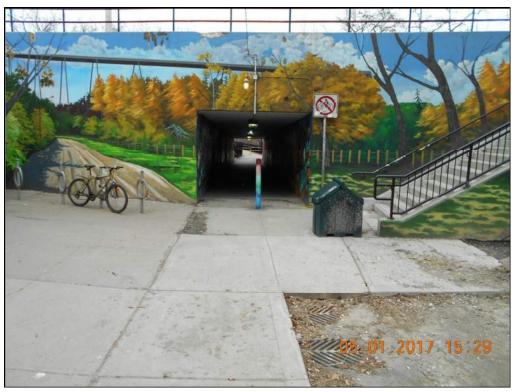
Retaining Walls – are generally in good to fair condition with some local spalls and delamination (see Photographs 2, 17, 21, 22 and 24).

Photo 2: South Entrance

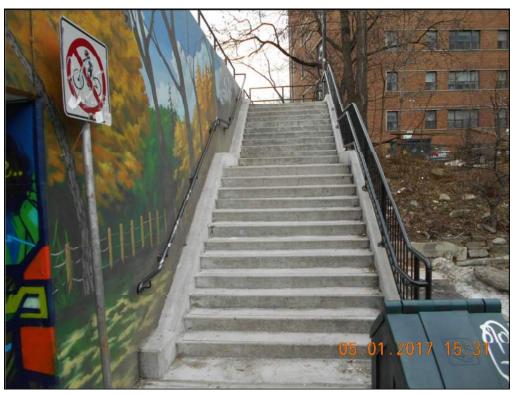
South Stairs – are generally in good condition with evidence of resurfacing (see Photograph 3).

Photo 3: Stairs from South Entrance to Bloor Street

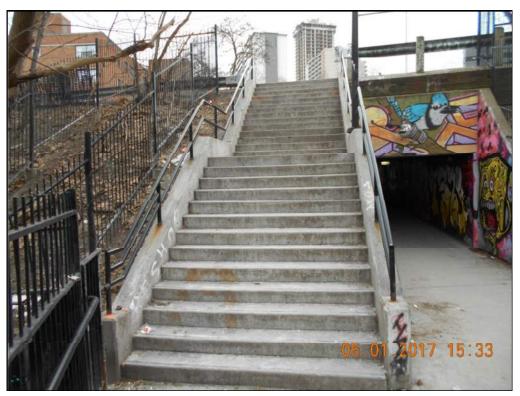
North Stairs – are generally in good condition with evidence of resurfacing. Noted the east curb has some spalled concrete from previous patches (see Photograph 4).

Photo 4: Stairs from North Entrance to Bloor Street

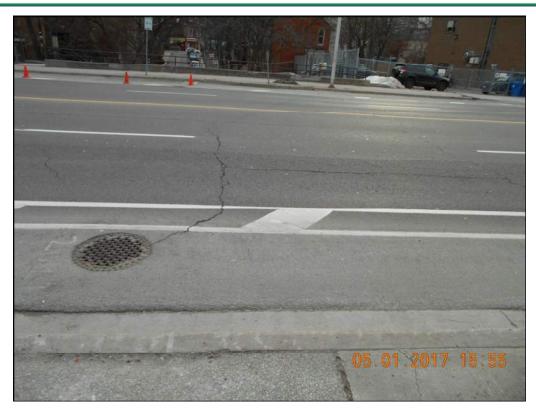
Asphalt (above tunnel) – is generally in good to fair condition with unsealed cracks in the northernmost Bloor Street lane (see Photographs 7 and 8).

Photo 7: Asphalt Wearing Surface above Tunnel (looking south)

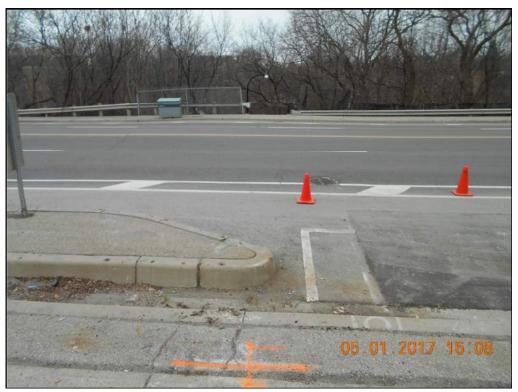
Photo 8: Asphalt Wearing Surface above Tunnel (looking north)

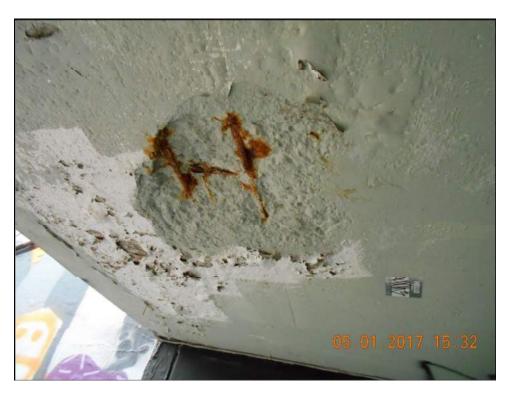
Soffit – is in generally good condition with localized spalling noted near the north entrance (see Photograph 15) and medium to wide cracks noted at the construction joints and parallel to the south entrance fascia (see Photograph 16).

Photo 15: Spall at North Entrance Soffit

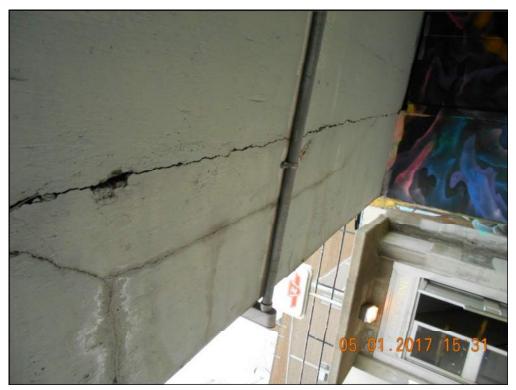
Photo 16: South Entrance Soffit

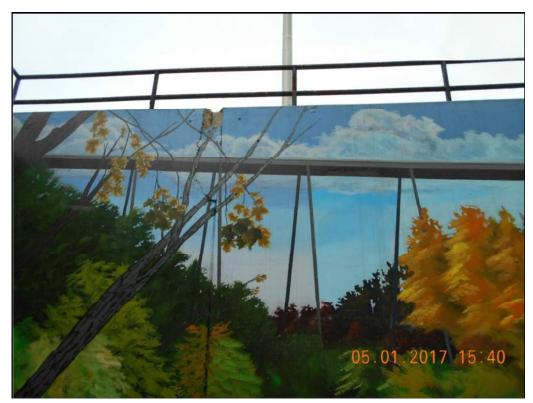
Photo 17: Crack and Spall in South Retaining Wall

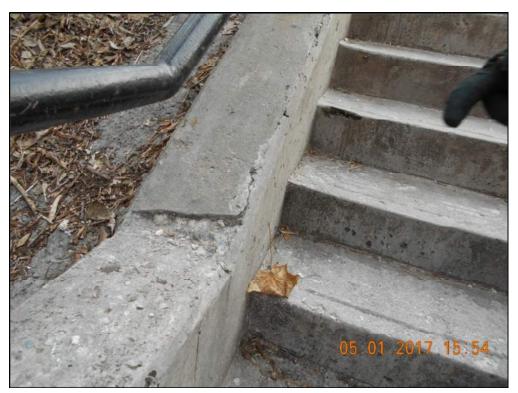
Photo 18: Spalling of Patch on North Stair Curb

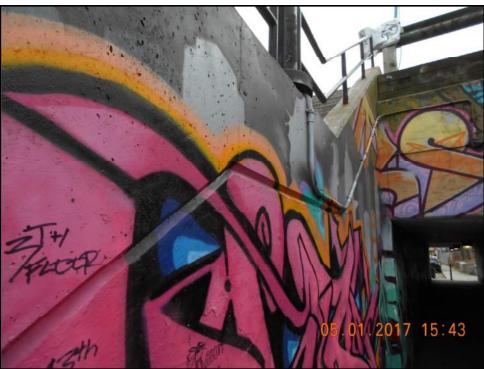
Photo 21: North Stairs Wall (Newer Concrete Curb)

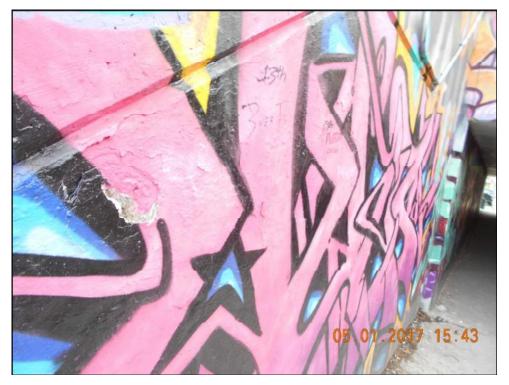
Photo 22: North Stairs Wall (Original Concrete Curb)

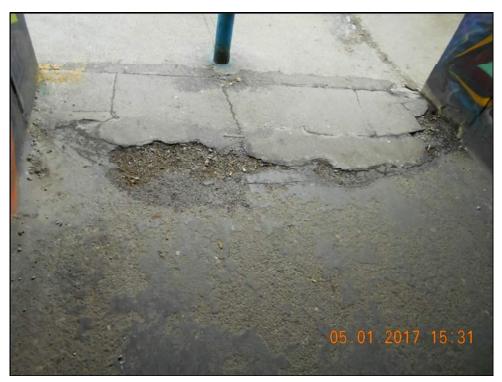
Floor Slab – is in generally fair to good condition with localized delamination, spalling and medium cracks noted at the south entrance and scaling noted (see Photograph 23).

Photo 23: South Entrance Floor Slab

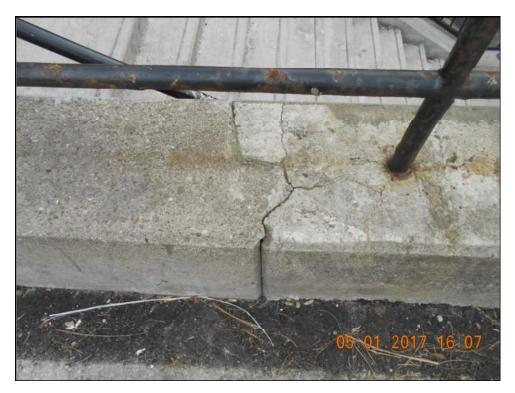
Railings – are generally in fair to poor condition with peeling paint, rust and scaling throughout (see Photograph 24).

Photo 24: Construction Joint in South Retaining Wall and Typical Railing Condition
